RE: Taproot – Produced Water Release, Hale Site, Briggsdale, CO

# Taproot Rockies Midstream

8.19.21 Produced Water Release  
Weld County, CO  
Hale Site

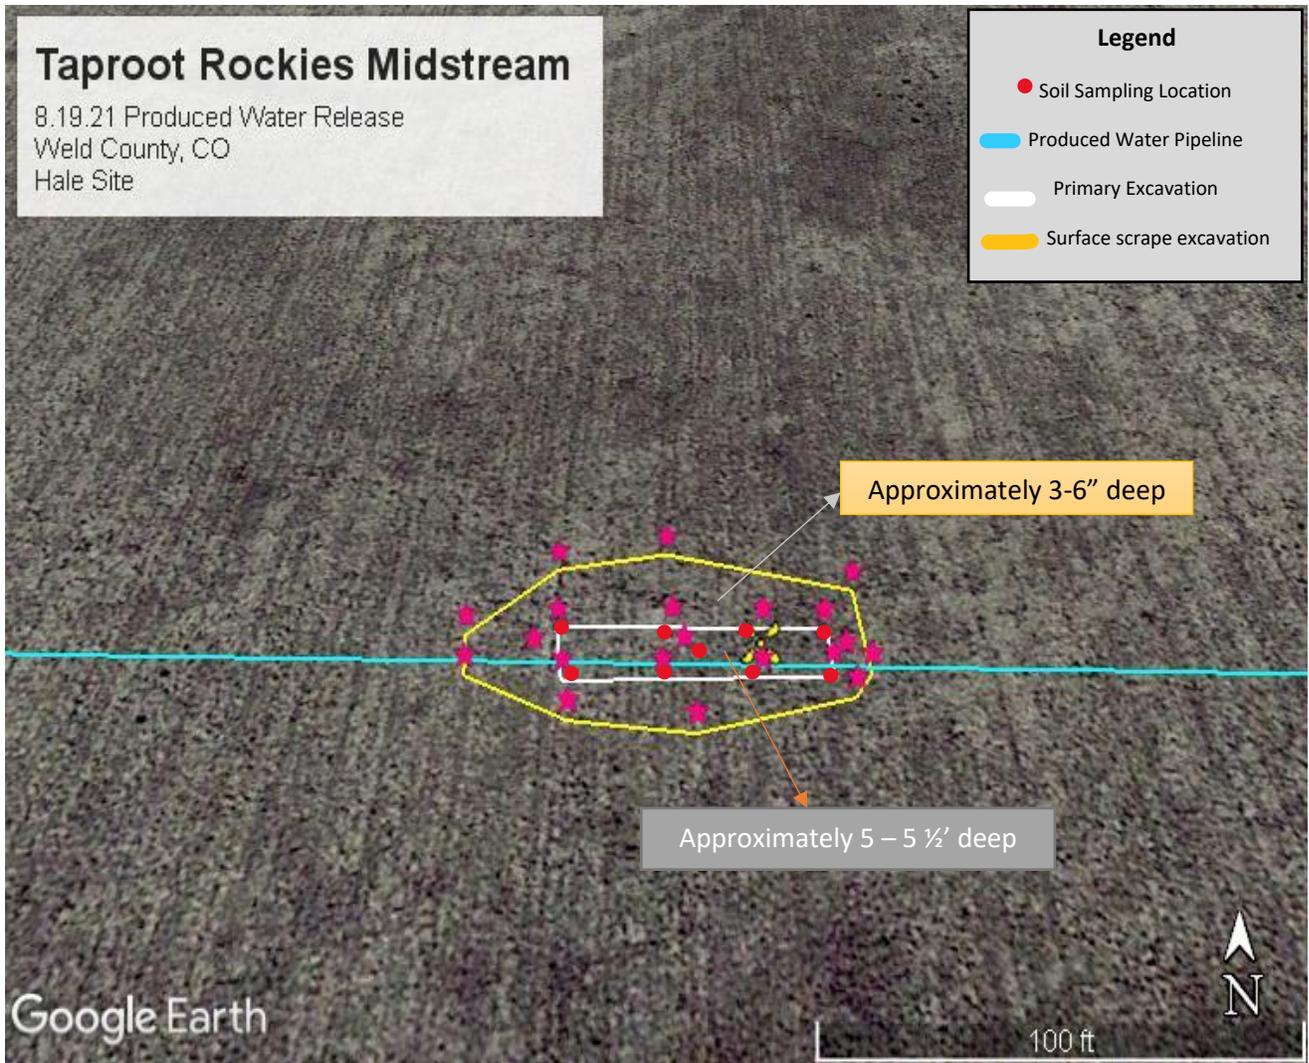
- Soil Sampling Location
- Produced Water Pipeline
- Primary Excavation
- Surface scrape excavation

**0900-1630 hrs:** Primary area of impact was excavated. The excavation was approximately 70' in length by 15' wide and 5.5' deep. Impacted material was transferred to Pawnee Landfill for disposal. Secondary excavation was accomplished by using a surface scraper (road grater) to remove impacted soil in an area approximately 30' by 40' and 3-6" in depth.

**0700-1200 hrs:** Additional impacted soil excavated utilizing HydroVac and excavator. Impacted material was transferred to Pawnee Landfill for disposal. Nine soil samples were collected from the primary excavation. Eight samples were collected from the sidewall (SW 1 – 8) and one sample was collected from the floor of the excavation (FS 1).

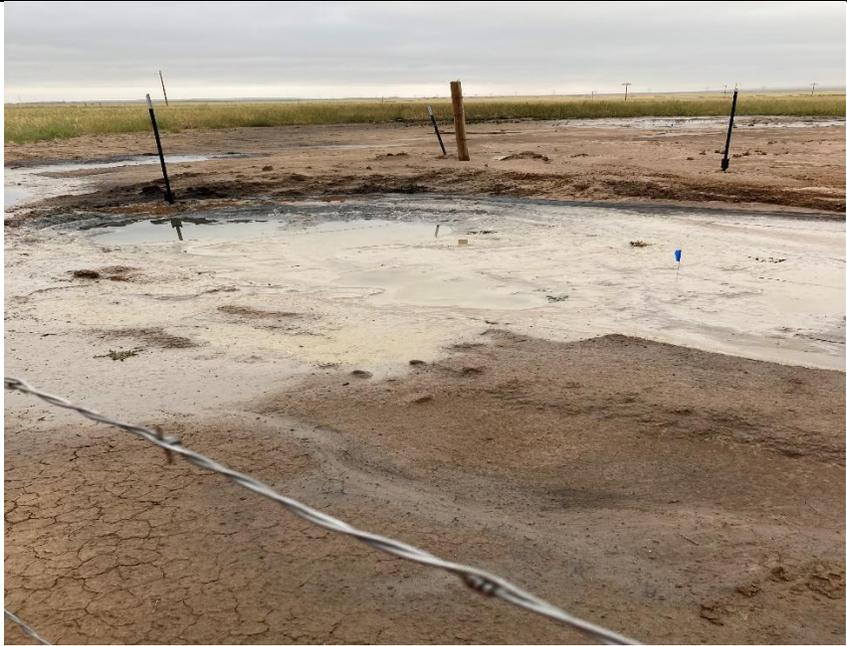
**Photo: 1**  
**Description:**  
Initial site conditions.

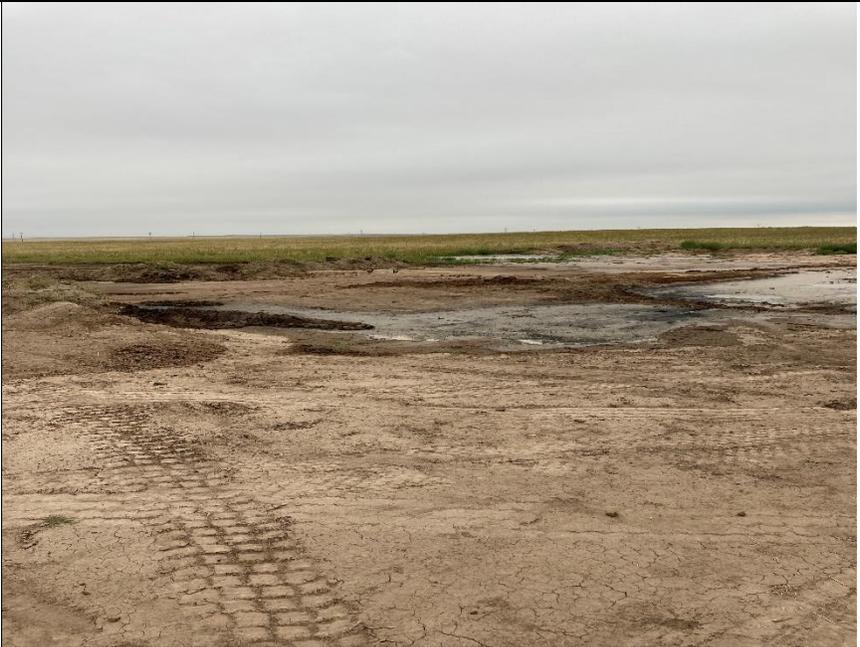
**Photo: 2**  
**Description:**  
Initial site conditions.

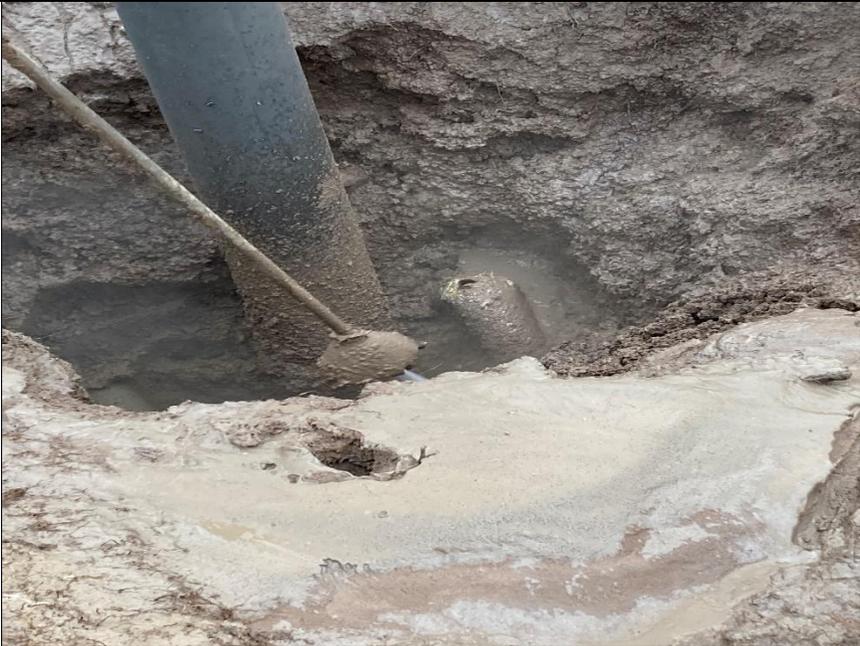
**Photo: 3**  
**Description:**  
Hydro Excavation.  
Daylighting pipeline.

**0700-0900 hrs:** HydroVac unit observed onsite to recover free liquids. The impacted area was approximately 100' in length by 50' wide.

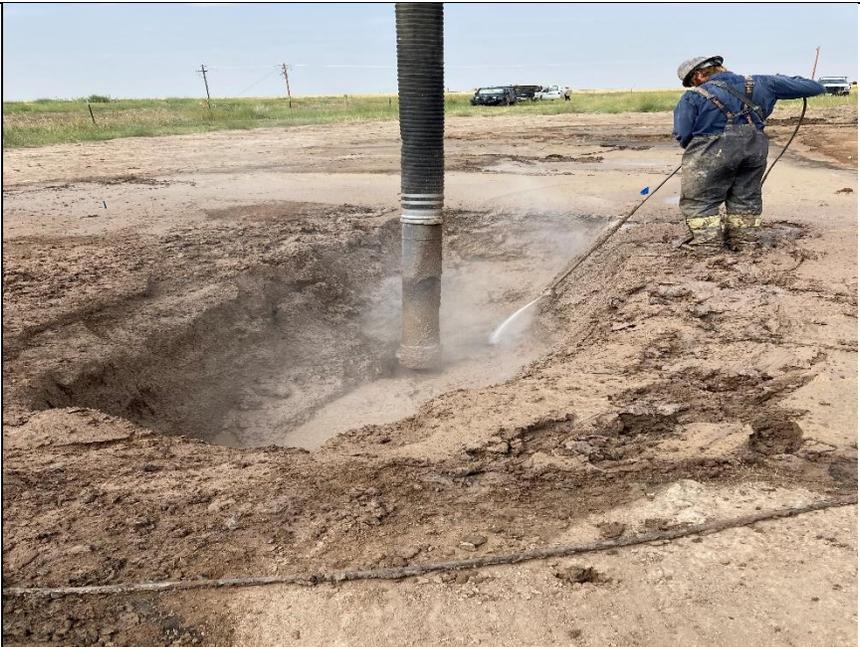
**Photo: 4**  
**Description:**  
Hydro Excavation.

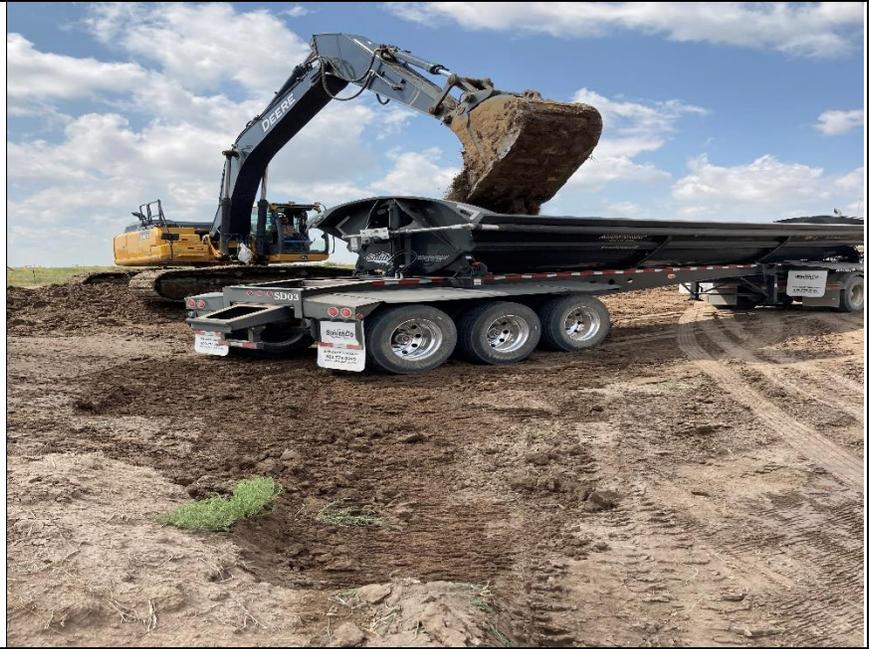
**Photo: 5**

Loading impacted soil.
