Inspection Photos

API: 071-06976

Operator: EVERGREEN NATURAL RESOURCES

Inspection Date: 8/27/2021

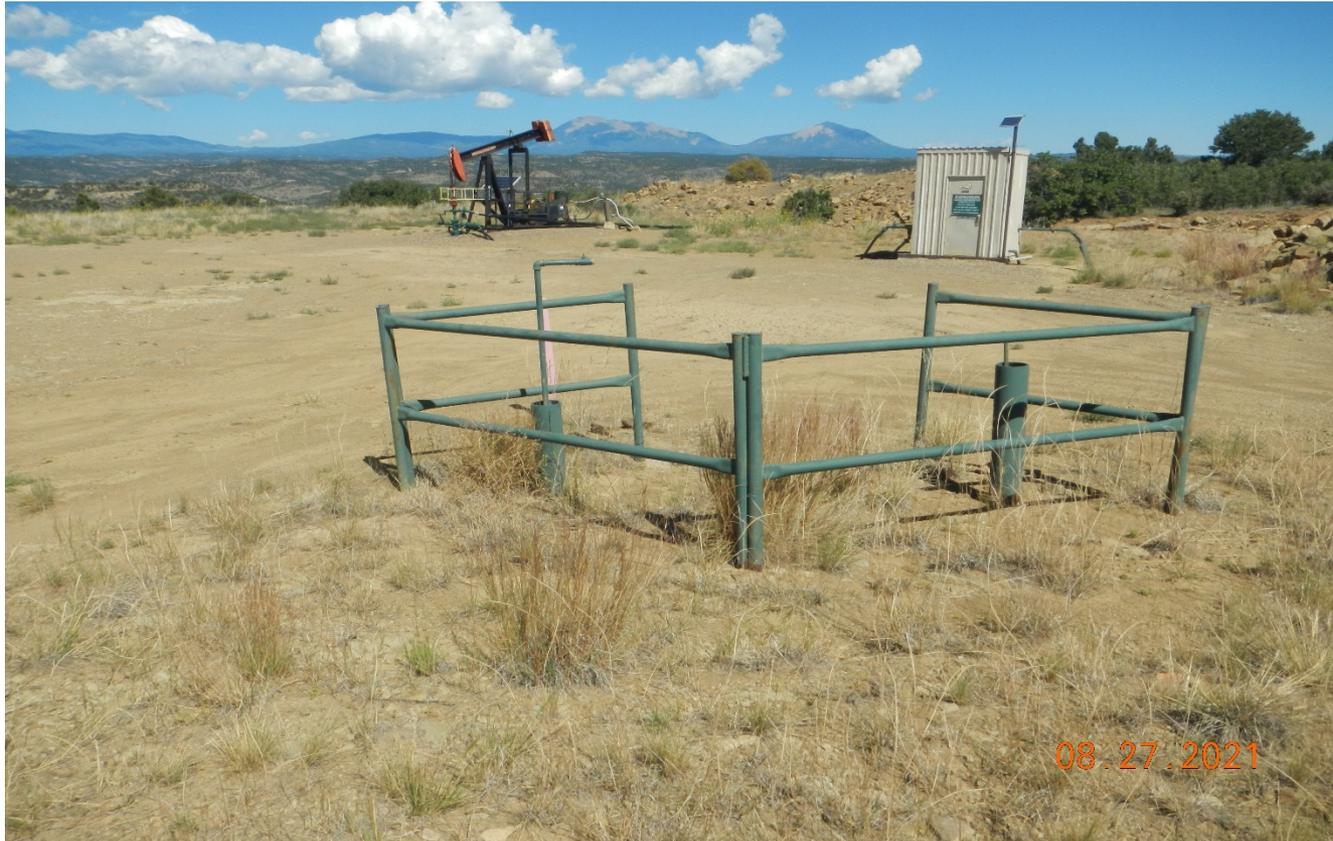
Photo 1. Facing north towards the well site.

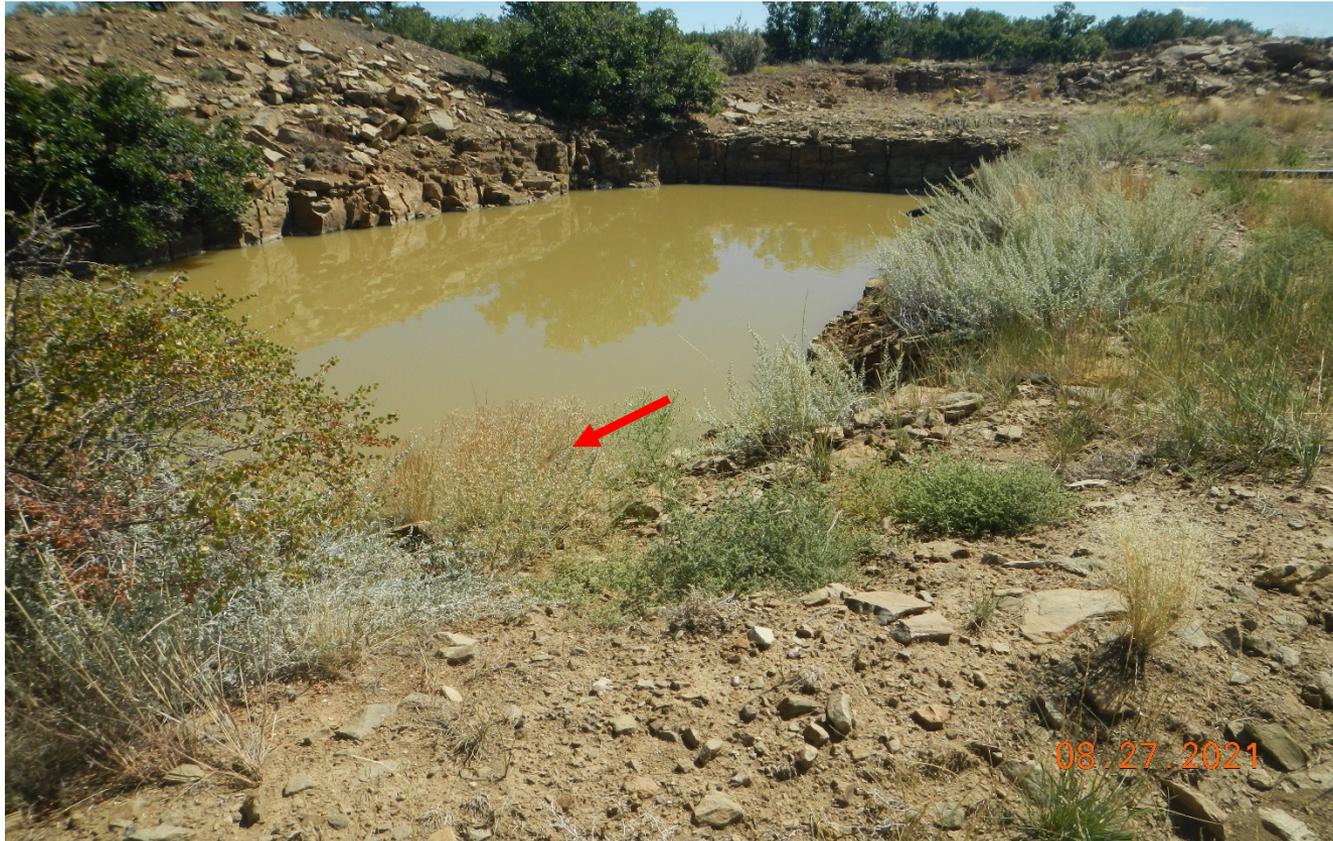
Photo 2. Facing toward the pit. There are noxious weeds (Diffuse knapweed) shown at red arrow. Some of the noxious weeds are beginning to disperse seed.

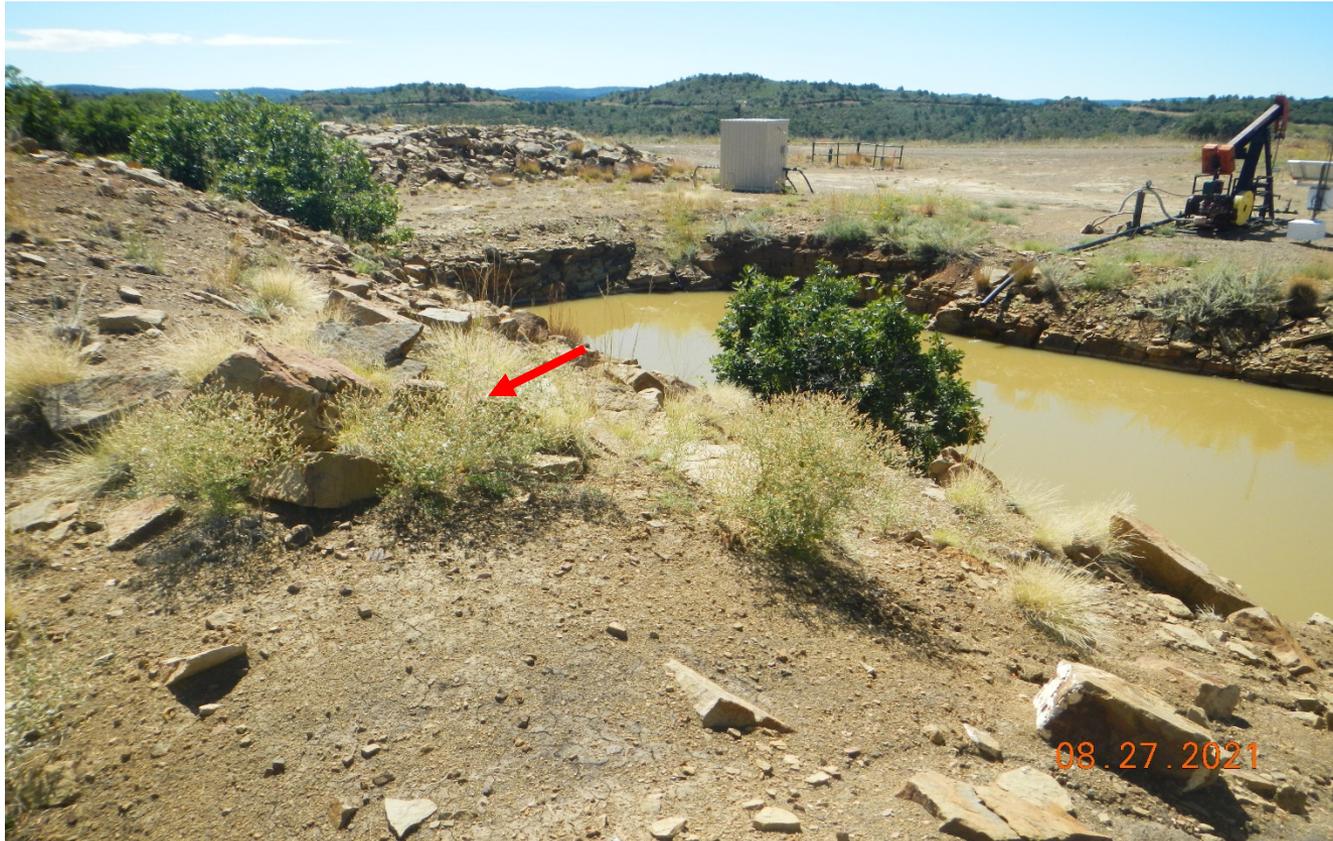
Photo 3. Facing south on the pit berm. There are noxious weeds (Diffuse knapweed) shown at red arrow and on the backside. Some of the noxious weeds are beginning to disperse seed.
