Final Reclamation Inspection

Operator: PDC ENERGY INC - 69175

Location ID: 332811

Inspection Photos
Location Name: Korwick 5-28
Location ID: 332811

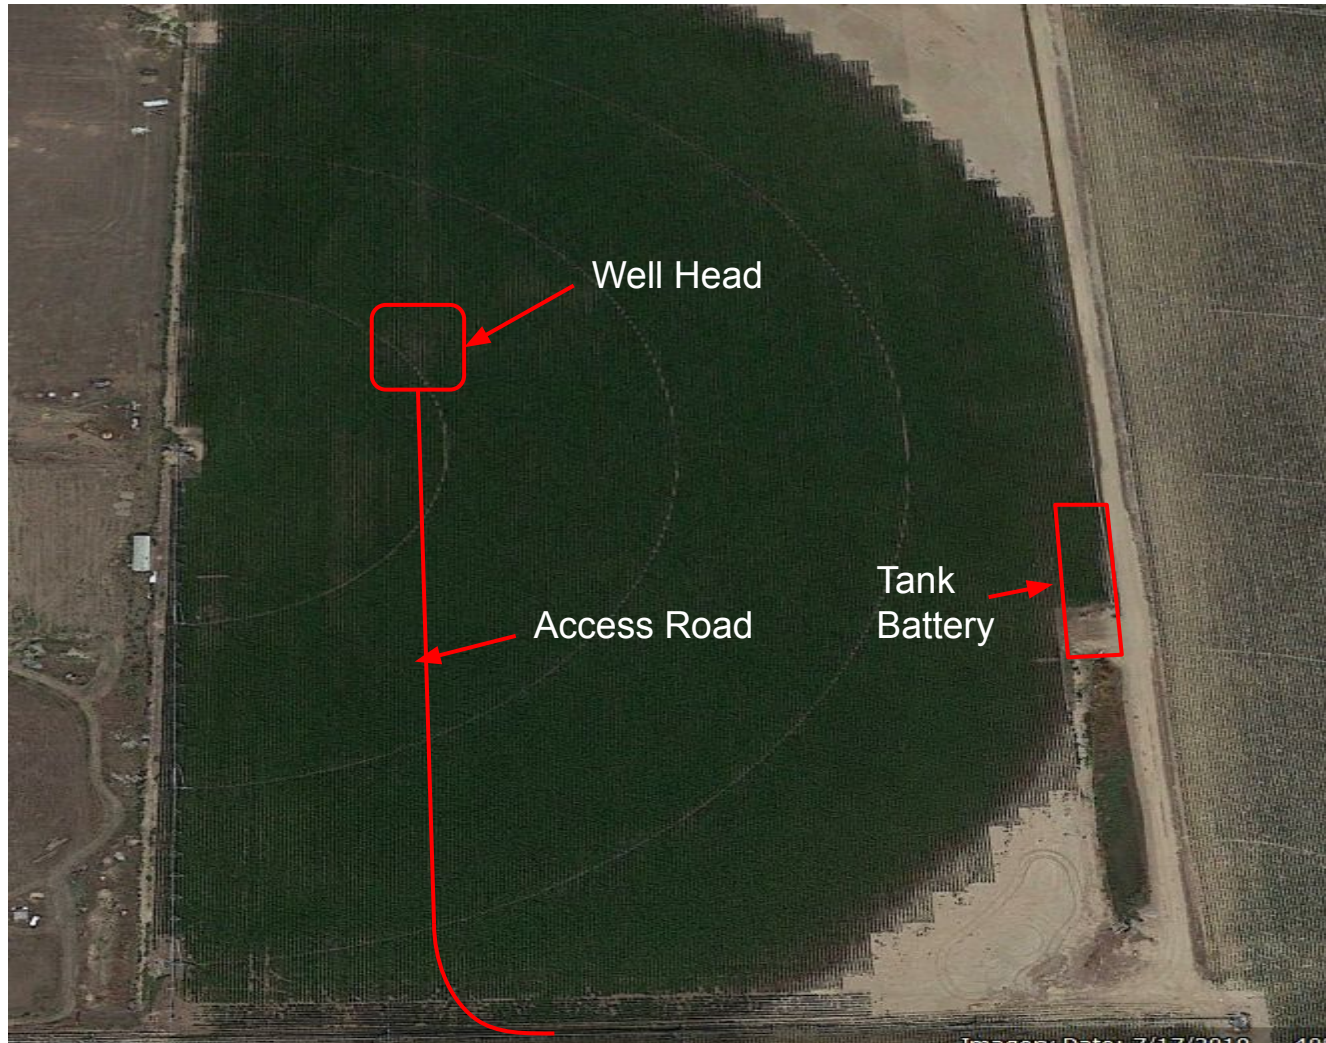
Photo 1. 2019 aerial imagery shows well head, access road and associated tank battery (north is up).

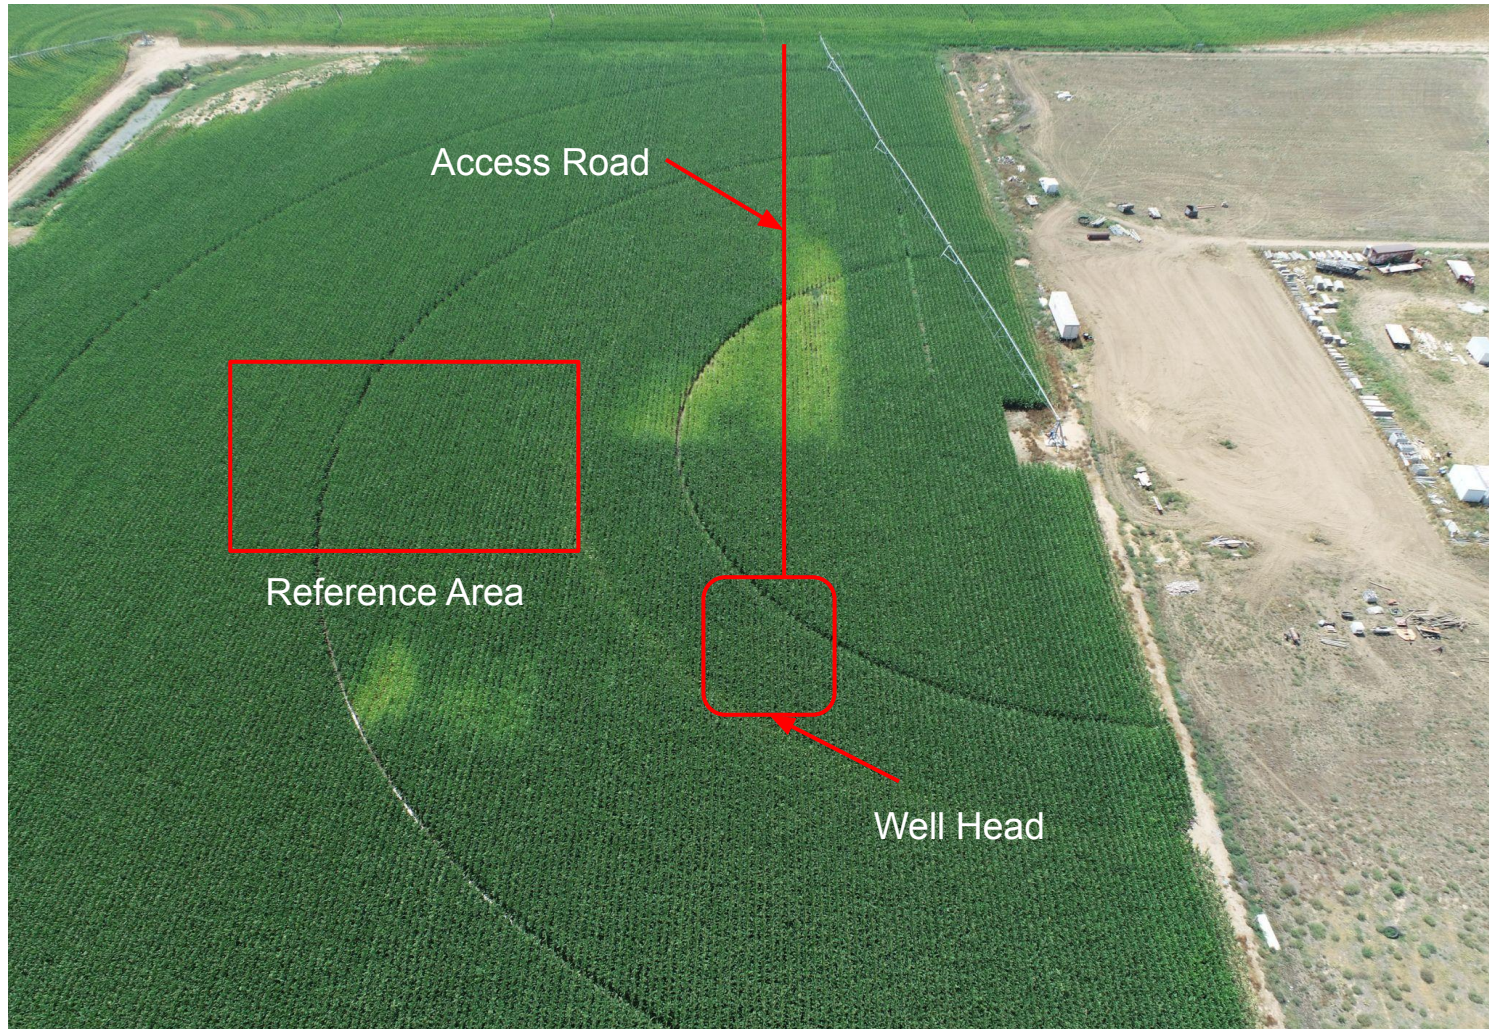
Photo 2. Overview photo of well head, access road and reference area taken from the north side of well head facing south using a drone. Photo shows crop within well head appear consistent with adjacent reference area. Note: Lighter crop patch next to access road is not associated with oil/gas operations, likely a watering issue because of the size.

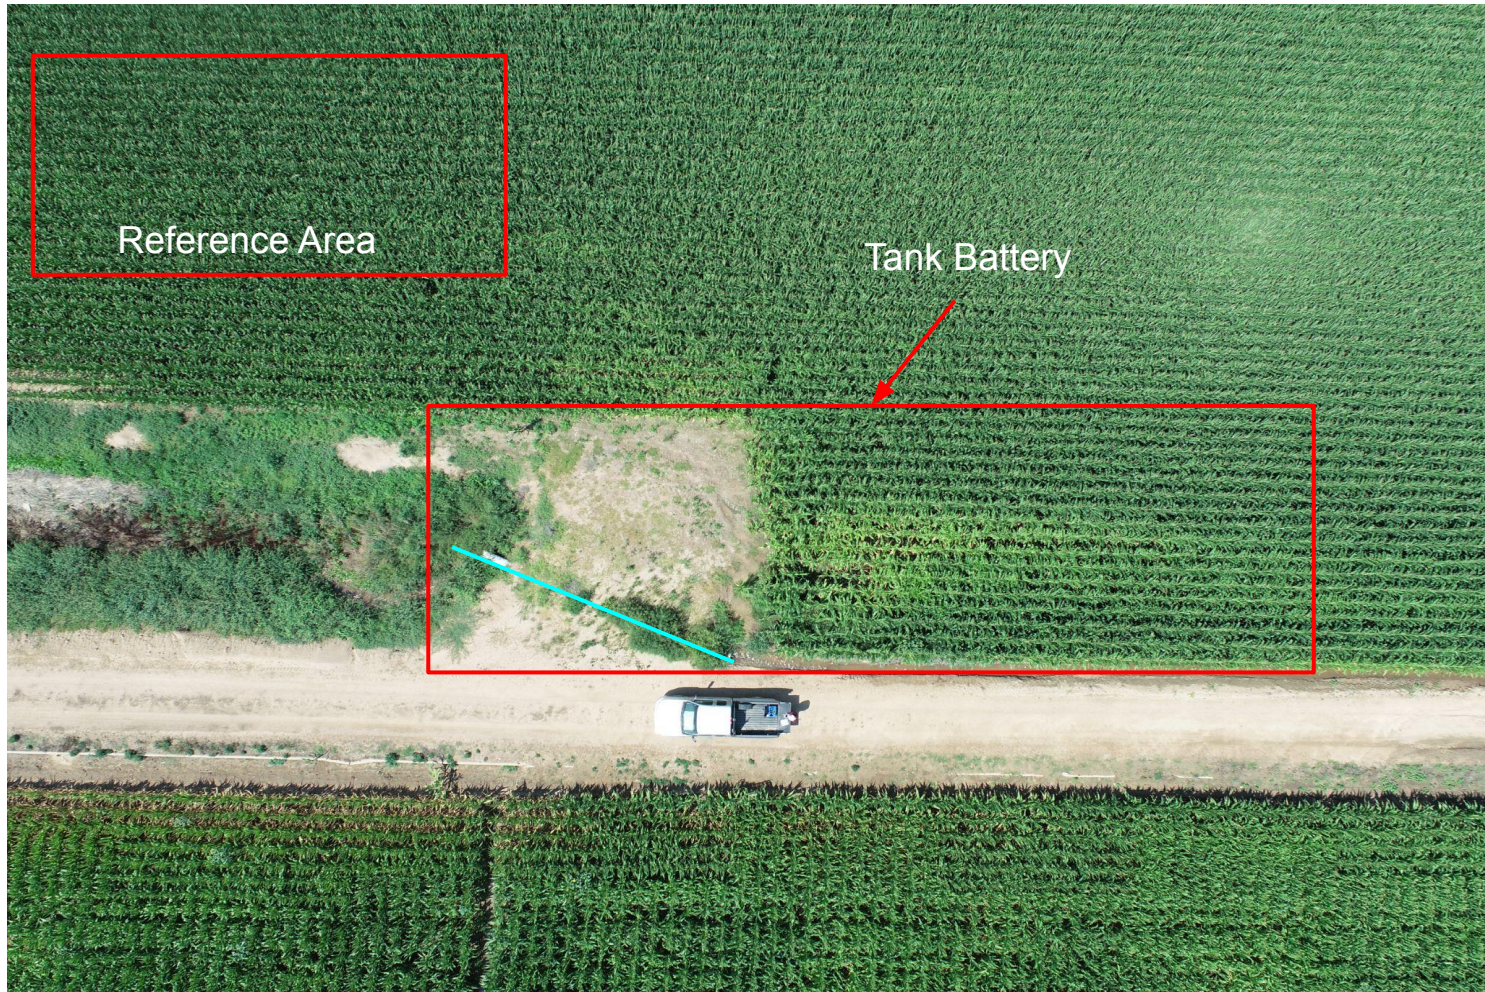
Photo 3. Overview photo taken of tank battery and reference area (north is right). Note: Half of tank battery still remains, likely serving as access to eastern edge of field. New culvert has been constructed and feeds holding pond just south of the tank battery (highlighted in blue).

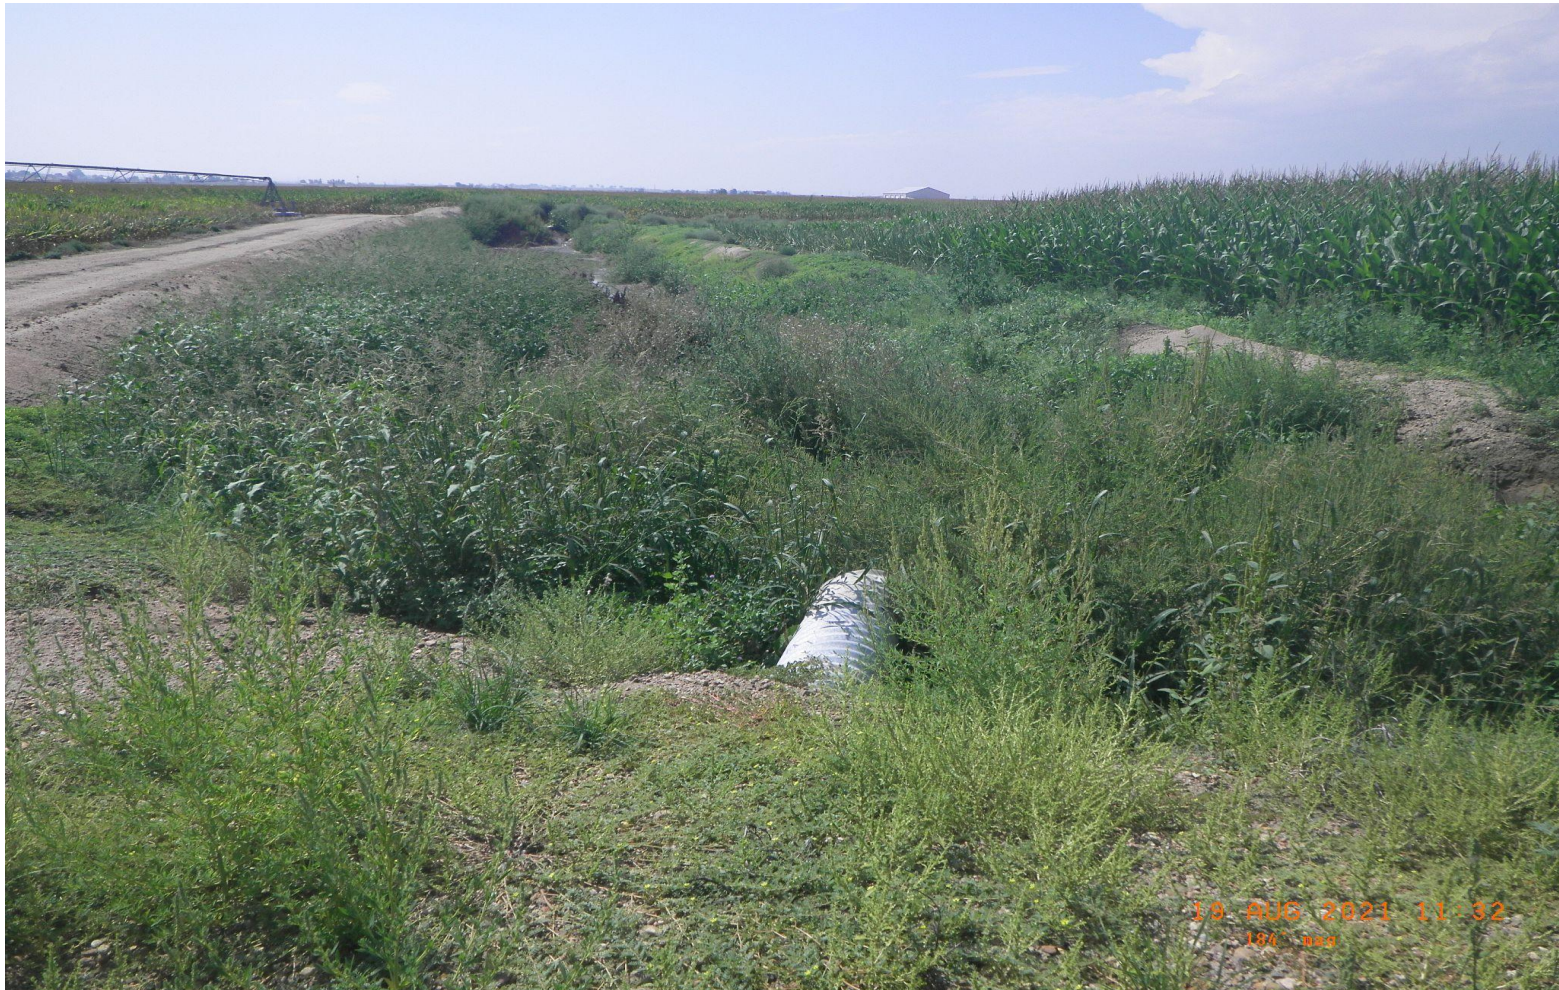
Photo 4. Ground photo of culvert taken from southern portion of tank battery. Photo shows north to south running culvert that feeds into holding pond just south of tank battery disturbance pad.

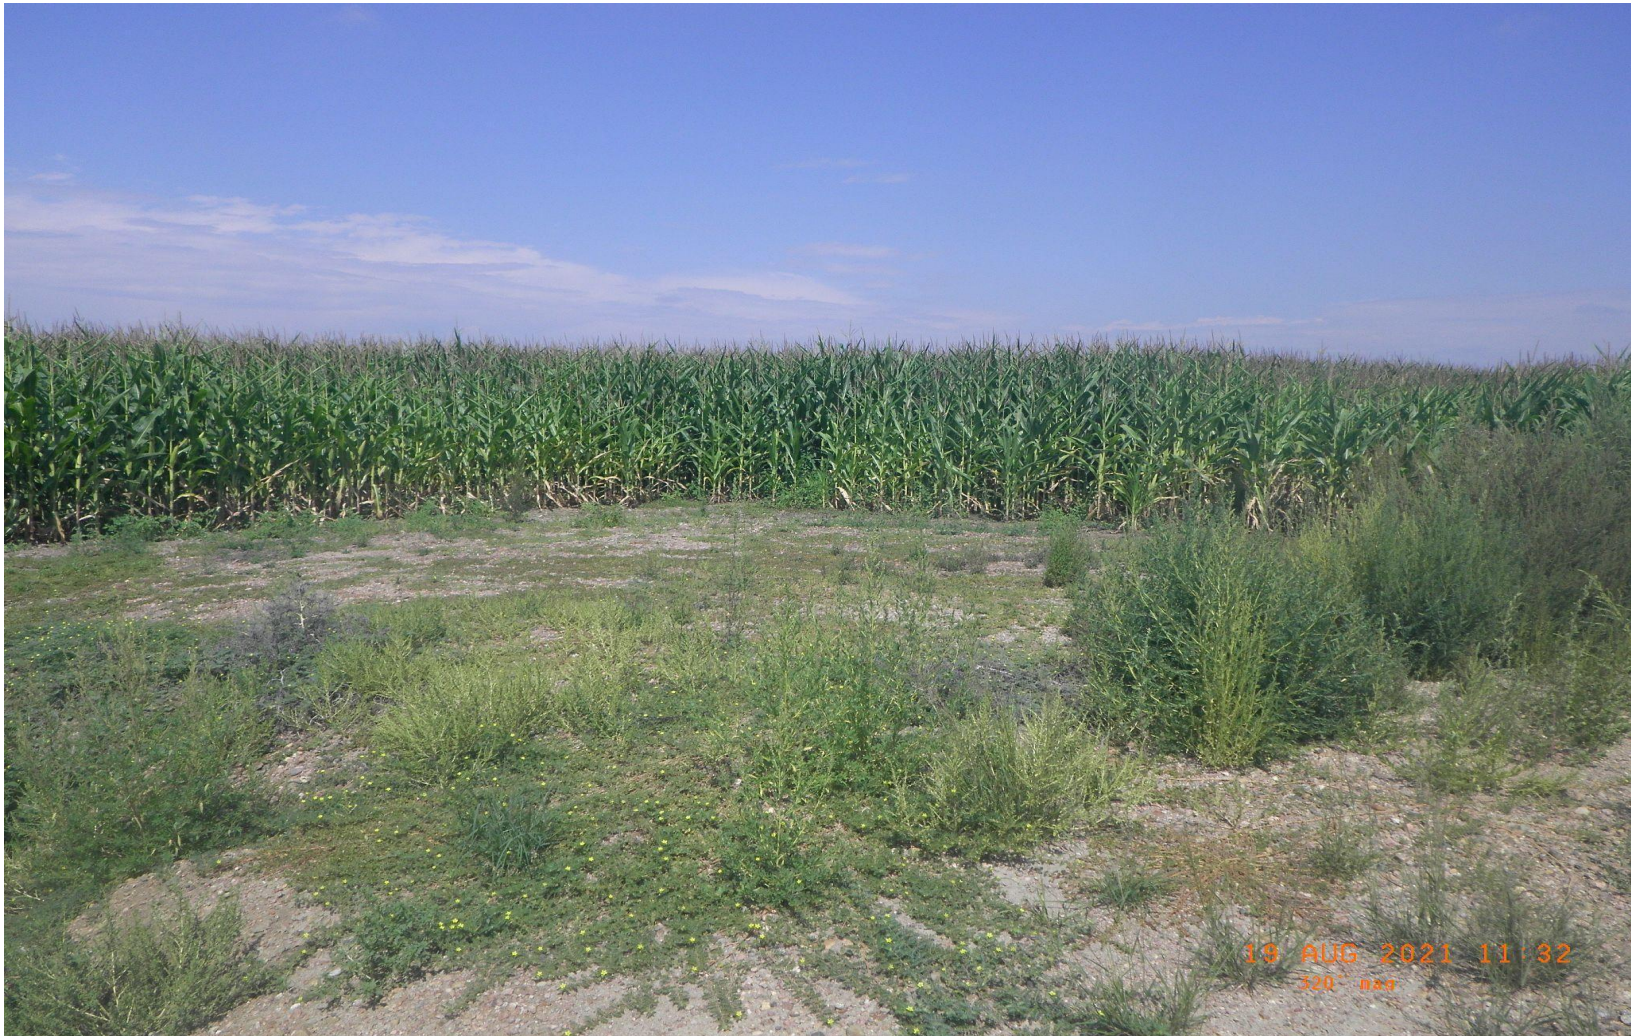
Photo 5. Ground photo taken from southeast corner of tank battery looking northwest. The ground is compacted and the vegetation resembles the reference areas nearby.
