Inspection Photos
Operator: Kinder Morgan
API: 083-06437
Date: 8/31/2021

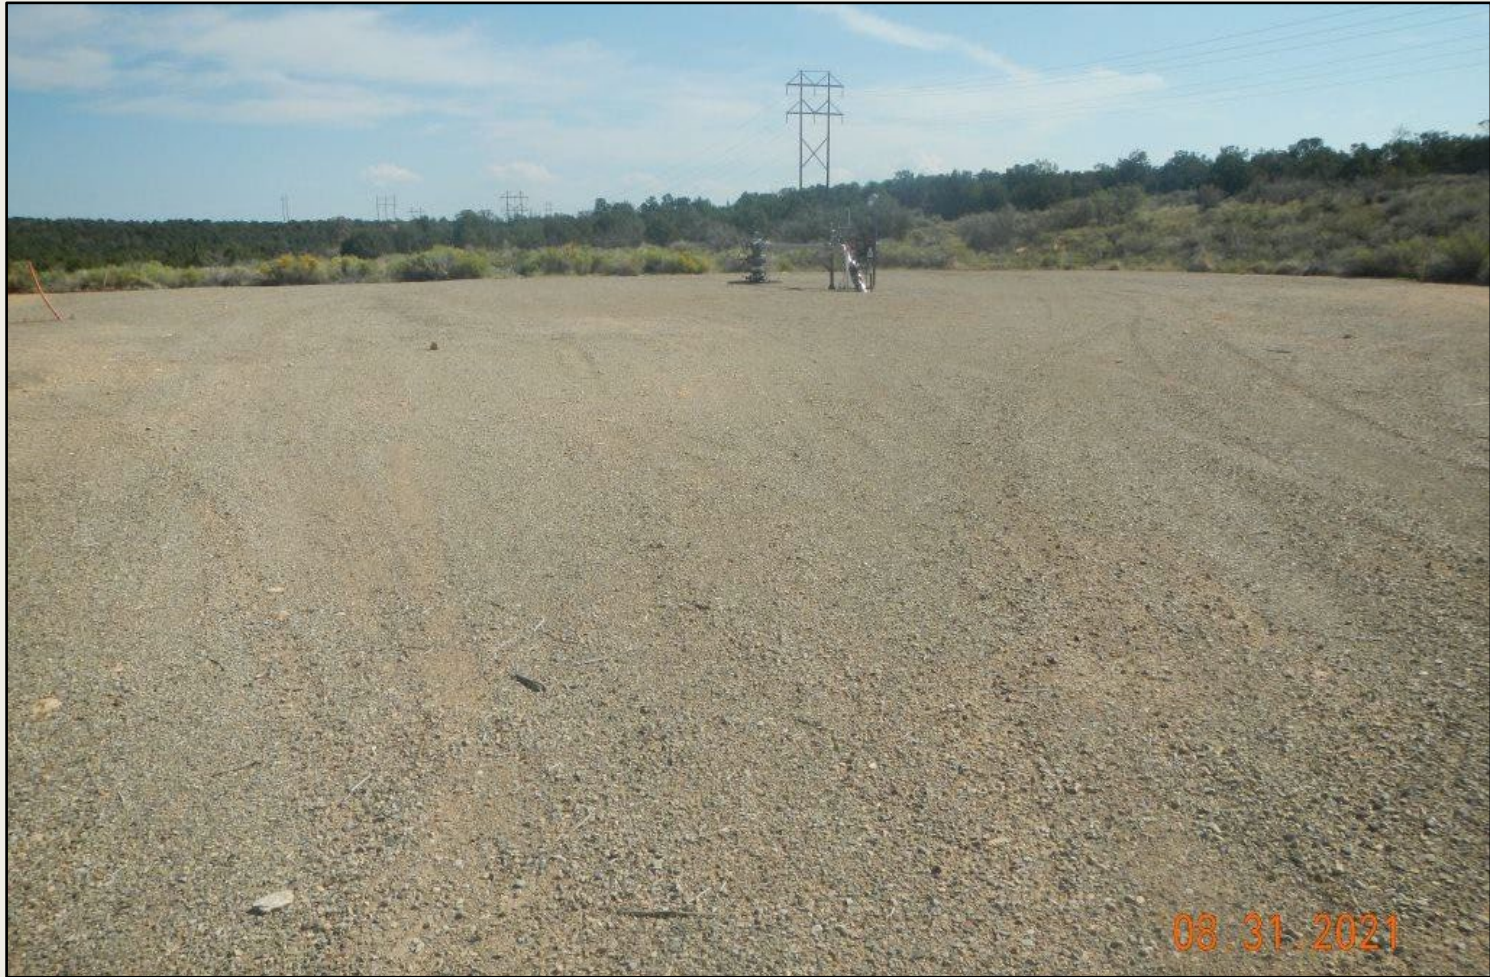
Photo 1. View of the project area from the well pad entrance facing center.

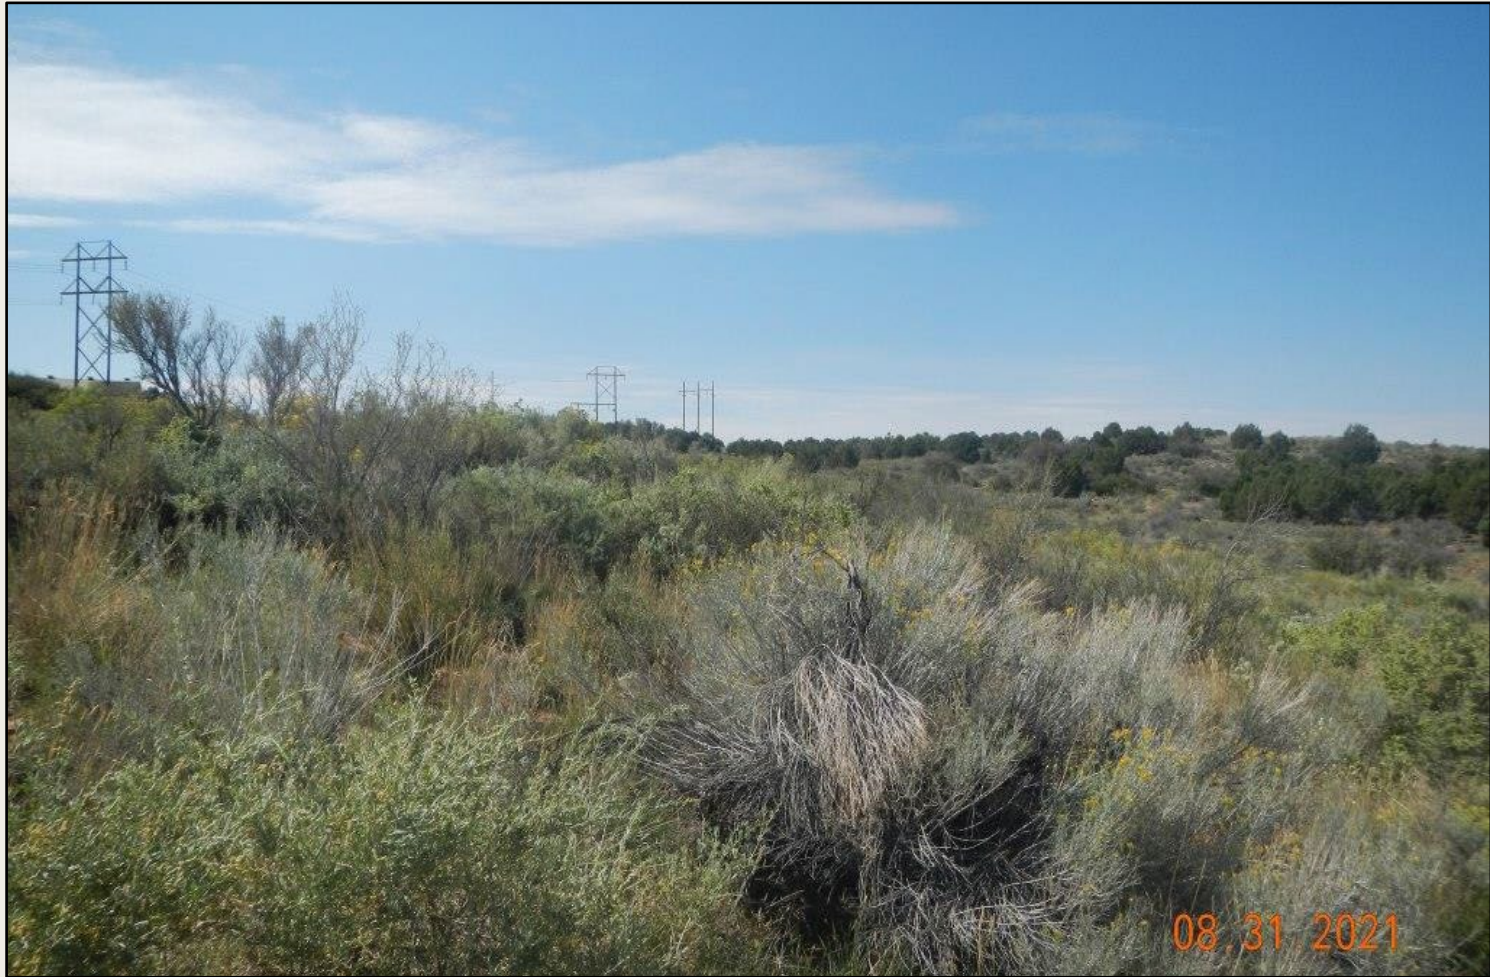
Photo 2. View of the western project area from the northwestern corner facing northward. Revegetation is progressing with rubber rabbitbrush, fourwing saltbush, Indian ricegrass, western wheatgrass, mountain pepperweed, sand dropseed, and crested wheatgrass.

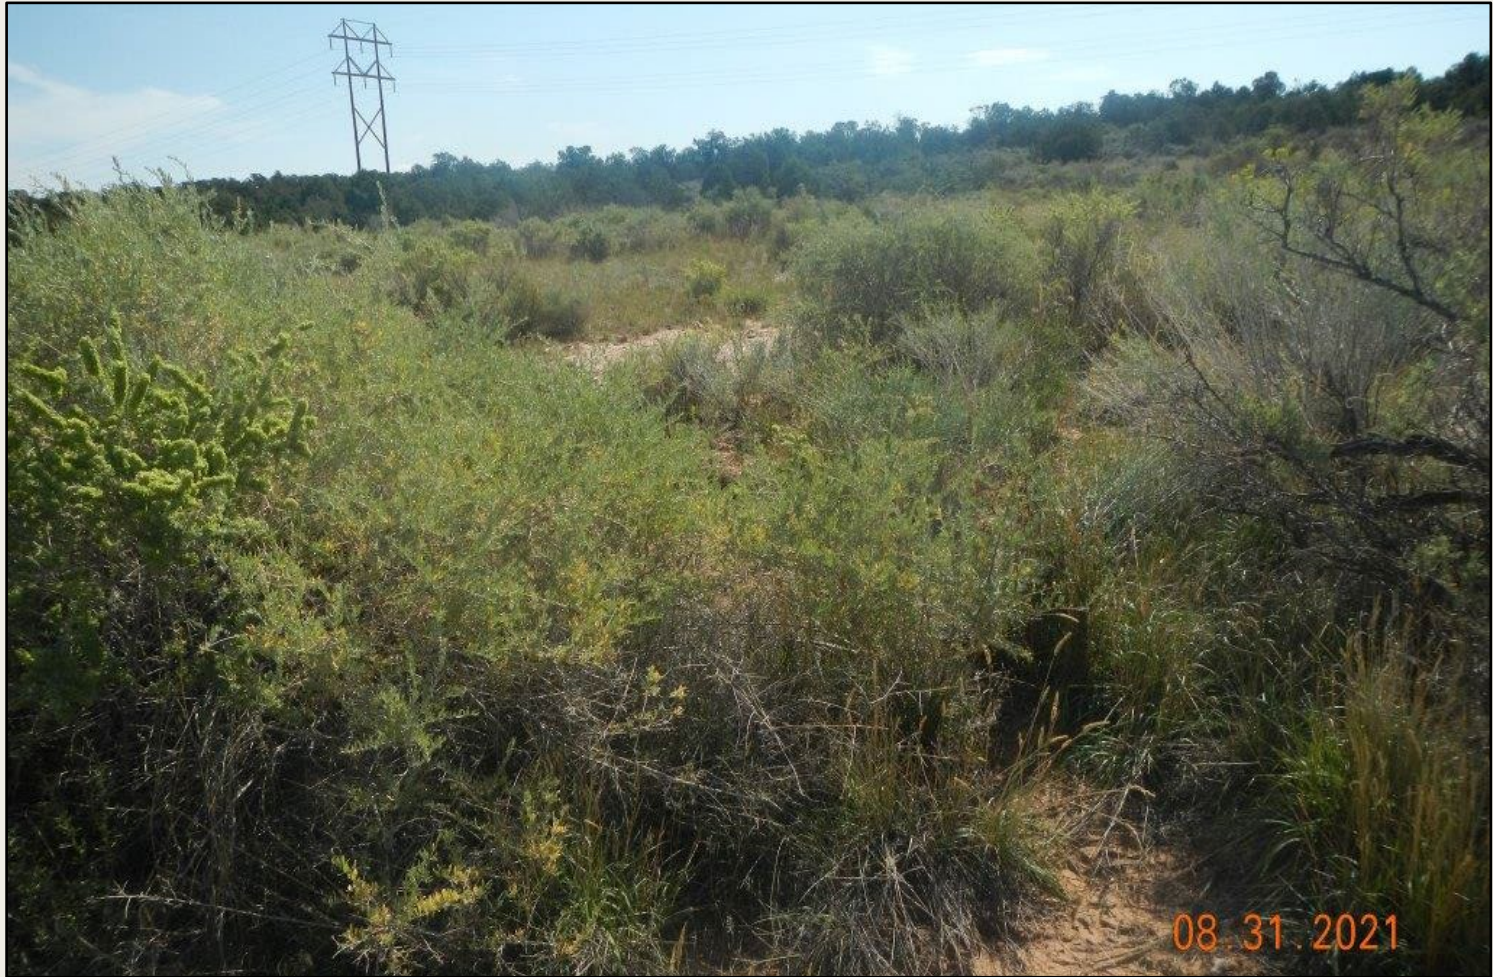
Photo 3. View of the northern project area from the northwestern corner facing eastward.

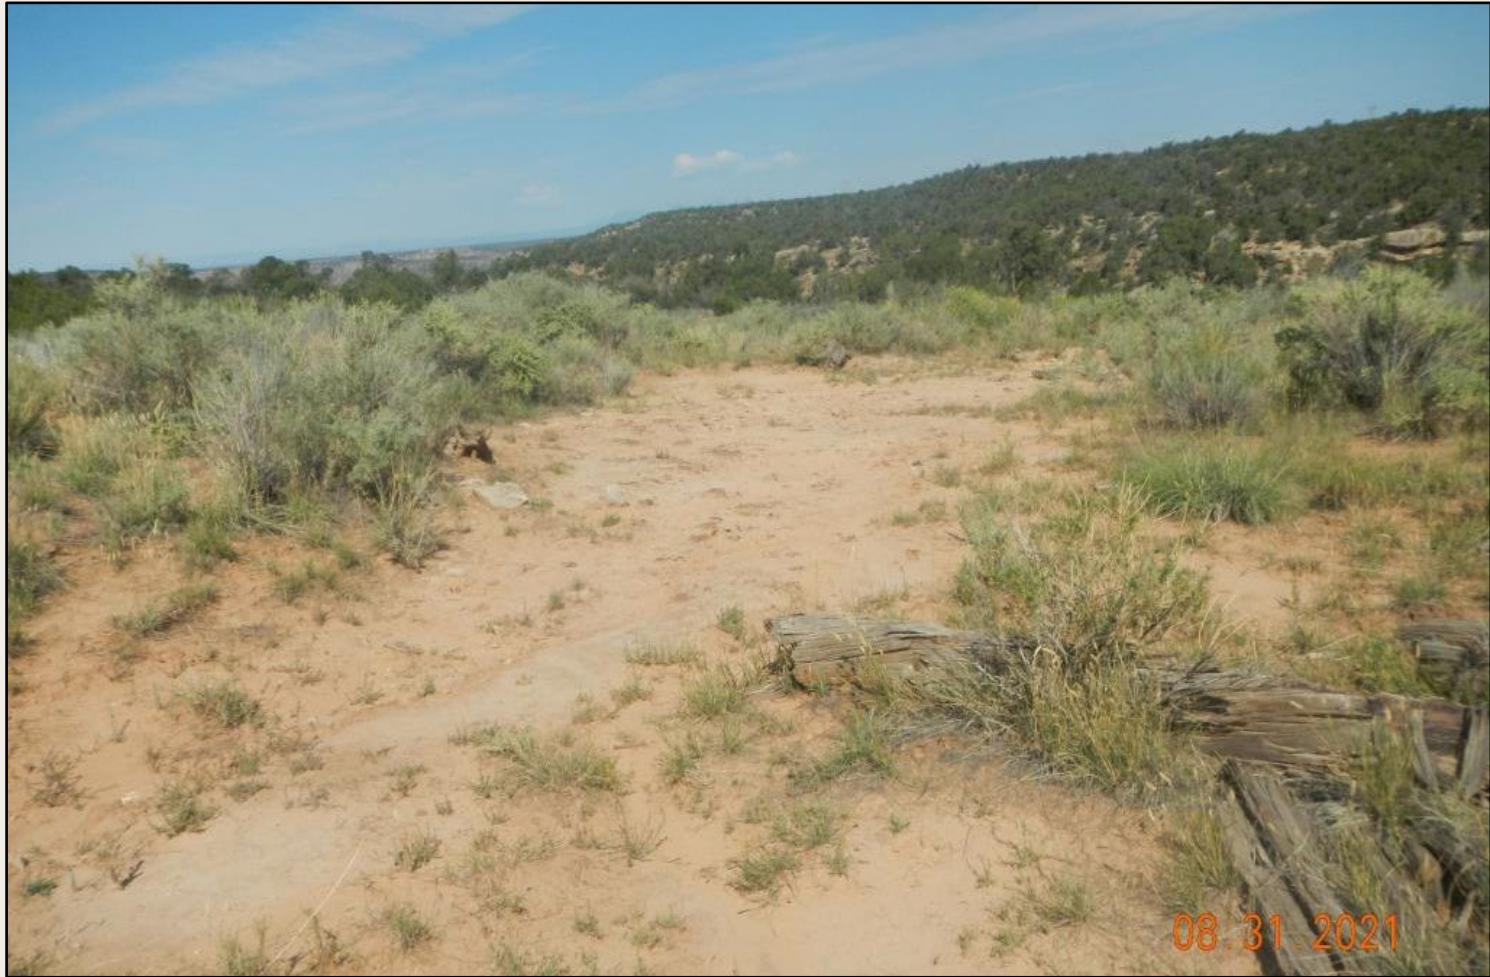
Photo 4. View of area (approximately 8ft wide and 25ft long) in the northern project area with bare soils that needs to be stabilized with desirable vegetation. Soils may be impacted and need remediation.
