Inspection Photos

Operator: CAERUS ENERGY SERVICES LLC -
10668

Location ID: 467272
Rio Blanco County, CO

Aaron Trujillo
NW Reclamation Specialist
COGCC

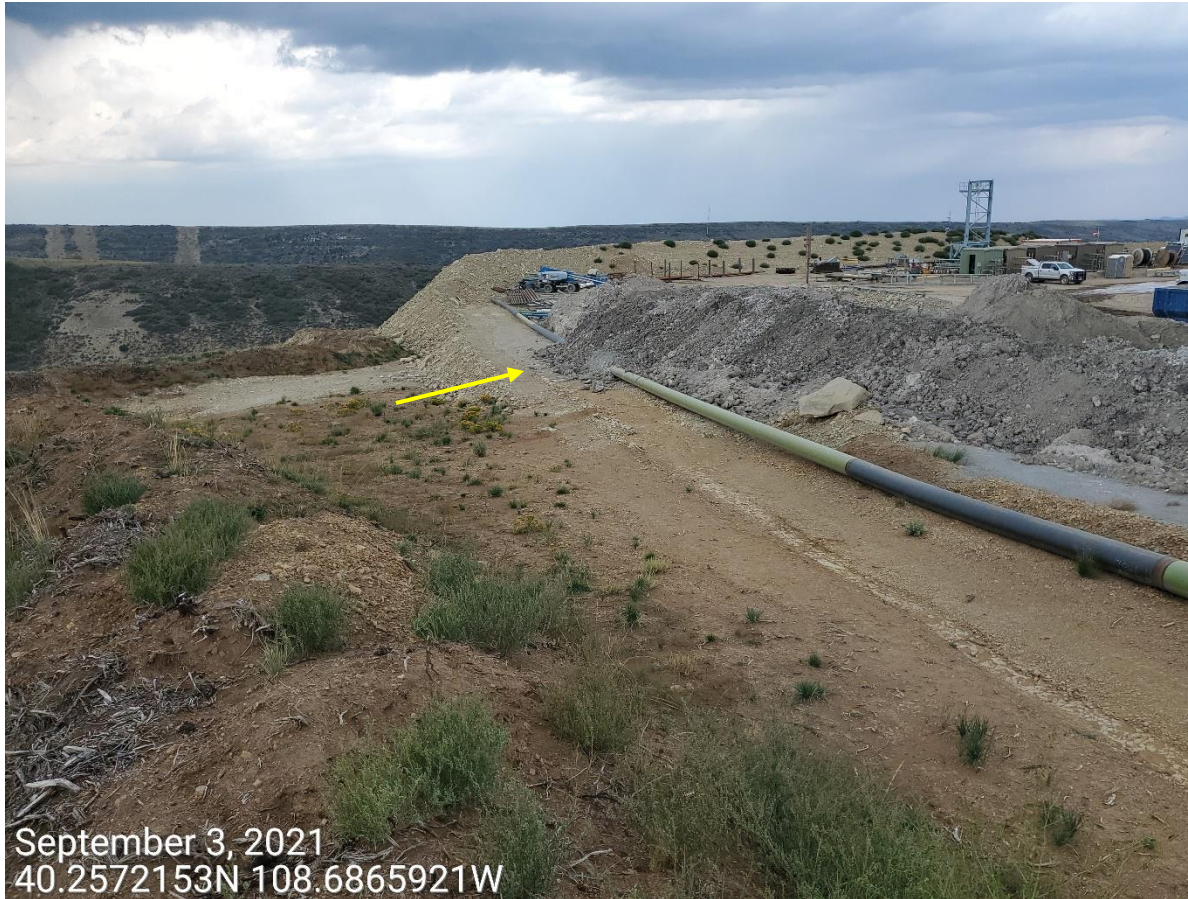
Photo 1: Photo taken from the south end of the Location, facing west. Photo shows control measures to contain drill cuttings is missing, or inadequate. Areas observed on the left of the photo include the perimeter stormwater controls (retention pond) for the Location
