TANK BATTERY DECOMMISSIONING FORM

SITE NAME: Francen 14-30 Tank Battery							DATE: 6/14/2021	REM. PROJECT #: 17139	WEATHER: 90s Sunny	
SITE DIRECTIONS: 1500 feet East and 200 feet North of CR 49 along CR64							CLIENT: PDC- Erin Crawford			
LEGALS AND LAT/LONG: 40.450831, -104.595674							TASMAN PERSONNEL: Jesse Marcus			
SOIL TYPES: Silty Clay							SURFACE GRADIENT: Southeast			
SOIL SAMPLING							FACILITY INFRASTRUCTURE			
Date/Time	Soil Sample ID	PID (ppm)	Visual	Olfactory	Photo?	Grab or Lab Sample?	EQUIPMENT		Quantity	
							Above Ground Storage Tank (AST)		1	
6/14/2021 10:53	AST01 @0-6"	0.4	No Staining	No Odor	Yes	Lab	Buried or Partially Buried Vessel		0	
6/14/2021 11:00	ECD01-W @0-6"	0.5	No Staining	No Odor	Yes	Grab	Separator		1	
6/14/2021 11:01	ECD02-E @0-6"	0.4	No Staining	No Odor	Yes	Grab	Emission Control Device (ECD)		2	
6/14/2021 11:09	MH01 @0-6"	1.1	No Staining	No Odor	Yes	Grab	Dump Line		1	
6/14/2021 12:12	SEP01-DL-B @6'	8.3	No Staining	HC Odor	Yes	Lab	Wellhead

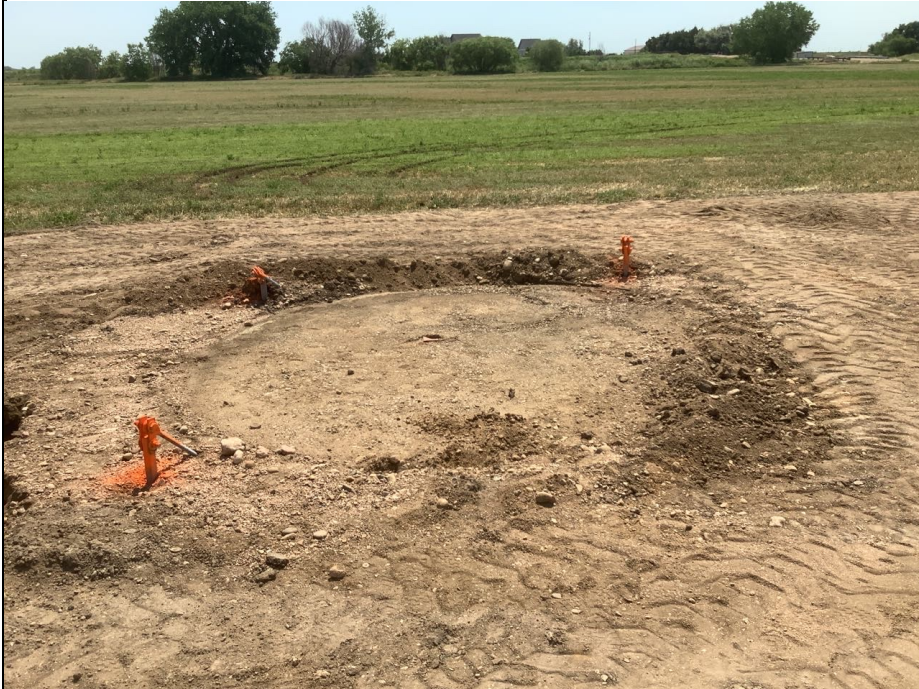
Equipment ID: AST Footprint		Equipment Type:		Equipment ID:		Equipment Type:	
Material:	Volume:	Contents:		Material:	Volume:	Contents:	
Notes/Conditions:				Notes/Conditions: SEP01-DL-B @6' SEP01-DL-N @2.5' SEP01-DL-E @2.5'

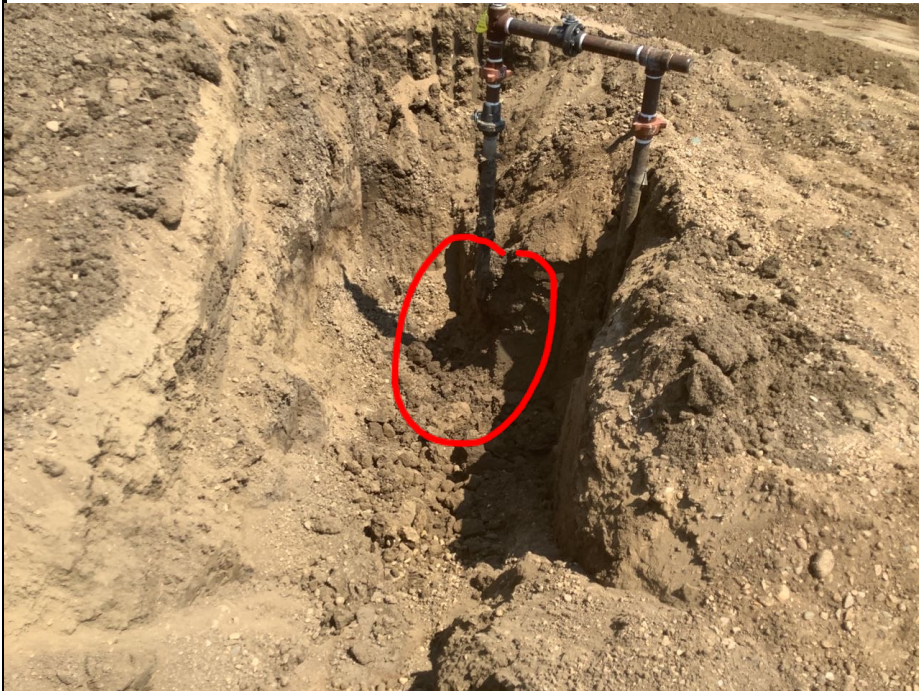
Equipment ID: SEP01-FL @4'		Equipment Type:		Equipment ID:		Equipment Type:	
Material:	Volume:	Contents:		Material:	Volume:	Contents:	
Notes/Conditions:				Notes/Conditions: SEP01-DL-S @2.5' SEP01-DI-W @2.5'

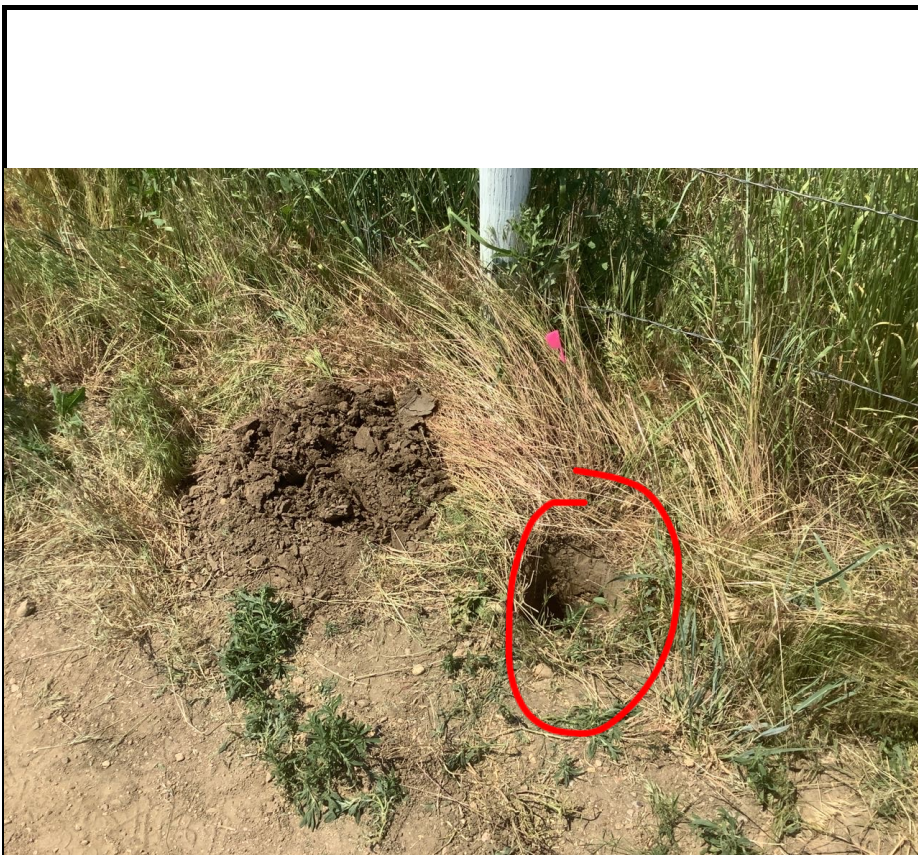
Equipment ID: BKG01		Equipment Type:		Equipment ID: AST bottom		Equipment Type:	
Material:	Volume:	Contents:		Material:	Volume:	Contents:	
Notes/Conditions:				Notes/Conditions:
