# Inspection Photos

Operator: LARAMIE ENERGY LLC # 10433

Location ID: 335950

Garfield County, CO

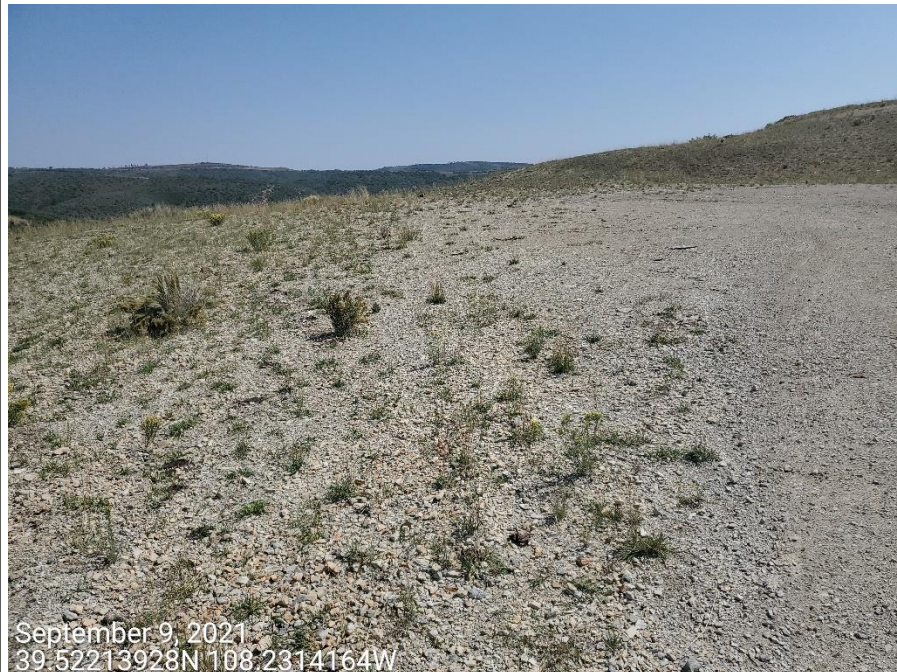
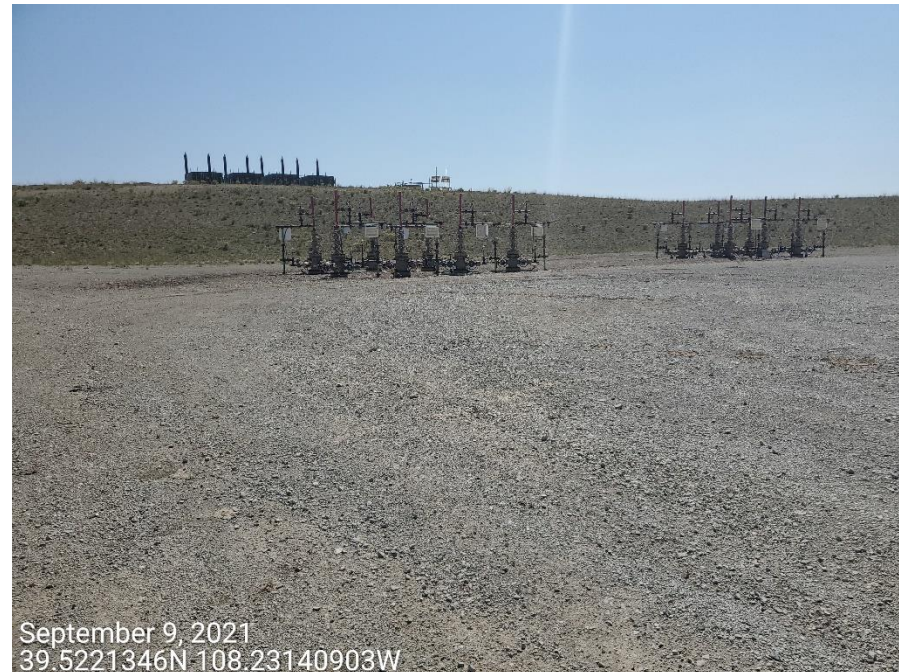
**Photo 1:** Photos 1-2 taken from the northeast end of the Location, facing southeast, south to west. Photos provide overview of the Location.

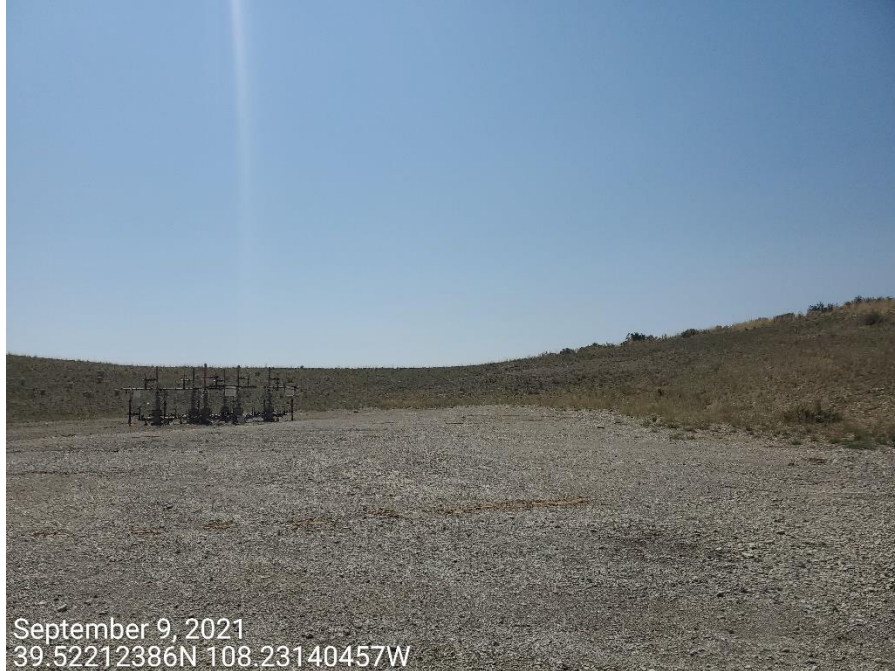
**Photo 2:** See comments under photo 1.

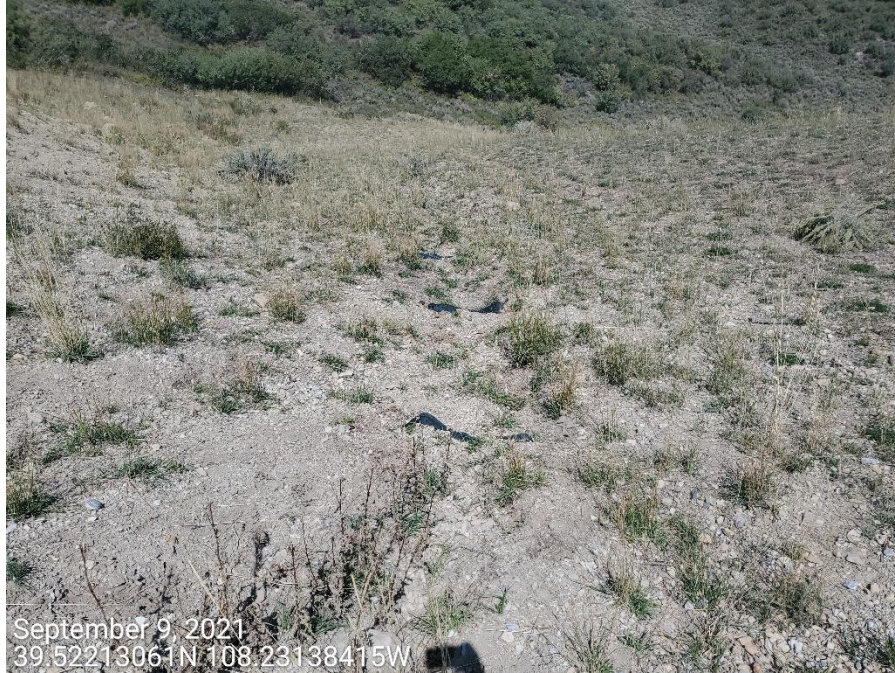
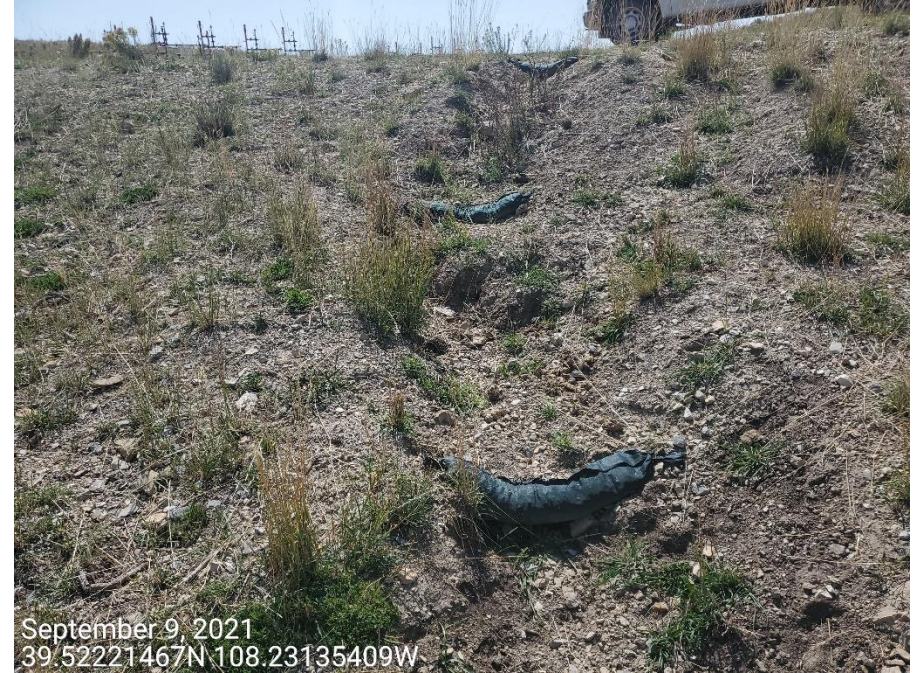
**Photo 3:** Photos taken from the northern interim area. Photos show gully erosion degradation due to runoff from the Location. Rock-socks observed within the channel. Stormwater and erosion control measures observed are inadequate alone to control runoff from the Location in a manner that minimizes erosion and site degradation.

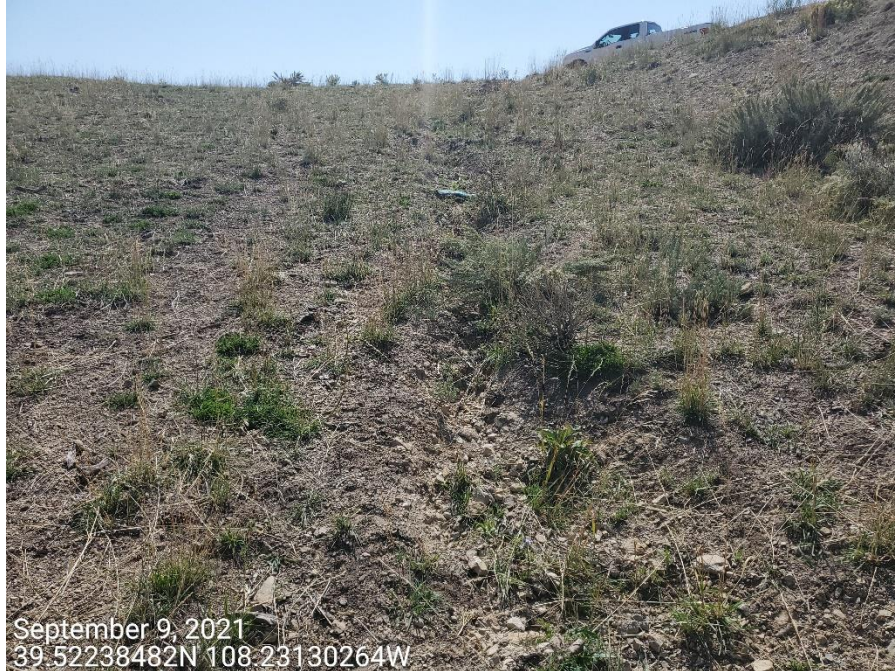
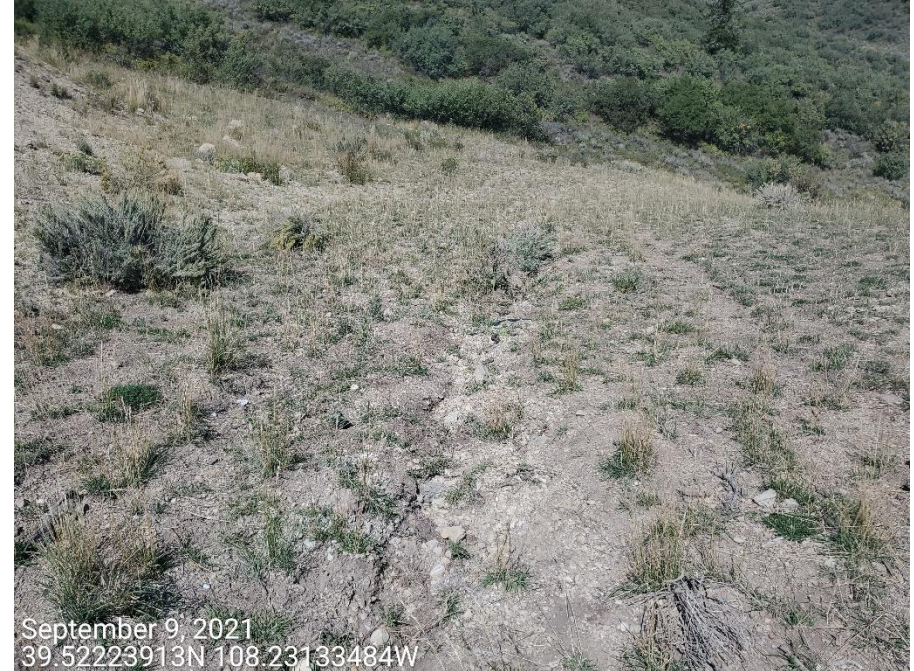
**Photo 4:** Photos taken from the northern interim area. Photos show gully erosion degradation due to runoff from the Location. Rock-socks observed within the channel. Stormwater and erosion control measures observed are inadequate alone to control runoff from the Location in a manner that minimizes erosion and site degradation.

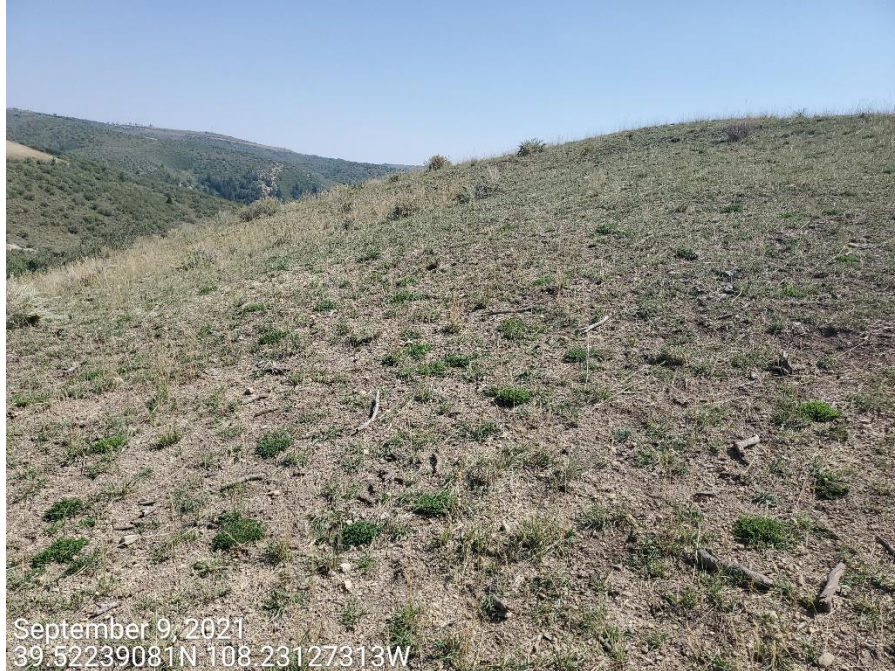
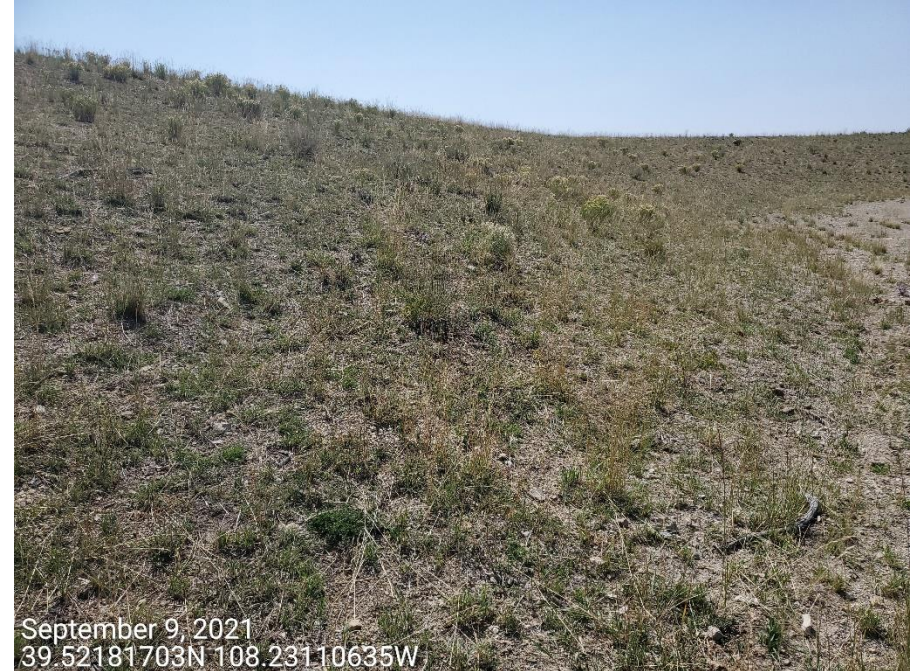
**Photo 5:** Photos provide example of the interim areas on the Location; interim reclamation in process. No immediate issues observed.
