TABLE 1
SOIL SAMPLE LOCATIONS
NOBLE ENERGY, INC. - HSR CHARLTON 08-20

Site Location Map
 HSR Charlton 8-20 Wellhead
 SENE S20 T4N R65W
 Weld County, Colorado

TASMAN GEOSCIENCES	Tasman Geosciences, Inc. 6855 W 119 th Avenue Broomfield, CO 80020	Noble Energy, Inc. – DJ Basin HSR Charlton 08-20 Wellhead SENE, Section 20, Township 4 North, Range 65 West Weld County, Colorado	Wellhead & Flowline Closure Site Overview Map (09/13/2021)	FIGURE 2
DESIGNED BY:	JW					
DRAWN BY:	CA

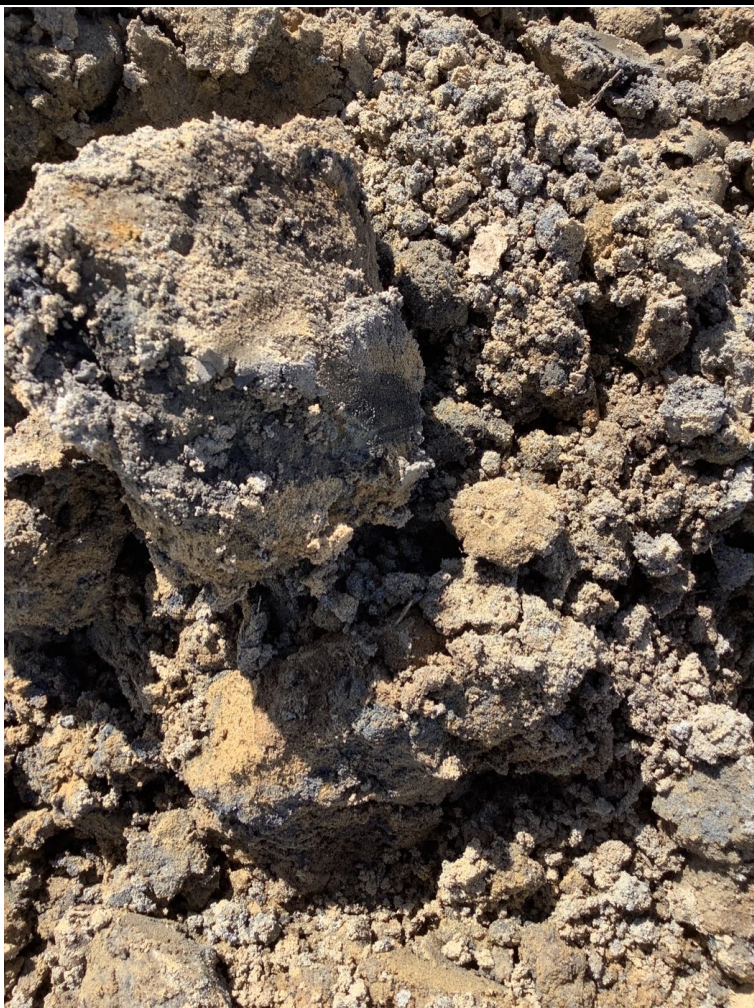
Equipment ID: SS01		Equipment Type: Wellhead		Equipment ID: SS02		Equipment Type: Wellhead			
Material: Steel		Volume:	Contents: Oil/Gas/Water		Material: Steel		Volume:	Contents: Oil/Gas/Water	
Notes/Conditions: SS01 @2.5' north sample location. HC staining and odor.					Notes/Conditions: SS02 @2.5' east sample location. HC Staining and odor.

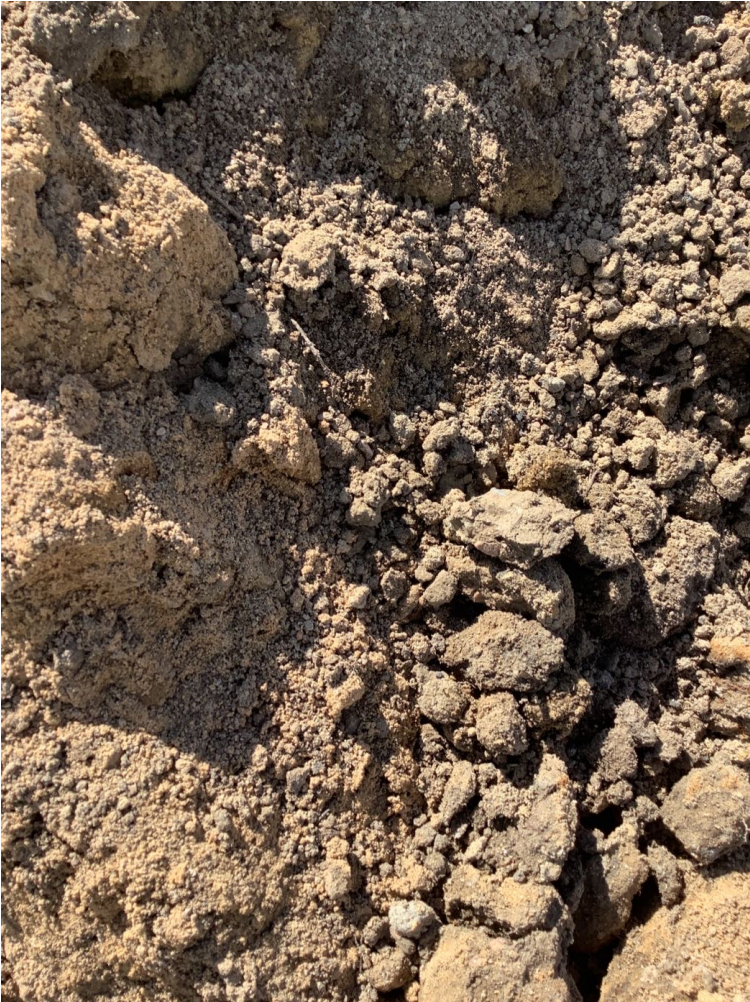
Equipment ID:SS03		Equipment Type: Wellhead		Equipment ID:SS04		Equipment Type: Wellhead																	
Material:Steel		Volume:		Material: Steel		Volume:		Contents:Oil/Gas/Water		Contents:Oil/Gas/Water													
Notes/Conditions: SS03@2.5' south sample location. HC staining and odor.												Notes/Conditions: SS04@2.5'. West sample location. Black and gray staining with a HC odor.

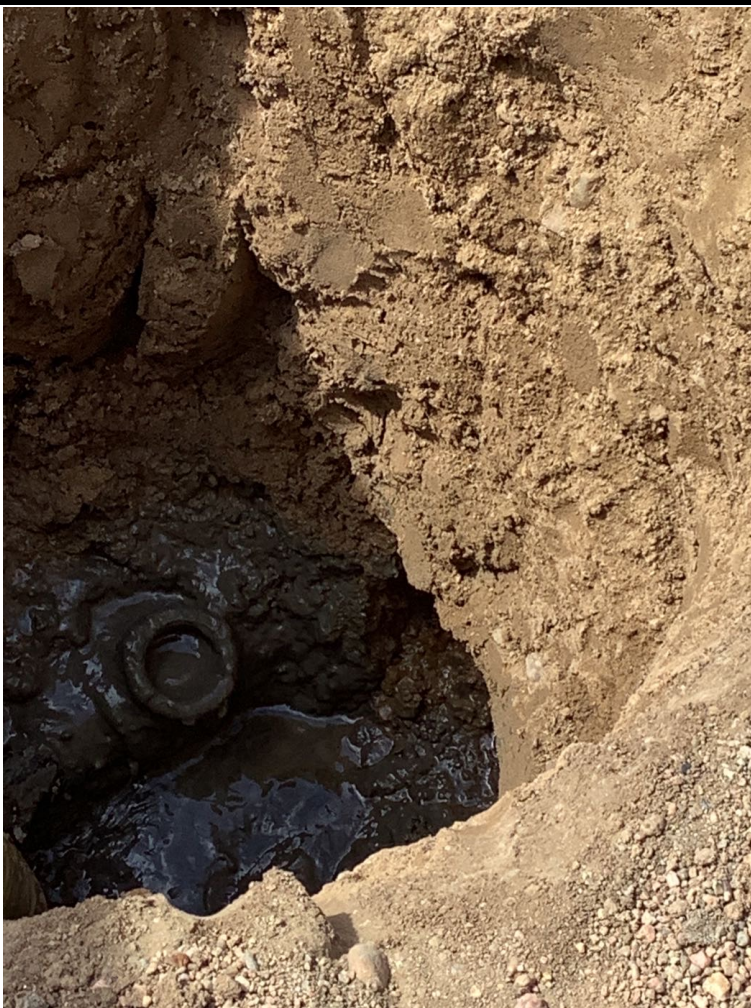
Equipment ID: FL01-B

Notes/Conditions: FL01-B @ 3' flowline sample location at separator. Some gray staining with a slight HC odor.

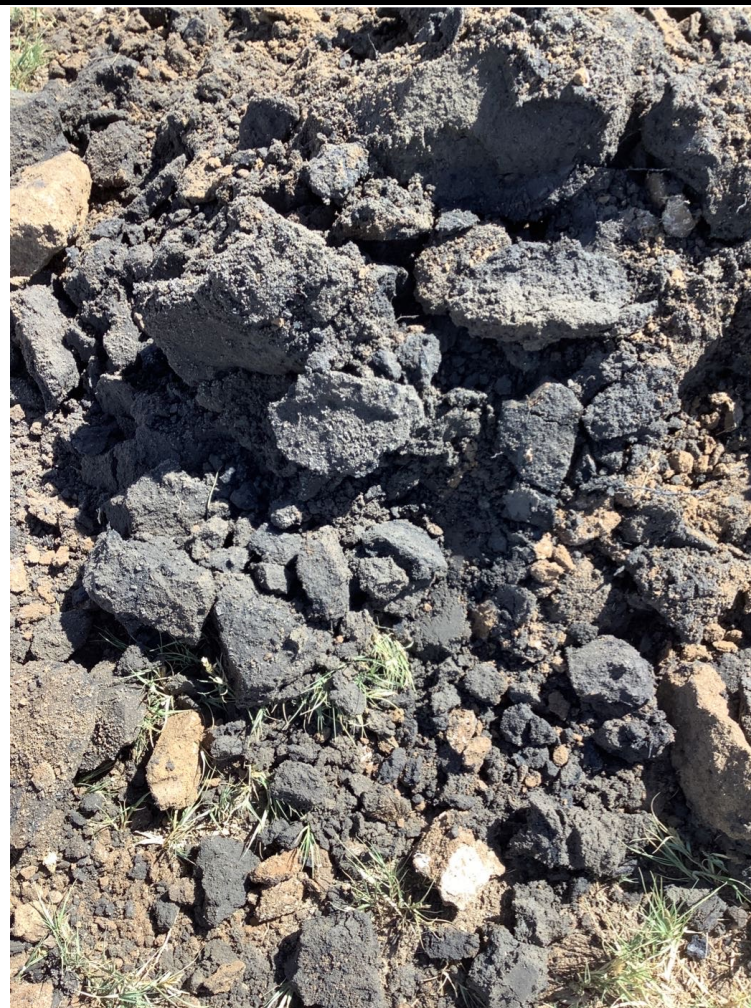
Equipment ID: BG01

Equipment Type:
Material:
Volume:
Contents:
Notes/Conditions: Background sample BG01 @ 2.5' sample location taken SE of site.

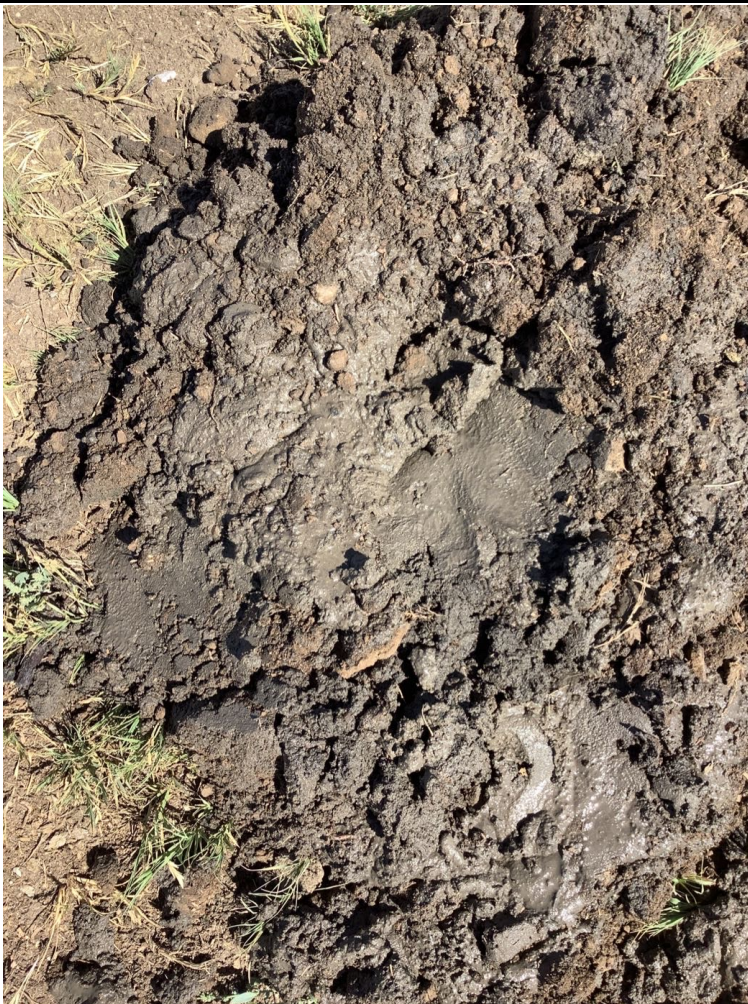
Equipment ID:BG01

Equipment Type:
Material:
Volume:
Contents:
Notes/Conditions: Background sample BG01@4' sample location taken SE of site.

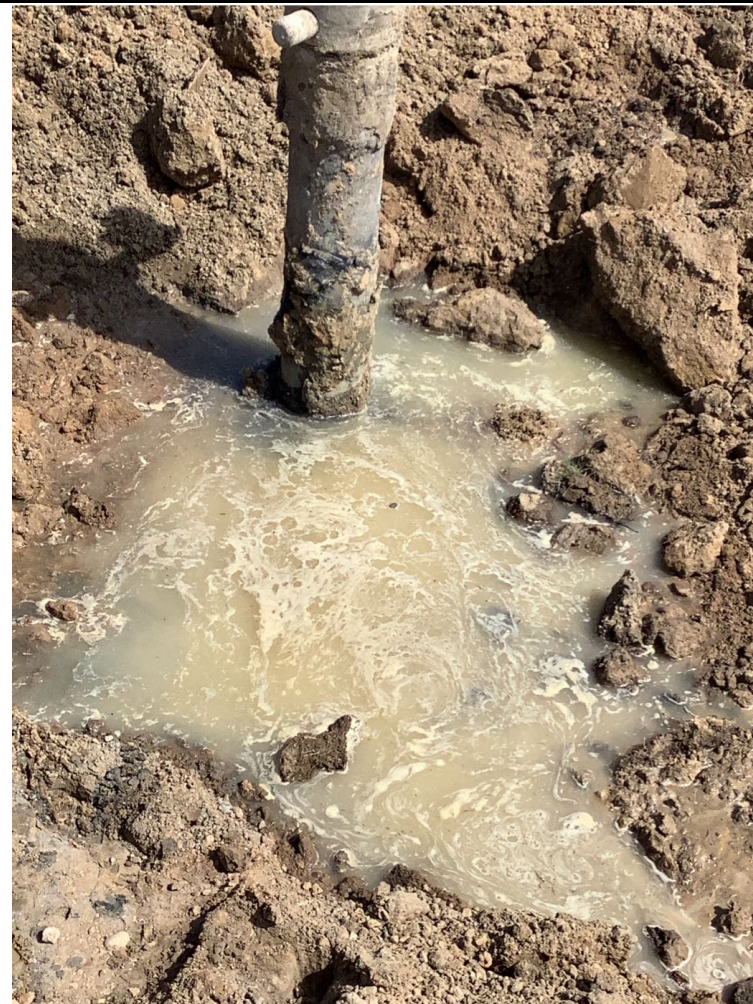
Equipment ID:GW01

Material:
Volume:
Contents:
Notes/Conditions: GW01 groundwater sample location.
