Final Reclamation Inspection

Operator: PDC ENERGY INC - 69175

Location ID: 323104

Inspection Photos
Location Name: FHA 10-1
Location ID: 323104

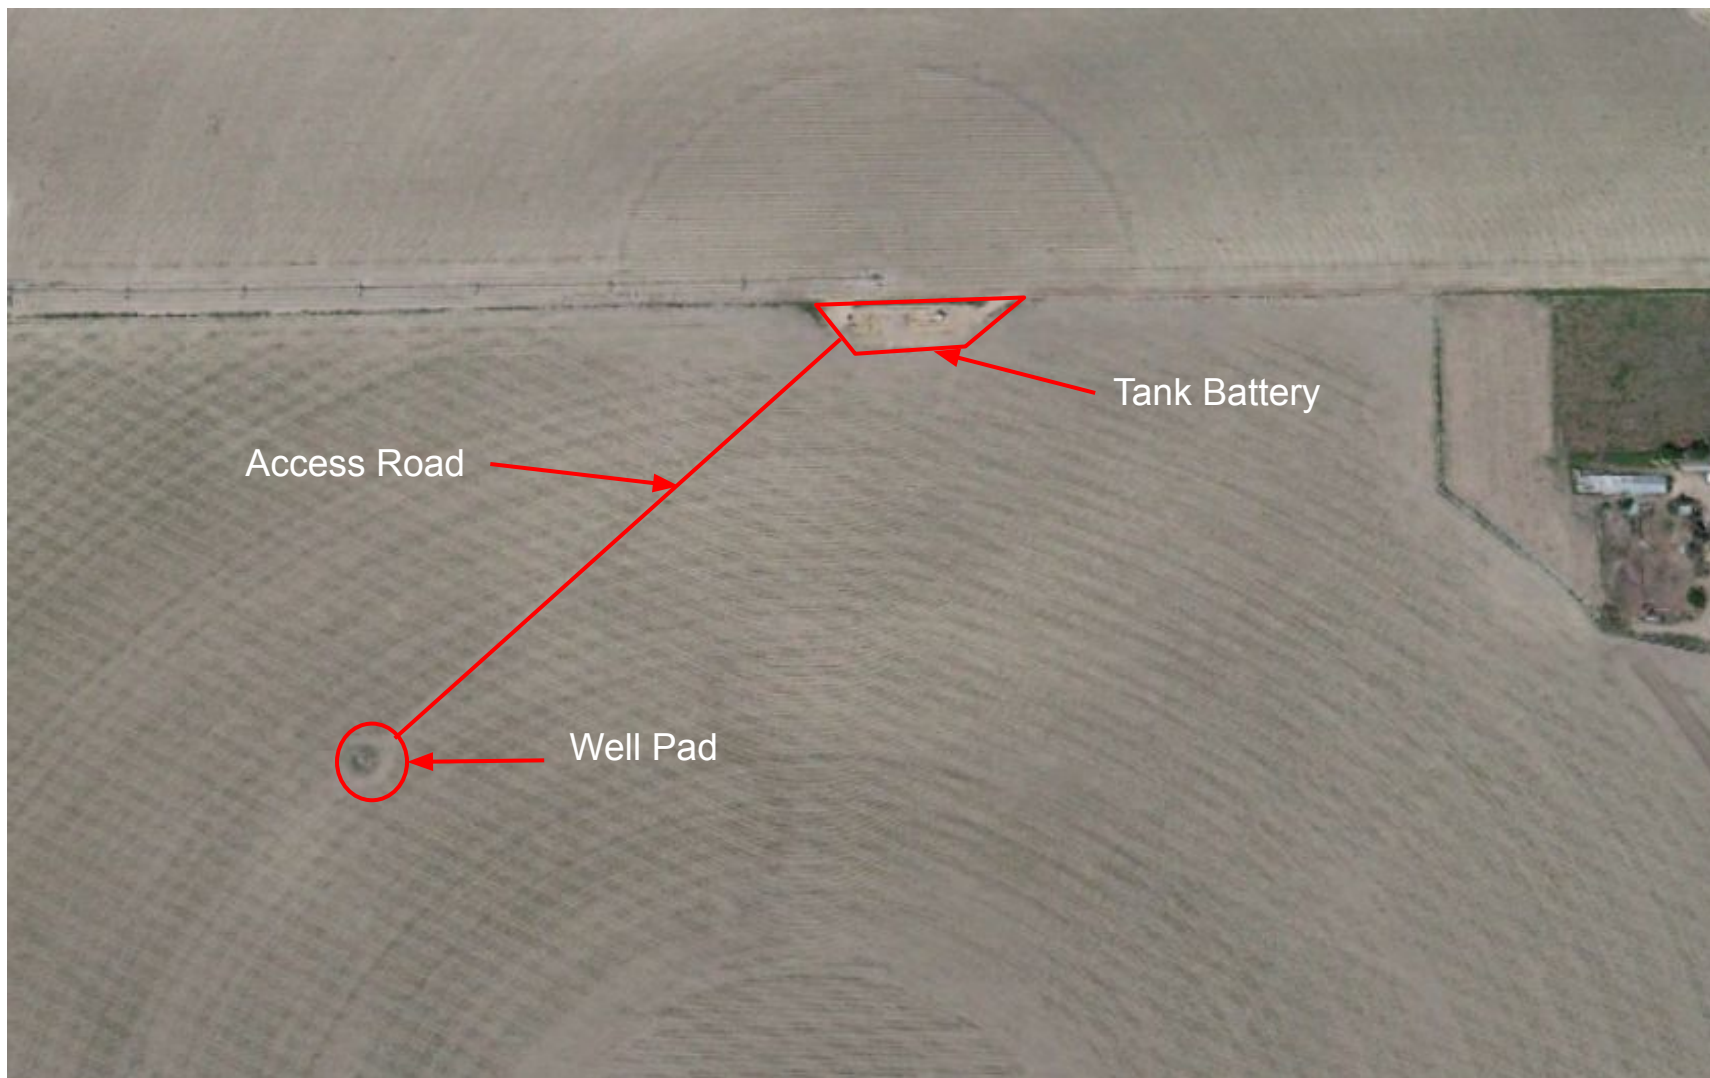
Photo 1. 2016 aerial imagery of the well head, tank battery, and access road.

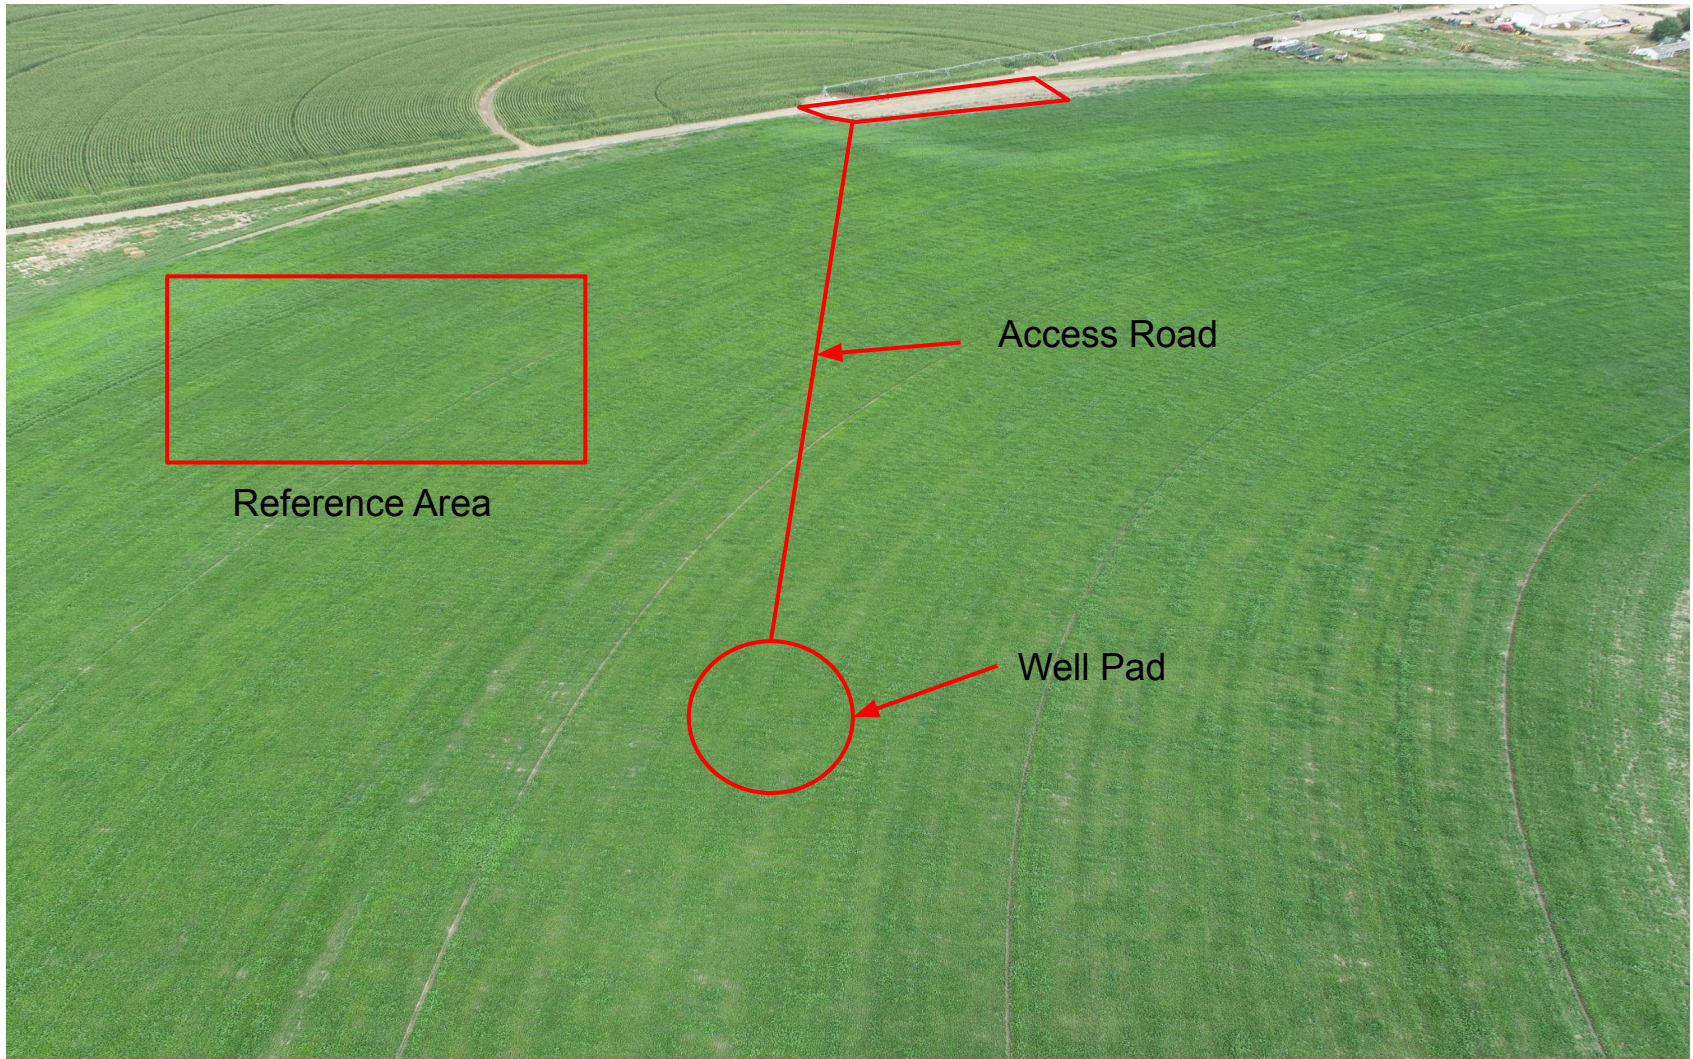
Photo 2. Overview photo of the well pad and reference area taken from the southwest edge of the well pad using a drone. Photo shows alfalfa crop within well head disturbance pad appears consistent with the rest of the crop field.

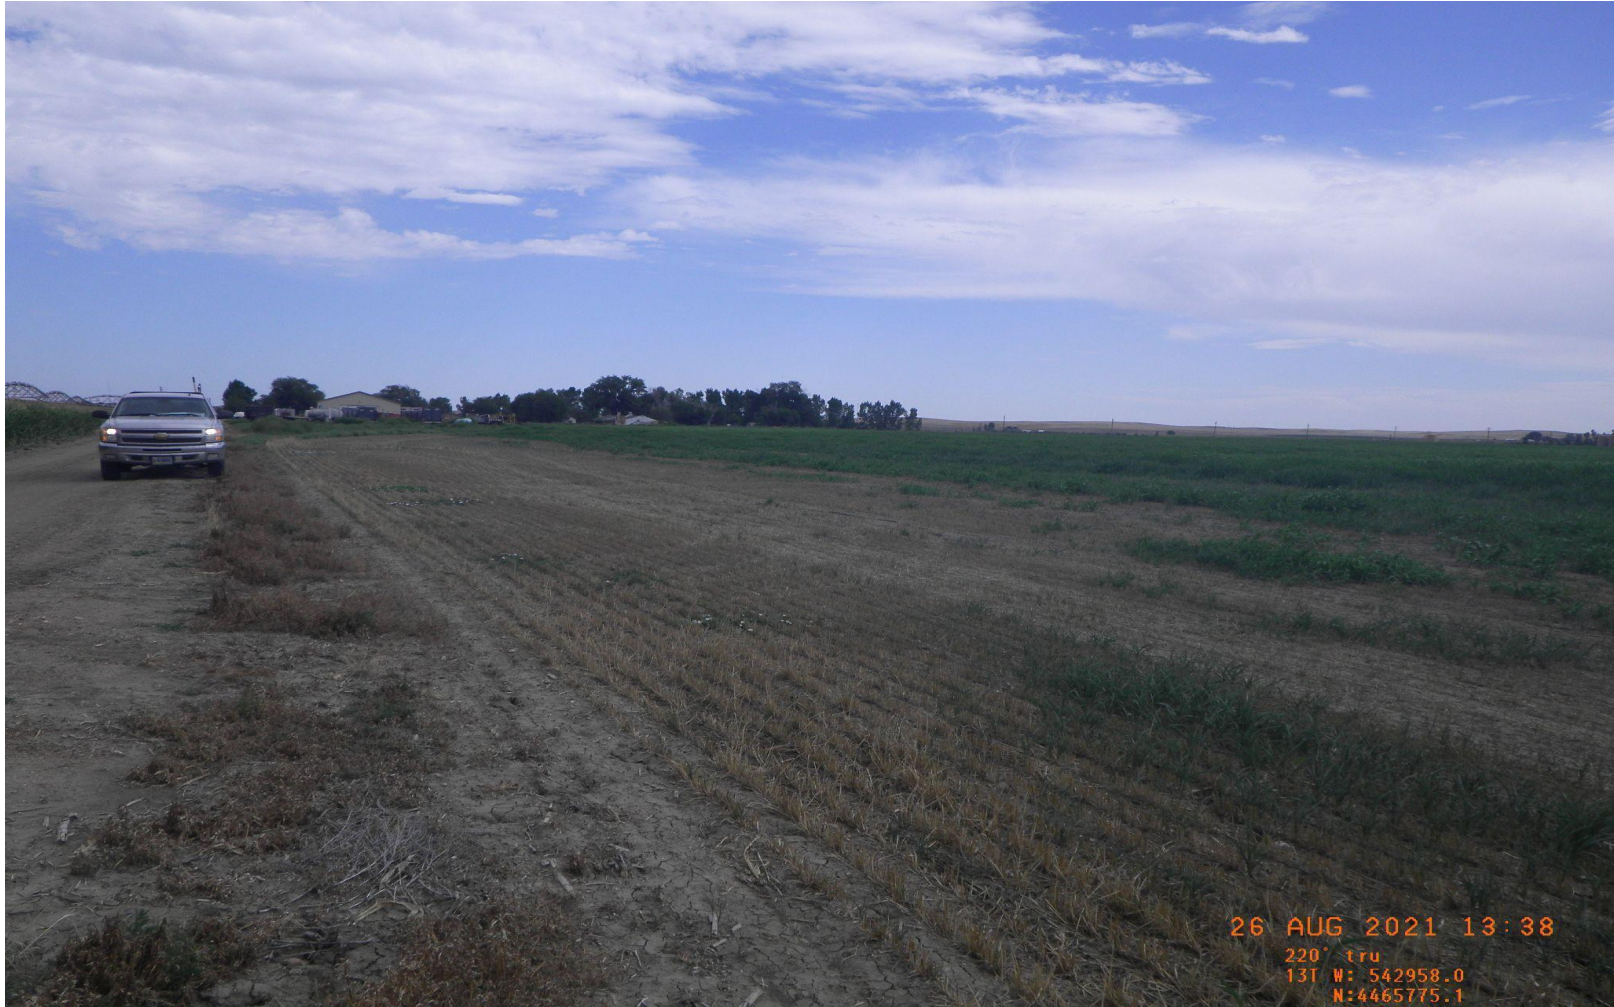
Photo 3. Tank battery overview photo taken at ground level from eastern edge of tank battery, looking west. Note: wheat crop appears to be processed and dead as opposed to just stunted. Significant bare batches throughout disturbance pad and patches of field bindweed present. Not representative of reference area.

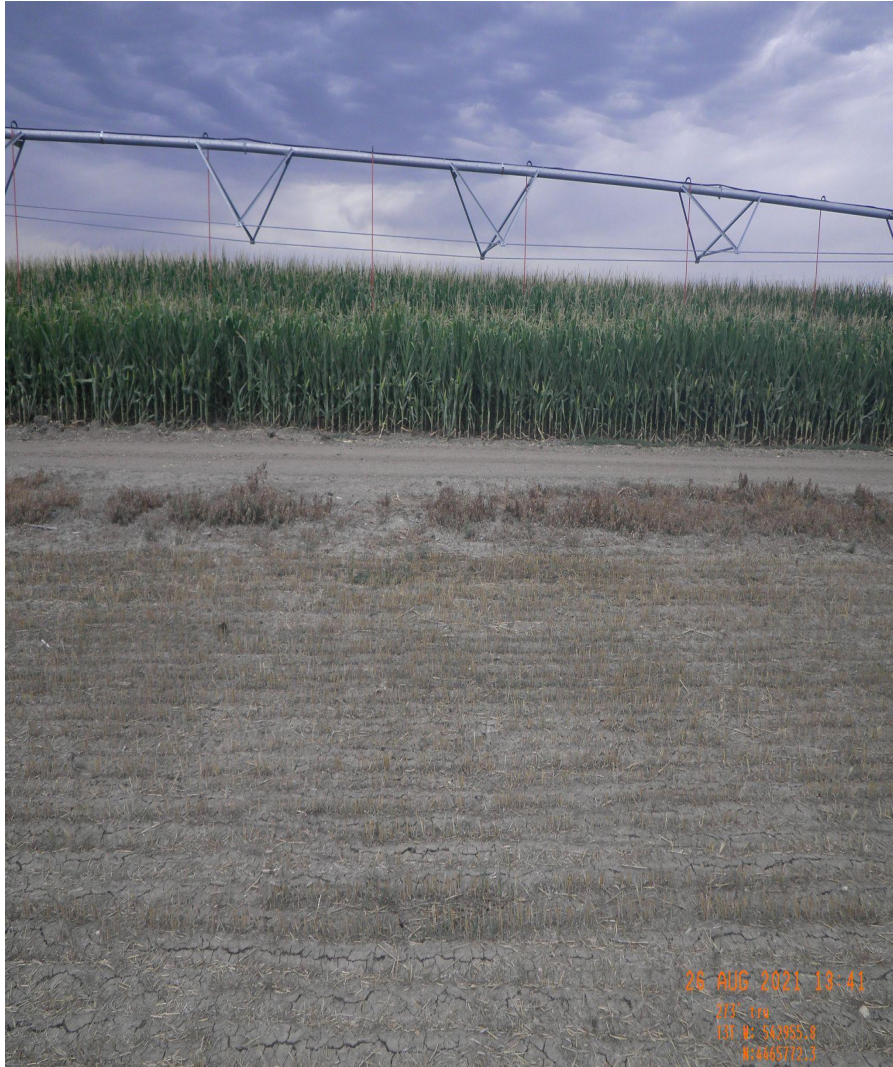
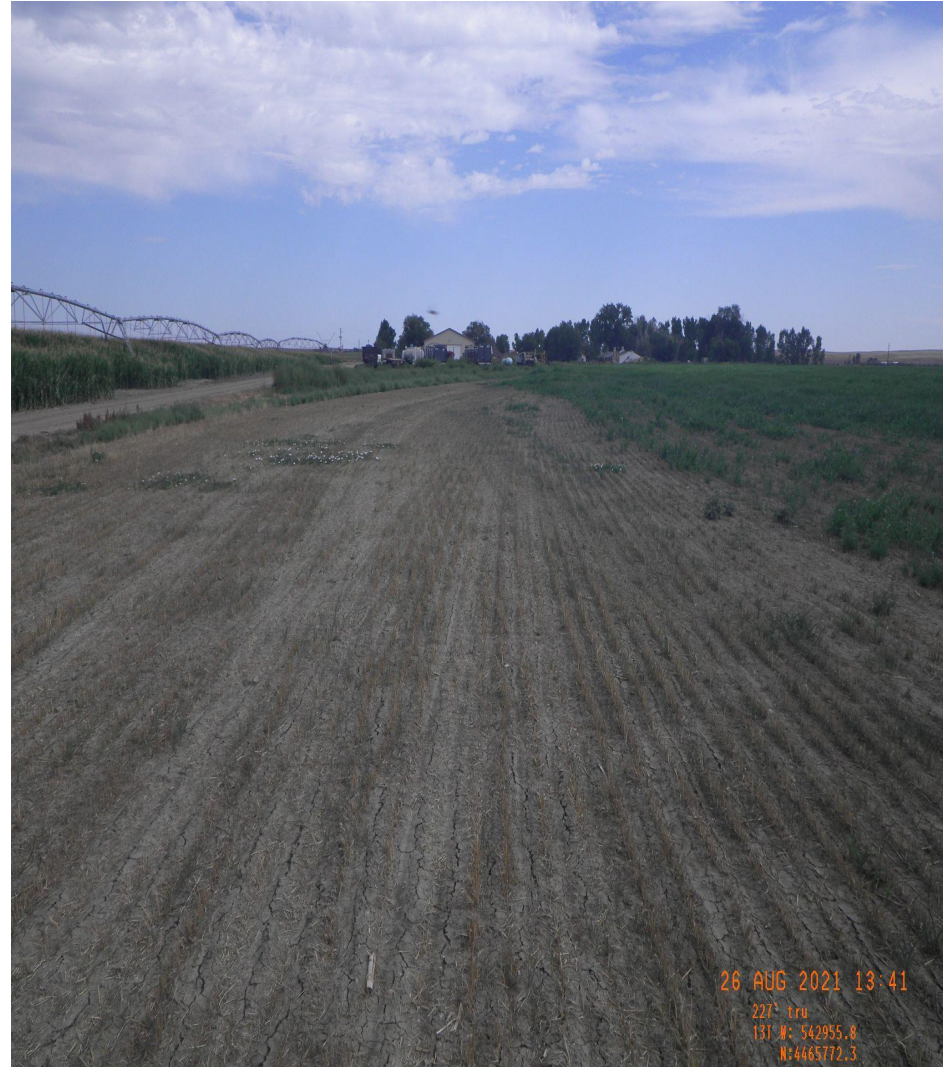
Photo 4. Ground photos taken from the middle of the tank battery. Left photo facing north, right photo facing east.

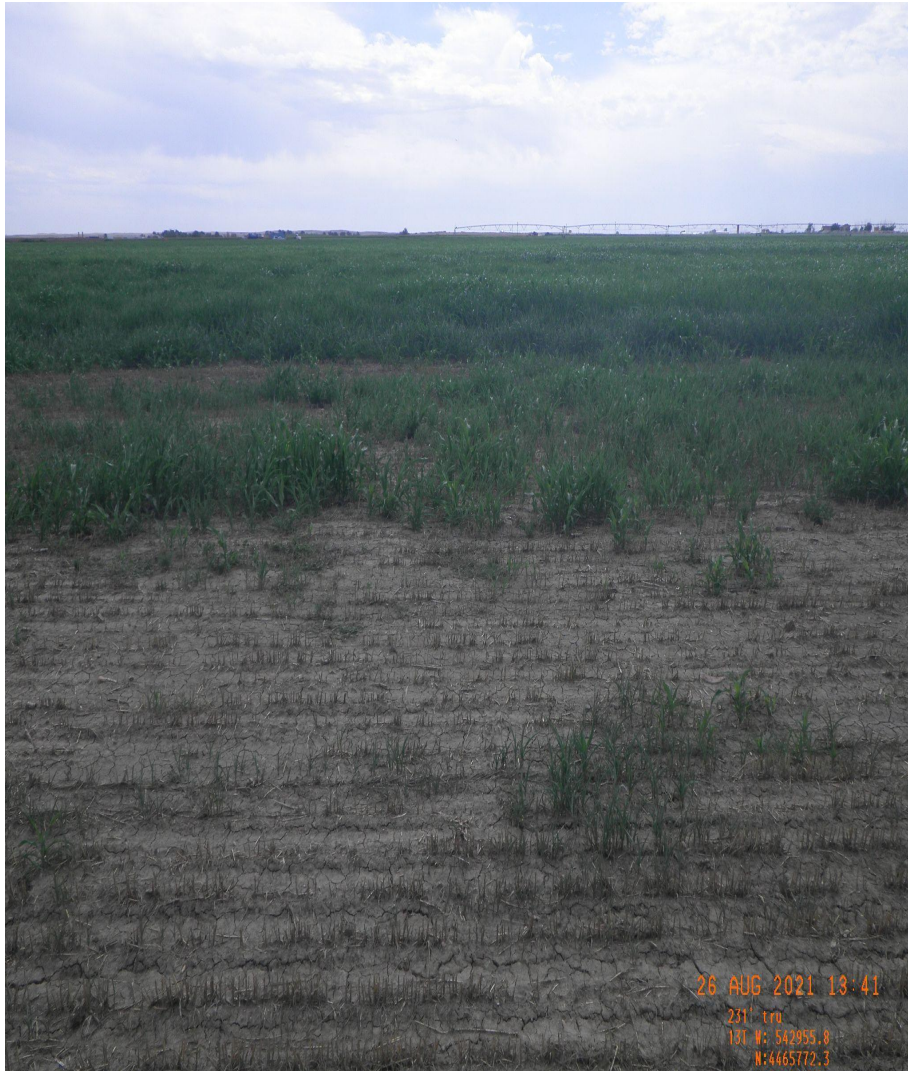
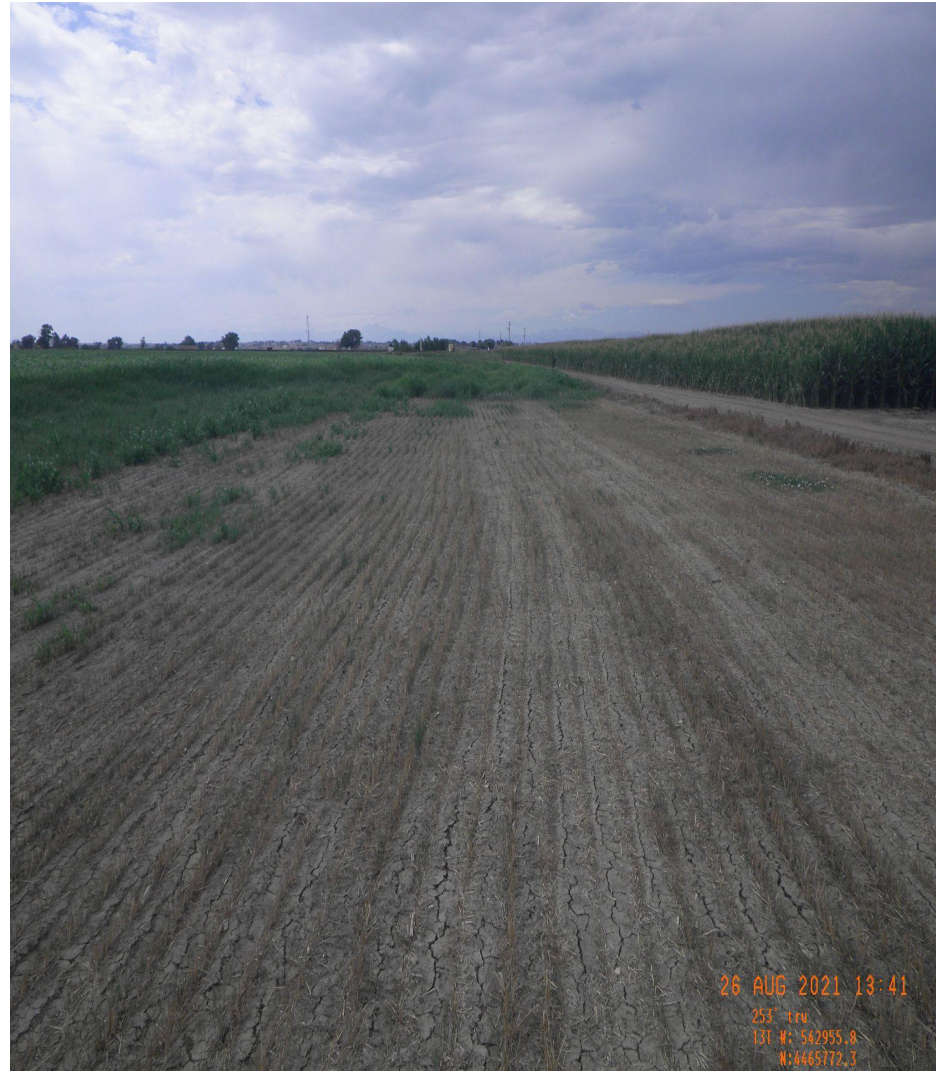
Photo 5. Ground photos taken from the middle of the tank battery. Left photo facing south, right photo facing west.

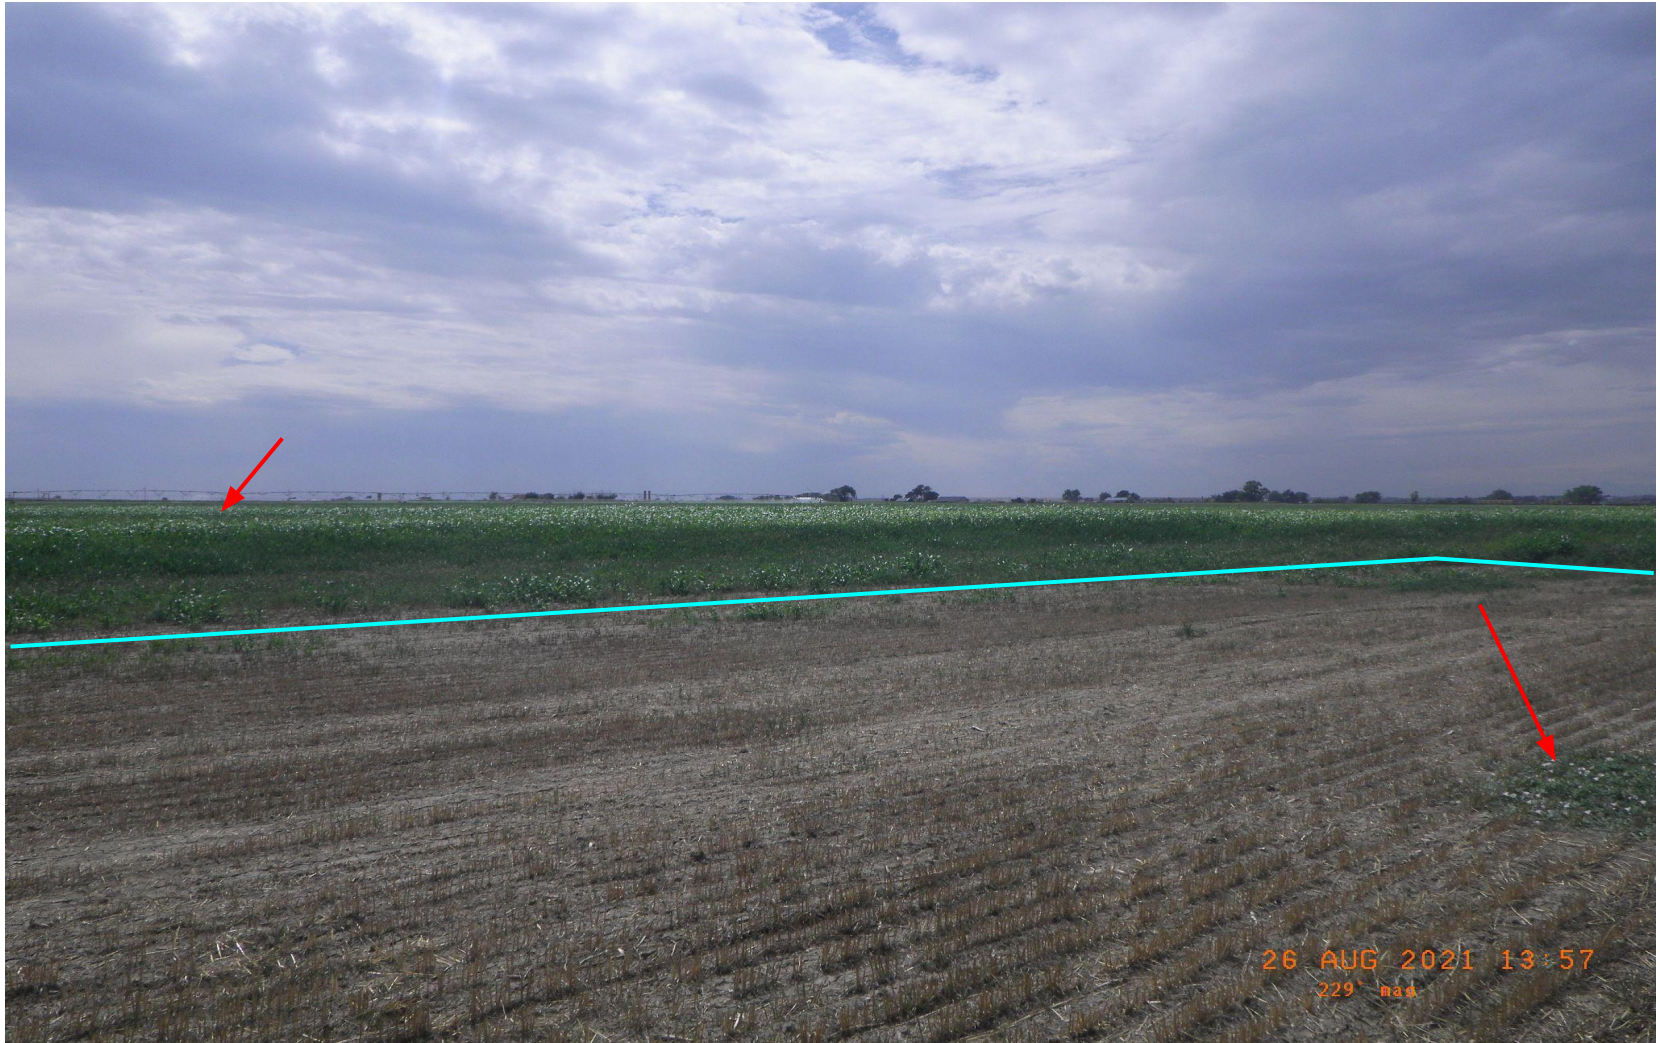
Photo 6. Reference photo taken from middle of tank battery looking southwest down well pad access road. Note wheat crop heights just outside of tank battery disturbance pad and field bindweed (both designated with red arrows). Southern edge of tank battery highlighted in light blue
