# WELLHEAD ABANDONMENT FORM

<b>SITE NAME:</b> Dinner 14 B-1 Wellhead							<b>DATE:</b> 7/15/2021	<b>REM. PROJECT #:</b> 18114	<b>WEATHER:</b> 80's Sunny		
<b>SITE DIRECTIONS:</b> HWY 85 / CR 44, 0.1 mi E, N into							<b>CLIENT:</b> PDC - Erin Crawford				
<b>LEGALS AND LAT/LONG:</b> 40.306339, -104.747187							<b>TASMAN PERSONNEL:</b> Jesse Marcus				
<b>SOIL TYPES:</b> Silty Sand - SM							<b>SURFACE GRADIENT:</b> Southwest				
SOIL SAMPLING							FACILITY INFRASTRUCTURE				
Date/Time	Soil Sample ID	PID (ppm)	Visual	Olfactory	Photo?	Grab or Lab Sample?	EQUIPMENT		Quantity		
							Above Ground Storage Tank (AST)				
7/15/2021 11:27	SS01@10'	1519	HC Staining	Strong HC Odor	Yes	Lab	Buried or Partially Buried Vessel				
7/15/2021 11:47	FLR01@4'	457.3	HC Staining	HC Odor	Yes	Grab	Separator				
7/15/2021 11:48	WHS01-N@0-6"	0.5	No Staining	No Odor	Yes	Grab	Emission Control Device (ECD)				
7/15/2021 11:49	WHS01-W@0-6"	2.3	No Staining	No Odor	Yes	Grab	Dump Line

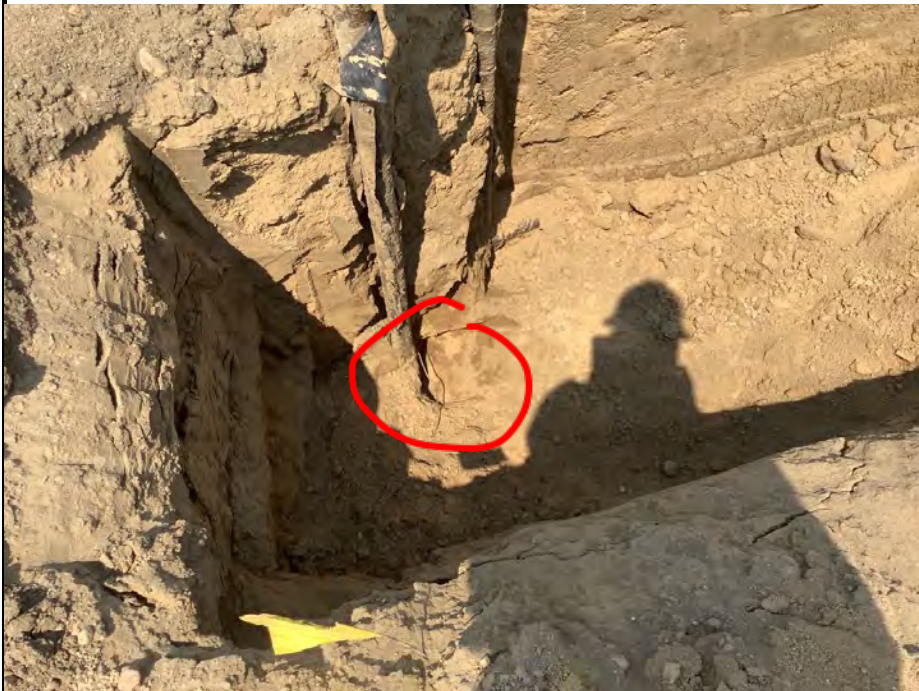
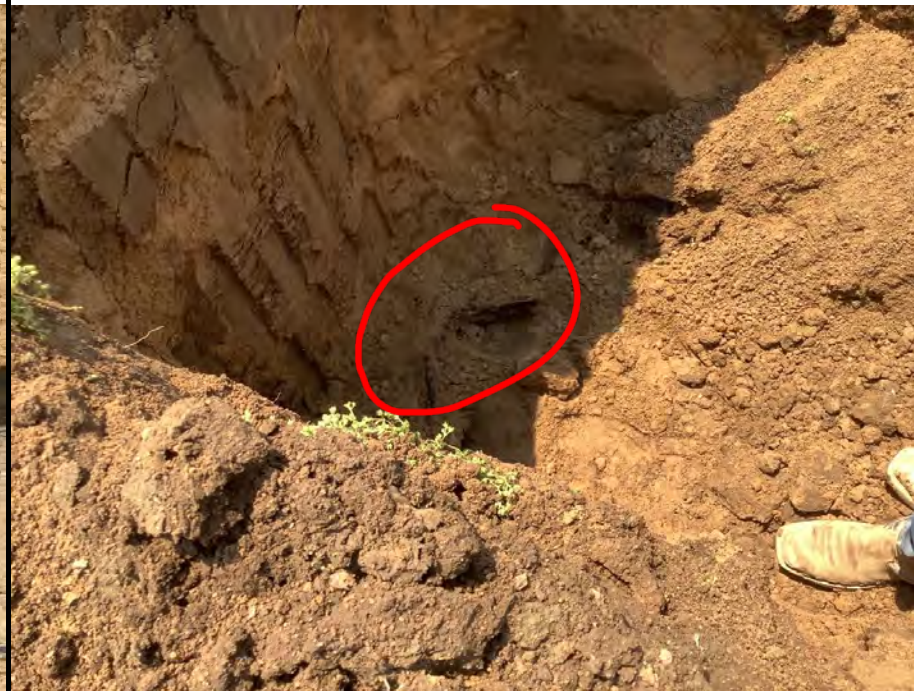
<b>Equipment ID:</b>		<b>Equipment Type:</b>		<b>Equipment ID:</b>		<b>Equipment Type:</b>			
<b>Material:</b>		<b>Volume:</b>		<b>Material:</b>		<b>Volume:</b>		<b>Contents:</b>	
<b>Notes/Conditions:</b> FL01-01 @ 4'					<b>Notes/Conditions:</b> FL01-02 @ 4'

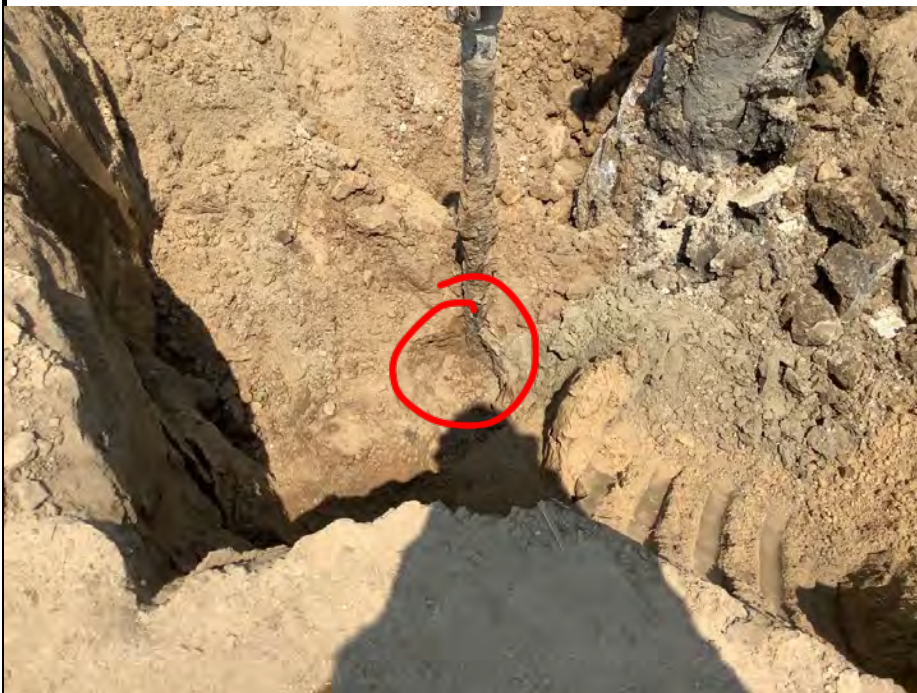
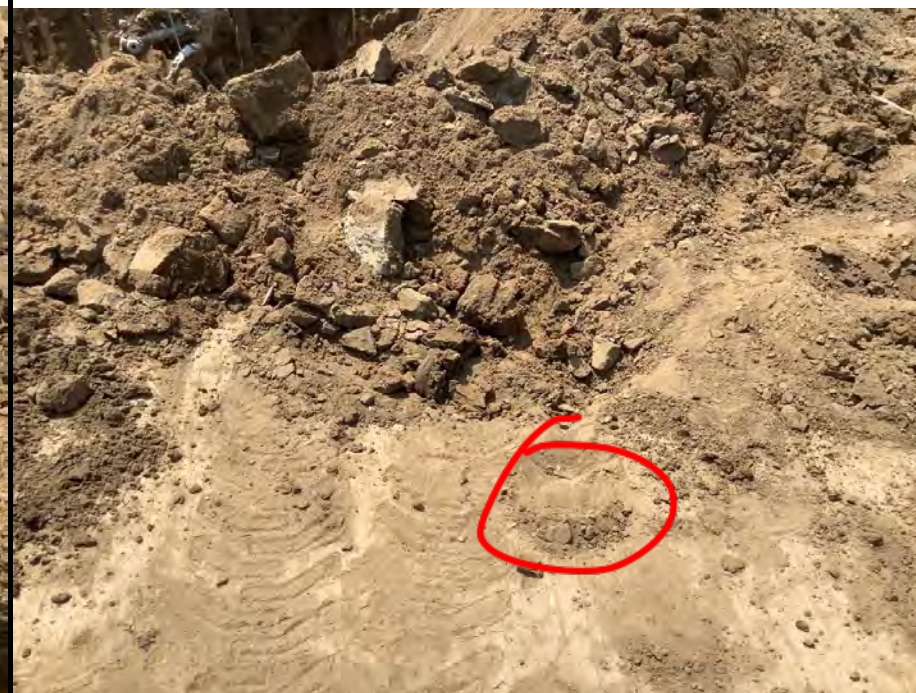
Equipment ID:		Equipment Type:		Equipment ID:		Equipment Type:	
Material:		Volume:		Material:		Volume:	
Contents:				Contents:			
Notes/Conditions: FLR01 @ 4'				Notes/Conditions: WHS01-N @ 0-6"

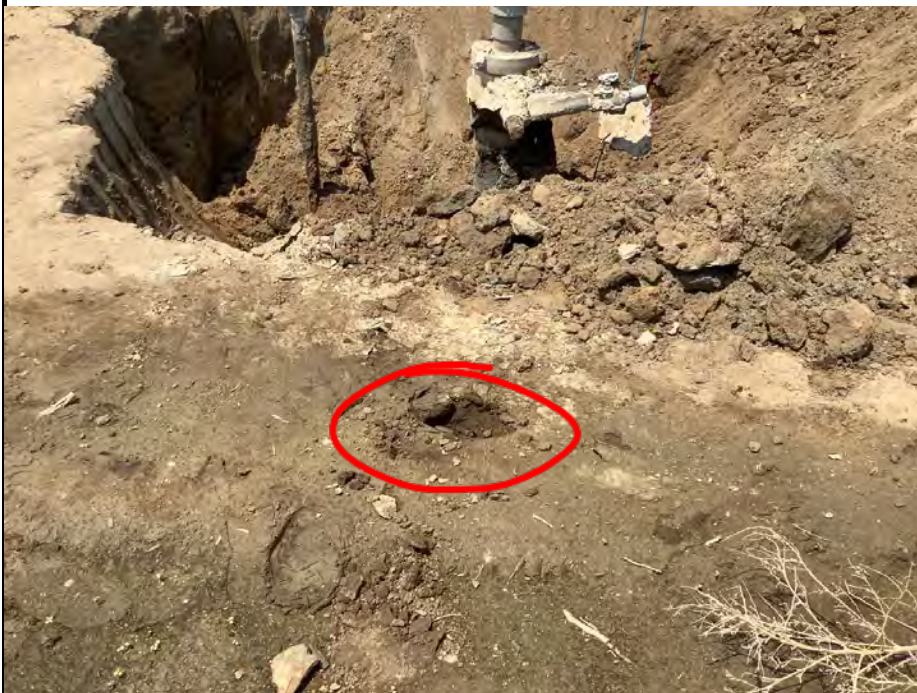
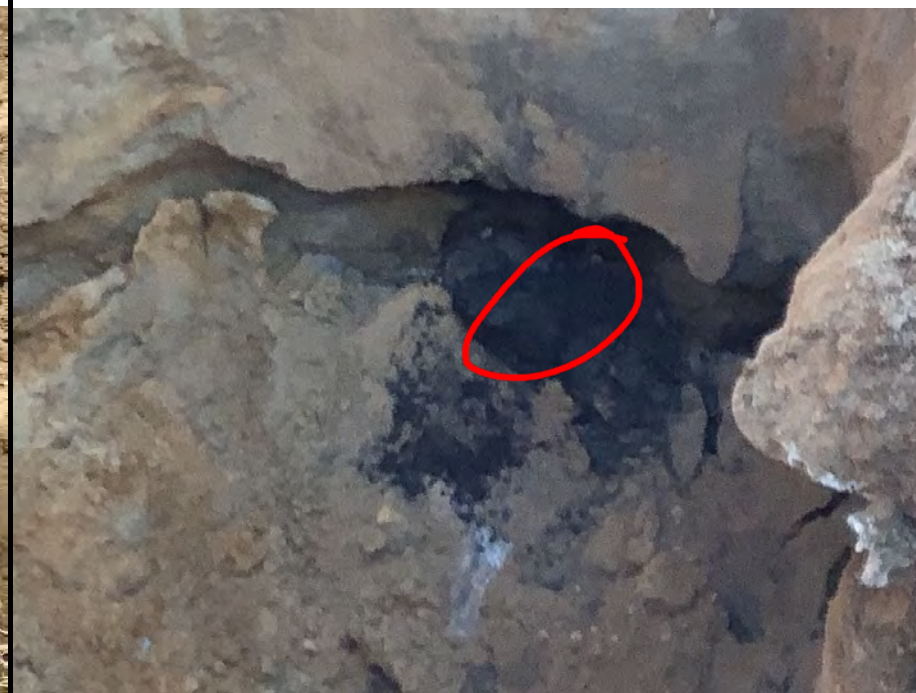
<b>Equipment ID:</b>		<b>Equipment Type:</b>		<b>Equipment ID:</b>		<b>Equipment Type:</b>	
<b>Material:</b>	<b>Volume:</b>	<b>Contents:</b>		<b>Material:</b>	<b>Volume:</b>	<b>Contents:</b>	
<b>Notes/Conditions:</b> WHS01-E@0-6"				<b>Notes/Conditions:</b> SS01@10'

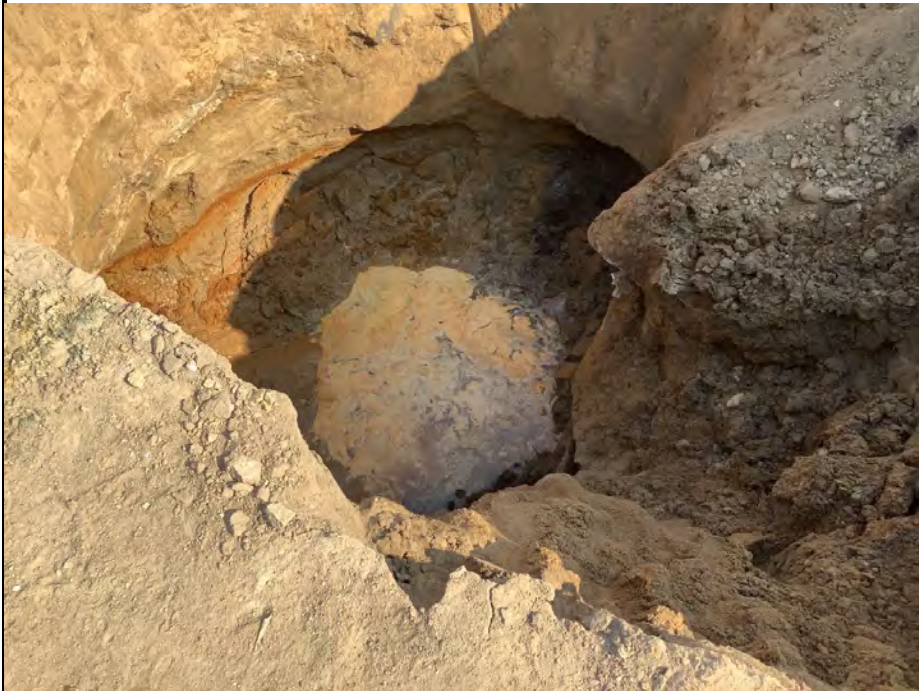
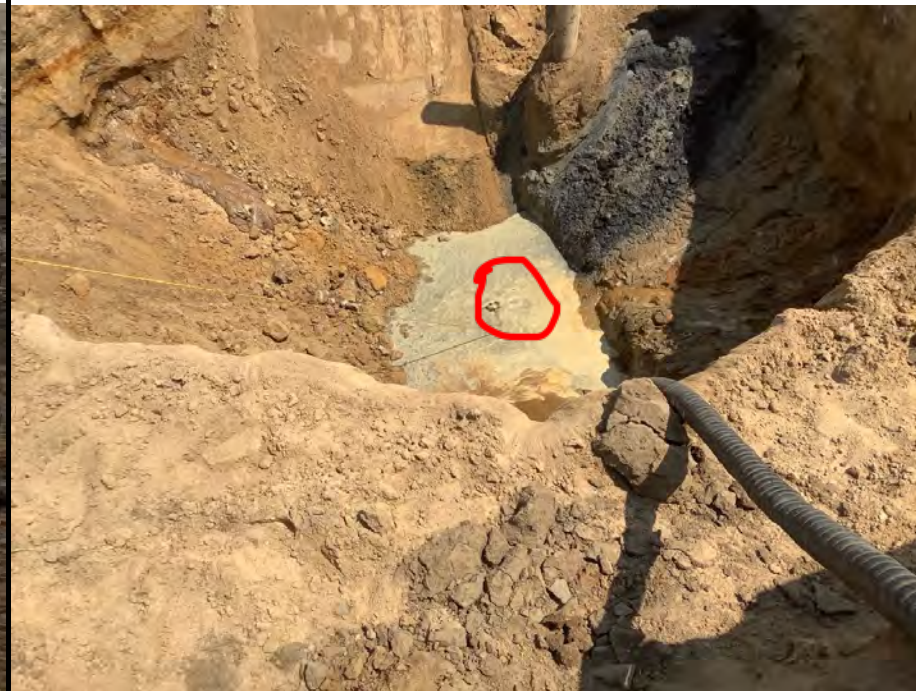
<b>Equipment ID:</b>		<b>Equipment Type:</b>		<b>Equipment ID:</b>		<b>Equipment Type:</b>			
<b>Material:</b>		<b>Volume:</b>		<b>Material:</b>		<b>Volume:</b>		<b>Contents:</b>	
<b>Notes/Conditions:</b> GW in contact with impacts, GW01					<b>Notes/Conditions:</b> B@22', SS02@22'

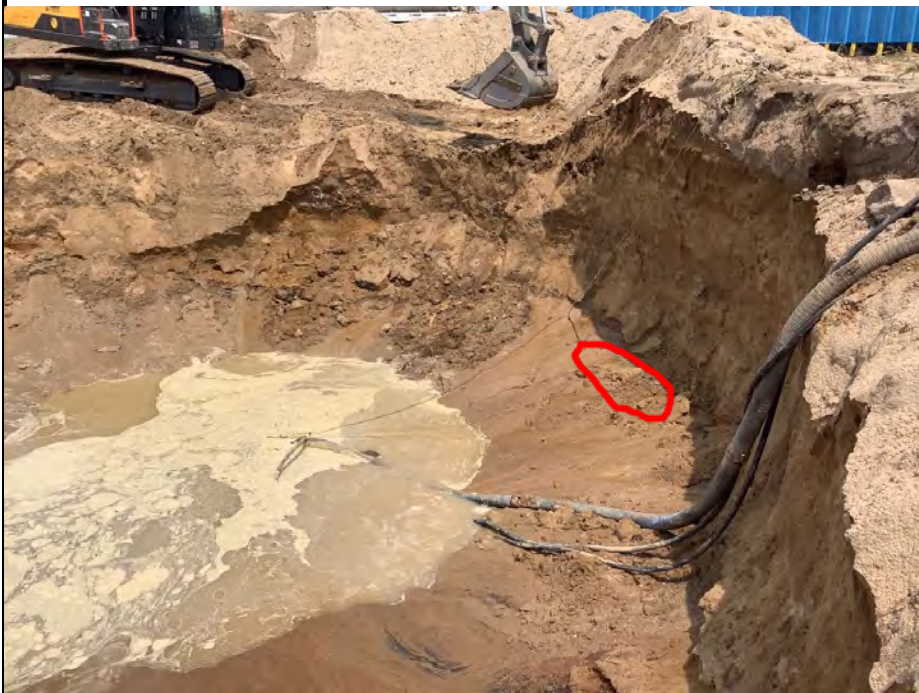
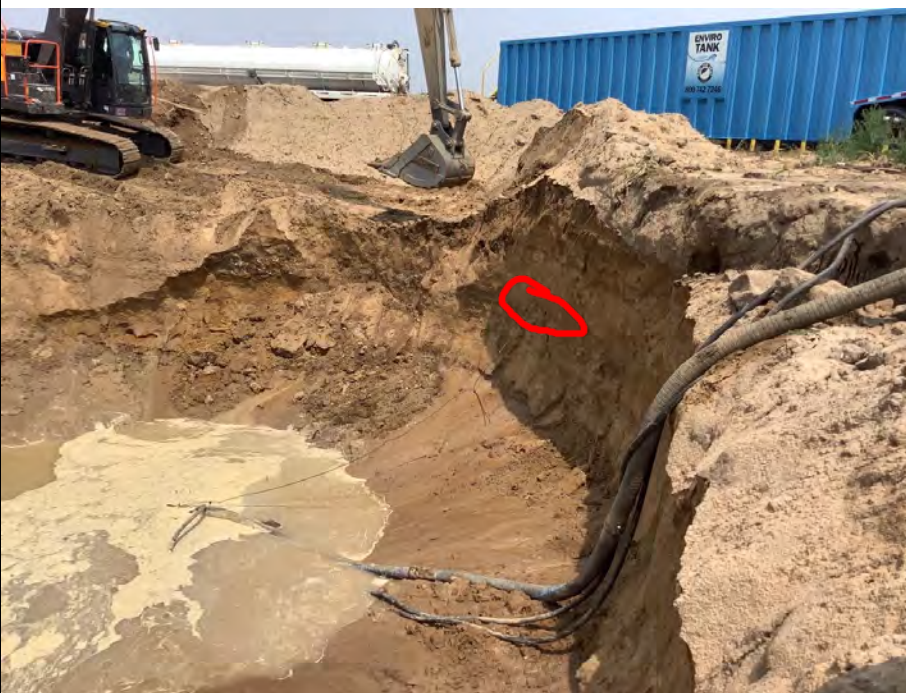
<b>Equipment ID:</b> SS09		<b>Equipment Type:</b>		<b>Equipment ID:</b> SS10		<b>Equipment Type:</b>	
<b>Material:</b>	<b>Volume:</b>	<b>Contents:</b>		<b>Material:</b>	<b>Volume:</b>	<b>Contents:</b>	
<b>Notes/Conditions:</b>				<b>Notes/Conditions:</b>

8/2/2021 12:54	SS10@5'	0.2	No Staining	No Odor	Yes	Lab	Dump Line					
8/2/2021 14:30	GS14@18'	204	HC Staining	Slight HC Odor	No	Grab	Wellhead					
							Flowline					
							Other:					
							Soil Loads Removed					
							IMPACTED SOIL IDENTIFIED?					
							ESTIMATED VOLUME OF IMPACTS:					
							Date		Number		CY	
							8/2/2021		24		240	
							Total Removed		24		240	
							Disposal Facility: WM - Ault					
							Groundwater Recovery					
							DATE GW ENCOUNTERED:			DEPTH:		
							GROUNDWATER IN CONTACT WITH IMPACTED SOIL?					
							LNAPL OR SHEEN OBSERVED ON GW?					
GROUNDWATER SAMPLING							Date		BBLS			
Date/Time	Groundwater Sample ID	Depth Collected	Turbid?	Sheen?	Odor?	Photo?	8/2/2021		1,390			
							Total Removed		1390			
							Disposal Facility: NGL C6

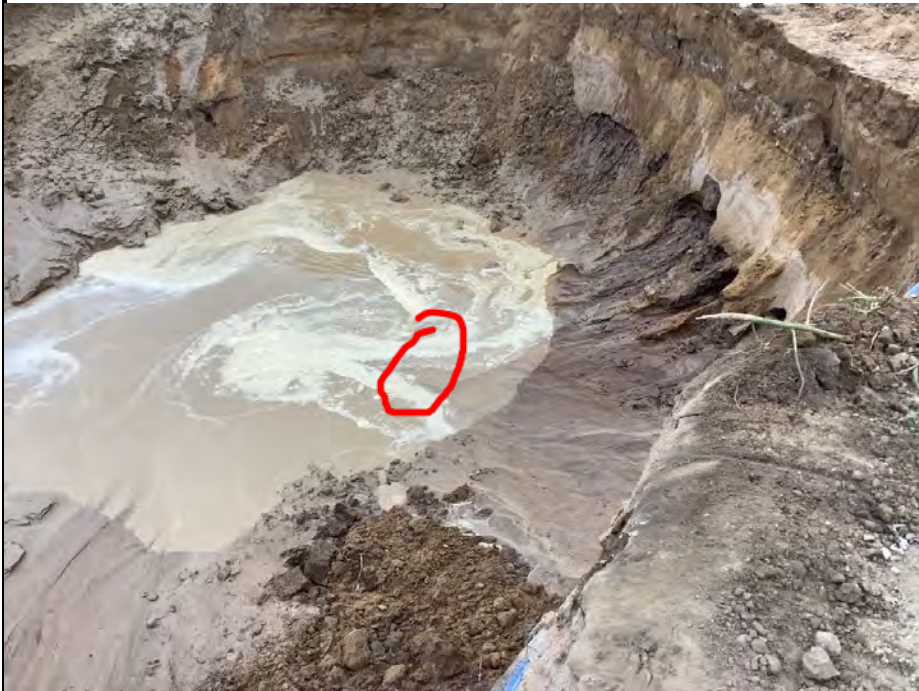
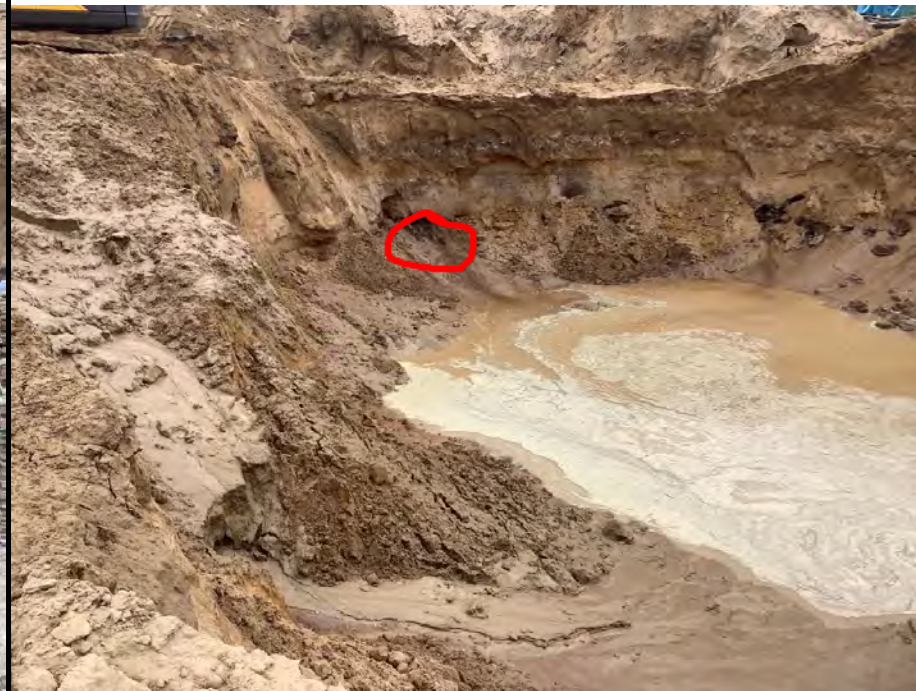
Equipment ID:SS13		Equipment Type:		Equipment ID:SS14		Equipment Type:	
Material:	Volume:	Contents:		Material:	Volume:	Contents:	
Notes/Conditions:				Notes/Conditions:

<b>SITE NAME:</b> Dinner 14 B-1 Wellhead							<b>DATE:</b> 8/3/2021	<b>REM. PROJECT #:</b> 18114	<b>WEATHER:</b> 80s and partly cloudy	
<b>SITE DIRECTIONS:</b> Hwy 85 & CR 44, turn N into site approx 0.2 miles							<b>CLIENT:</b> PDC/ Erin Crawford			
<b>LEGALS AND LAT/LONG:</b> 40.306339, -104.747187. SESW 14 4N 66W 6							<b>TASMAN PERSONNEL:</b> Cody Miller			
<b>SOIL TYPES:</b> Silty Sand - SM							<b>SURFACE GRADIENT:</b> Northeast			
SOIL SAMPLING							FACILITY INFRASTRUCTURE			
Date/Time	Soil Sample ID	PID (ppm)	Visual	Olfactory	Photo?	Grab or Lab Sample?	EQUIPMENT		Quantity	
							Above Ground Storage Tank (AST)			
8/3/2021 09:40	SS11@20'	1.3	Organic Content	No Odor	Yes	Lab	Buried or Partially Buried Vessel			
8/3/2021 10:04	SS12@20'	0.8	Organic Content	No Odor	Yes	Lab	Separator			
8/3/2021 10:10	SS13@18'	0.9	Organic Content	No Odor	Yes	Lab	Emission Control Device (ECD)			
8/3/2021 10:42	SS14@10'	0.3	No Staining	No Odor	Yes	Lab	Dump Line

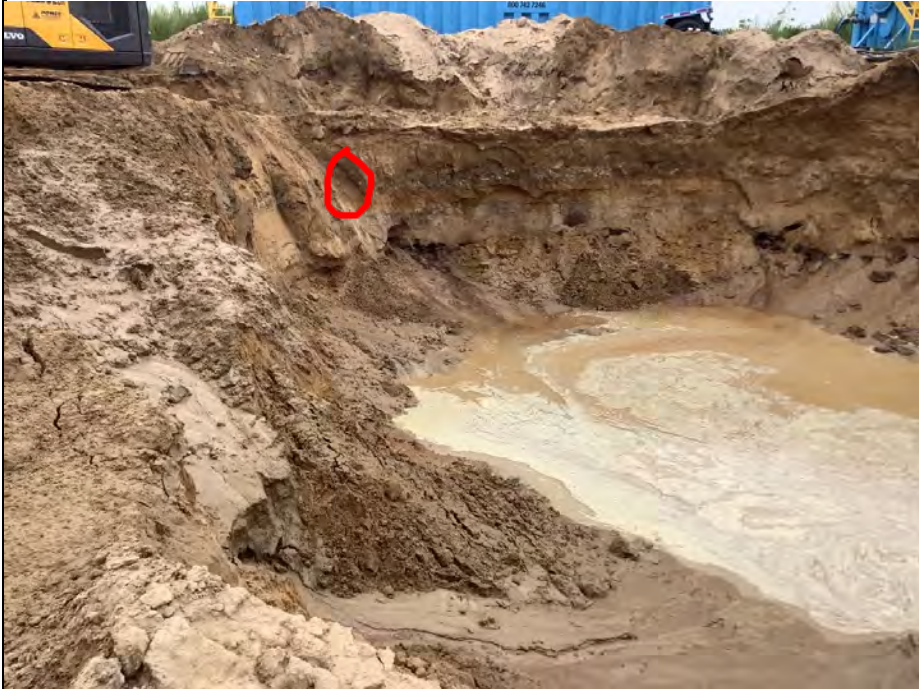
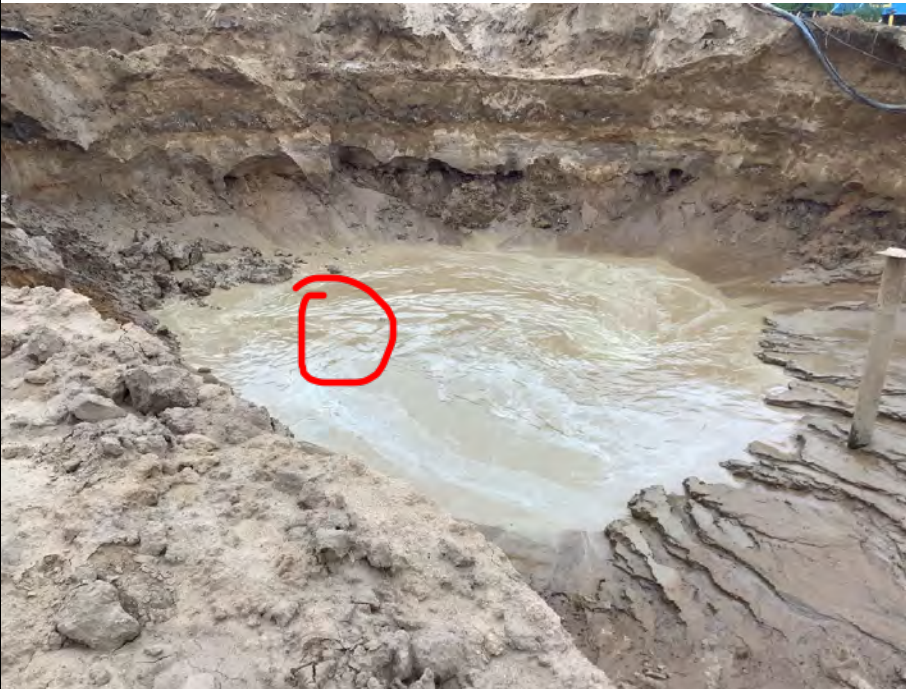
<b>Equipment ID:</b> SS15		<b>Equipment Type:</b>		<b>Equipment ID:</b> GS15		<b>Equipment Type:</b>	
<b>Material:</b>	<b>Volume:</b>	<b>Contents:</b>		<b>Material:</b>	<b>Volume:</b>	<b>Contents:</b>	
<b>Notes/Conditions:</b>				<b>Notes/Conditions:</b>

8/3/2021 10:50	SS15@5'	0.4	Organic Content	No Odor	Yes	Lab	Wellhead			
8/3/2021 14:50	GS15@18'	275	HC Staining	Slight HC Odor	Yes	Grab	Flowline			
							Other:			
							Soil Loads Removed			
							IMPACTED SOIL IDENTIFIED?			
							ESTIMATED VOLUME OF IMPACTS:			
							Date		Number	CY
							8/3/2021		54	540
							Total Removed		54	540
							Disposal Facility: WM - Ault			
							Groundwater Recovery			
							DATE GW ENCOUNTERED:		DEPTH:	
							GROUNDWATER IN CONTACT WITH IMPACTED SOIL?			
							LNAPL OR SHEEN OBSERVED ON GW?			
GROUNDWATER SAMPLING							Date		BBLS	
Date/Time	Groundwater Sample ID	Depth Collected	Turbid?	Sheen?	Odor?	Photo?	8/3/2021		990	
							Total Removed		990	
							Disposal Facility: NGL C6

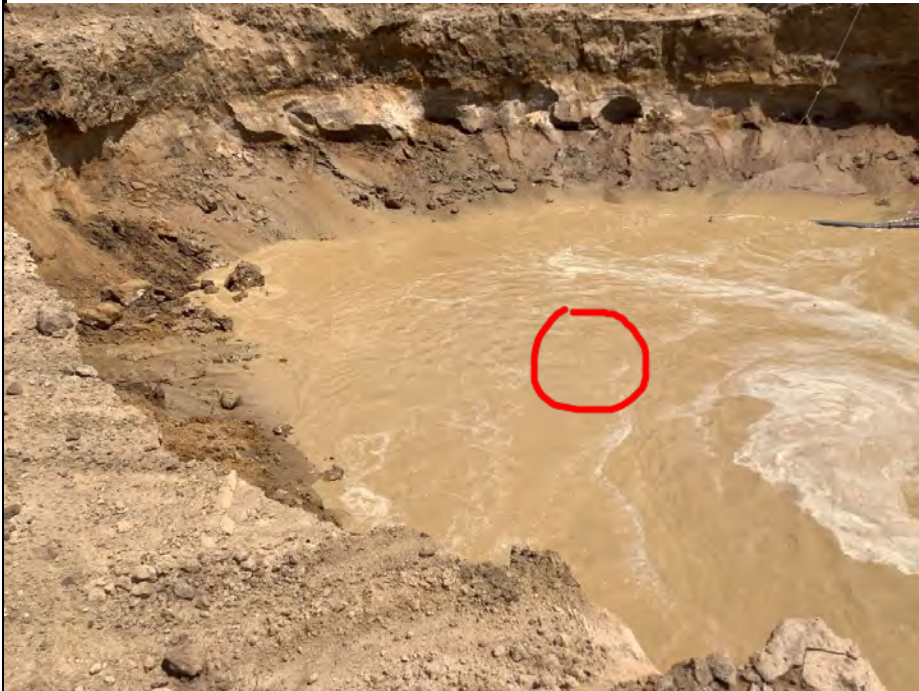
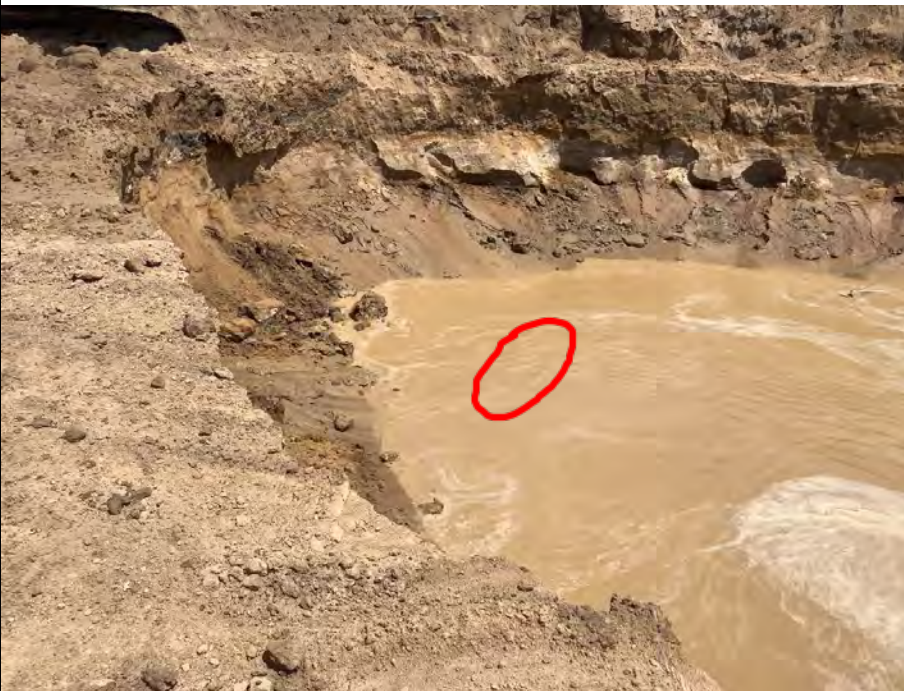
Equipment ID:SS20		Equipment Type:		Equipment ID:SS21		Equipment Type:	
Material:	Volume:	Contents:		Material:	Volume:	Contents:	
Notes/Conditions:				Notes/Conditions:

8/4/2021 13:05	SS20@20'	0.9	No Staining	No Odor	Yes	Lab	Wellhead				
8/4/2021 13:14	SS21@18'	1.1	Organic Content	No Odor	Yes	Lab	Flowline				
8/4/2021 13:26	SS22@10'	0.5	Organic Content	No Odor	Yes	Lab	Other:				
8/4/2021 13:32	SS23@5'	0.3	Organic Content	No Odor	Yes	Lab	Soil Loads Removed				
8/4/2021 14:30	SS24@20'	1.4	No Staining	No Odor	Yes	Lab	IMPACTED SOIL IDENTIFIED?				
8/4/2021 14:38	SS25@18'	9.6	HC Staining	No Odor	Yes	Lab	ESTIMATED VOLUME OF IMPACTS:				
8/4/2021 14:52	SS26@10'	0.4	Organic Content	No Odor	Yes	Lab	Date		Number	CY	
8/4/2021 14:58	SS27@5'	0.3	No Staining	No Odor	Yes	Lab	8/4/2021		29	290	
							Total Removed		29	290	
							Disposal Facility: WM - Ault				
							Groundwater Recovery				
							DATE GW ENCOUNTERED:		DEPTH:		
							GROUNDWATER IN CONTACT WITH IMPACTED SOIL?				
							LNAPL OR SHEEN OBSERVED ON GW?				
GROUNDWATER SAMPLING							Date		BBLS		
Date/Time	Groundwater Sample ID	Depth Collected	Turbid?	Sheen?	Odor?	Photo?	8/4/2021		880

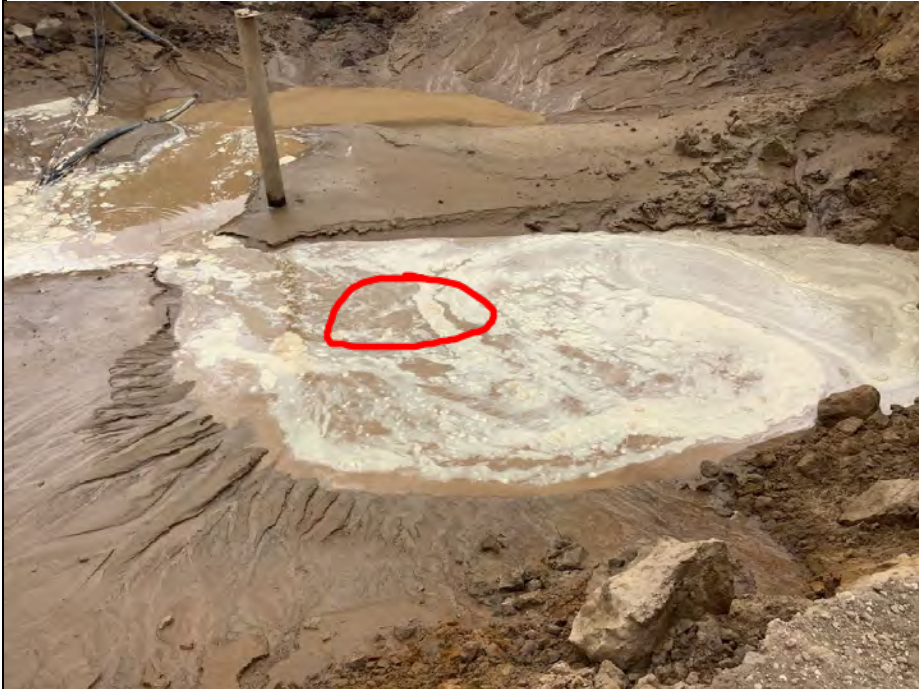
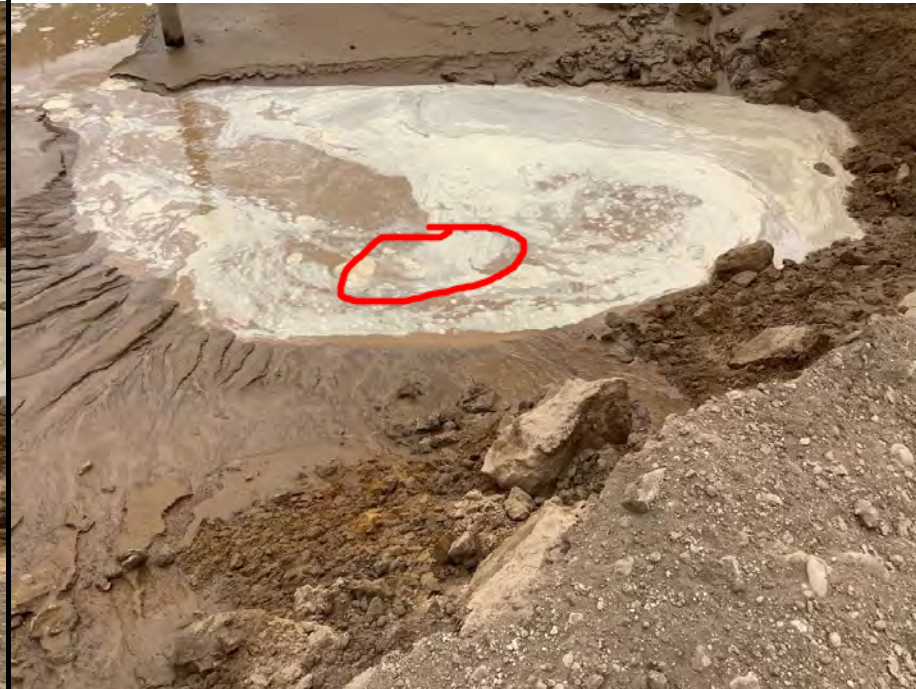
Equipment ID:SS35		Equipment Type:		Equipment ID:SS36		Equipment Type:	
Material:	Volume:	Contents:		Material:	Volume:	Contents:	
Notes/Conditions:				Notes/Conditions:

8/6/2021 11:34	SS35@20'	0.4	No Staining	No Odor	Yes	Lab	Wellhead				
8/6/2021 11:42	SS36@18'	0.4	Organic Content	No Odor	Yes	Lab	Flowline				
8/6/2021 12:00	SS37@10'	0.3	Organic Content	No Odor	Yes	Lab	Other:				
8/6/2021 12:06	SS38@5'	0.1	No Staining	No Odor	Yes	Lab	Soil Loads Removed				
8/6/2021 14:44	GS17@18'	60.2	HC Staining	Slight HC Odor	Yes	Grab	IMPACTED SOIL IDENTIFIED?				
							ESTIMATED VOLUME OF IMPACTS:				
							Date		Number	CY	
							8/6/2021		34	340	
							Total Removed		34	340	
							Disposal Facility: WM - Ault				
							Groundwater Recovery				
							DATE GW ENCOUNTERED:		DEPTH:		
							GROUNDWATER IN CONTACT WITH IMPACTED SOIL?				
							LNAPL OR SHEEN OBSERVED ON GW?				
GROUNDWATER SAMPLING							Date		BBLS		
Date/Time	Groundwater Sample ID	Depth Collected	Turbid?	Sheen?	Odor?	Photo?	8/6/2021		1,105		
							Total Removed		1105		
							Disposal Facility: NGL C6

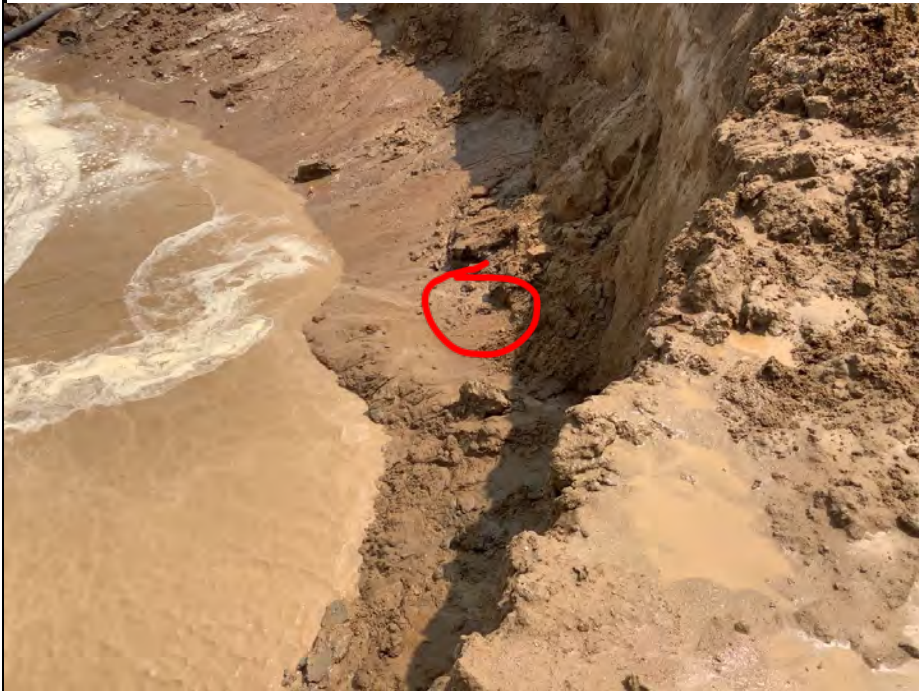
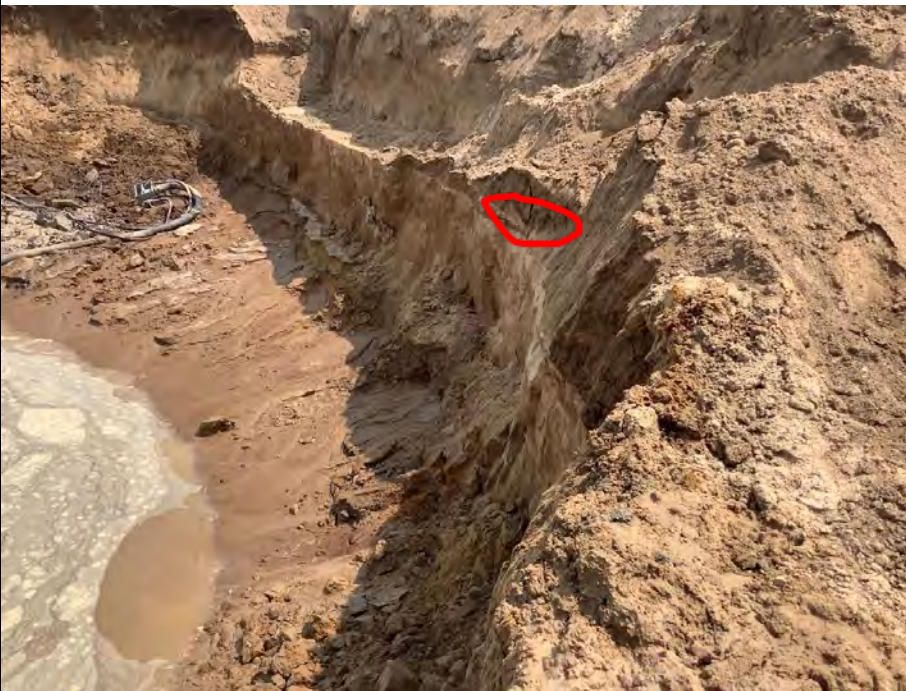
Equipment ID:SS41		Equipment Type:		Equipment ID:SS42		Equipment Type:	
Material:	Volume:	Contents:		Material:	Volume:	Contents:	
Notes/Conditions:				Notes/Conditions:

<b>SITE NAME:</b> Dinner 14 B-1 Wellhead							<b>DATE:</b> 8/9/2021		<b>REM. PROJECT #:</b> 18114		<b>WEATHER:</b> 90s and smoky	
<b>SITE DIRECTIONS:</b> Hwy 85 & CR 44, turn N into site approx 0.2 miles							<b>CLIENT:</b> PDC/ Erin Crawford					
<b>LEGALS AND LAT/LONG:</b> 40.306339, -104.747187. SESW 14 4N 66W 6							<b>TASMAN PERSONNEL:</b> Cody Miller					
<b>SOIL TYPES:</b> Silty Sand - SM							<b>SURFACE GRADIENT:</b> Northeast					
SOIL SAMPLING							FACILITY INFRASTRUCTURE					
Date/Time	Soil Sample ID	PID (ppm)	Visual	Olfactory	Photo?	Grab or Lab Sample?	EQUIPMENT		Quantity			
							Above Ground Storage Tank (AST)					
8/9/2021 12:42	SS39@20'	2.3	No Staining	No Odor	Yes	Lab	Buried or Partially Buried Vessel					
8/9/2021 12:50	SS40@18'	1.8	Organic Content	No Odor	Yes	Lab	Separator					
8/9/2021 13:10	SS41@10'	0.6	Organic Content	No Odor	Yes	Lab	Emission Control Device (ECD)					
8/9/2021 13:18	SS42@5'	0.1	No Staining	No Odor	Yes	Lab	Dump Line

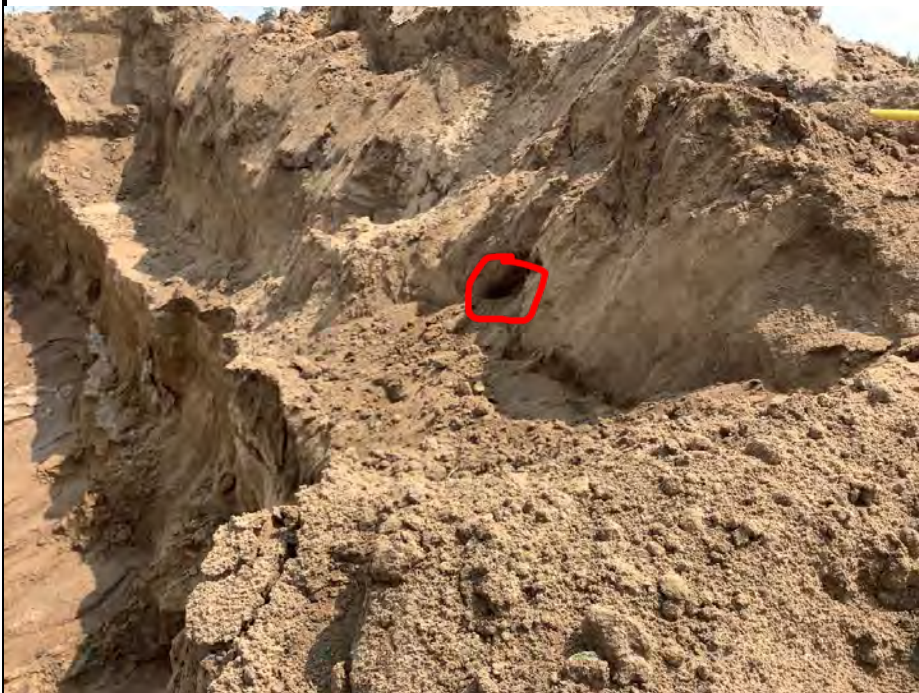
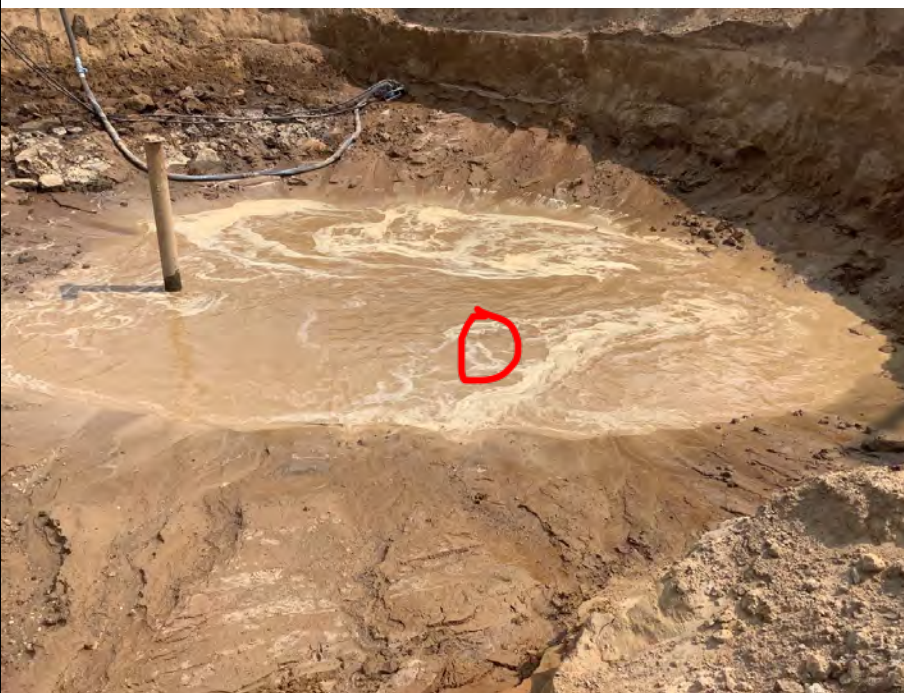
Equipment ID:SS43		Equipment Type:		Equipment ID:SS44		Equipment Type:	
Material:	Volume:	Contents:		Material:	Volume:	Contents:	
Notes/Conditions:				Notes/Conditions:

8/9/2021 13:24	SS43@2.5'	0.1	No Staining	No Odor	Yes	Lab	Wellhead					
8/9/2021 14:44	SS44@20'	1.2	Organic Content	No Odor	Yes	Lab	Flowline					
8/9/2021 14:52	SS45@18'	0.9	Organic Content	No Odor	Yes	Lab	Other:					
8/9/2021 14:58	SS46@10'	0.4	Organic Content	No Odor	Yes	Lab	Soil Loads Removed					
8/9/2021 15:02	SS47@5'	0.8	No Staining	No Odor	Yes	Lab	IMPACTED SOIL IDENTIFIED?					
8/9/2021 15:35	BKG02@5'	0.3	No Staining	No Odor	Yes	Lab	ESTIMATED VOLUME OF IMPACTS:					
8/9/2021 15:40	BKG02@10'	0.4	Organic Content	No Odor	Yes	Lab	Date		Number	CY		
8/9/2021 15:47	BKG02@18'	0.3	Organic Content	No Odor	Yes	Lab	8/9/2021		11	110		
							Total Removed		11	110		
							Disposal Facility: WM - Ault					
							Groundwater Recovery					
							DATE GW ENCOUNTERED:		DEPTH:			
							GROUNDWATER IN CONTACT WITH IMPACTED SOIL?					
							LNAPL OR SHEEN OBSERVED ON GW?					
GROUNDWATER SAMPLING							Date		BBLS
