Inspection Photos
Operator: Simcoe
Facility: 067-06679
Date: 9/16/2021

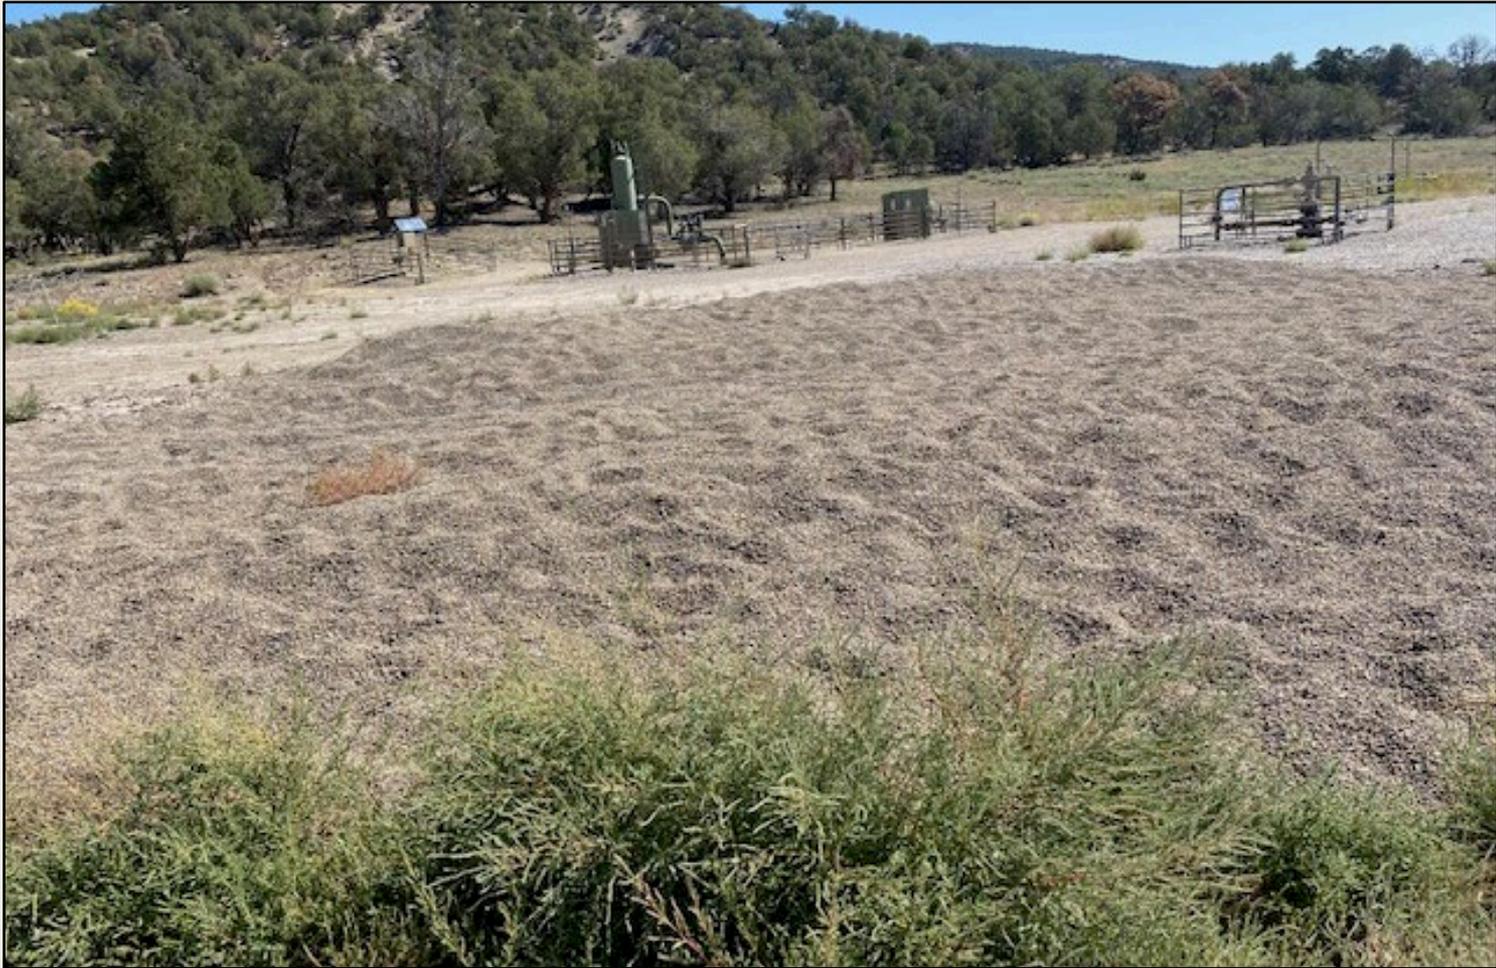
Photo 1. View of the project area from the northwestern corner facing center. Kochia weeds (up to 3ft tall) need to be managed.

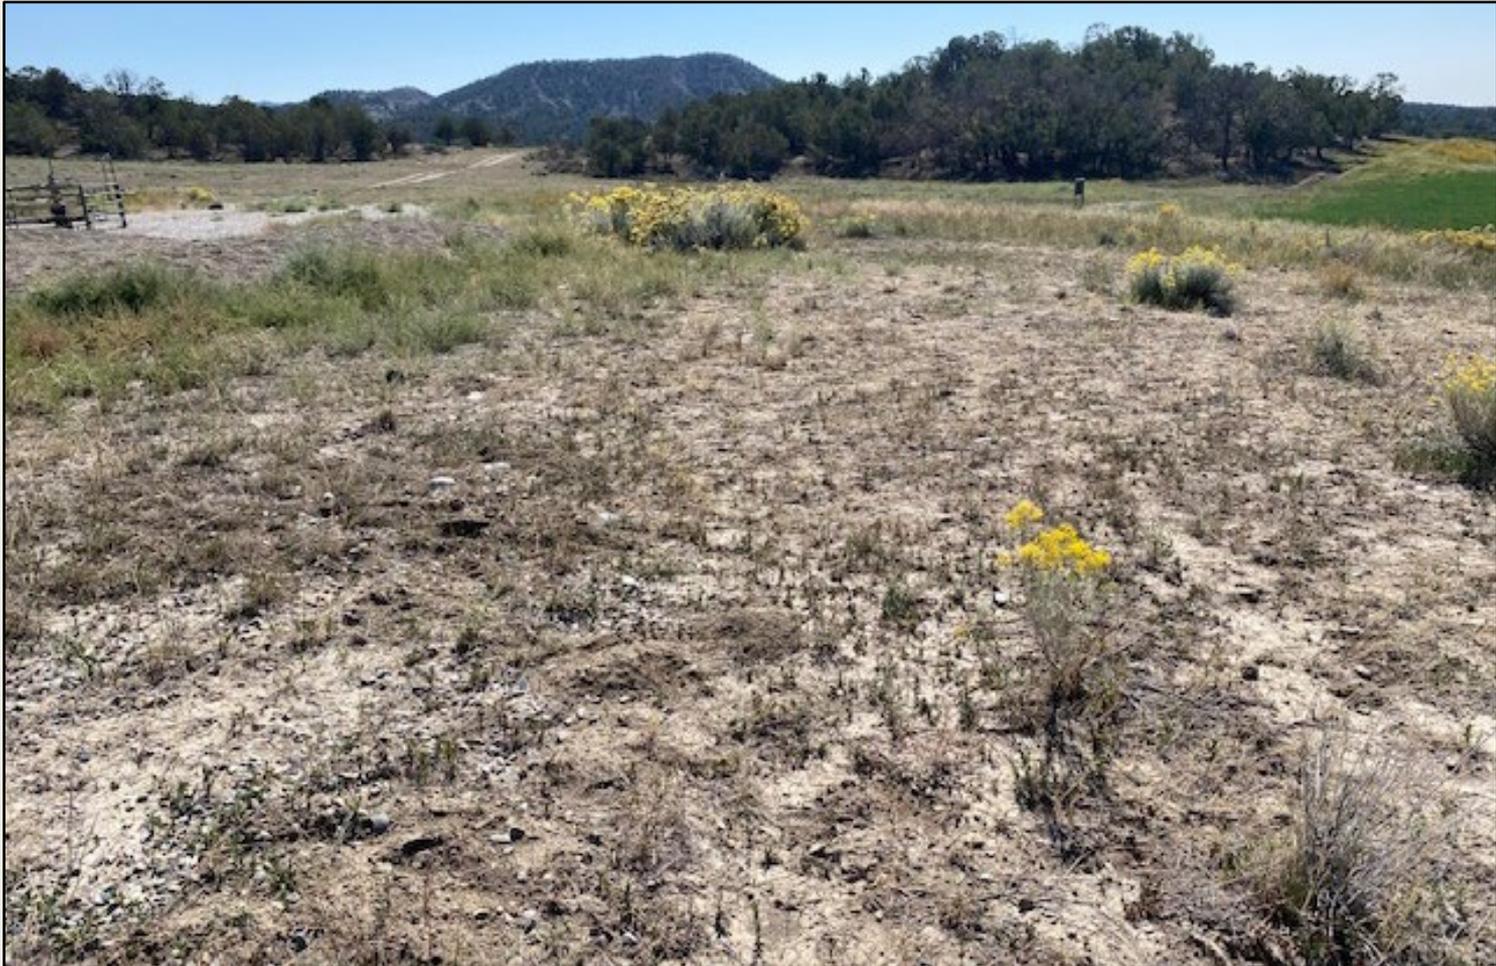
Photo 2. View of the western fill slope from the northwestern corner facing southward. Revegetation is progressing in portions with western wheatgrass, smooth brome, and sand dropseed.

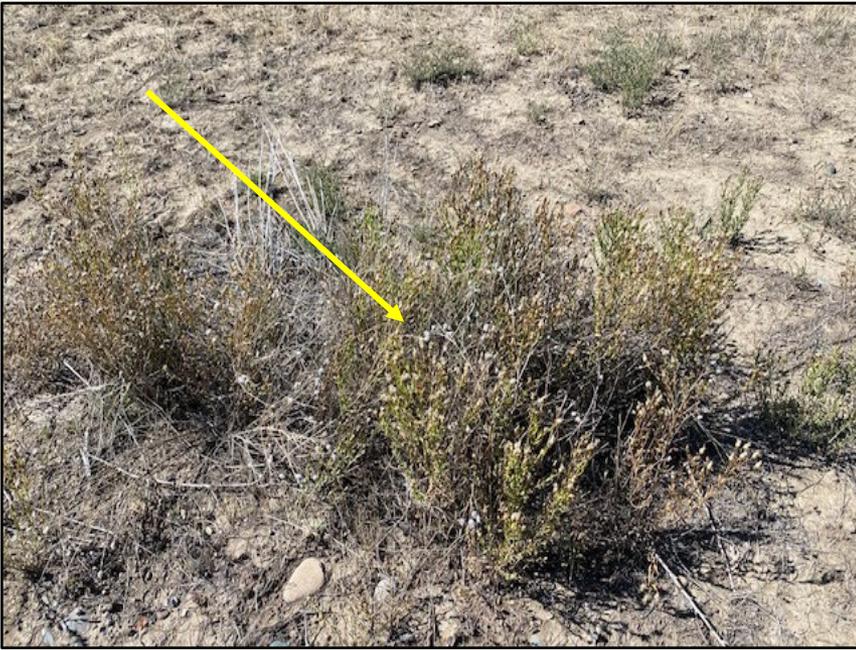
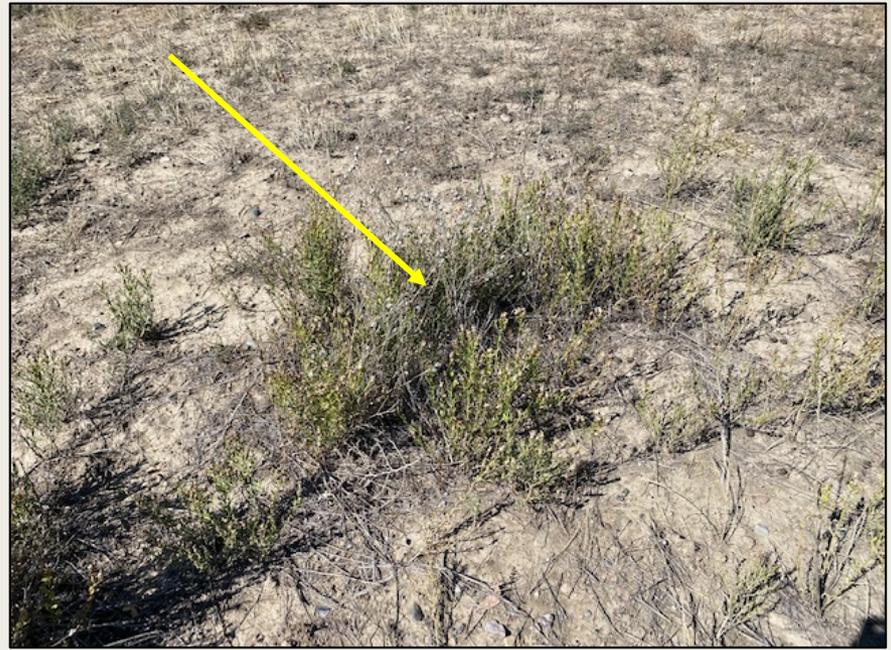
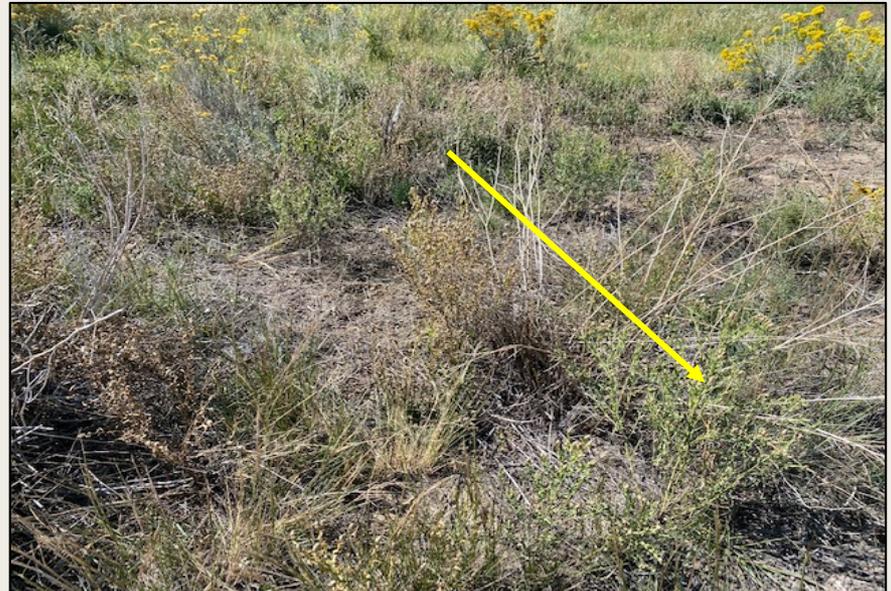
Photos 3-5. View of Russian knapweeds remaining within the interim reclamation areas. Approximately 300 individuals observed.

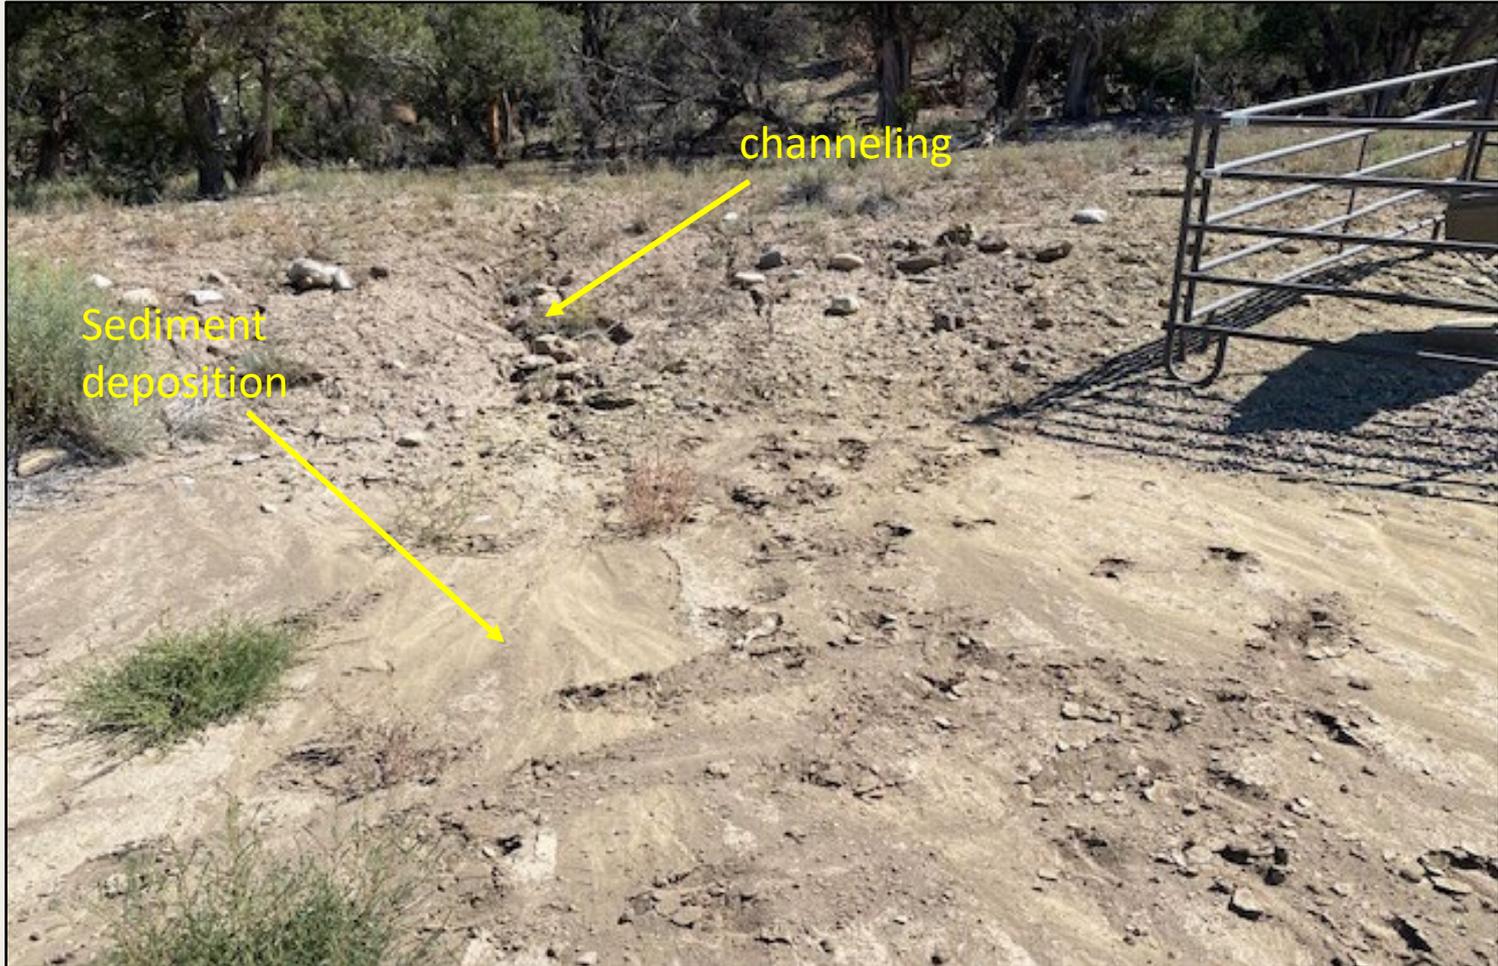
Photo 6. View of stormwater erosion and sediment deposition occurring on the well pad cut-slope.

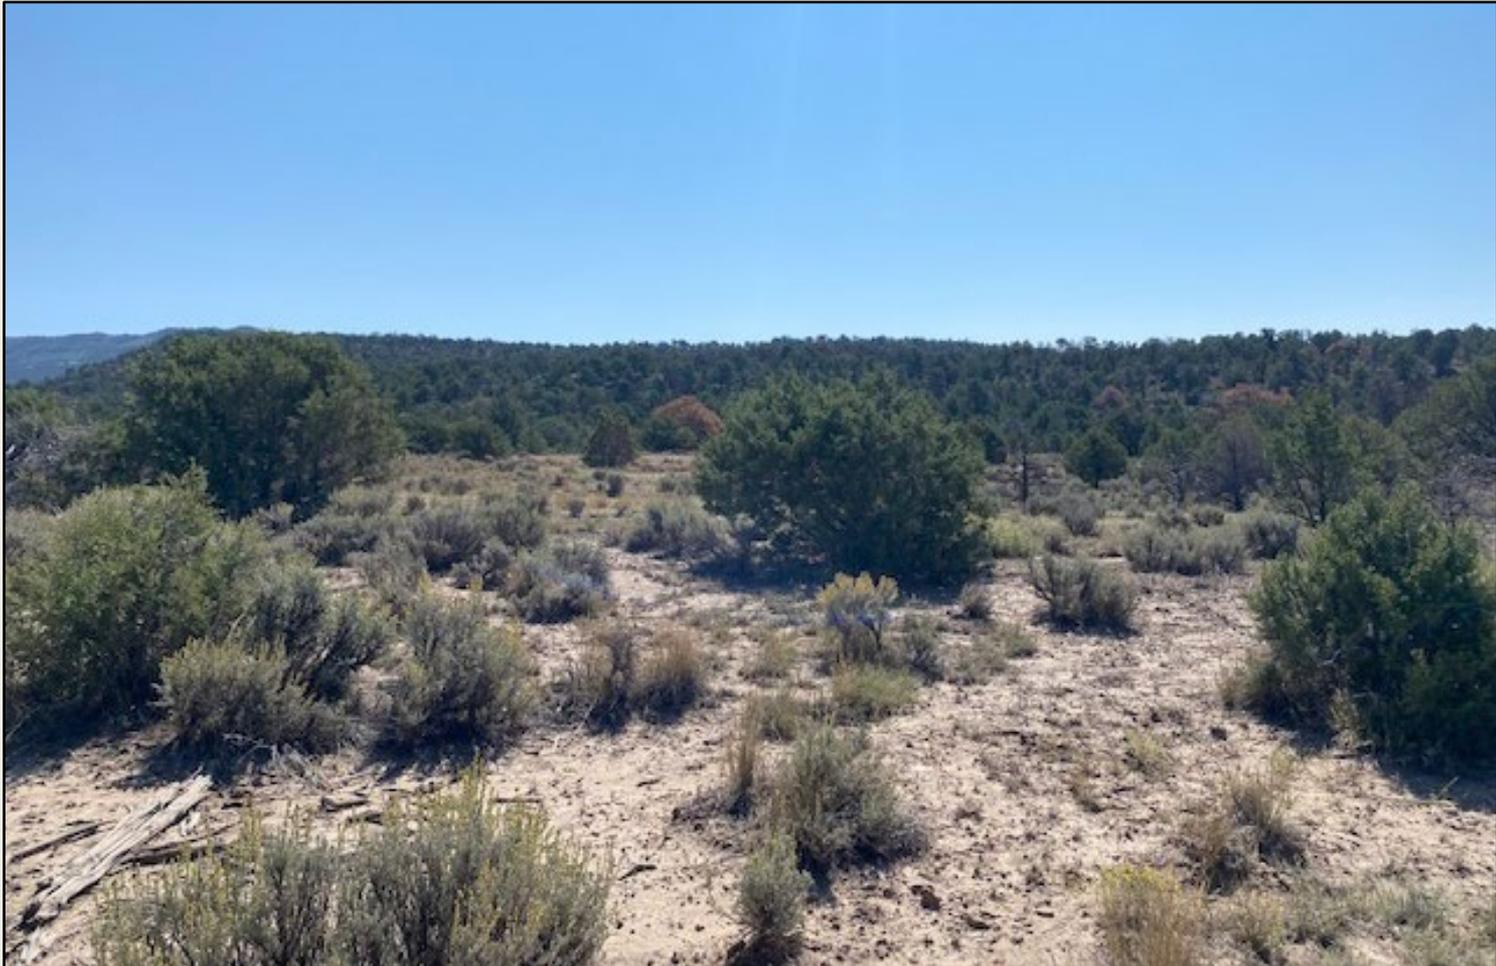
Photo 7. View of pinyon and juniper woodland with understory of sagebrush, prickly pear, and squirreltail.
