# Inspection Photos

Operator: SG INTERESTS I LTD - 77330

Location ID: 428197

Gunnison County, CO

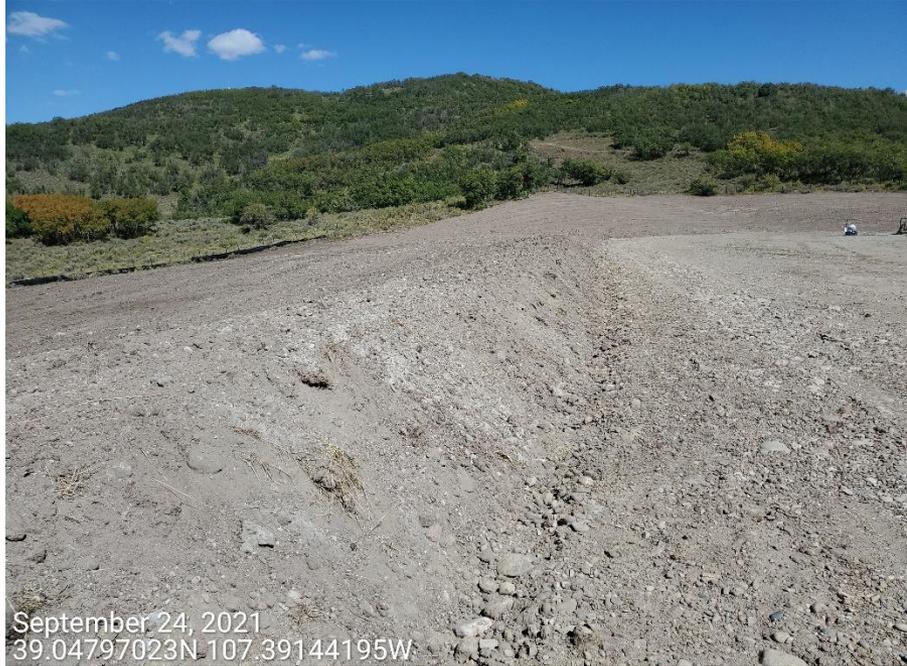
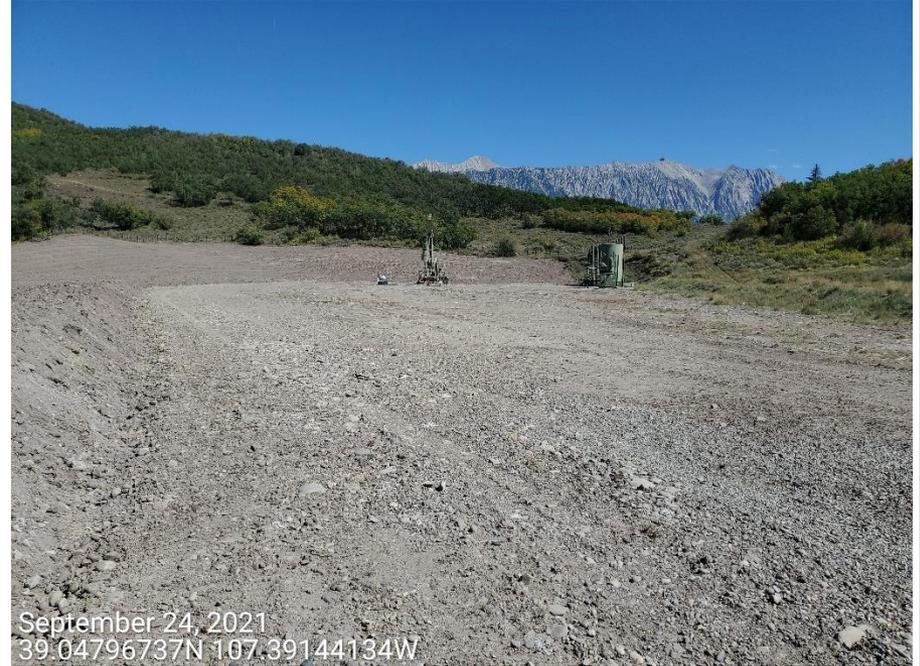
September 24, 2021  
39.04797023N 107.39144195W

**Photo 1:** Photo provides overview of the Location. Interim reclamation of the location has commenced. Unclear if revegetation activities have been conducted.

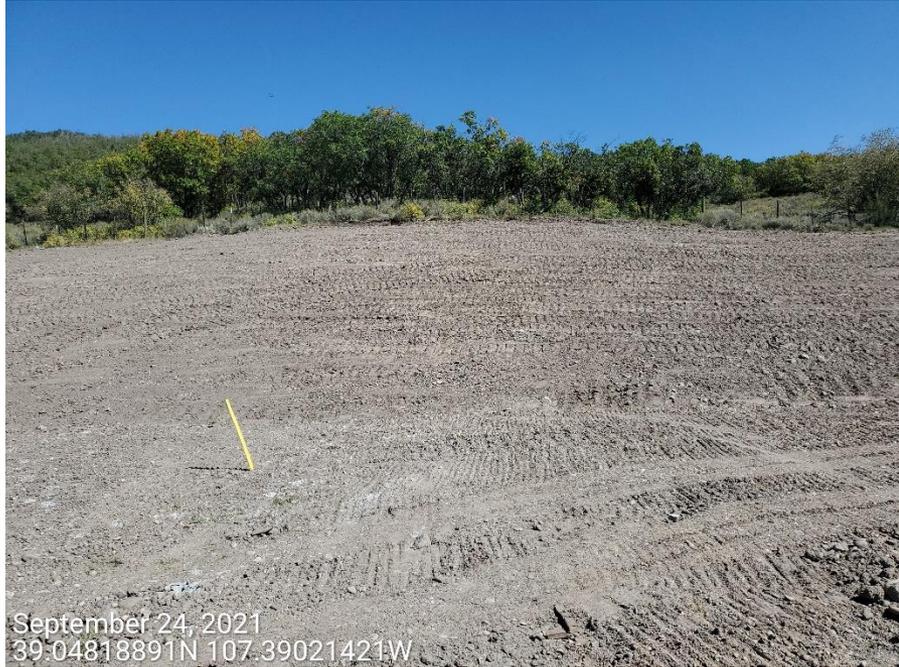
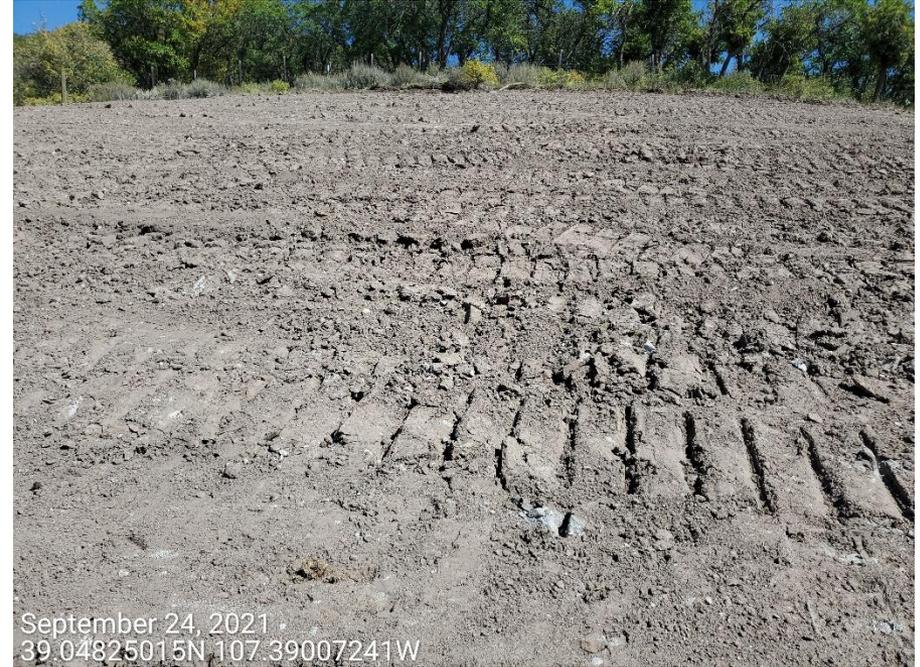
**Photo 2:** Photo provides example of the interim areas of the Location; BMPs on interim areas are missing or insufficient to protect and stabilize soils; tracking has been implemented along the contour of the slopes, rather than up and down, and will facilitate stormwater erosion.

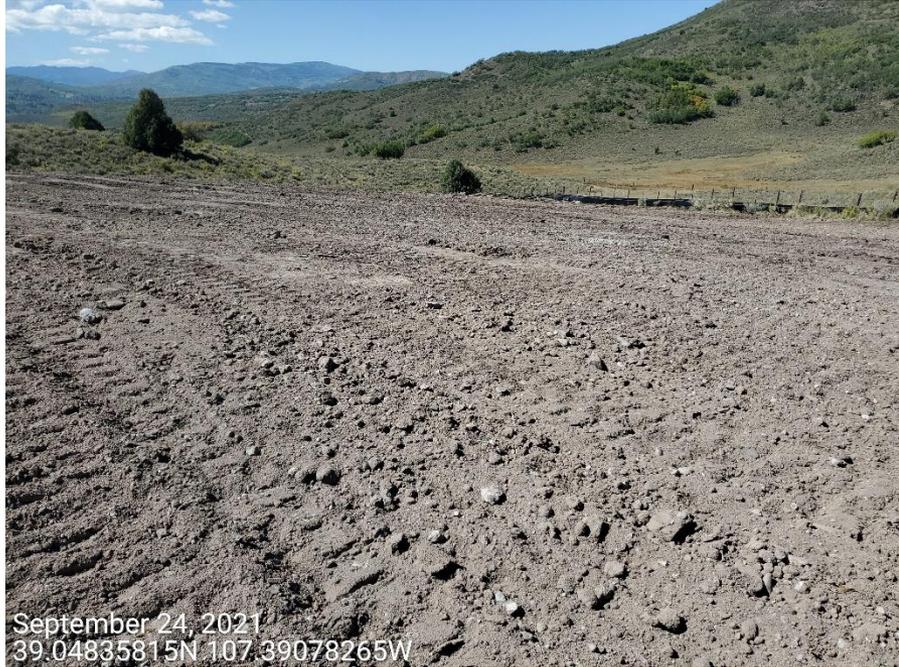
**Photo 3:** Photos taken from the interim areas of the Location; BMPs to stabilize soils missing or insufficient.

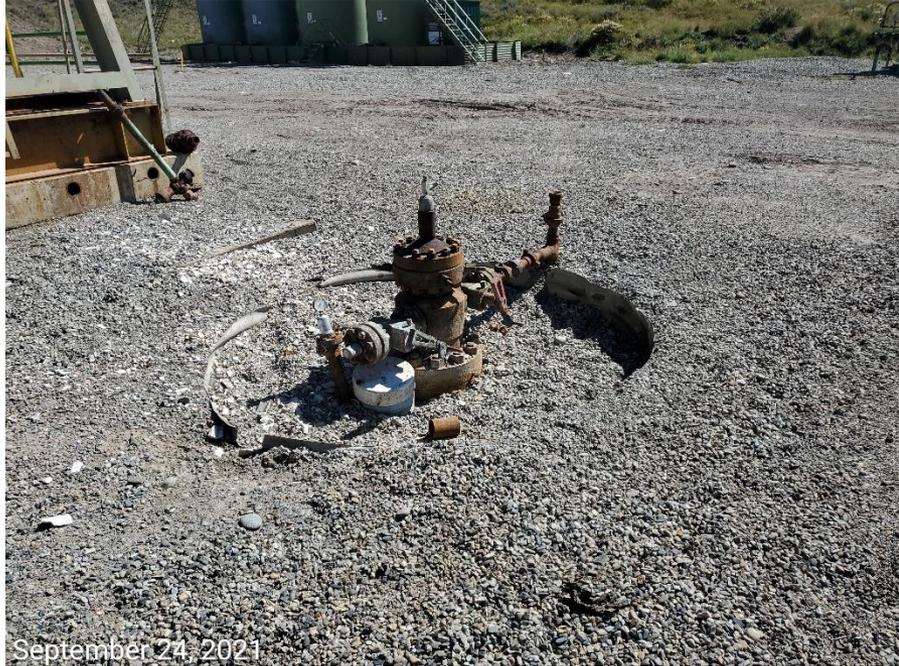
September 24, 2021

**Photo 4:** Photos shows cellar at wellhead has been backfilled.
