# Inspection Photos

Operator: GUNNISON ENERGY LLC #10515

Location ID: 324464

Gunnison County, CO

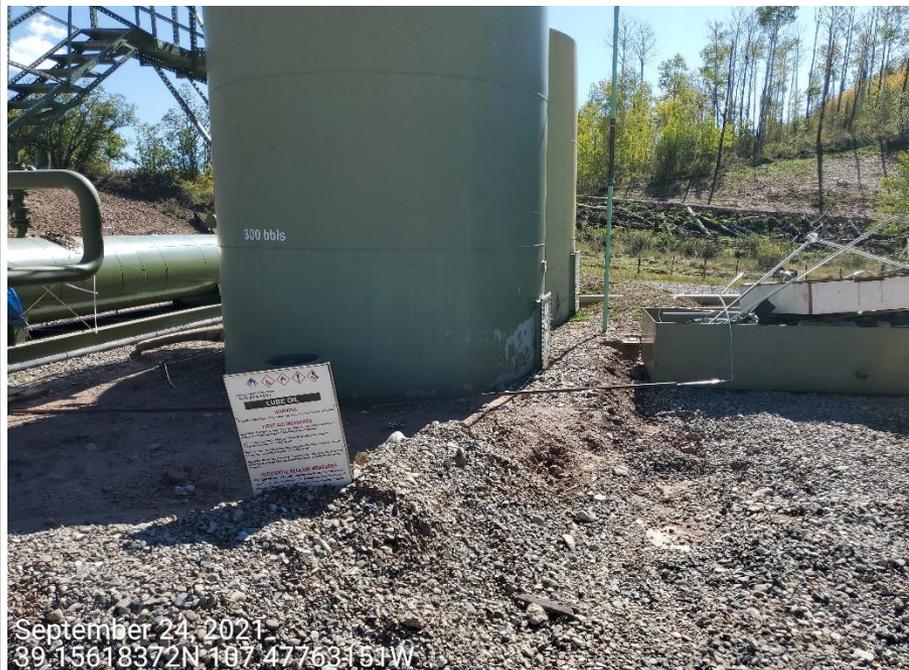
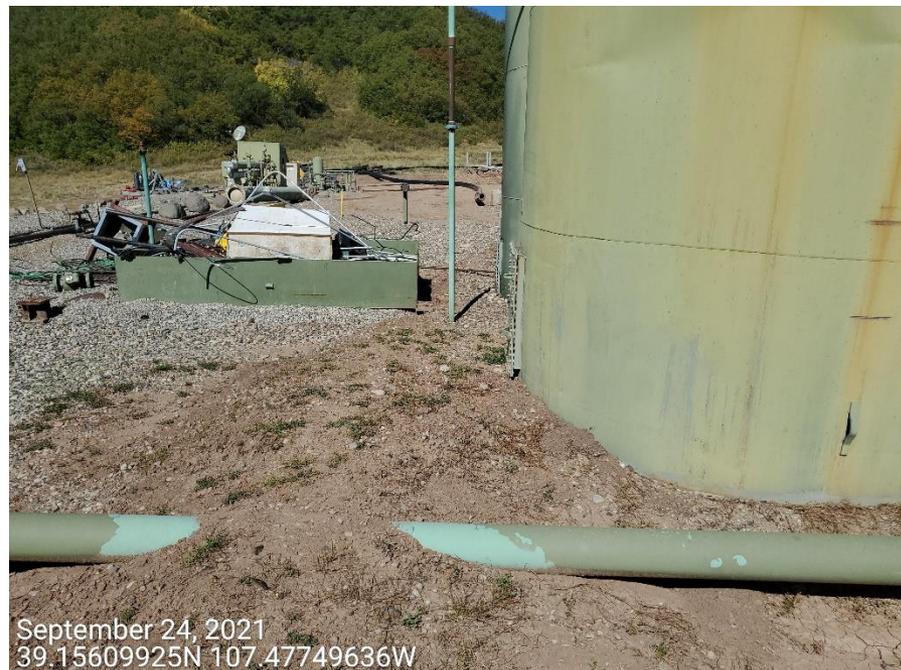
**Photo 1:** Photo shows adequate, impervious containment has not been installed at the tanks in accordance with good engineering practices.

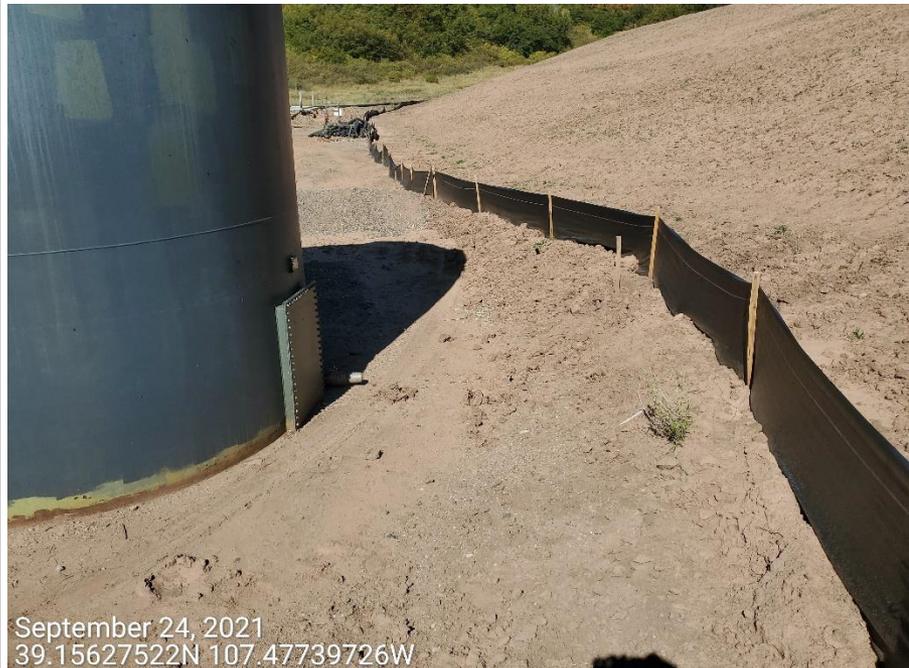
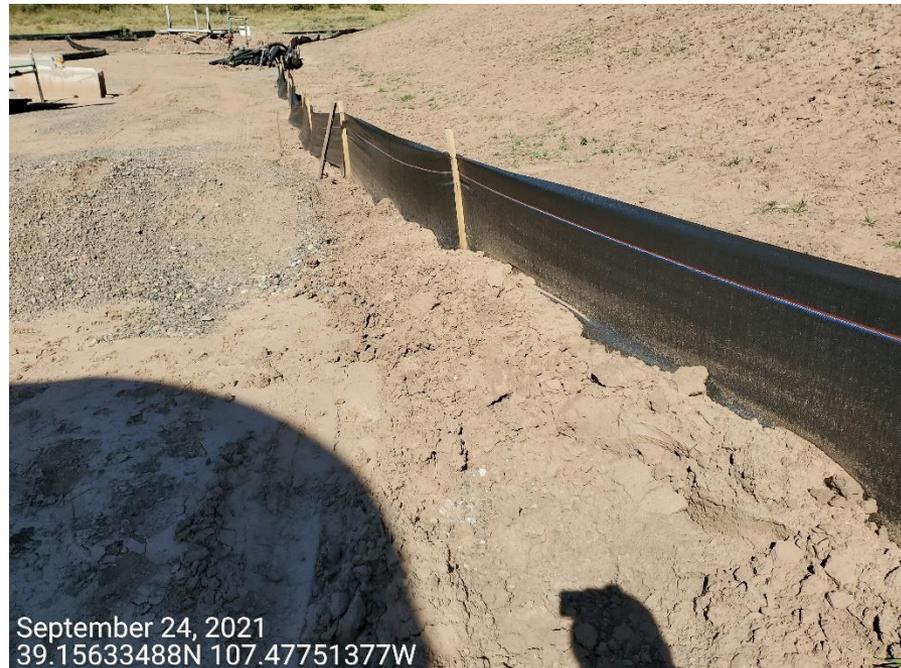
September 24, 2021  
39.15627522N 107.47739726W

**Photo 2:** Photo shows adequate, impervious containment has not been installed at the tanks in accordance with good engineering practices.

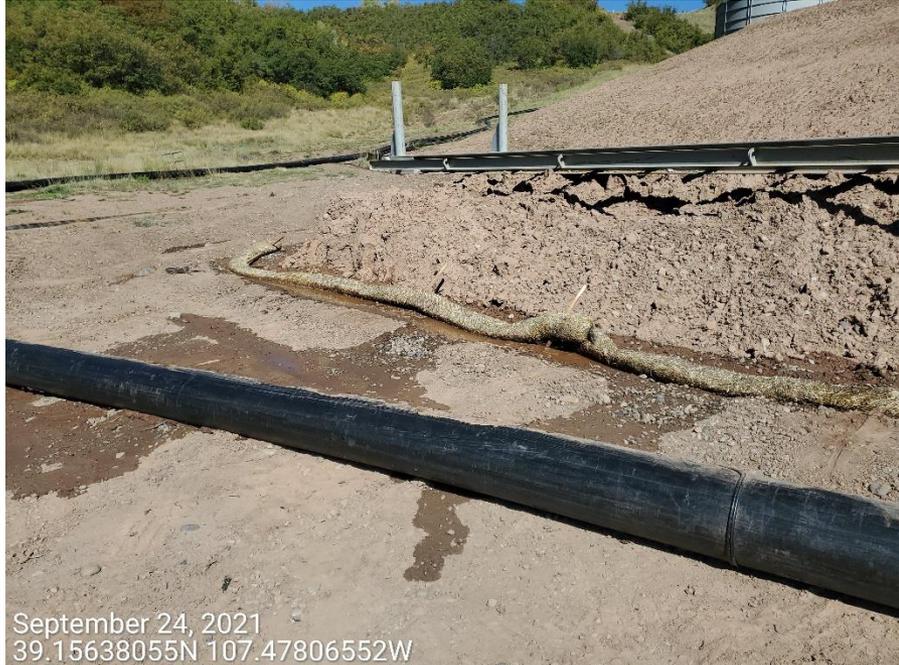
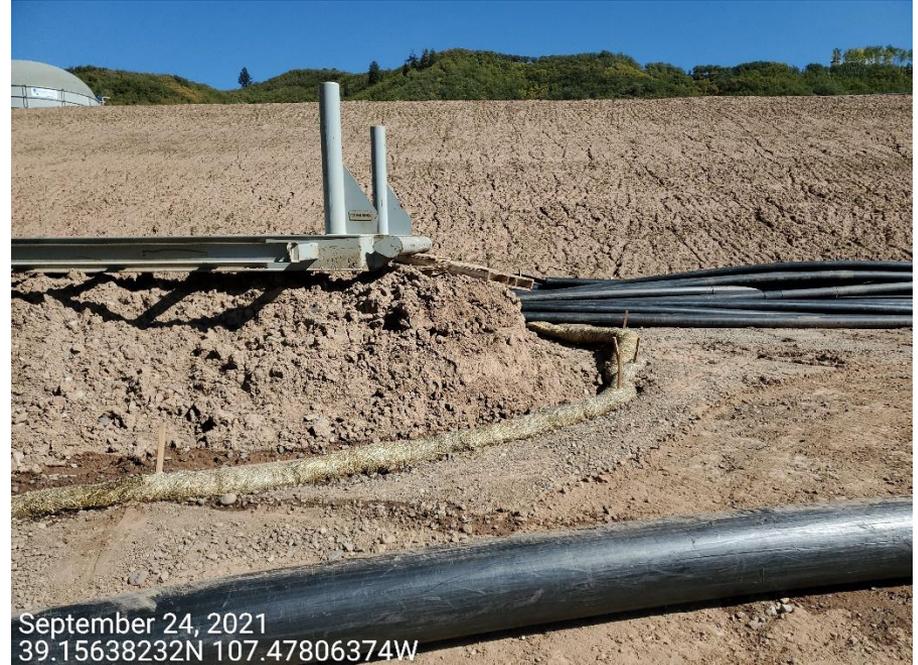
**Photo 3:** Photos shows control measurers at the stockpiled soil has not been installed in accordance with good engineering practices.

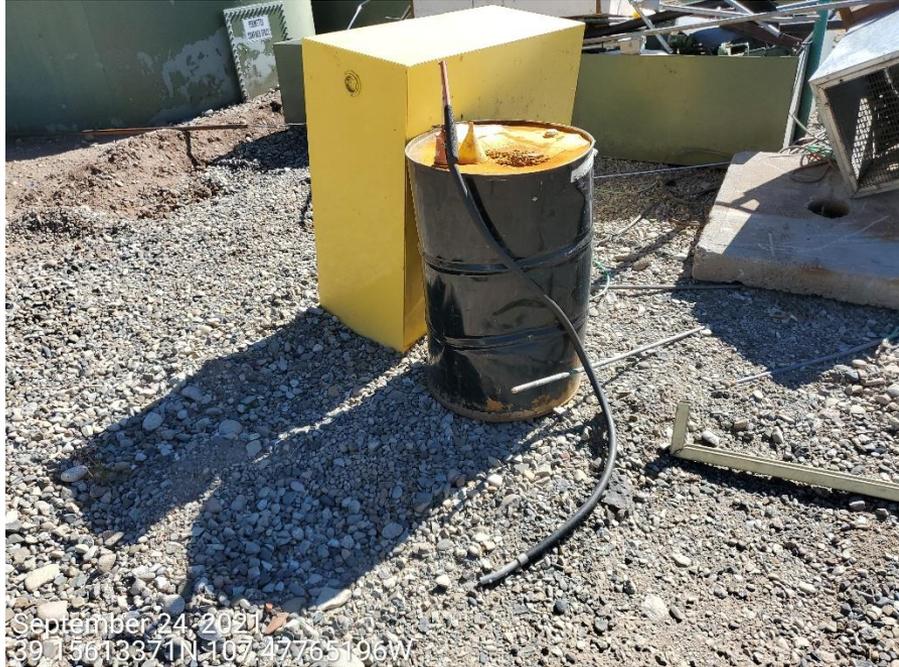
**Photo 4:** Photo shows example of unused equipment/trash/debris not necessary for production stored on the Location. Photo also shows barrel with inadequate spill prevention or containment BMPs

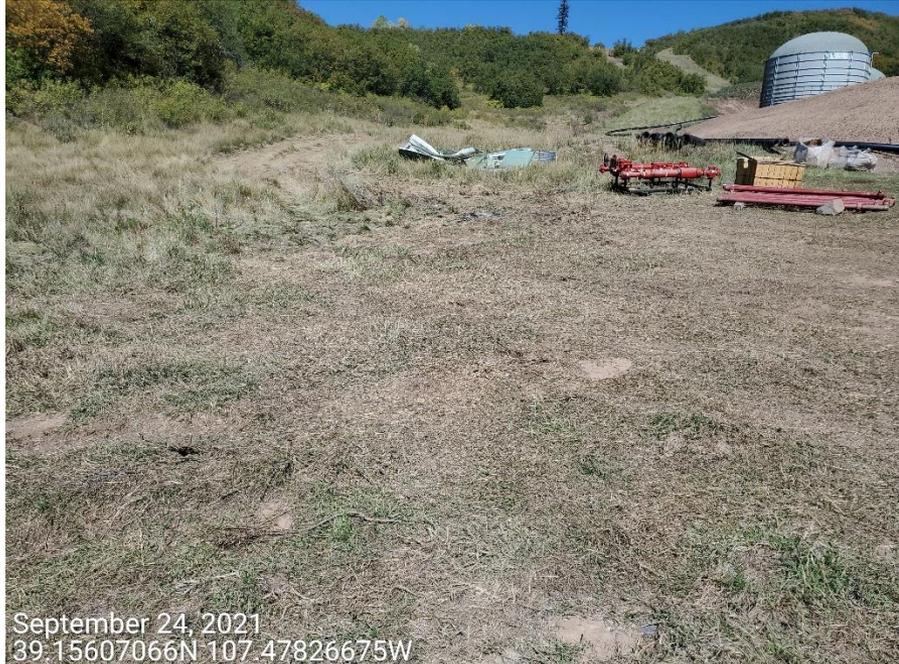
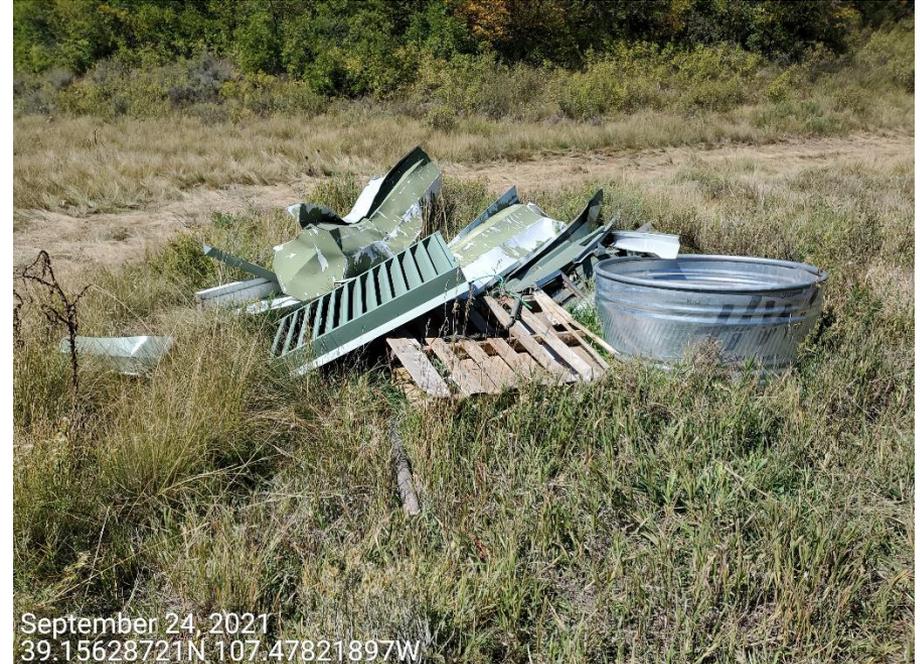
**Photo 5:** Photo taken from the northwest end of the Location. Photo shows various trash/debris/equipment being stored off-site of the Location.

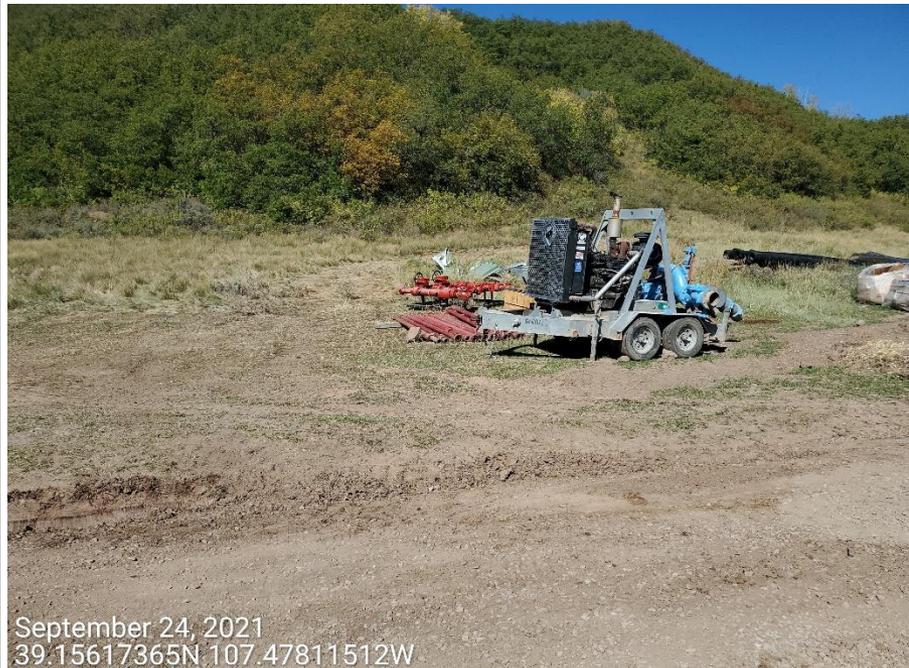
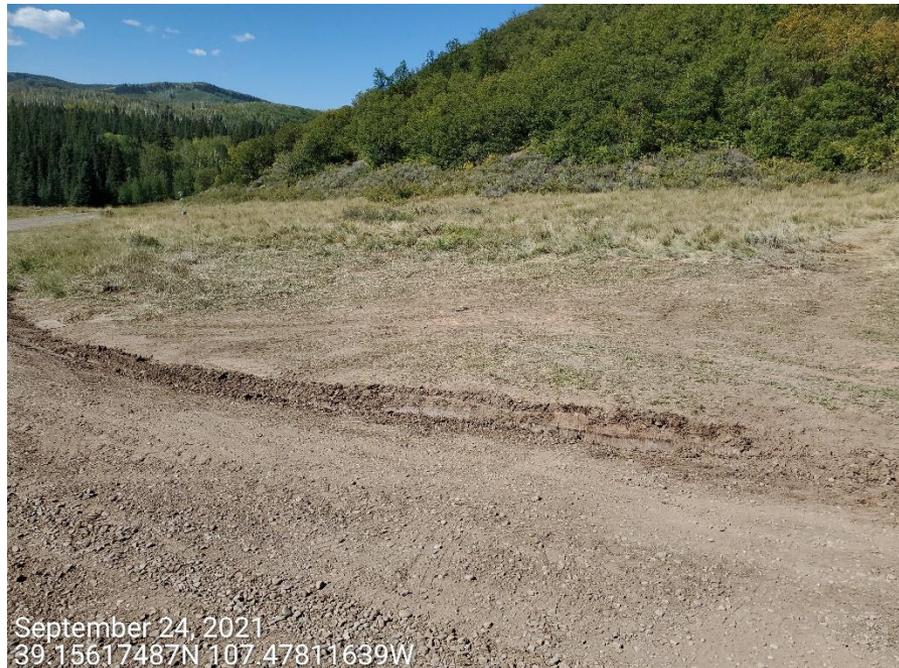
**Photo 6:** Photos taken from the north end of the Location. Photo shows areas requiring interim reclamation; interim reclamation has not been conducted in accordance with 1003 Rules and corrective actions.
