# Final Reclamation Inspection

Operator: PDC ENERGY INC - 69175

Location ID: 322814

Inspection Photos  
Location Name: Conquest/Holton 8-13  
Location ID: 322814

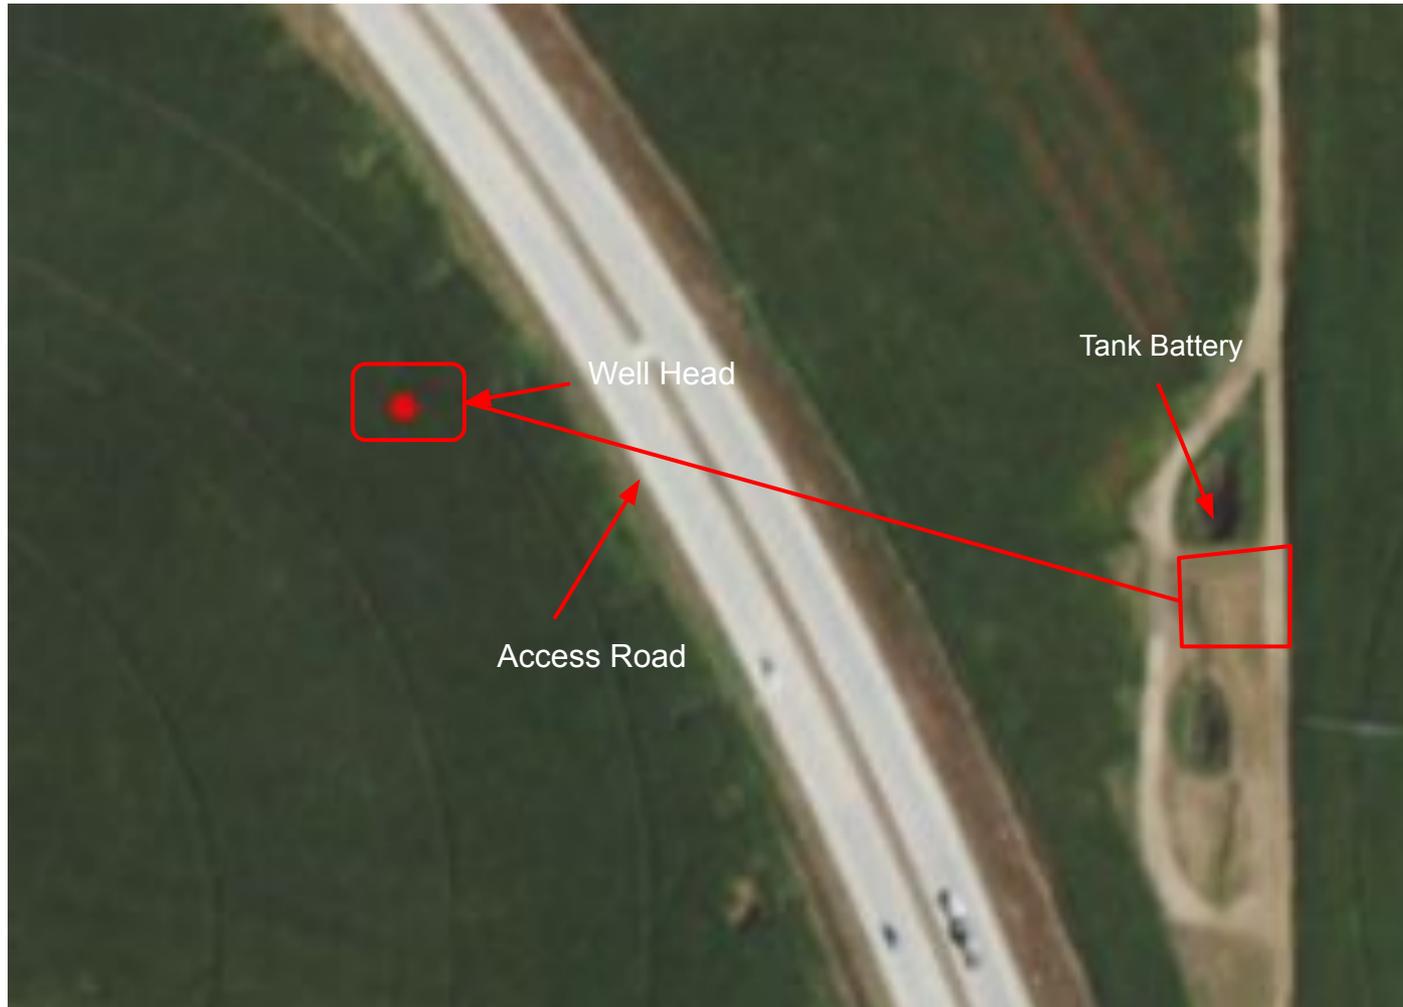
**Photo 1.** 2019 aerial imagery shows the well head, tank battery and associated access road (north is up). Note: the access road was built prior to the highway getting built.

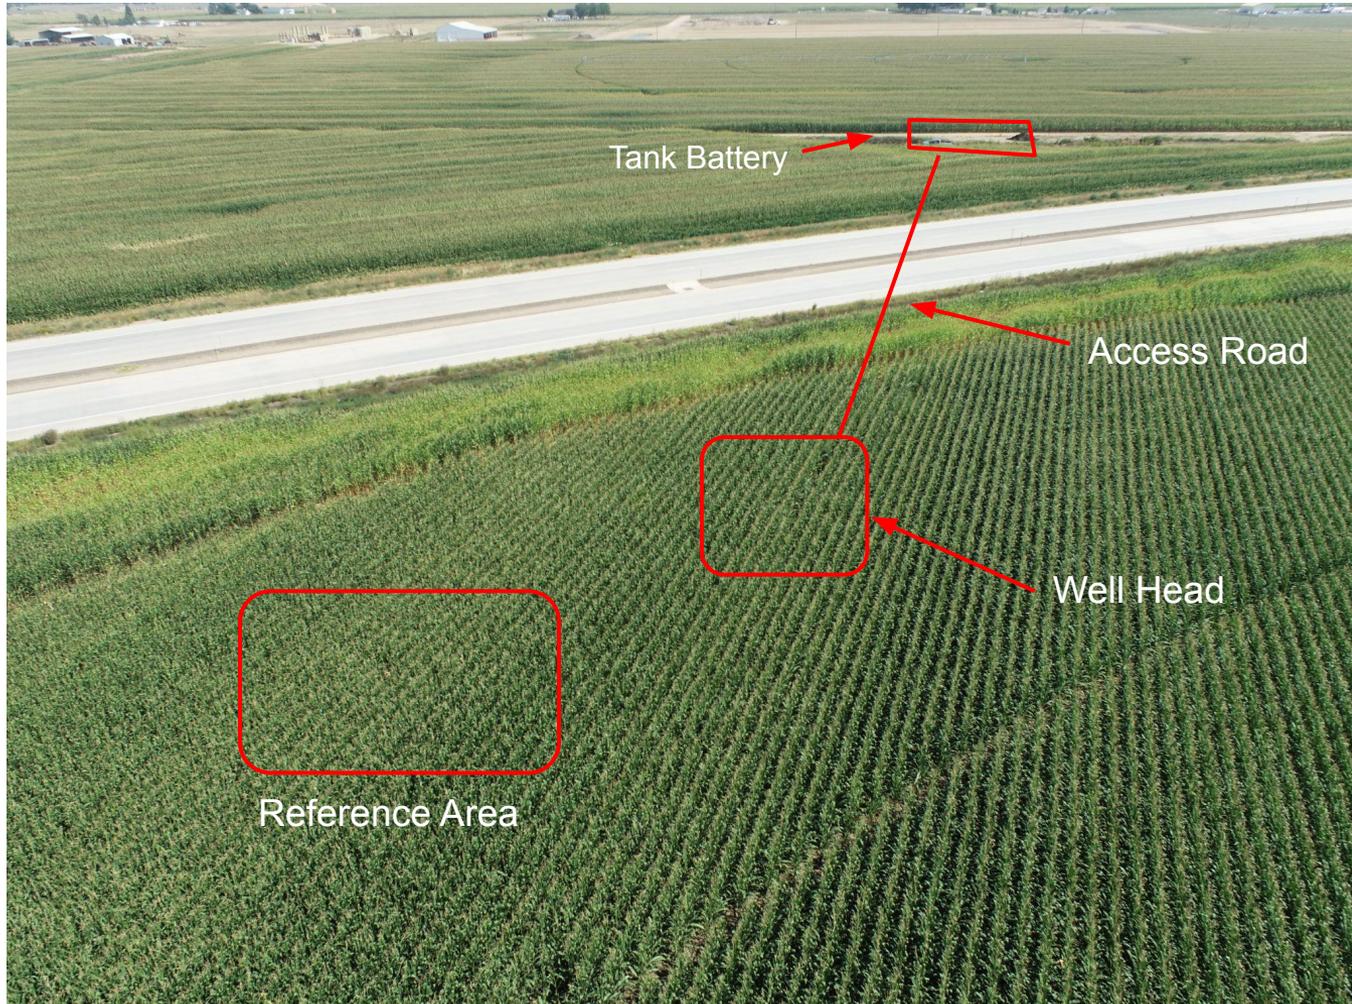
**Photo 2.** Overview photo of well head, tank battery, access road and reference area taken west of well head using a drone (looking east). Photo shows crop heights within the well head and along the access road appear consistent with adjacent reference area.

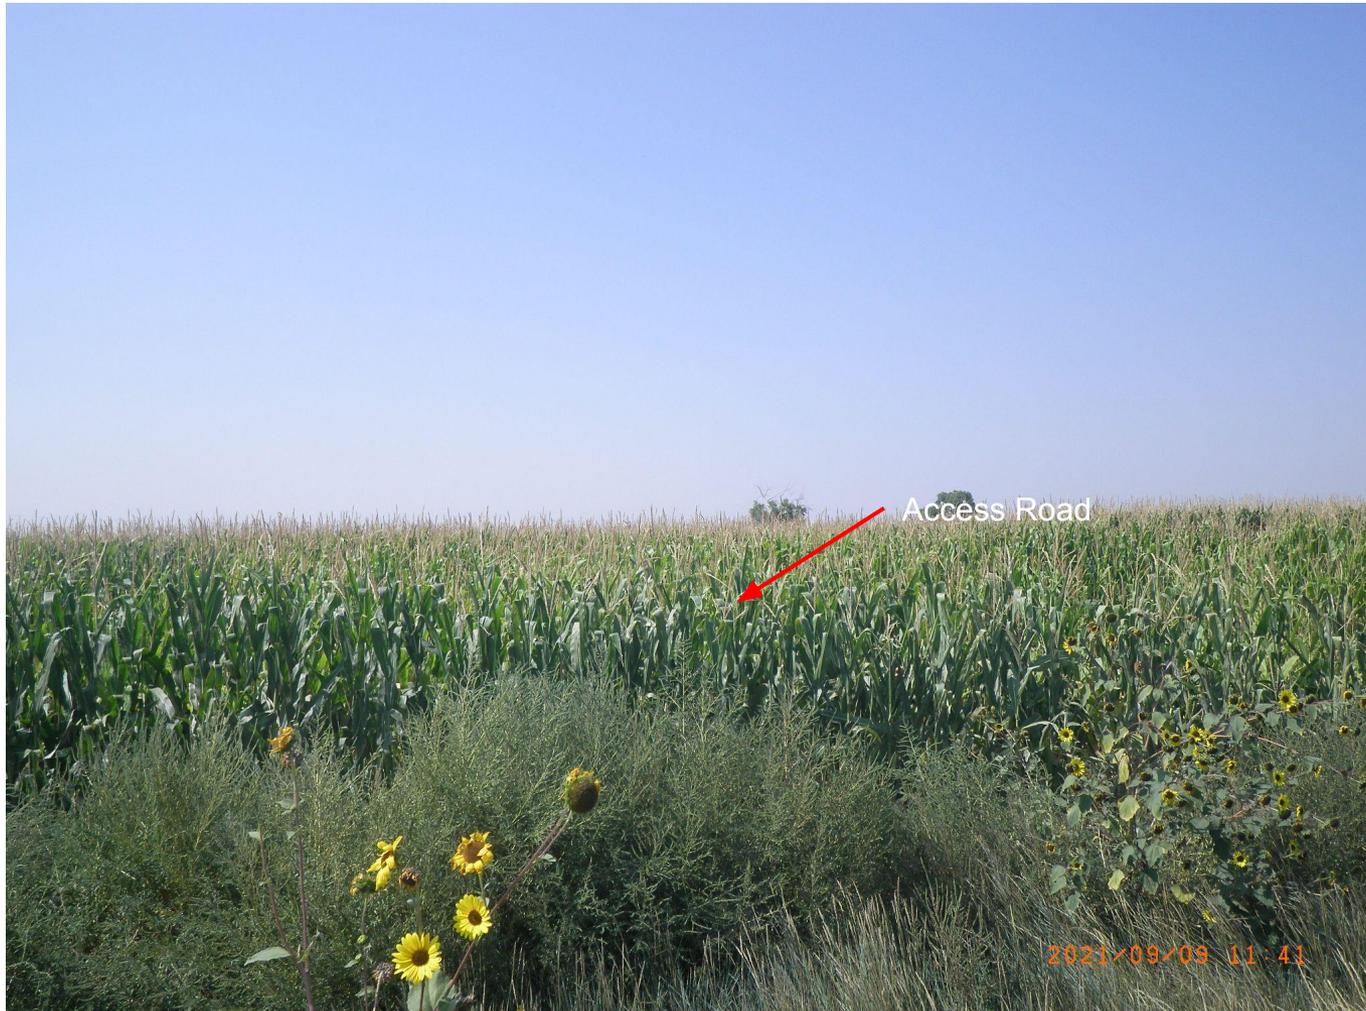
**Photo 3.** Ground photo of well head access road from highway, looking west. Note: the weeds in the front of the picture are associated with the highway/crop field edge, not oil and gas operations.

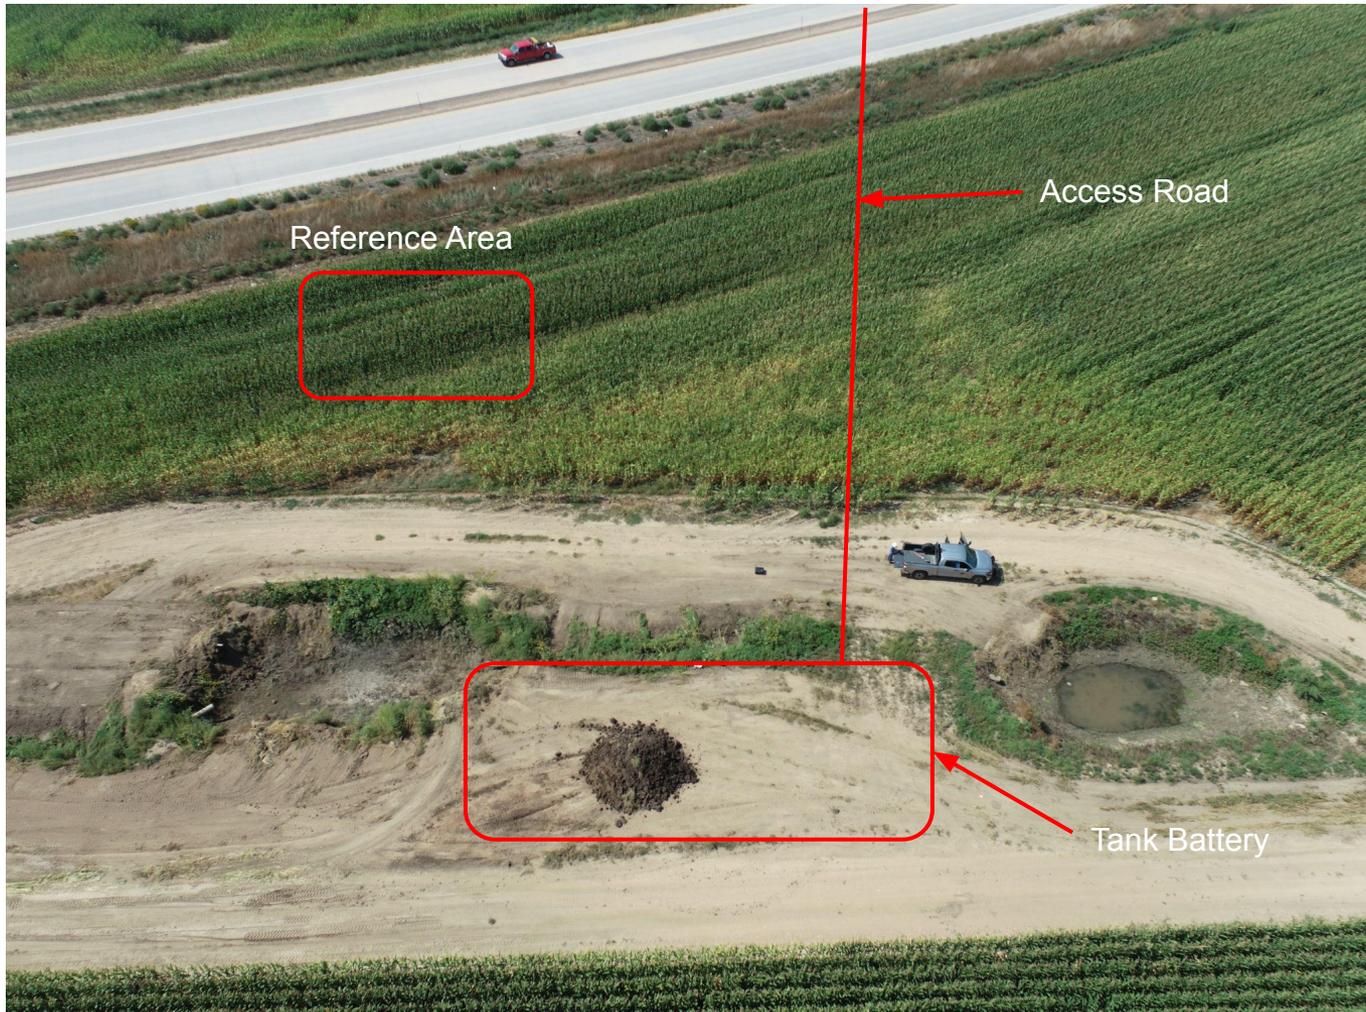
**Photo 4.** Overview photo taken of tank battery and reference area using a drone (west is up). Photo shows manure pile within tank battery, heavy equipment vehicle tracks, and very little plant growth (see following photos for closeups).

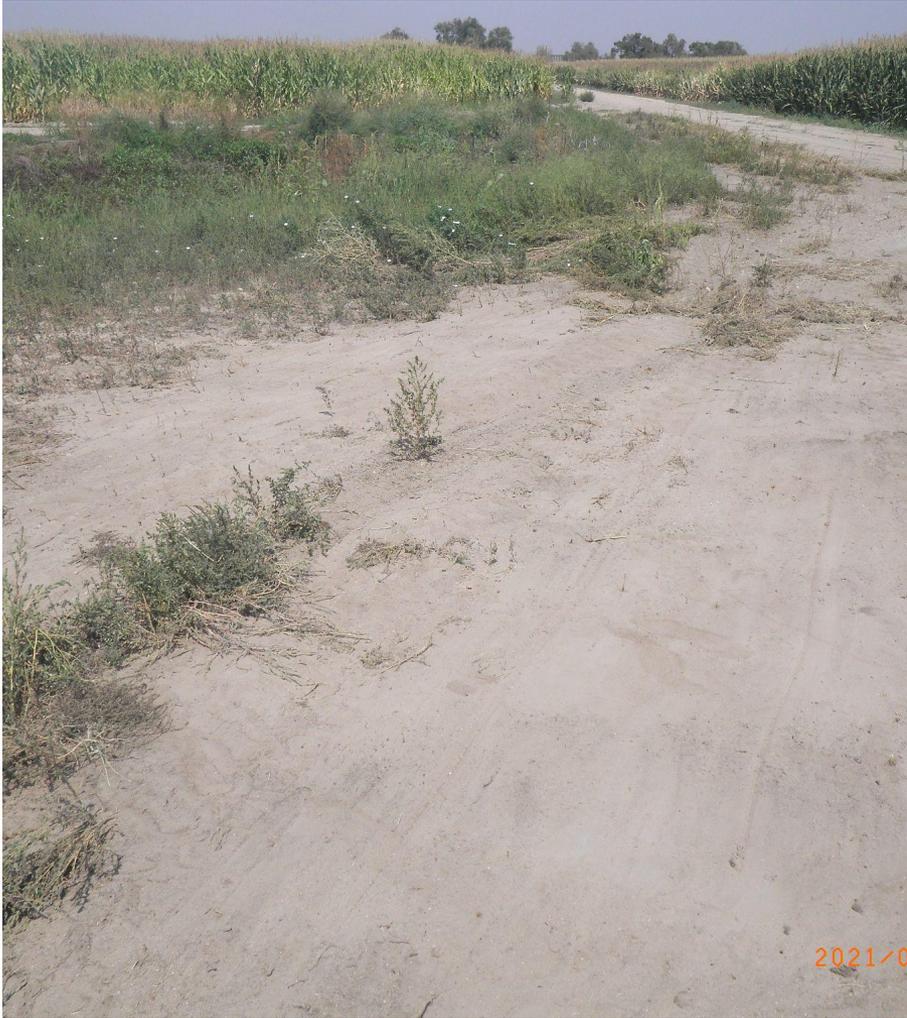
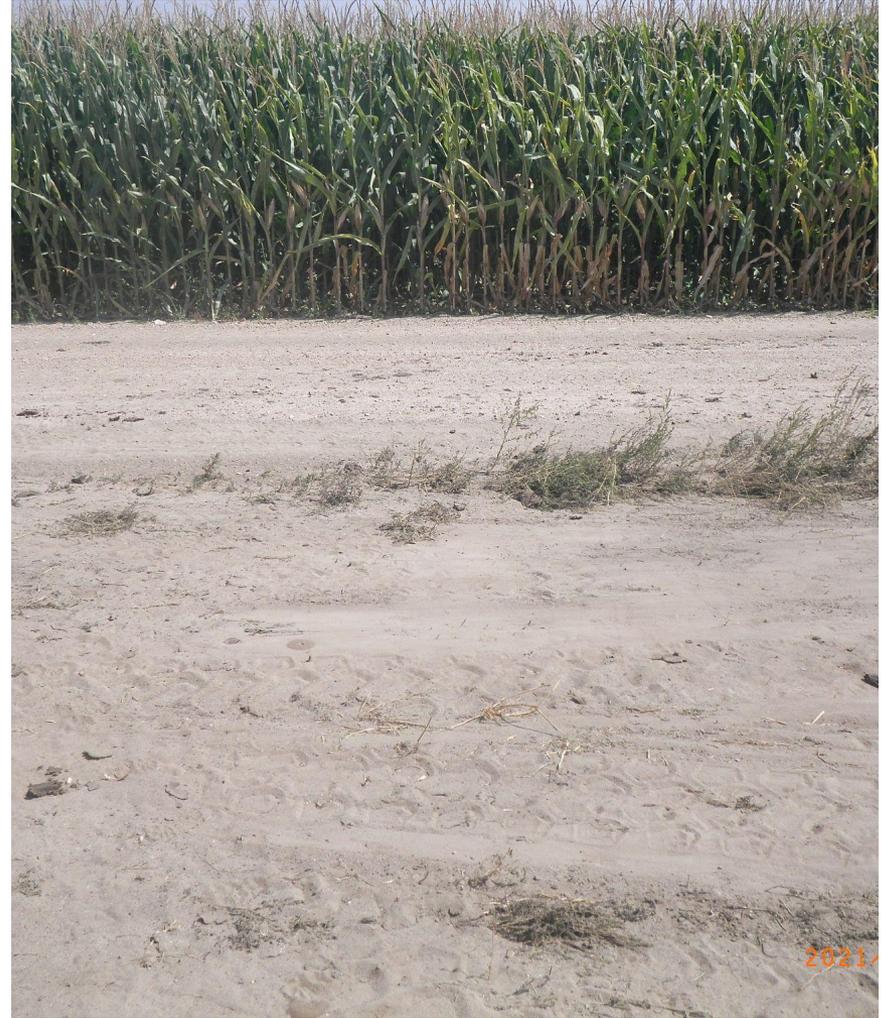
**Photo 5.** North and East photos taken at ground level from middle of tank battery.

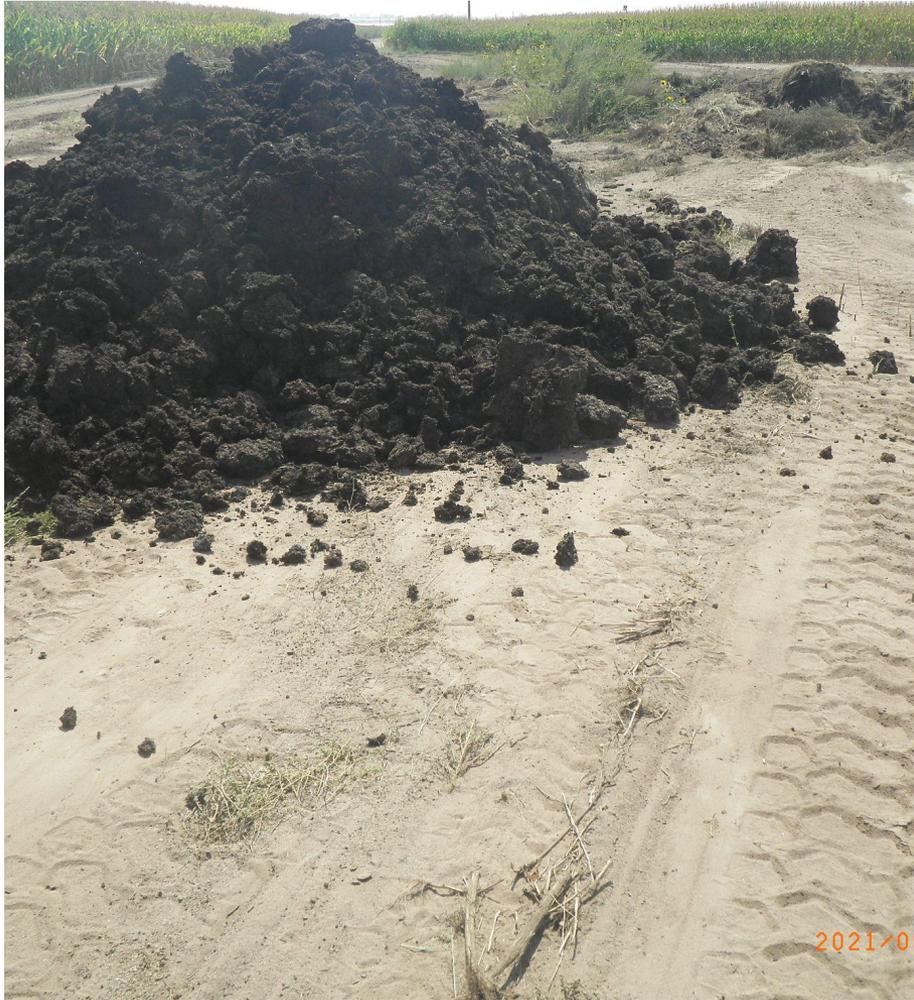
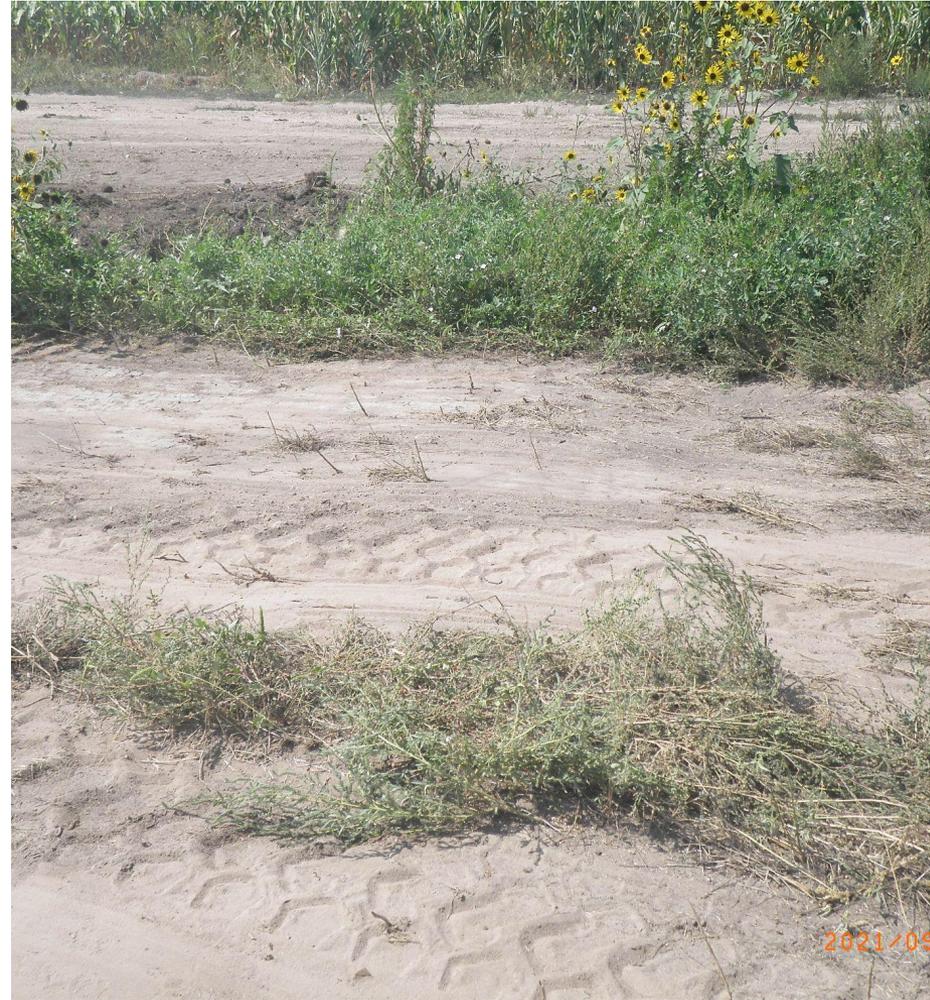
**Photo 6.** South and west photos taken at ground level from the middle of the tank battery.
