# Inspection Photos

API: 071-07049

Operator: EVERGREEN NATURAL RESOURCES

Inspection Date: 10/7/2021

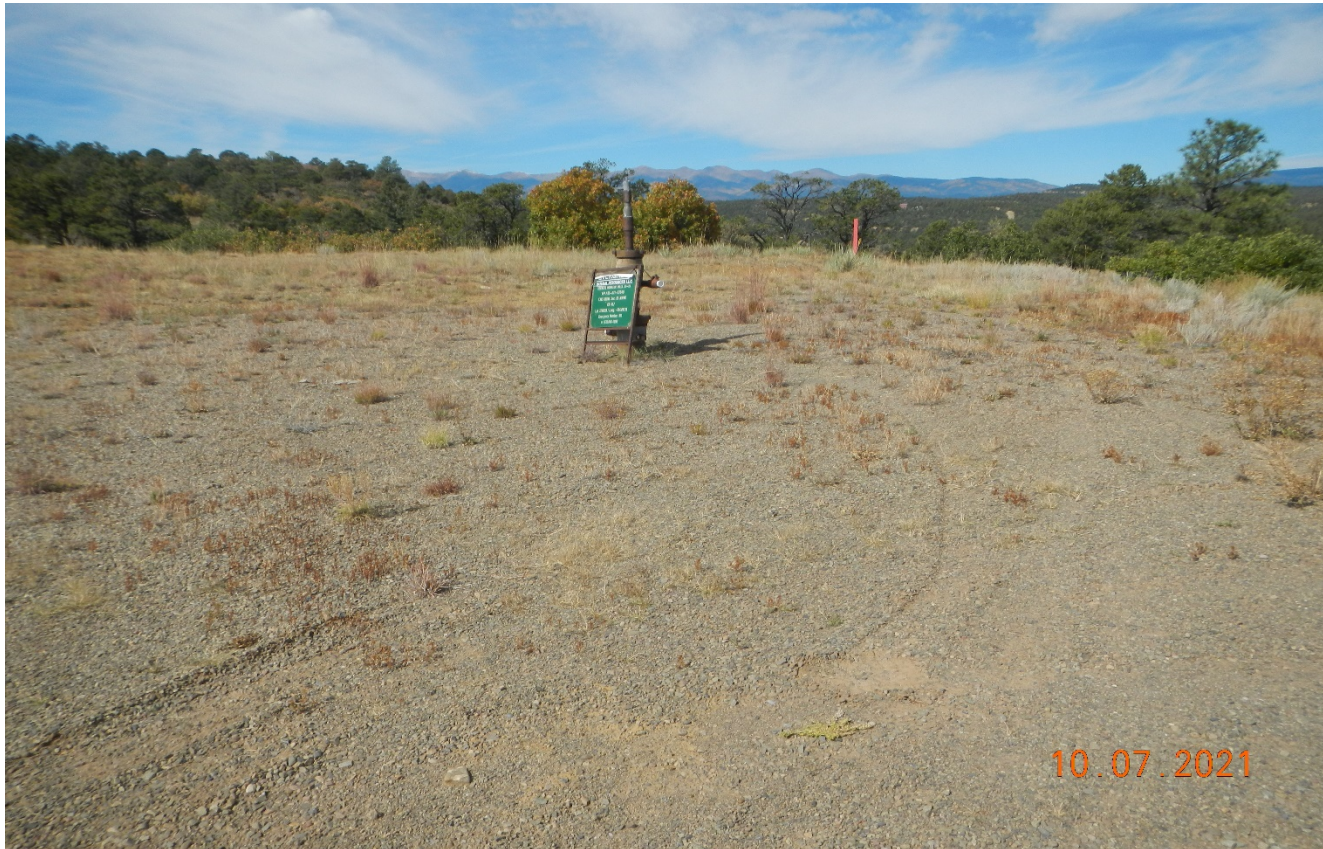
**Photo 1.** Facing west toward the location. Well sign is installed.

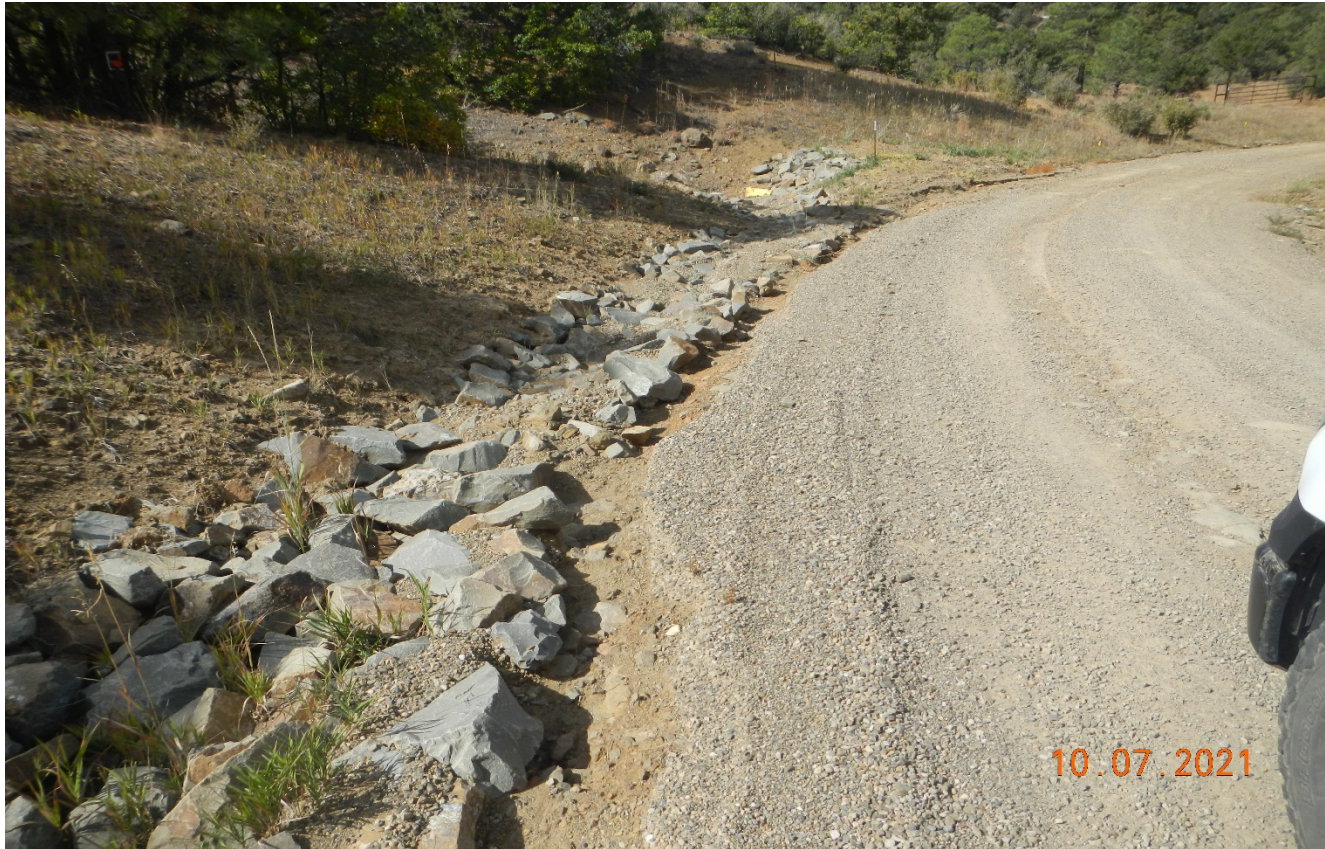
**Photo 2.** Facing west along the road where BMP's were installed last. Stormwater has eroded around the rock rip rap and needs to be repaired.

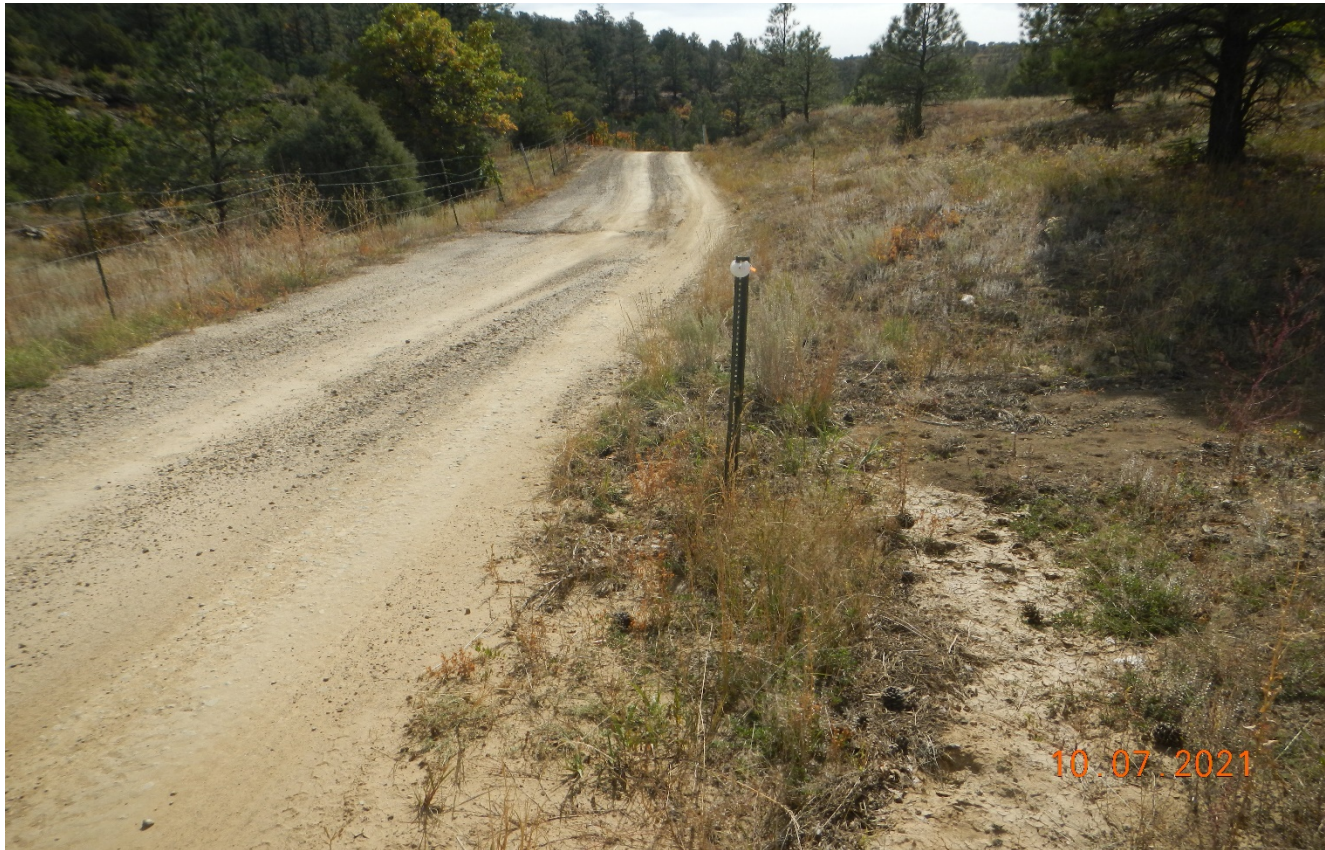
**Photo 3.** There is a culvert filled in with sediment causing stormwater to flow across the road. Lat/Long:37.16720,-104.82237.
