Inspection Photos
Operator: Simcoe
API: 067-09562
Date: 10/6/2021

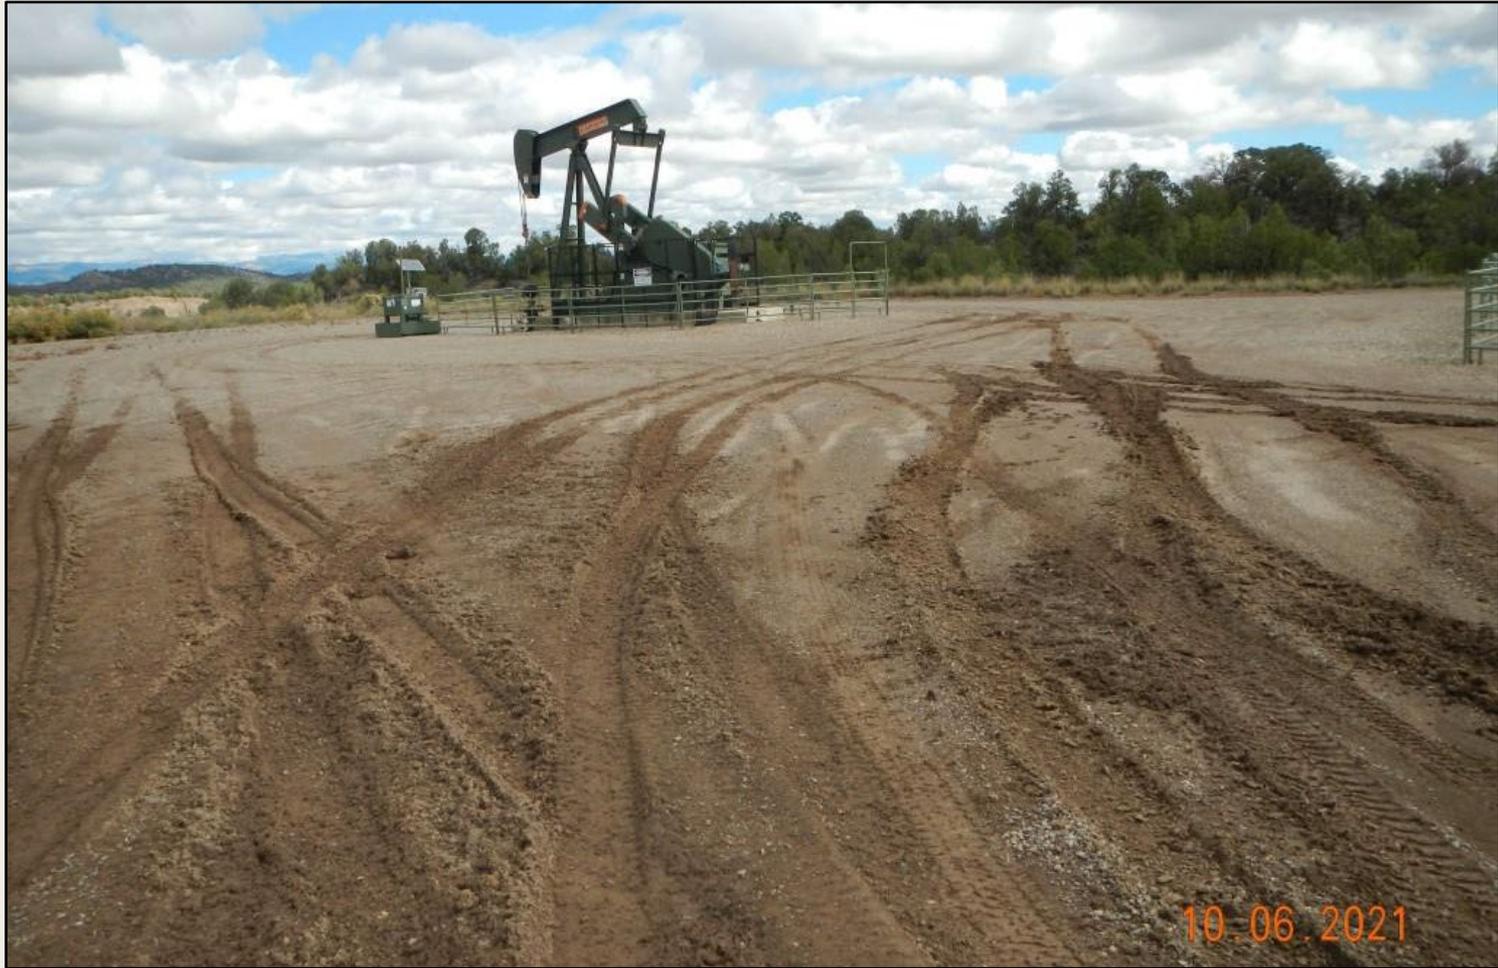
Photo 1. View of project area from the well pad entrance facing center.

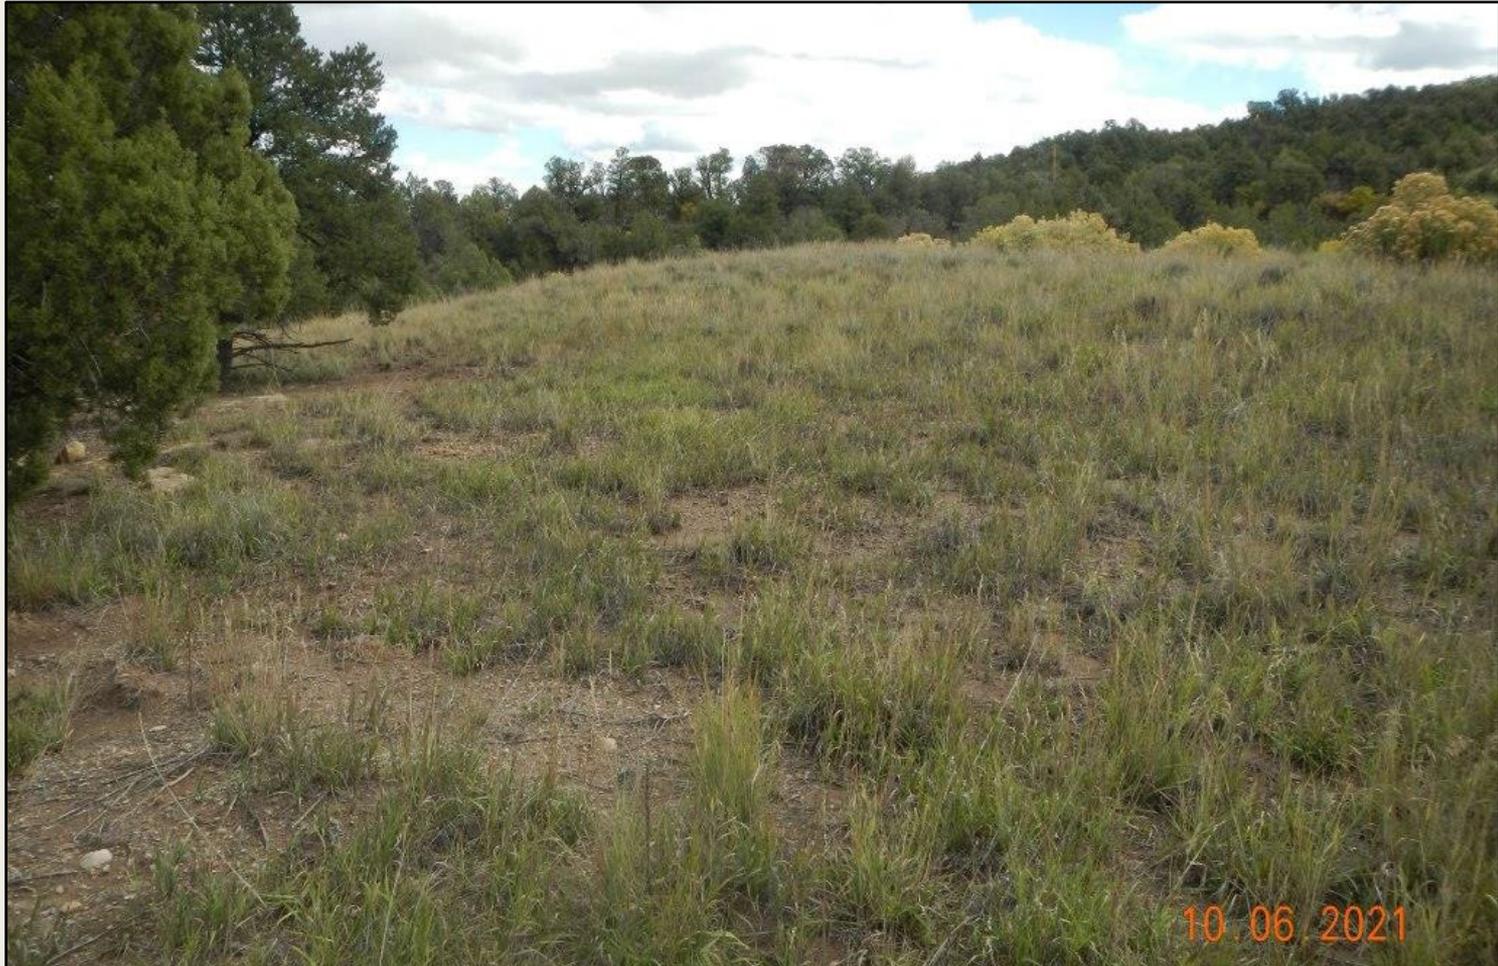
Photo 2. View of the northern project area from the northwestern corner facing eastward. Revegetation is progressing with western wheatgrass and smooth brome.

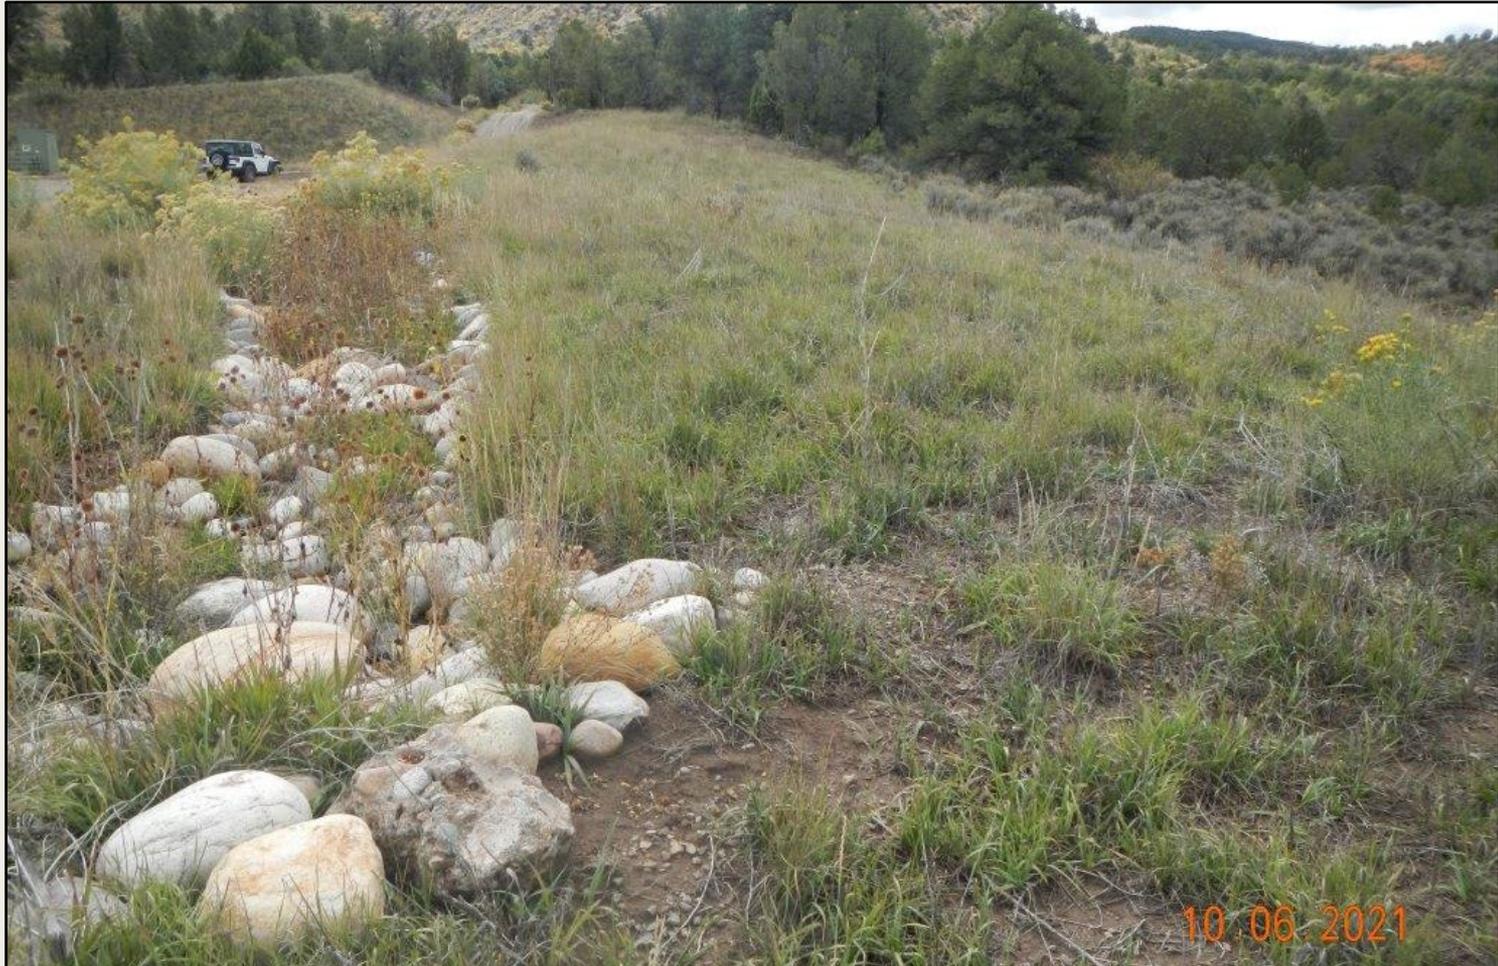
Photo 3. View of the western project area from the northwestern corner facing southward.

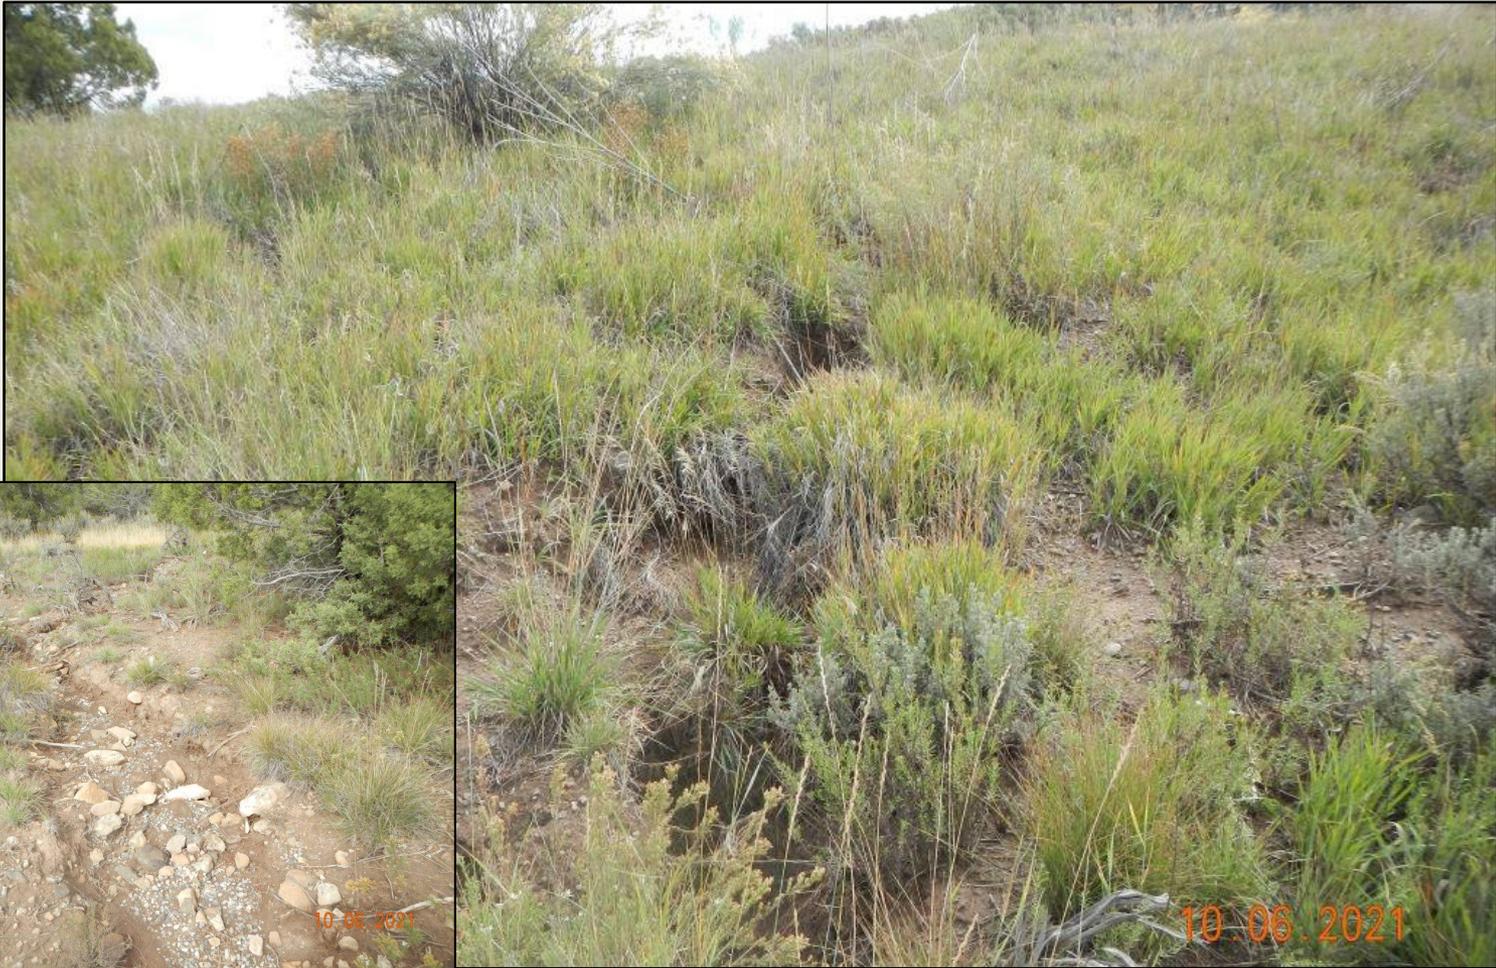
Photo 4. View of erosional channel approx. 2ft wide and 18 inches deep in the northwestern edge of the project area. (main photo facing upslope within the project area, and inset facing downstream and outside of the project area.
