Inspection Photos
Operator: Simcoe
API: 067-08102
Date: 10/6/2021

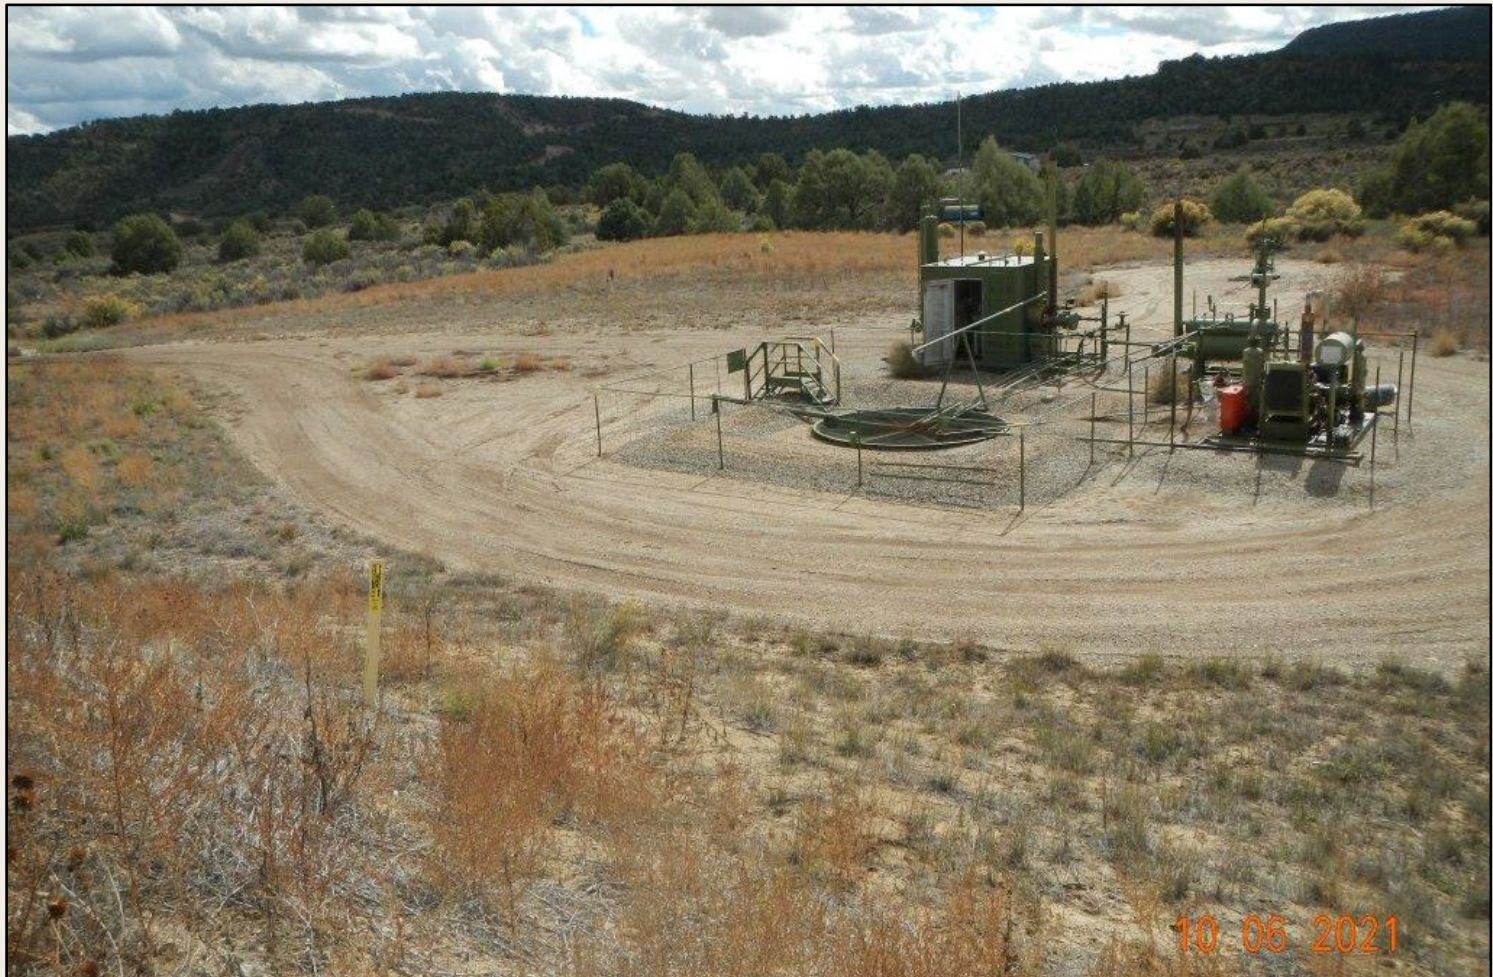
Photo 1. View of project area facing center from the northern well pad.

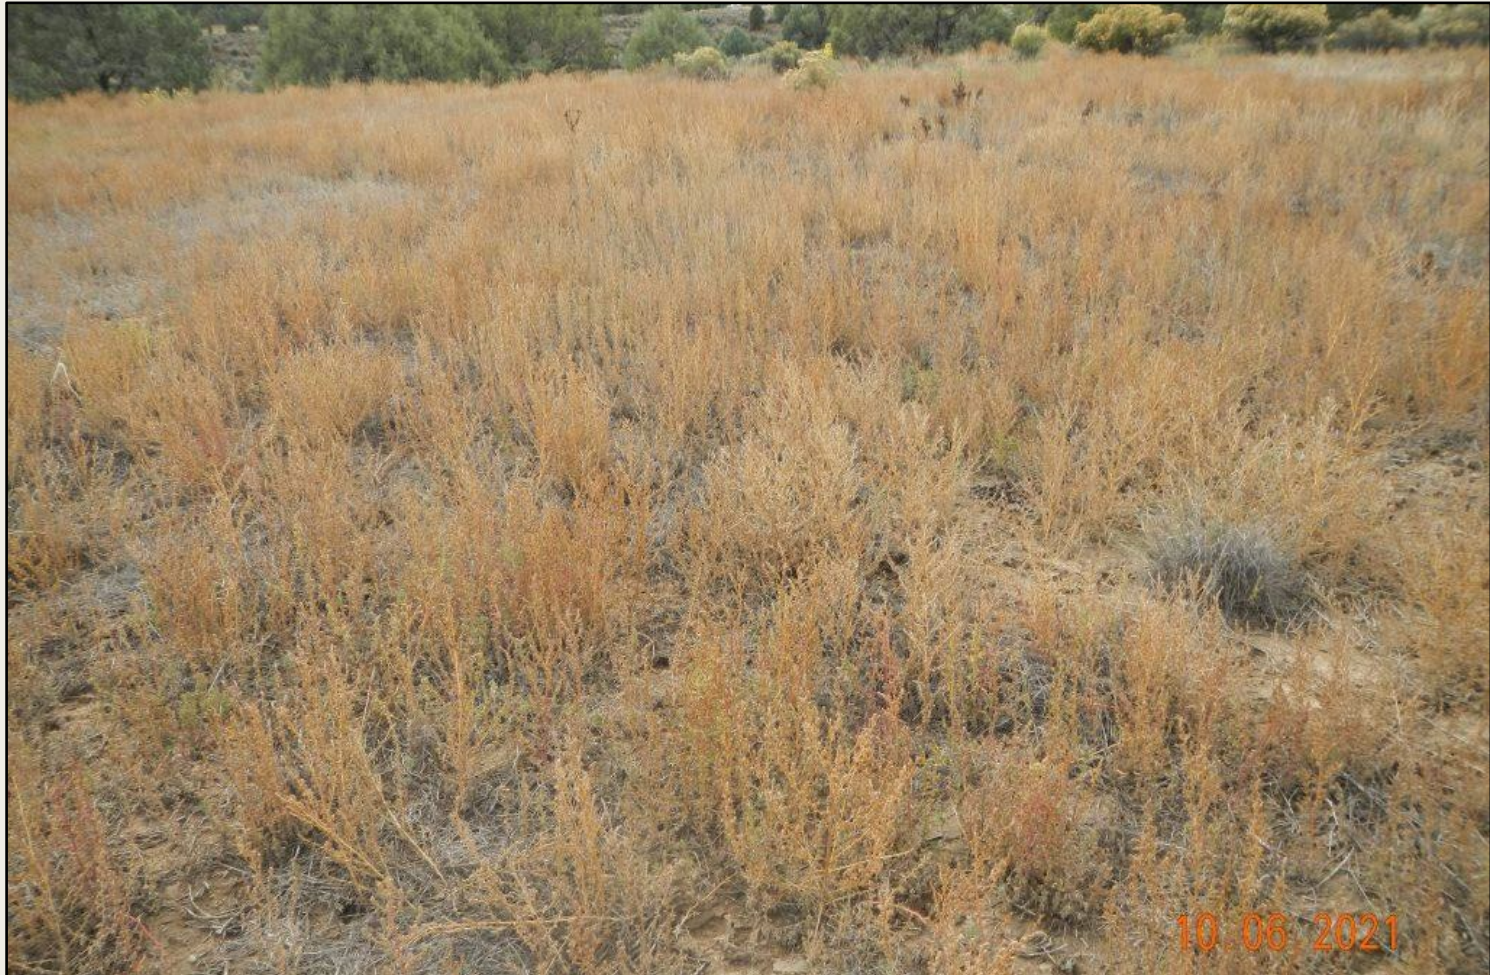
Photo 2. View of the southern project area facing westward. Dense kochia is present. Established vegetation appears to be dying. It is not apparent how/why. Potentially herbicide overspray.

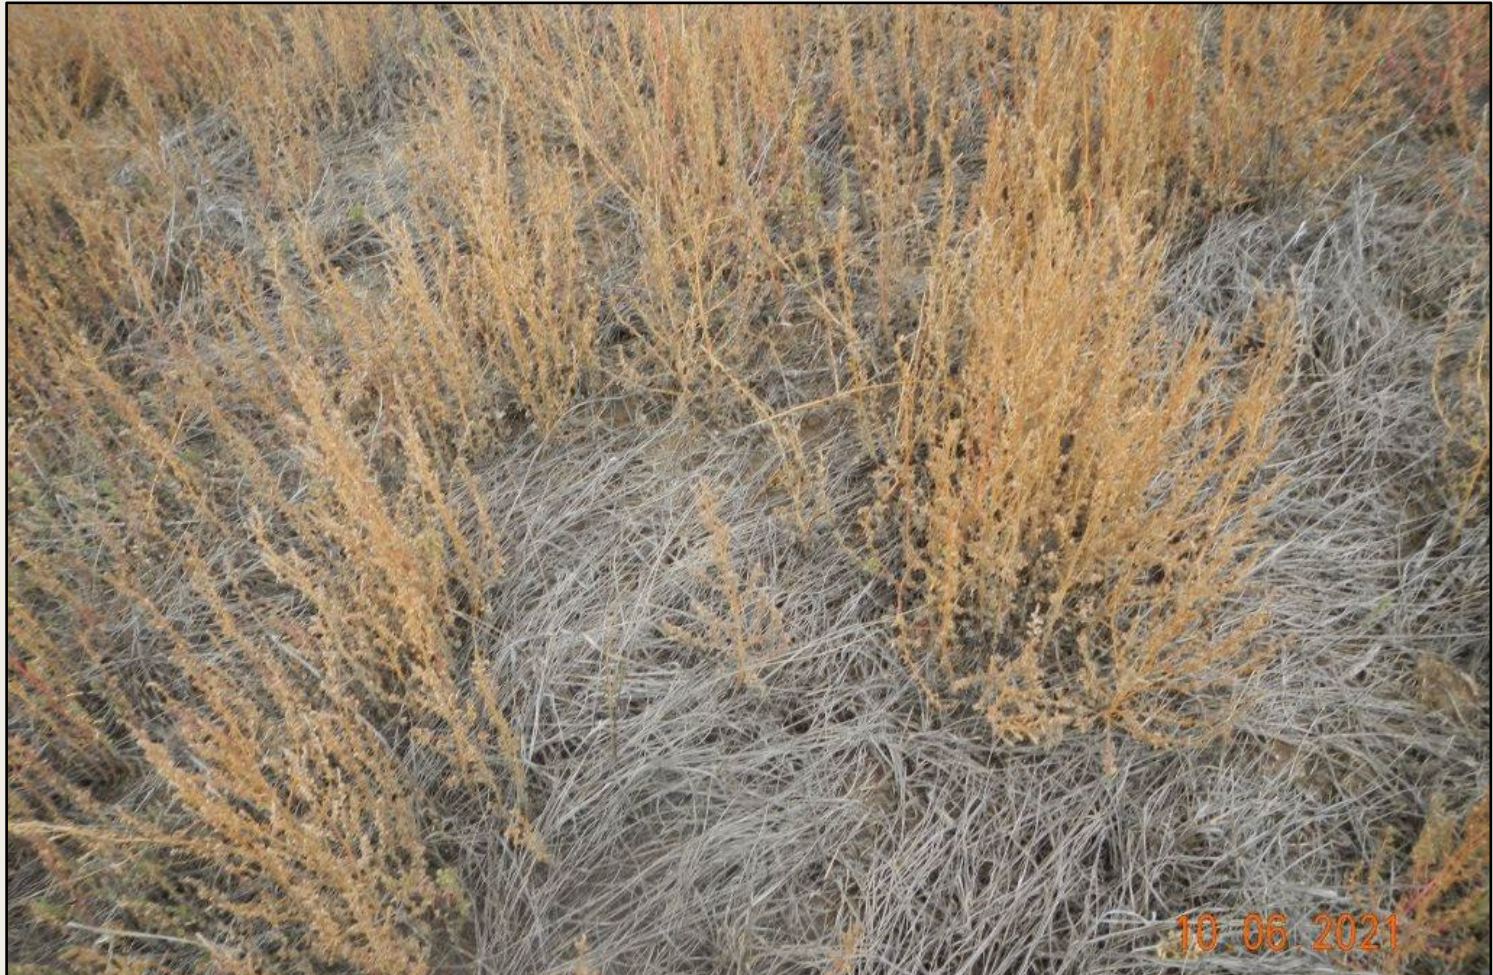
Photo 3. View of dying western wheatgrass plants in the southern project area.
