## Corrective Actions Report

API#: 057-06625

Site Name: Eagle Hill 1-32

Operator: Gulf Exploration

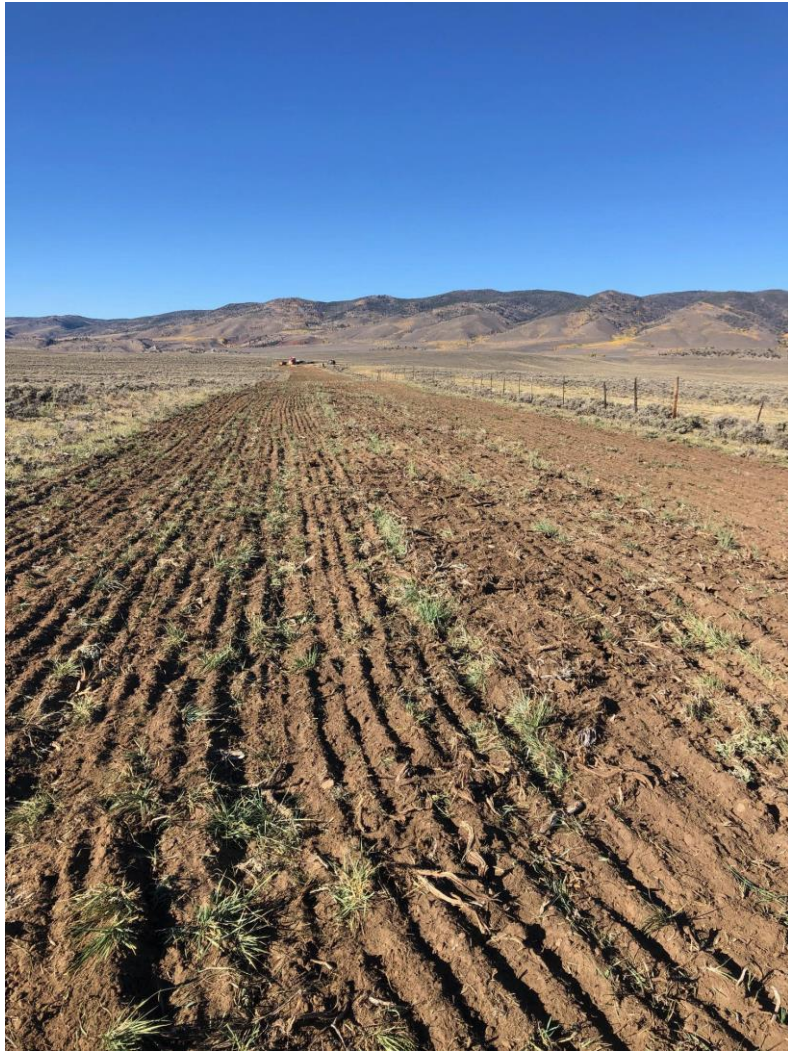
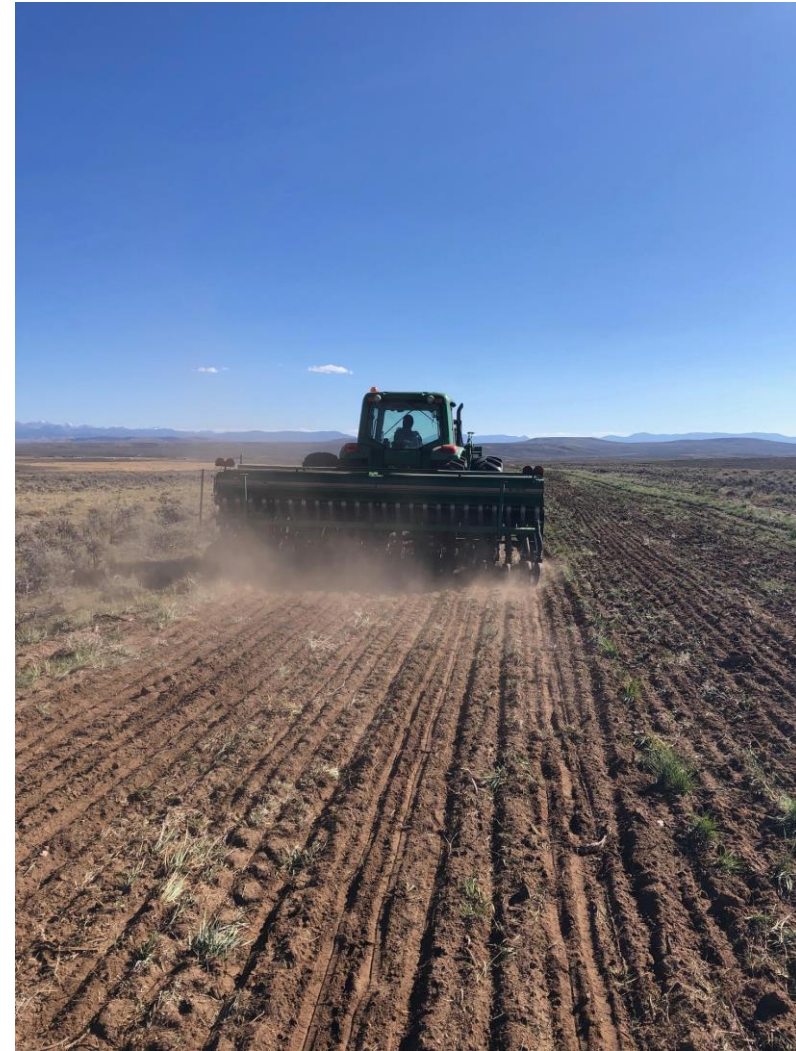
Picture 1 & 2: Seed bed preparation and drill seeding.

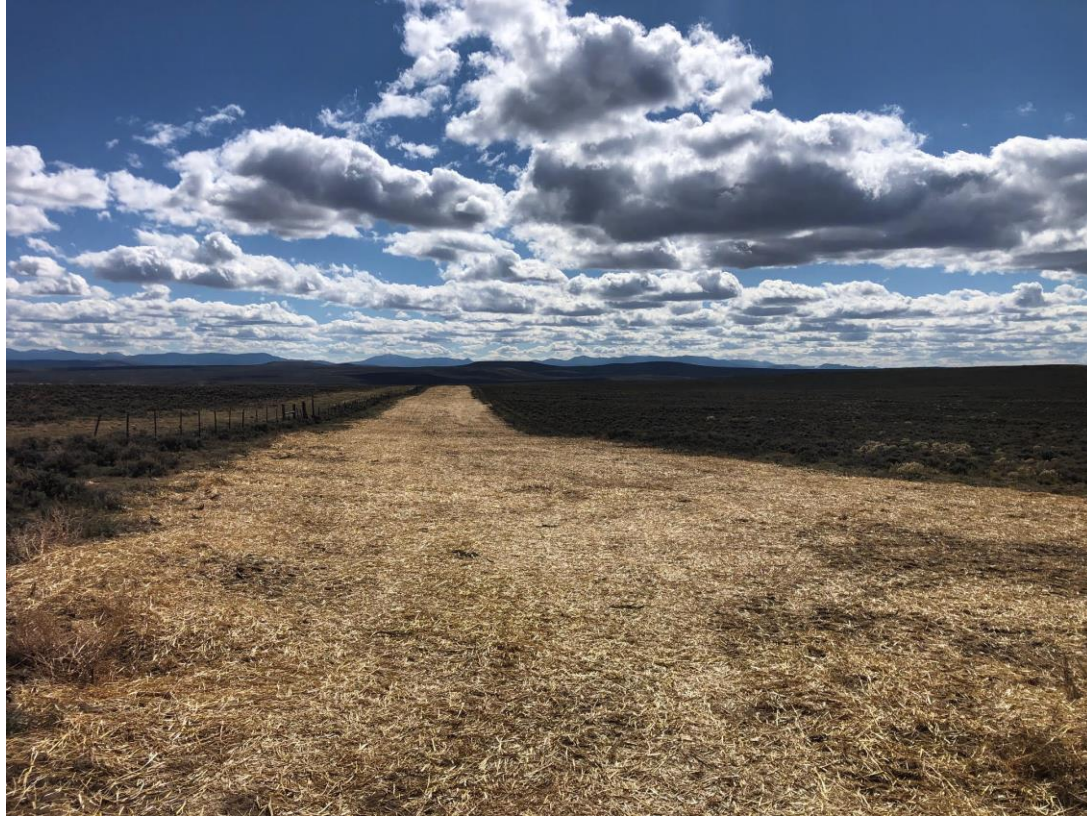
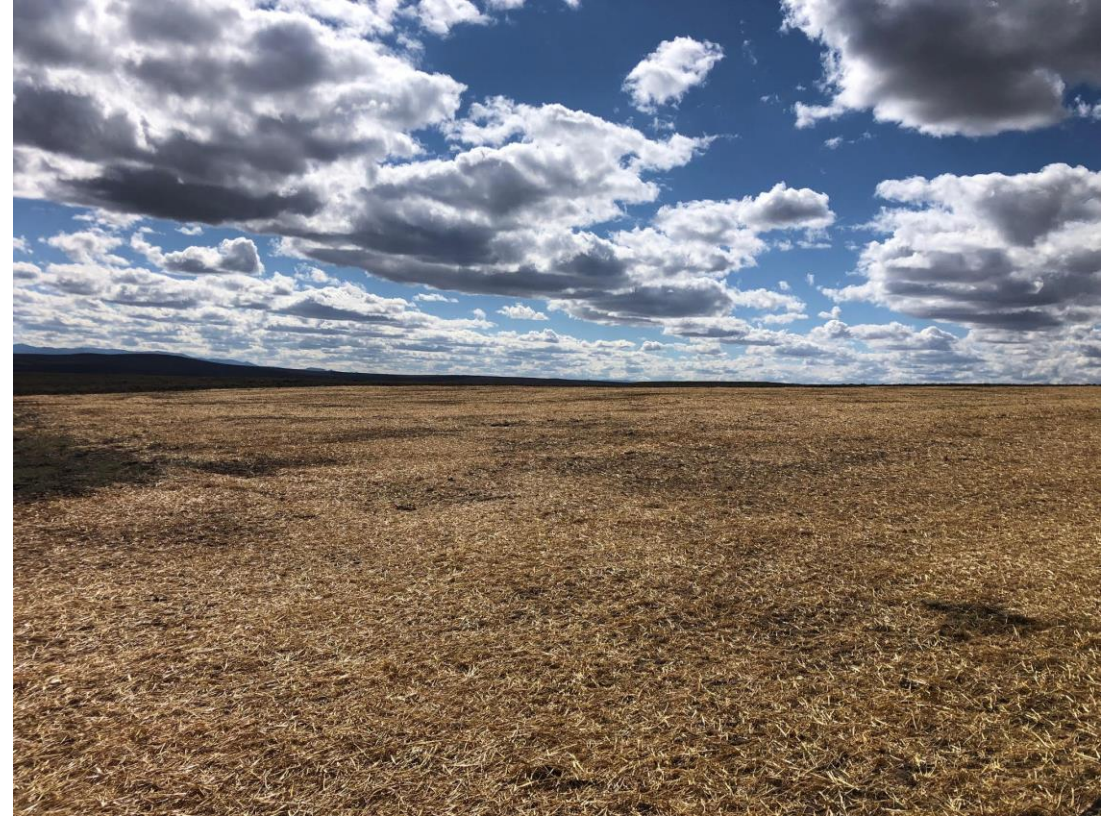
Picture 4: Straw Mulching in progress.

Pictures 5 & 6: Finished road and pad areas.

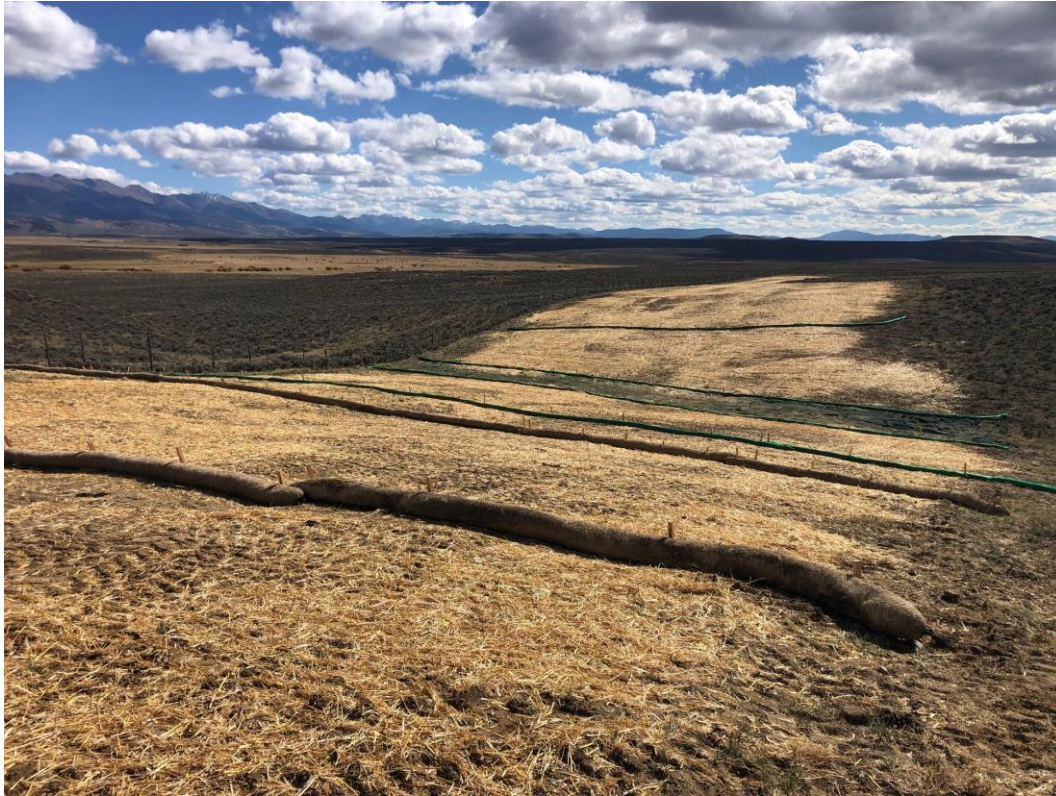
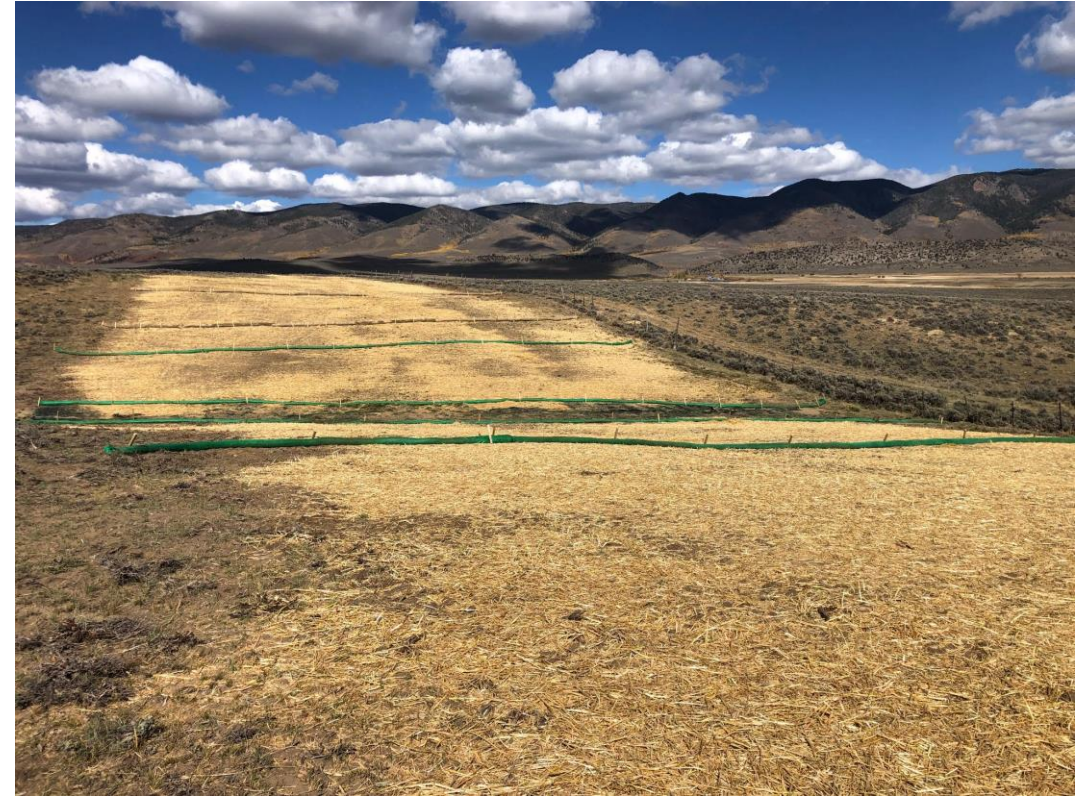
Pictures 7 & 8: Compost and Straw Erosion Logs were installed after seeding/mulching to stop any potential erosion. Soil prep, seeding, and straw crimping were completed on the contour to also help with erosion.

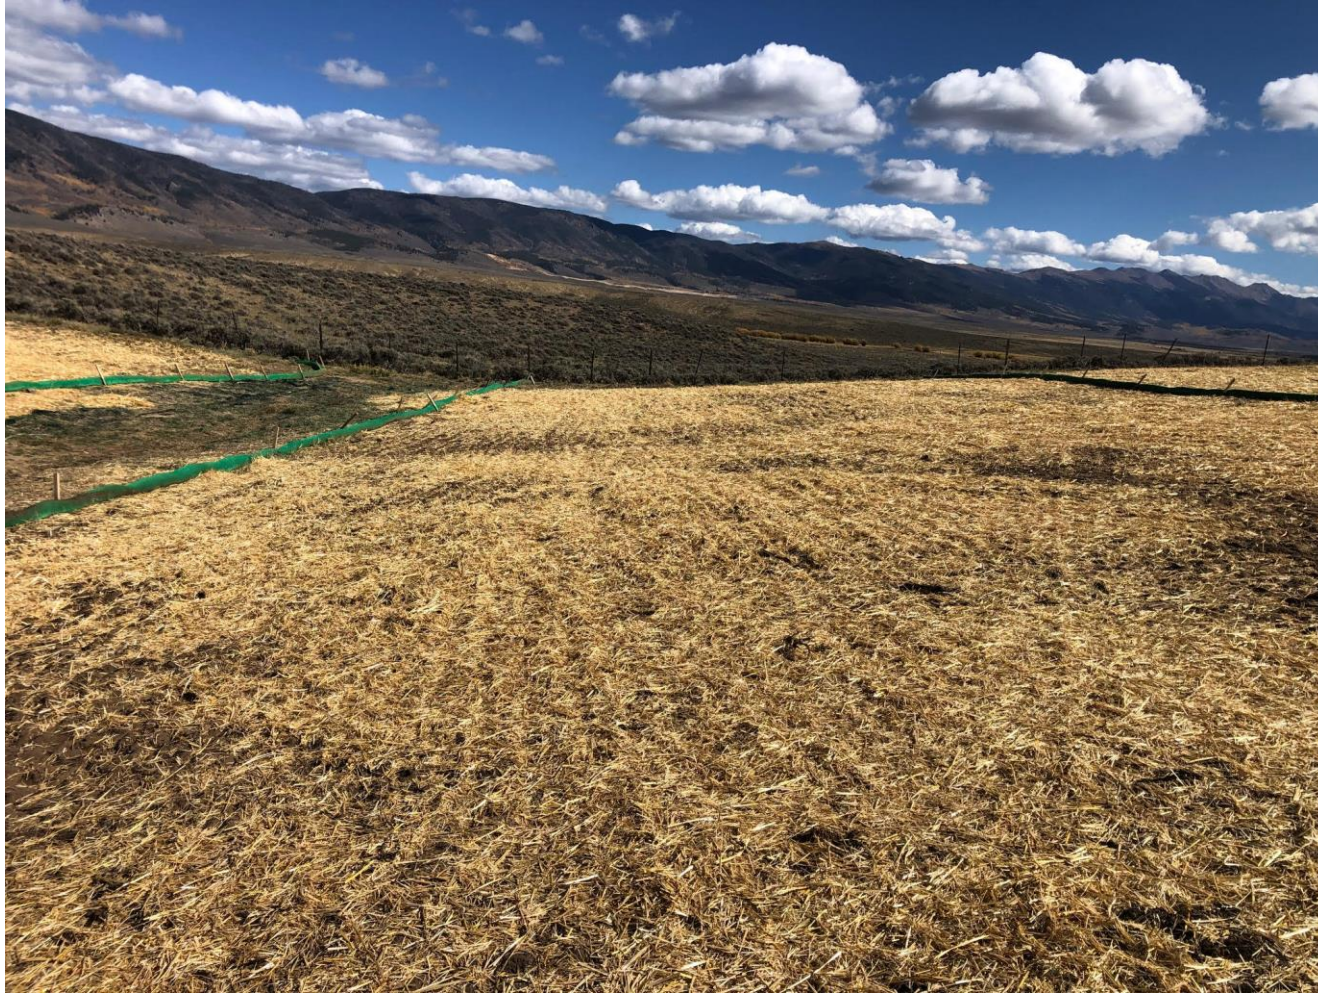
Picture 9: Contour crimping will help with erosion in the draw.

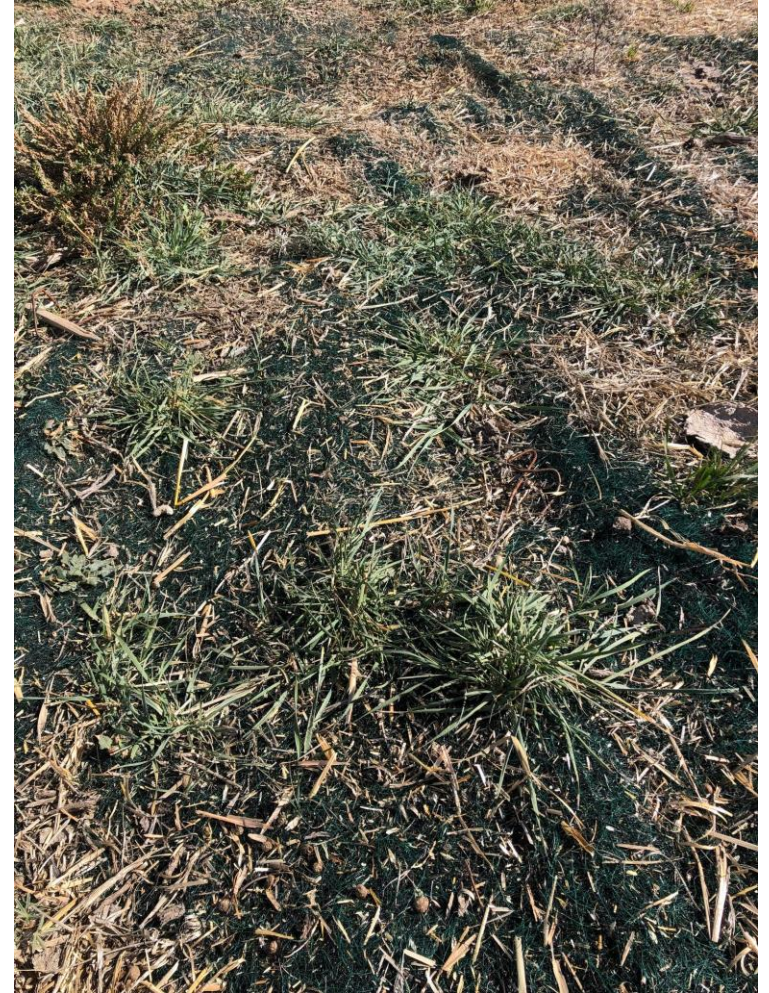
Picture 10: The blanket work and seeding from last fall was effective and had good growth in the swale so we left it as is so as not to set us back another year on grass establishment.
