Final Reclamation Inspection

Operator: NOBLE ENERGY INC - #100322

Location ID: 329023

Inspection Photos
Location Name: STATE #36-4E
Location ID: 329023

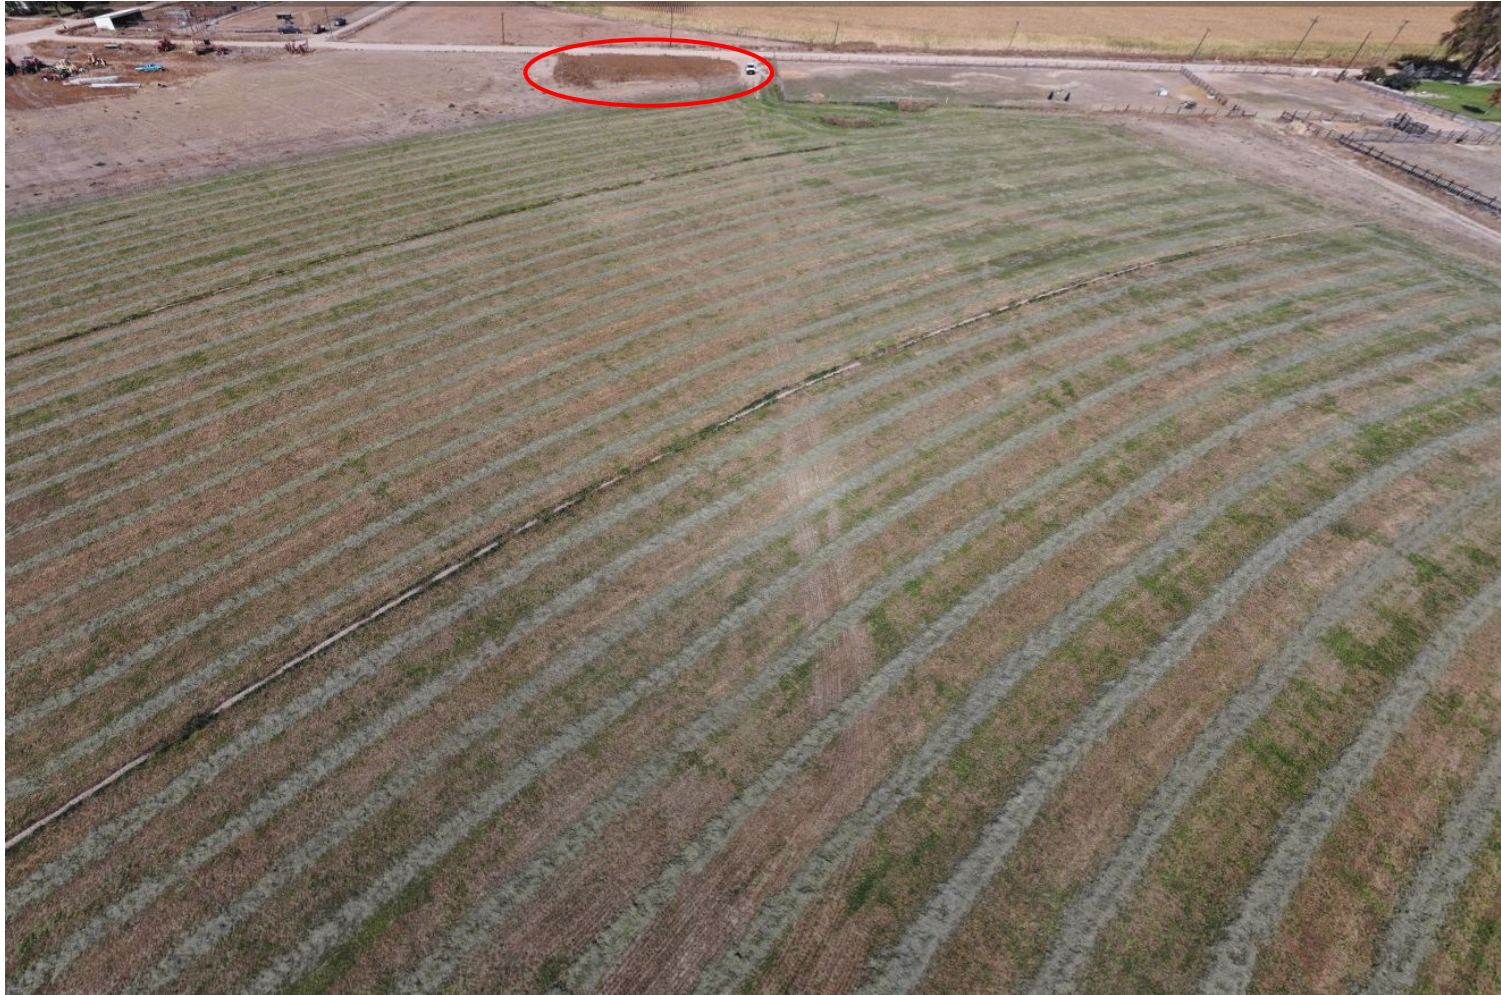
Photo 1. Drone aerial photo taken from the well location, facing North. Photo illustrates the well location and well location access road are reflective of reference crop areas. The associated offsite tank battery (red circle) is not reflective of reference areas.

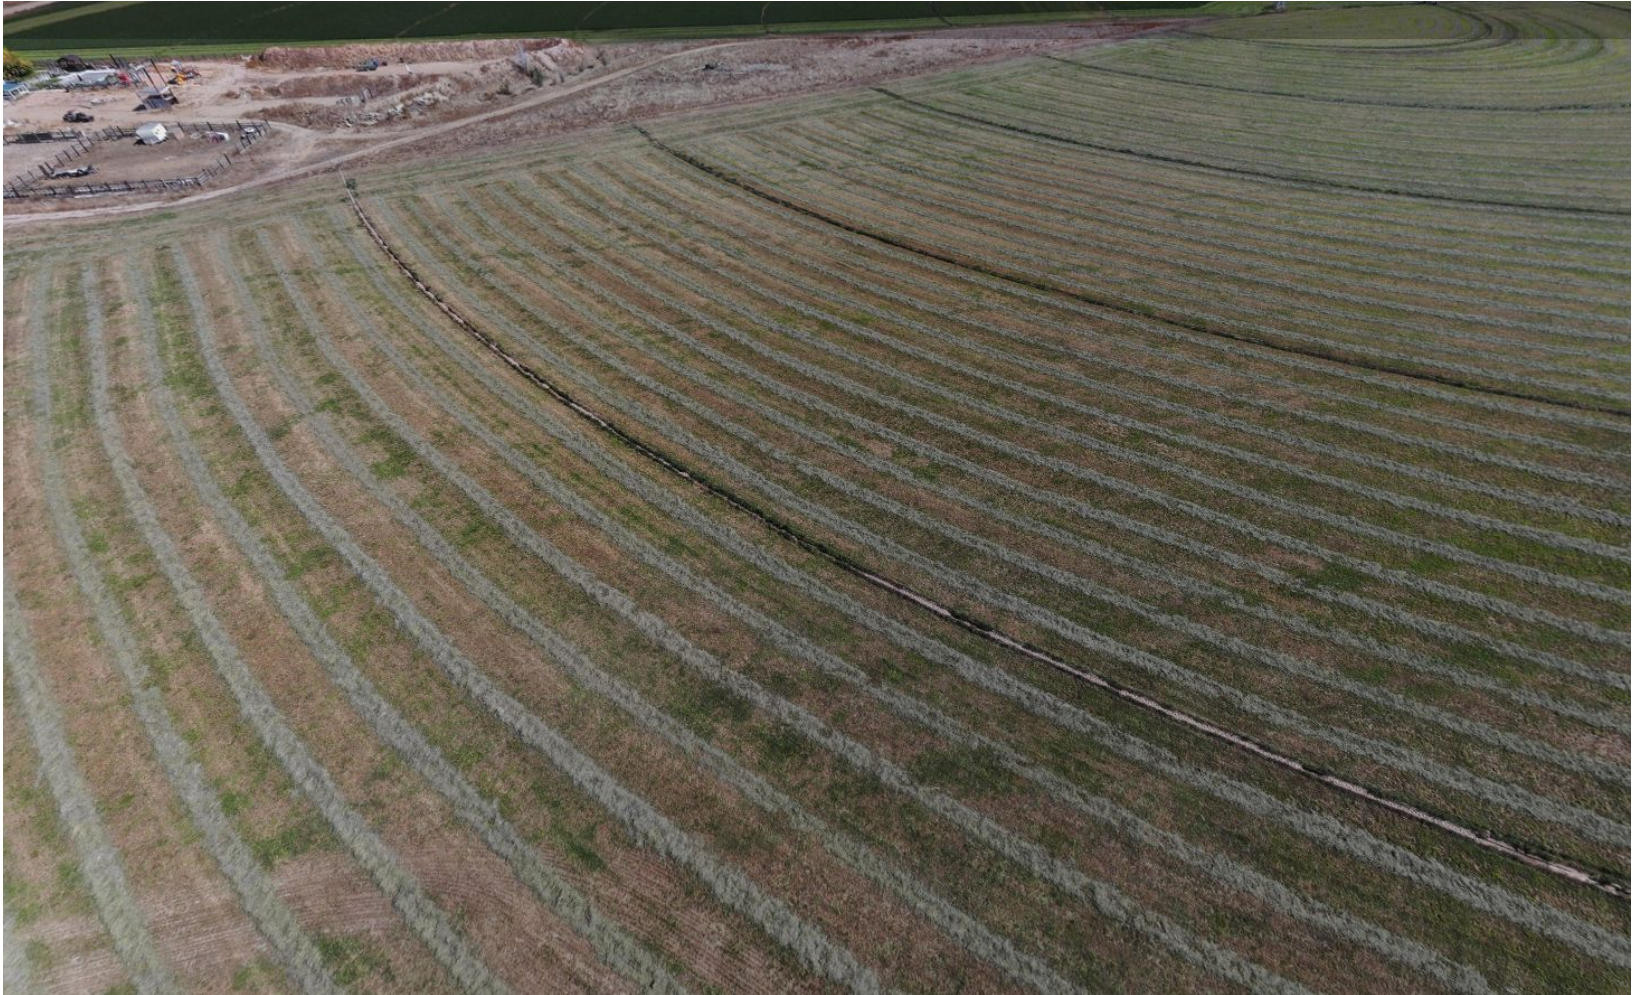
Photo 2. Drone aerial photo taken from the well location, facing East. See comments under Photo 1.

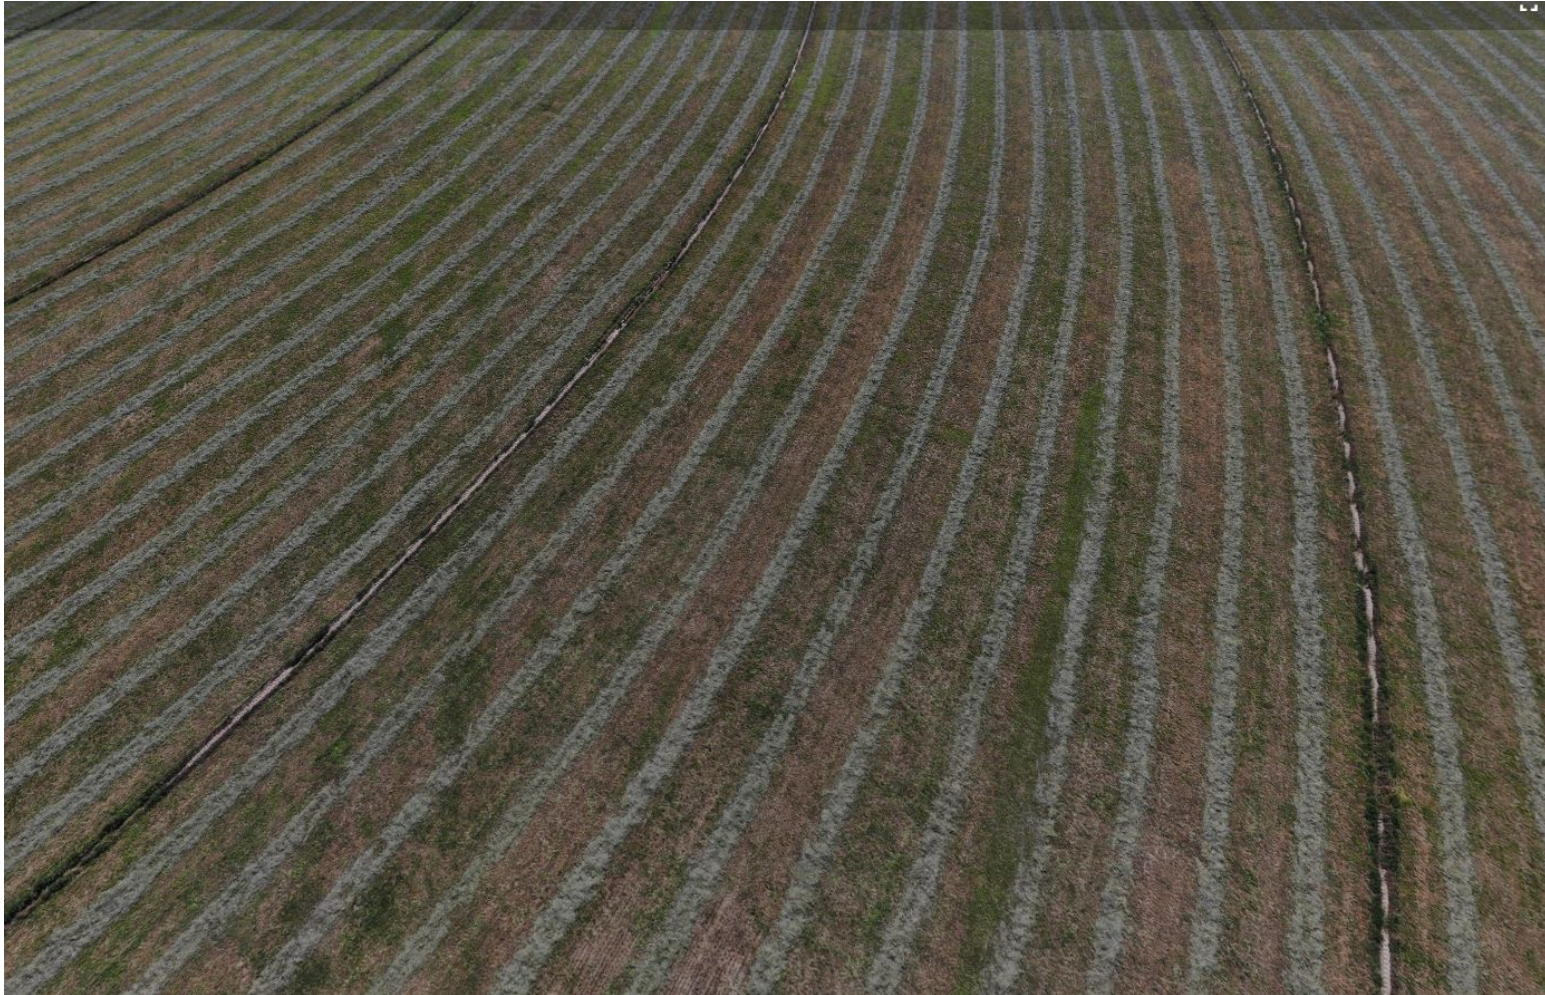
Photo 3. Drone aerial photo taken from the well location, facing South. See comments under Photo 1.

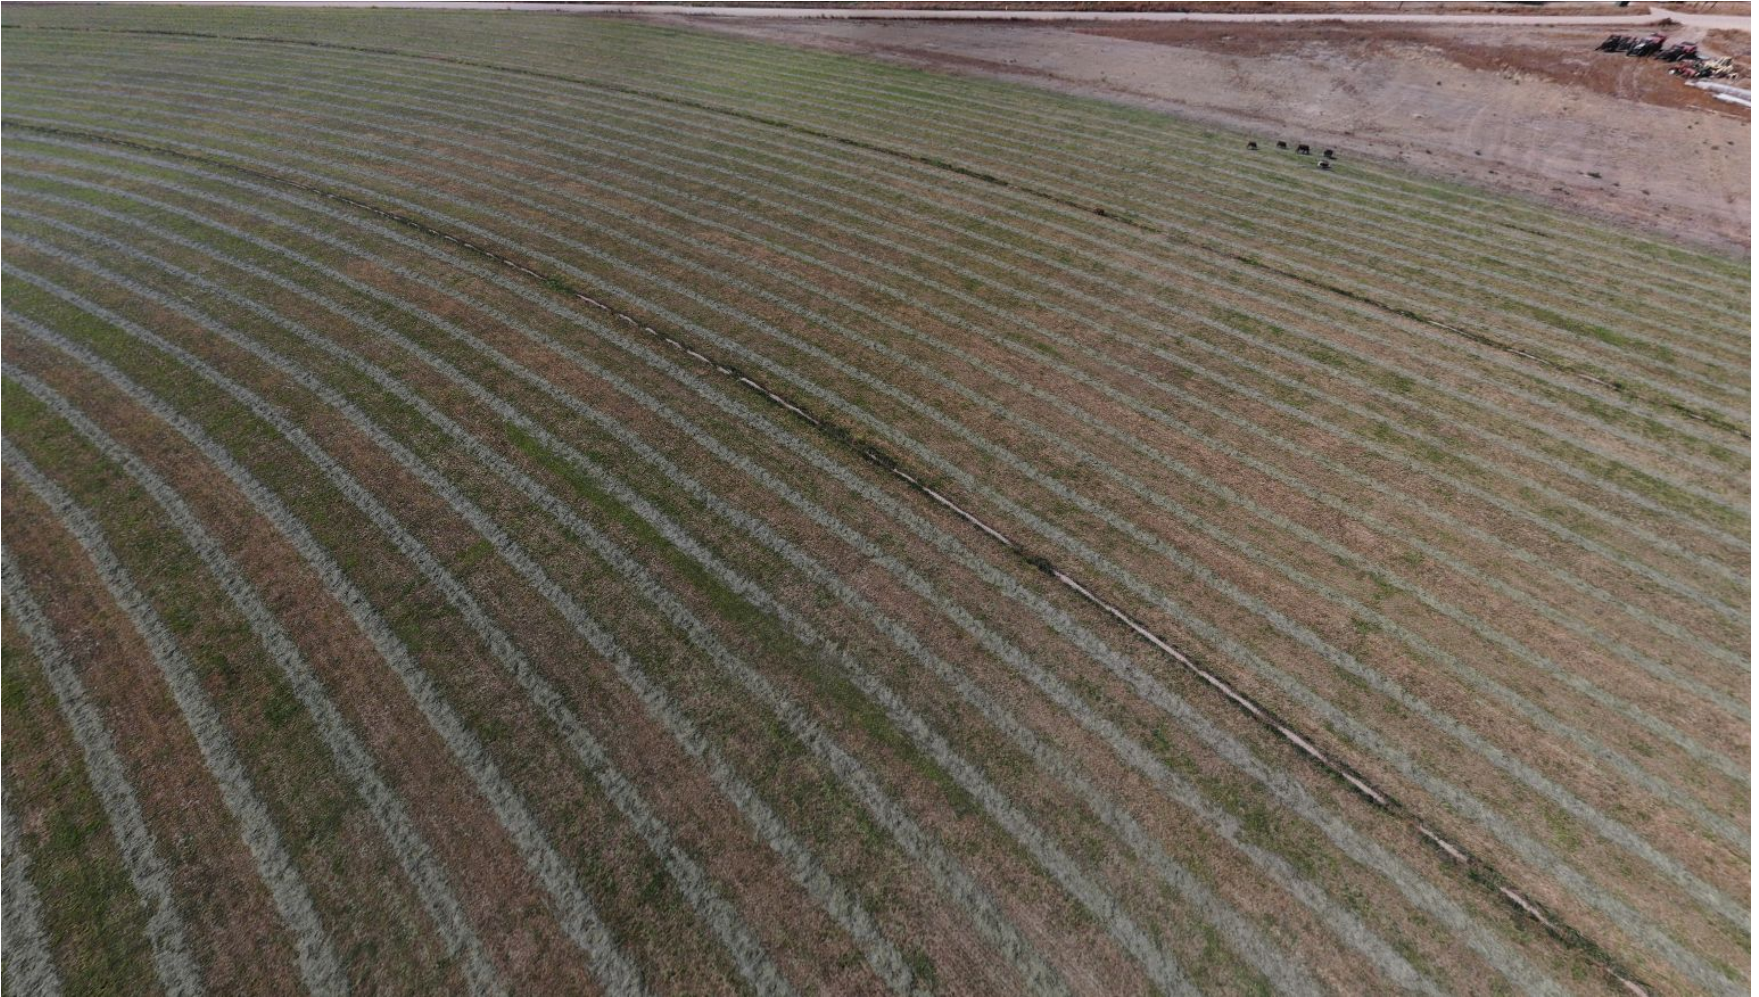
Photo 4. Drone aerial photo taken from the well location, facing West. See comments under Photo 1.

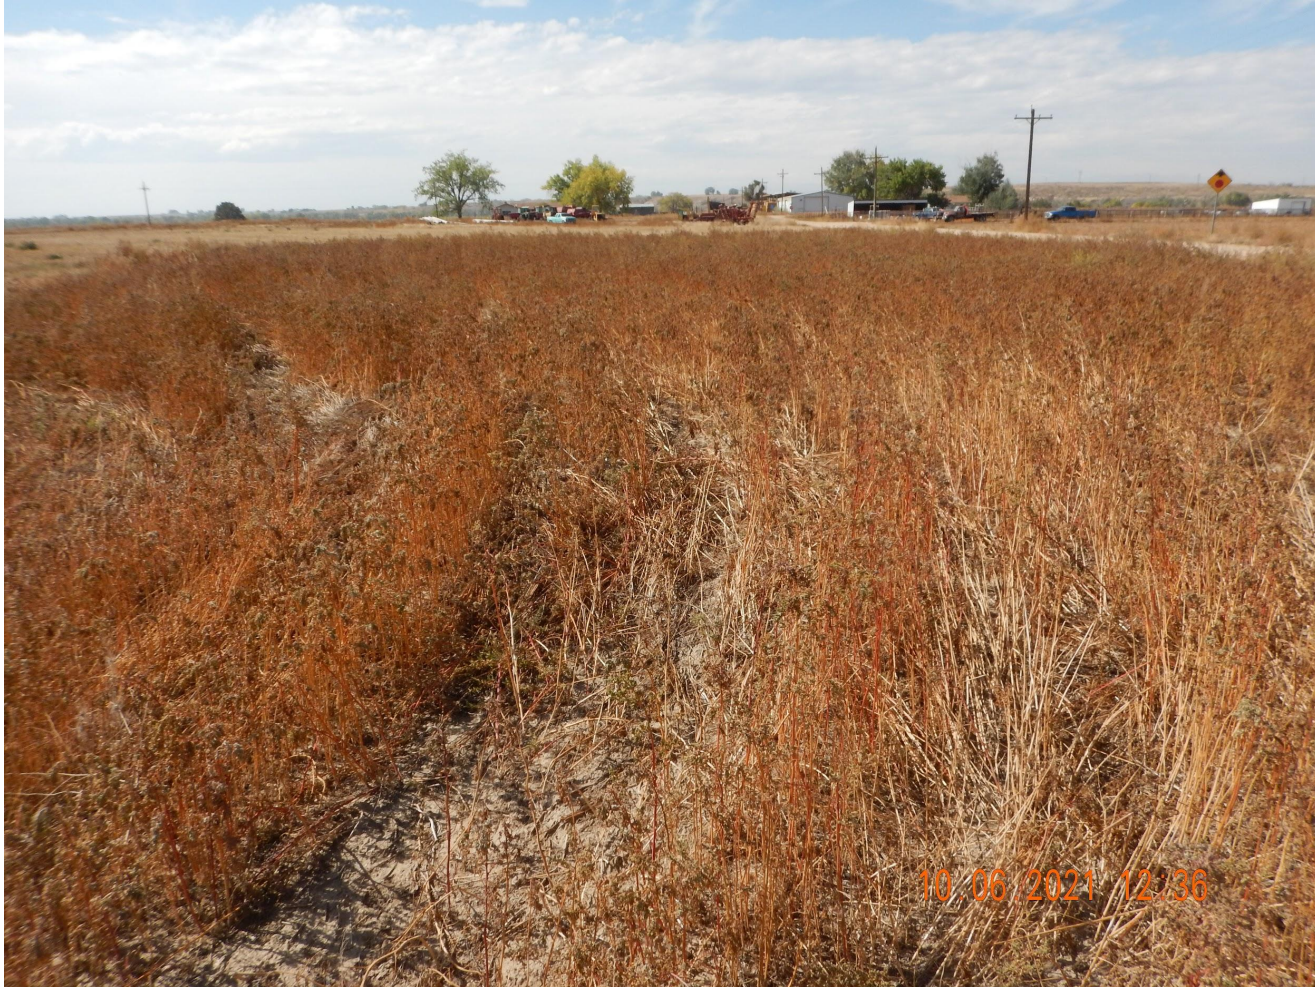
Photo 5. Photo taken from the associated offsite tank battery, facing West. Photo illustrates the tank battery consists mostly of annual, weedy vegetation.

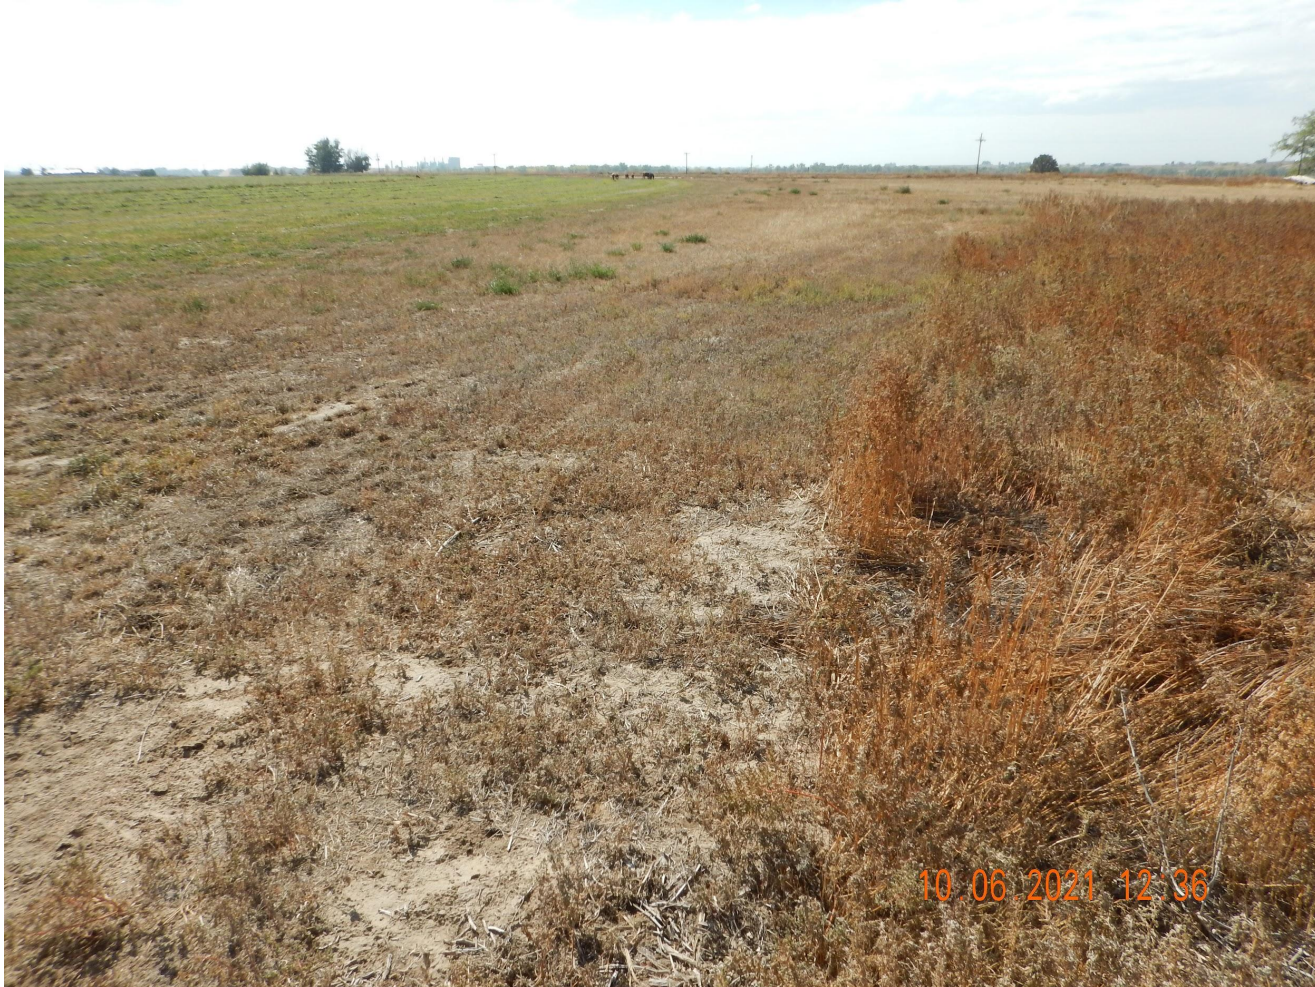
Photo 6. Photo taken from the associated offsite tank battery, facing Southwest. Photo illustrates the reference area appears to be native perennial vegetation consisting mostly of sand dropseed but could also be active cropland depending on the year.
