Inspection Photos

Operator: TEP ROCKY MOUNTAIN LLC - 96850

Location ID: 439173

Garfield County, CO

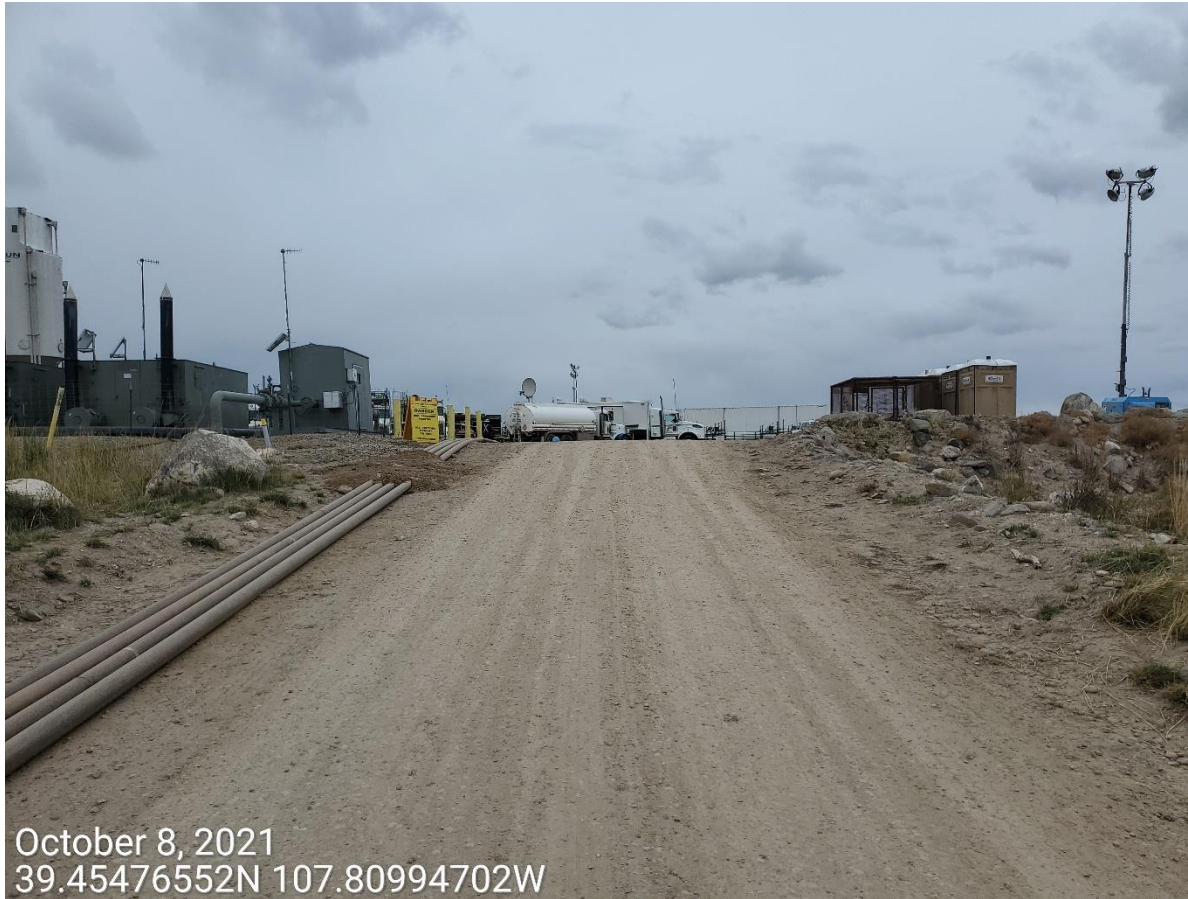
Photo 1: Photo taken from the Location entrance, facing west. Photo shows signage at the Location entrance is missing.

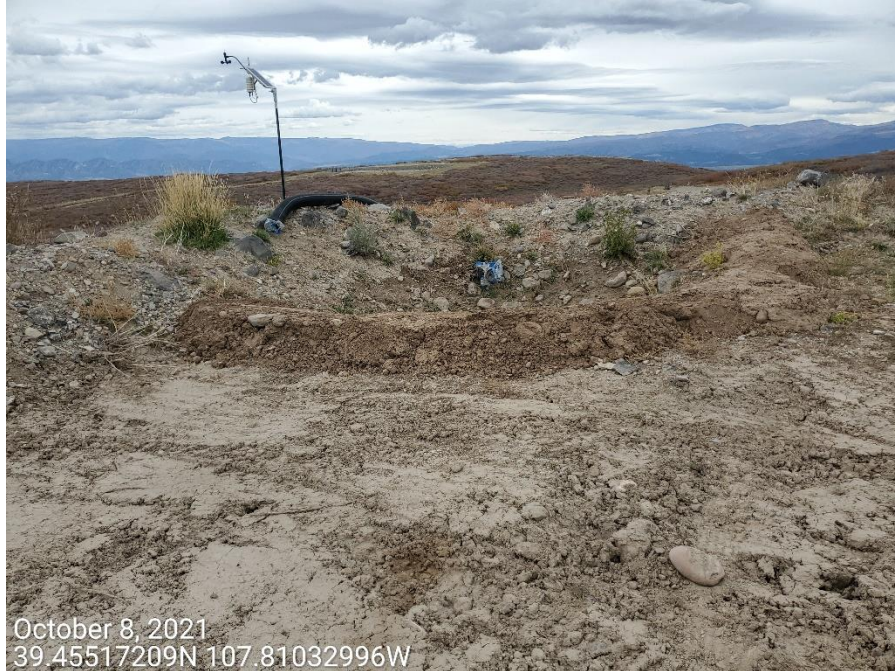
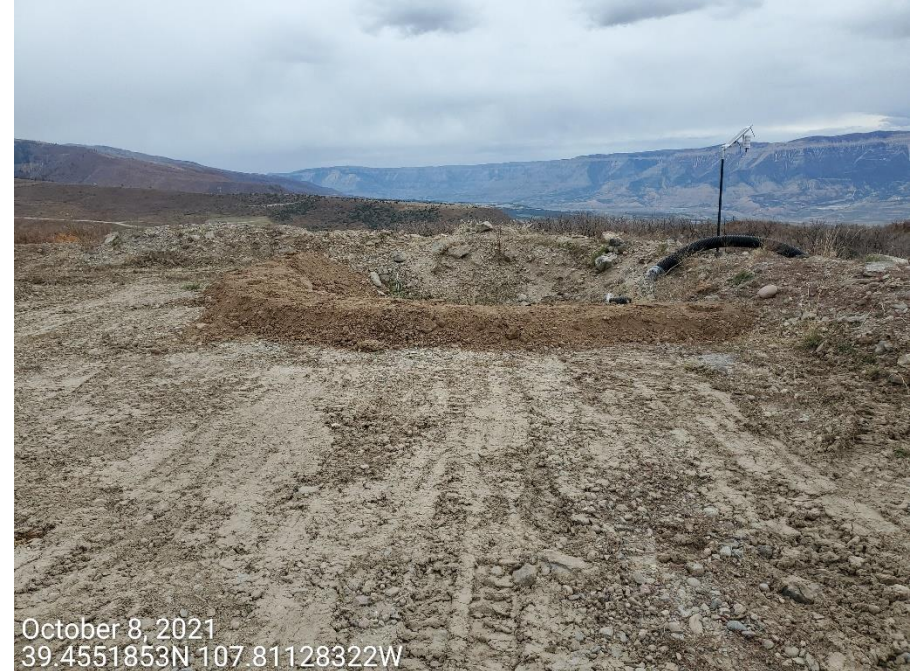
Photo 2: Photos show the sediment traps on the northeast and northwest corners of the pad; BMP has not been maintained in proper functioning condition; a berm has been constructed at trap and is preventing proper stormwater runoff and discharge from the pad. Drain pipe also not properly laid out and secured.

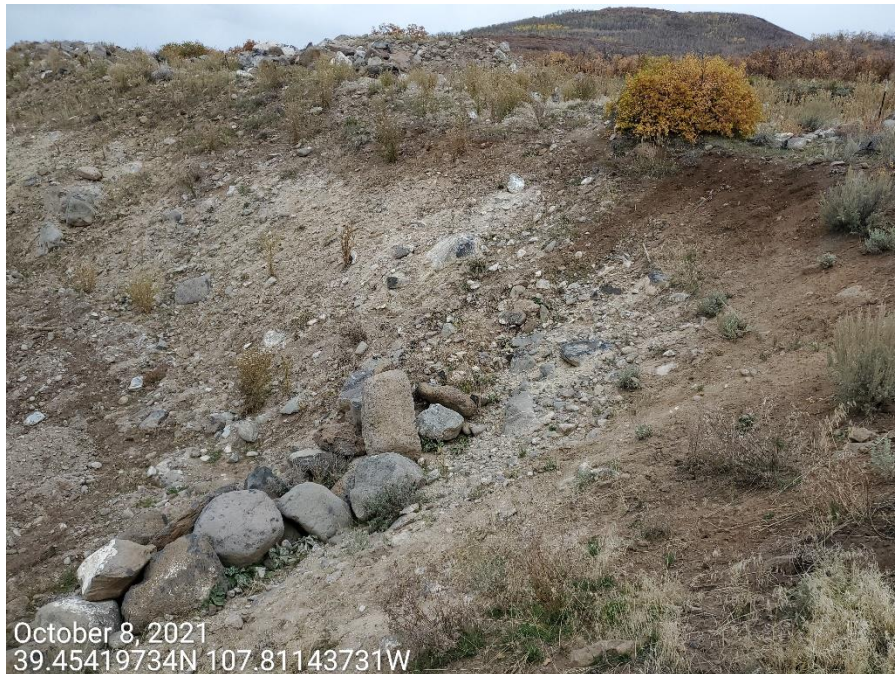
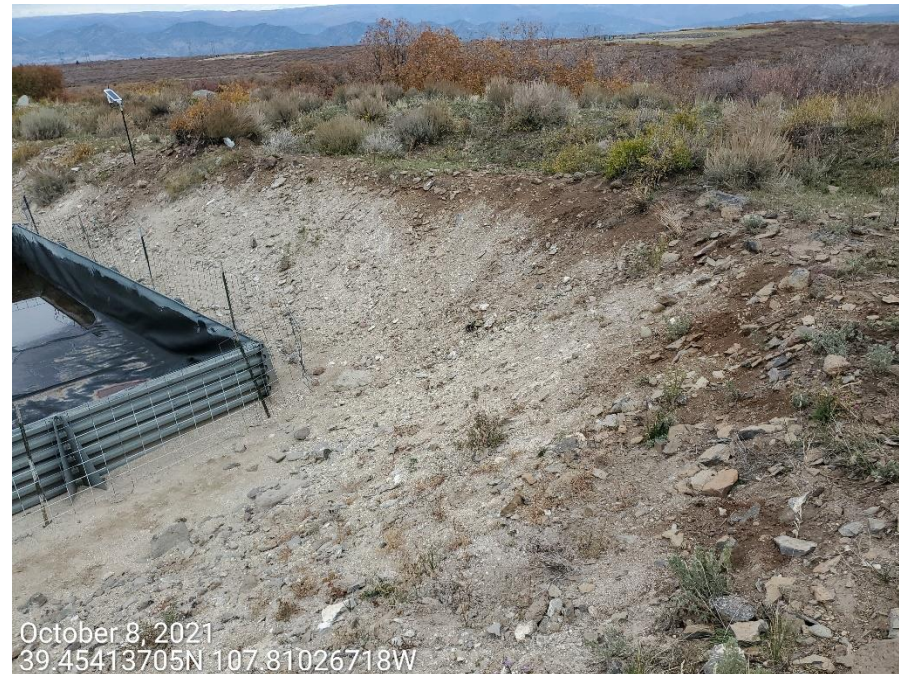
Photo 3: Photos taken from the cut slopes. Photos provide examples showing control measures to protect/stabilize the cut slopes of the location are missing or insufficient.

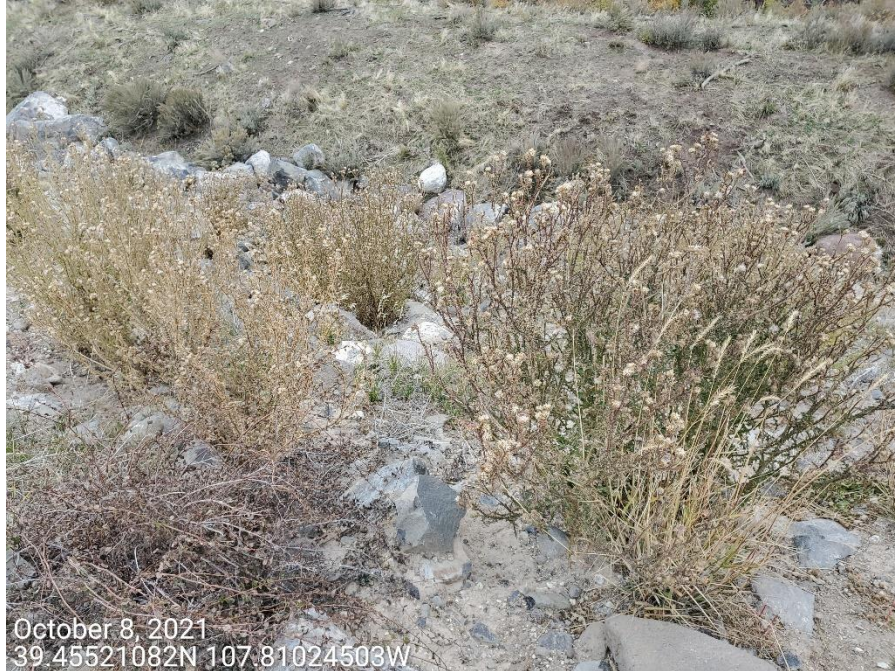
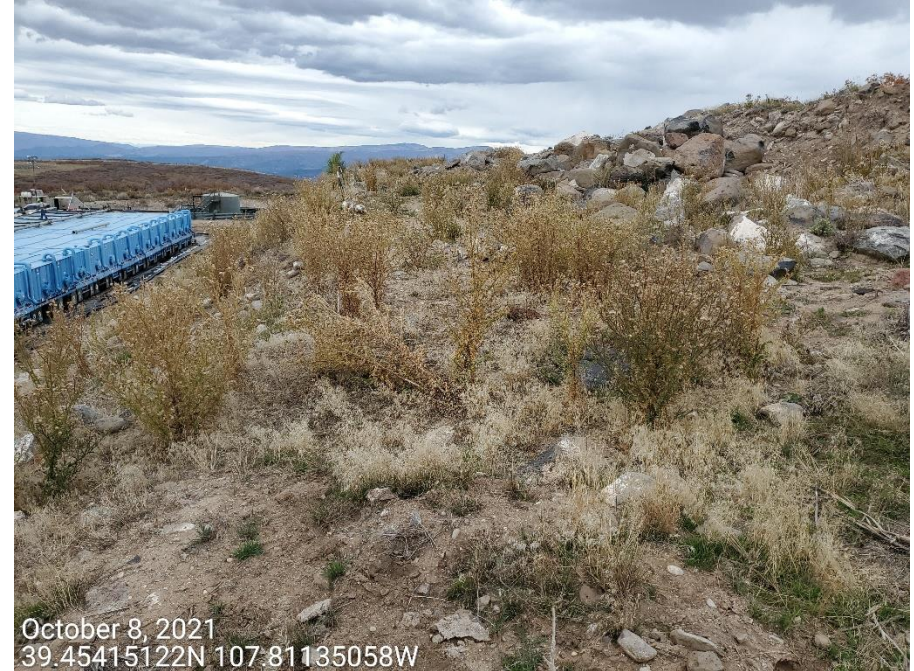
Photo 4: Photos provide example of Undesirable and Noxious Plant species observed established on the Location.
