Inspection Photos

Operator: TEP ROCKY MOUNTAIN LLC #96850

Location ID: 324061

COGCC

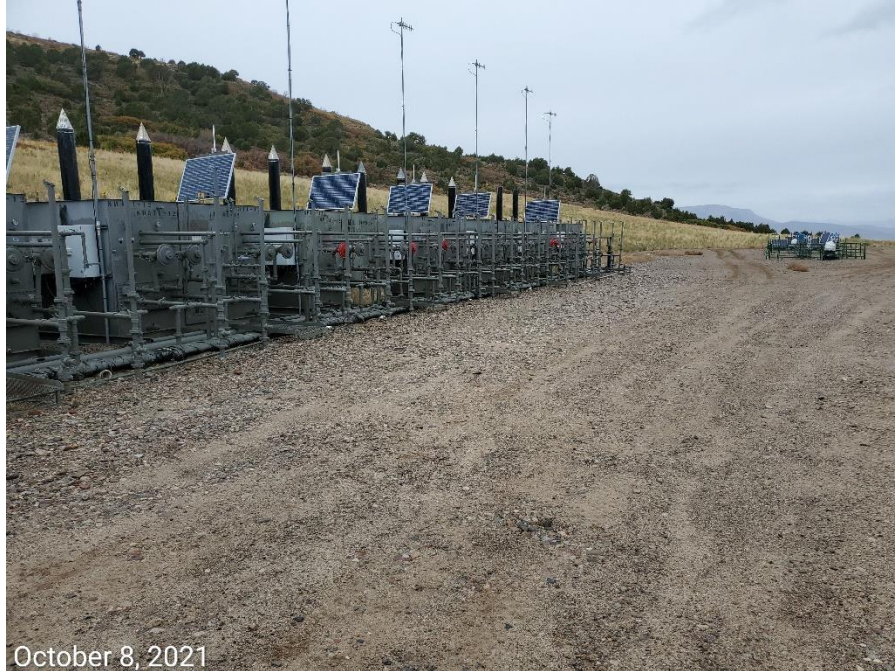
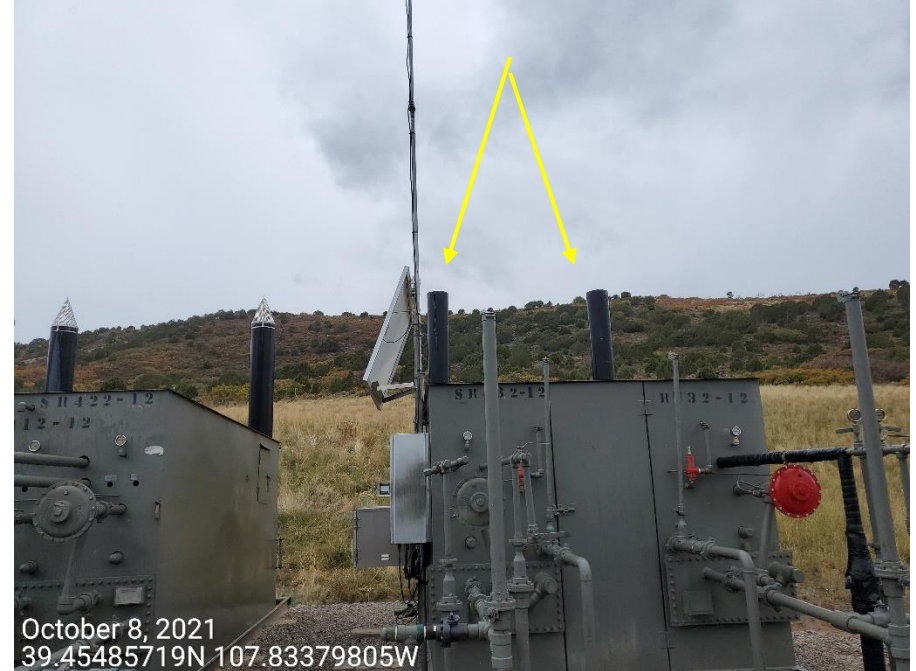
Photo 1: Photos show bird protection devices are missing from the two northern most separators on the Location.

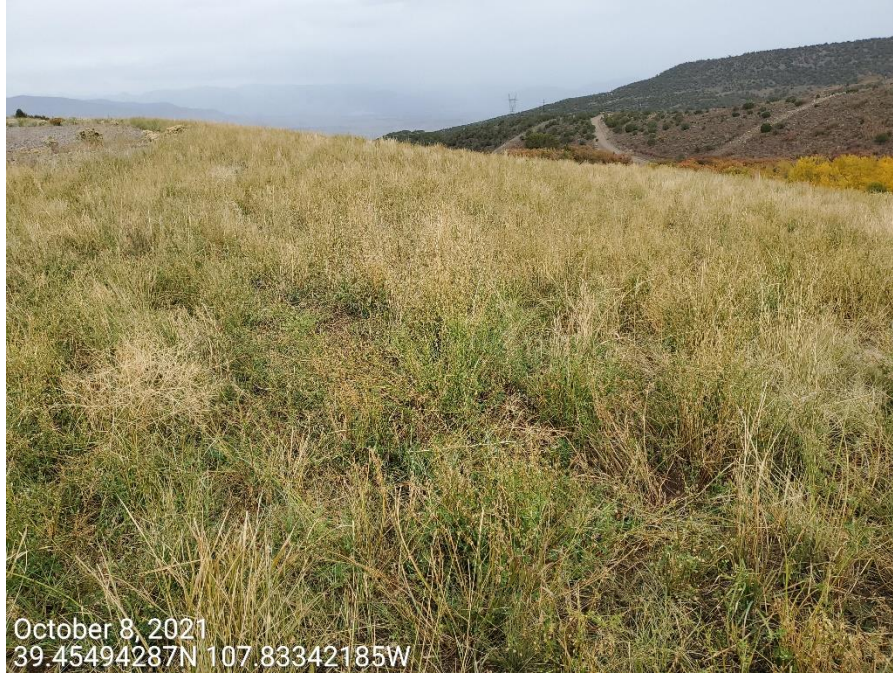
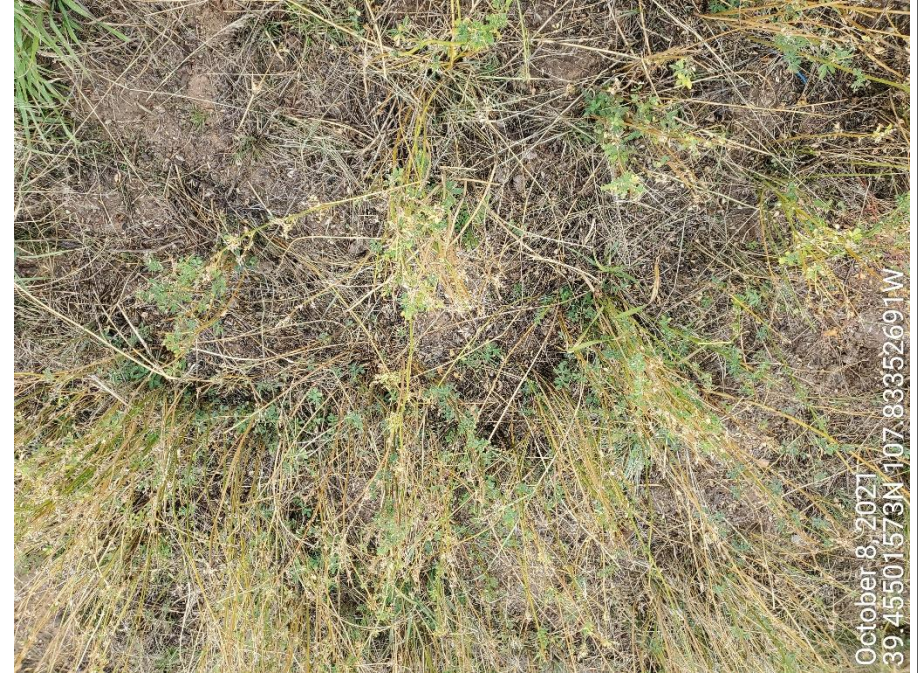
Photo 2: Photos taken from the eastern interim areas of the Location. Though areas are progressing towards 1003 standards, biennial species such as *Melilotus officinalis* were observed to be the dominant plant established on the eastern interim areas.

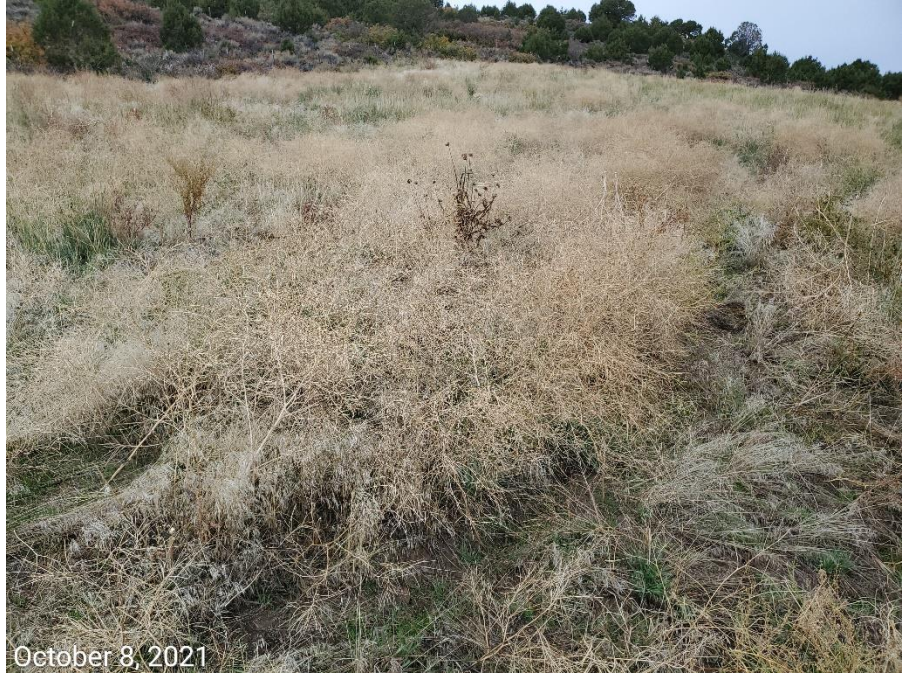
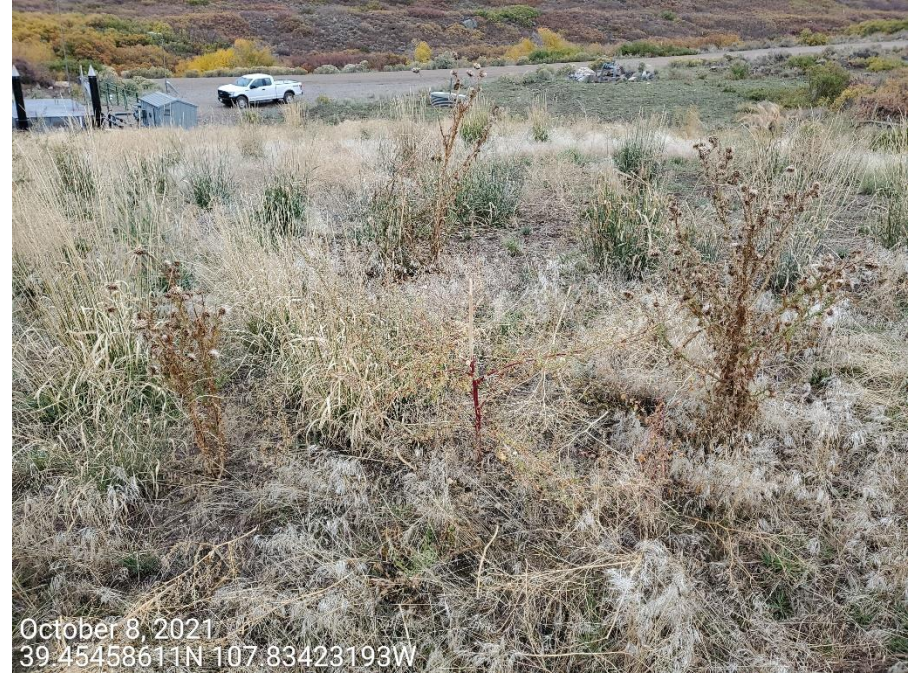
Photo 3: Photos taken from the western interim areas of the Location. Photo shows noxious weeds (Musk thistle). Photos also show areas that are dominated by undesirable plant species such as mustard and cheat grass that can hinder reclamation.

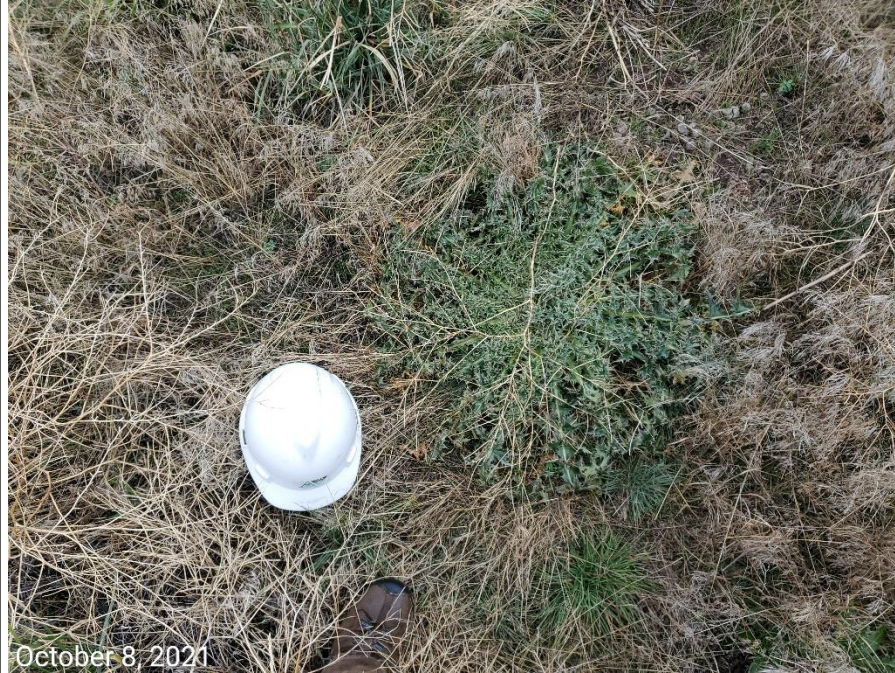
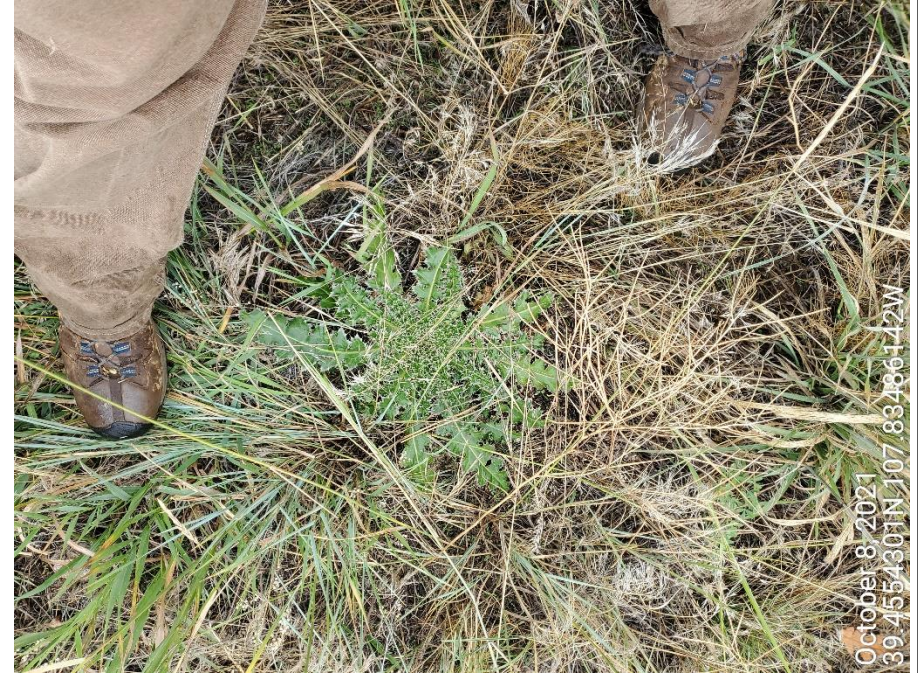
Photo 4: Additional photos taken from the western interim areas showing musk thistle rosettes.
