Inspection Photos

Operator: TEP ROCKY MOUNTAIN LLC #96850

Location ID: 323866

Garfield County, CO

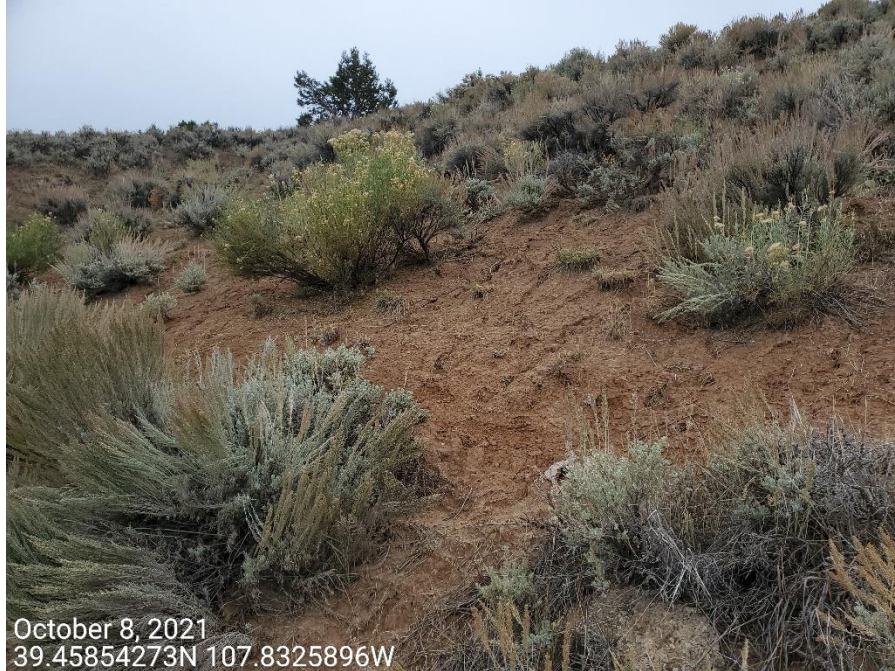
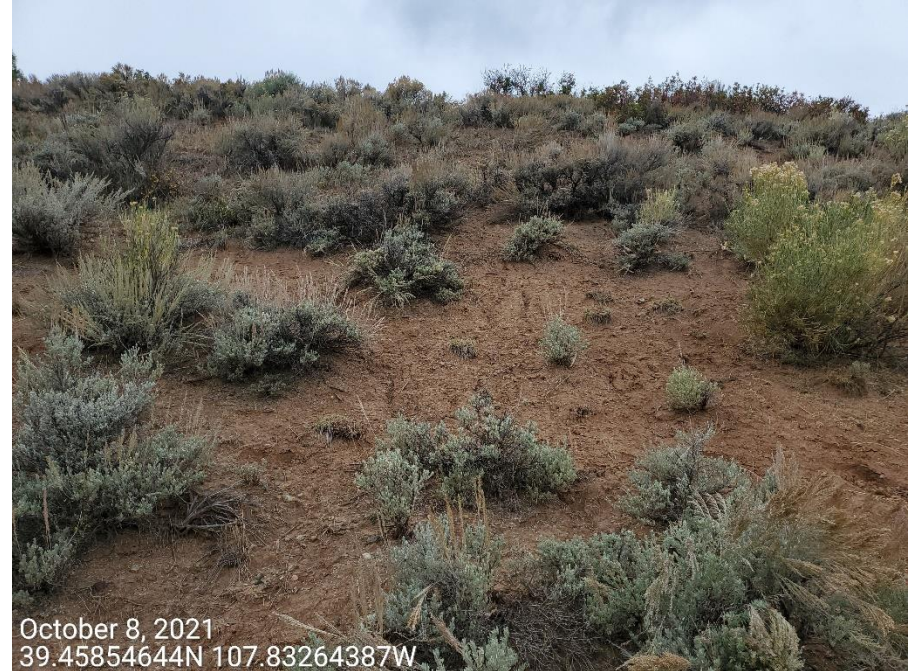
October 8, 2021
39.45854273N 107.8325896W

Photo 2: Photos taken from the western interim areas of the Location. Photo shows interim areas that are not progressing towards a uniform, desirable vegetative standard in accordance with 1003 rules; erosion evident in bare areas. Additional reclamation efforts required in these areas.
