## Annual Reclamation Assessment Report

<b>COGCC Location Name (ID)</b>	MATT-64N67W /24NWSW (331001)
<b>Operator Location Name</b>	Matt 1 Well Pad & Facility
<b>COGCC Operator Name (ID)</b>	PDC ENERGY, INC (69175)
<b>Legal Description</b>	NWSW Sec. 24 T4N-R67W
<b>Well Pad Geographic Coordinates (WGS84)</b>	40.295627/ -104.846841
<b>Facility Pad Geographic Coordinates (WGS84)</b>	40.294865/-104.848239

## Vegetation Progress Evaluation: Matt 1 Well Pad

## Vegetation Progress Evaluation: Matt 1 Facility

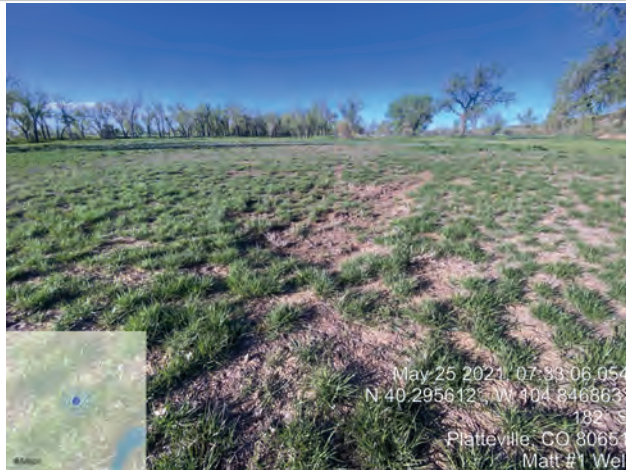
Reclamation Area Overview

All equipment has been removed from the location. The site has been reclaimed and exhibits moderate establishment of sand dropseed (*Sporobolus cryptandrus*), basin wildrye (*Leymus cinereus*), and crested wheatgrass (*Agropyron cristatum*). The reference is composed predominantly of noxious and undesirable weeds including hoary cress (*Lepidium draba*), blue mustard (*Chorispora tenella*), leafy spurge (*Euphorbia esula*), and cheatgrass (*Bromus tectorum*). Reclamation maintenance is suggested to mow the reclaimed surface to suppress weed encroachment from the reference and inter-seed the disturbance area to allow reclamation grasses to outcompete undesirable forbs.

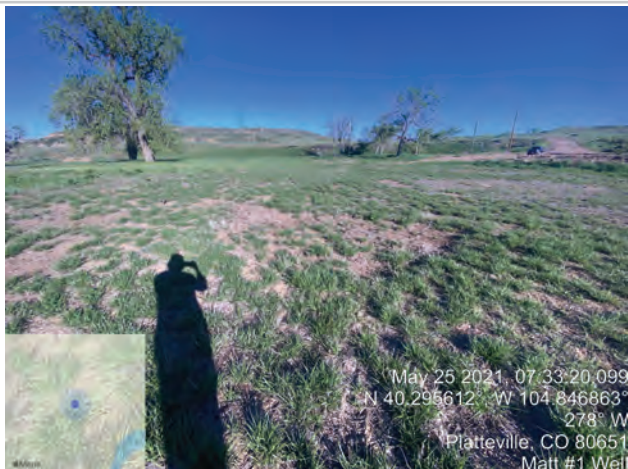
## Maintenance Task Photo 2: Subsidence

Leveling / Subsidence

Mow well site reclaimed surface in mid-June with a bagging attachment to suppress hoary cress (*Lepidium draba*), blue mustard (*Chorispora tenella*), leafy spurge (*Euphorbia esula*), and cheatgrass (*Bromus tectorum*) encroachment from the reference areas. To promote the exclusion of noxious and undesirable species in the reclaim, inter-seeding is recommended for the 46,688 ft<sup>2</sup> disturbance area. Due to the presence of sand dropseed (*Sporobolus cryptandrus*), basin wildrye (*Leymus cinereus*), and crested wheatgrass (*Agropyron cristatum*) in the reference, these species are recommended for the seed mix.

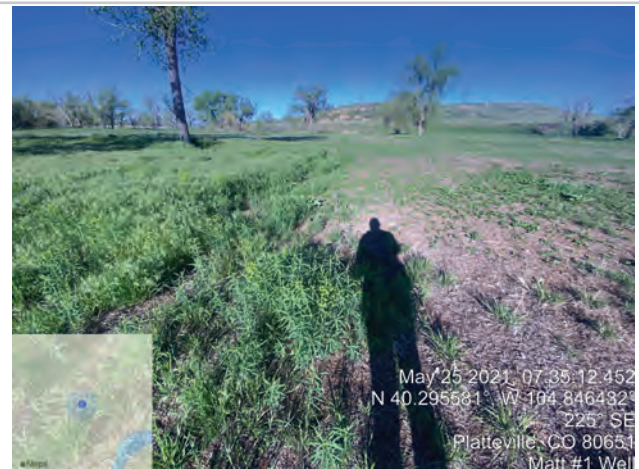
## Maintenance Task Photo 3: Weed Encroachment

OBSERVATIONS	
Oil and Gas Equipment on Location <input type="checkbox"/> <i>Meterhouse Present</i> <input type="checkbox"/>	No oil and gas equipment remains on location.
Livestock Disturbances <input type="checkbox"/>	No evidence of grazing or other livestock disturbances observed.
Vehicle Disturbances <input checked="" type="checkbox"/>	Surface owner drove through reclamation area during inspection. Tire tracks were present from previous occurrences of egress through reclaim.
Wildlife Disturbances <input type="checkbox"/>	None observed.
Other Disturbances <input type="checkbox"/>	None observed.
Weeds Observed <input checked="" type="checkbox"/>	<i>Lepidium draba</i> (hoary cress), <i>Chorispora tenella</i> (blue mustard), <i>Euphorbia esula</i> (leafy spurge), and <i>Bromus tectorum</i> (downy brome).
Erosion Observed <input type="checkbox"/>	None observed.

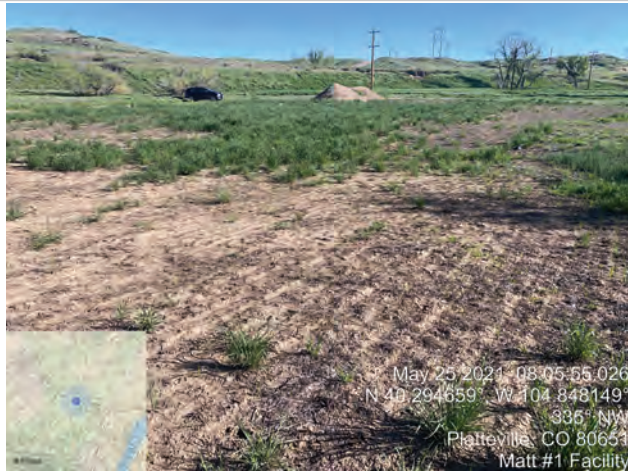
### Reclamation Area Overview

All equipment has been removed from the location. A surface owner stockpile of road base is present within the northern disturbance area. Compaction alleviation, cross seeding, amendment application, and mulch application efforts are evident at the time of inspection. The seeded grasses have germinated within the reclaim with consistent density but show signs of stress and poor establishment. The reference is composed of sand dropseed (*Sporobolus cryptandrus*), alkali muhly (*Muhlenbergia asperifolia*), crested wheatgrass (*Agropyron cristatum*) intermixed with noxious and undesirable weeds including hoary cress (*Lepidium draba*), blue mustard (*Chorispora tenella*), leafy spurge (*Euphorbia esula*), and cheatgrass (*Bromus tectorum*). While plant vigor and density concerns within the reclaimed surface may resolve naturally over time, this potentially lengthy process may delay reclamation success. Amendment application and inter-seeding are recommended.

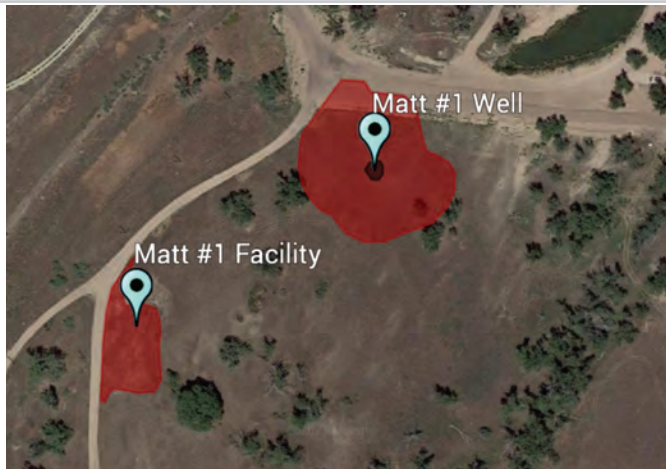
## Aerial Image

Location shows evidence of reclamation best practice implementation; compaction alleviation and cross seeding, amendment application, and mulch application evidence was observed. Germinated grasses are consistent in density but have large inter-plant distances and in the reference. Amendment application and consideration of inter-seeding are advised.
