# Inspection Photos

10/13/2021

Operator: CAERUS PICEANCE LLC - 10456

Location ID: 334613

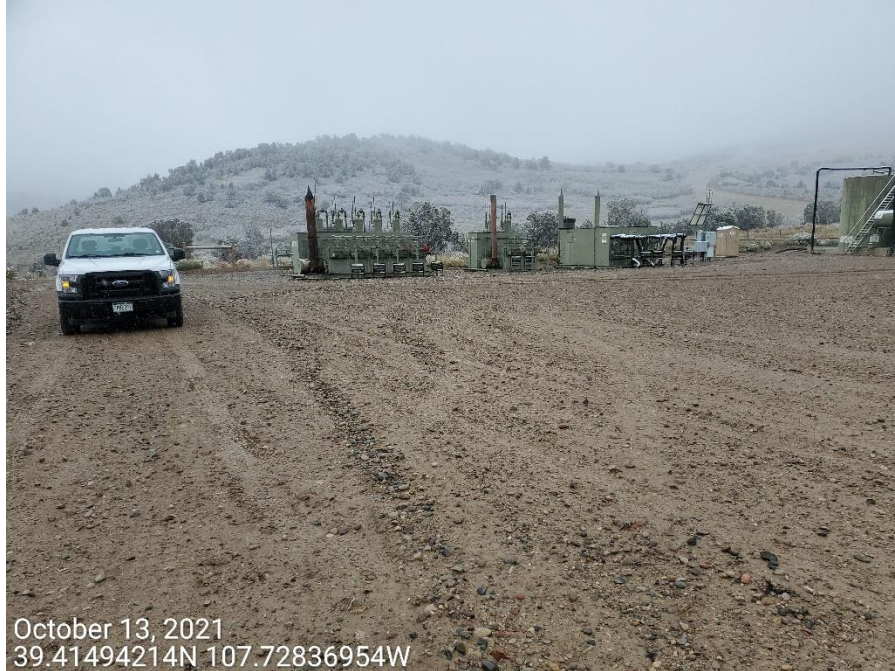
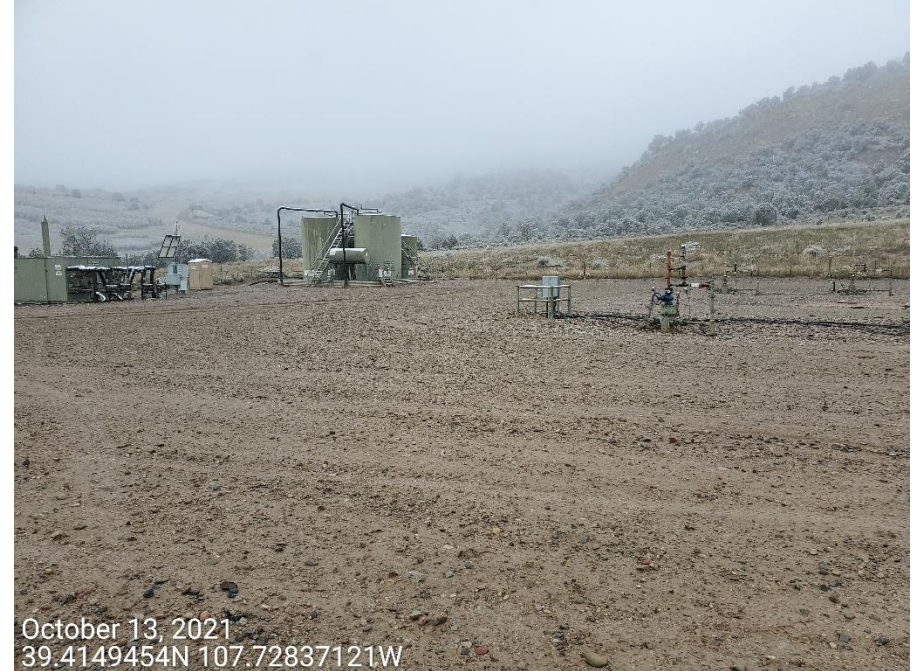
**Photo 1:** Photos 1-2 provide an overview from the east end of the Location facing south, southwest, northwest to north.

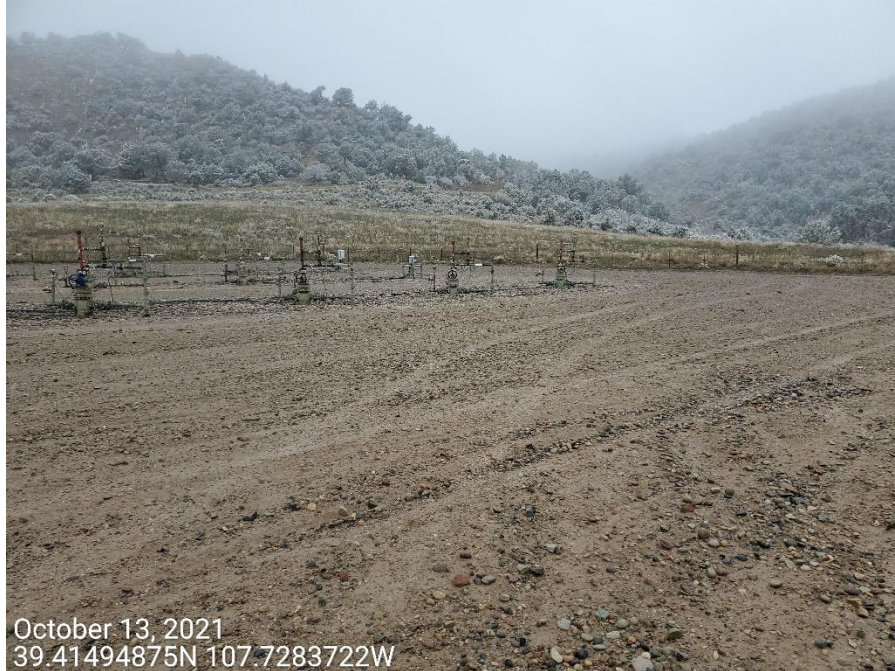
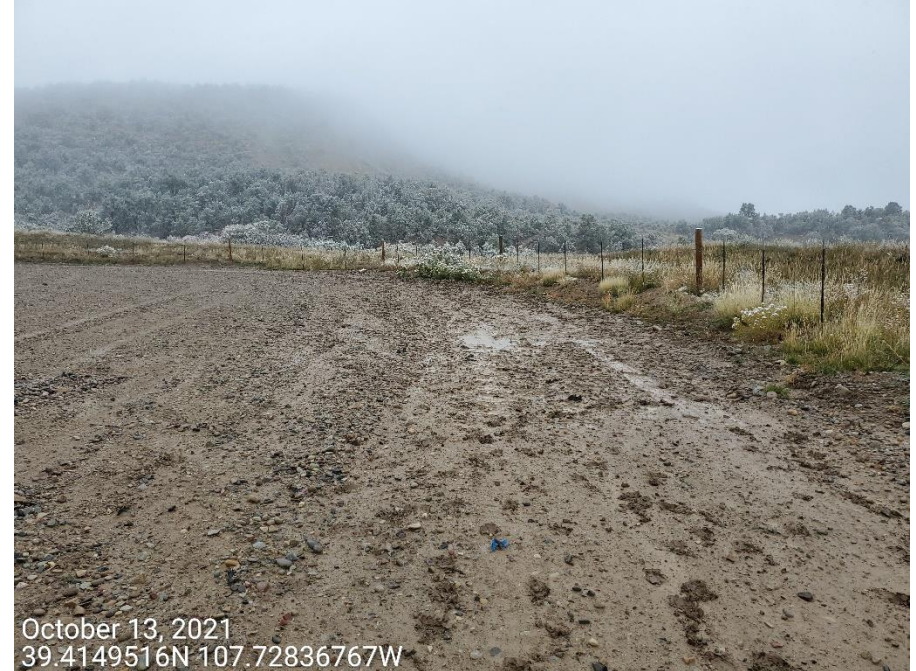
**Photo 2:** See comments under photo 1.

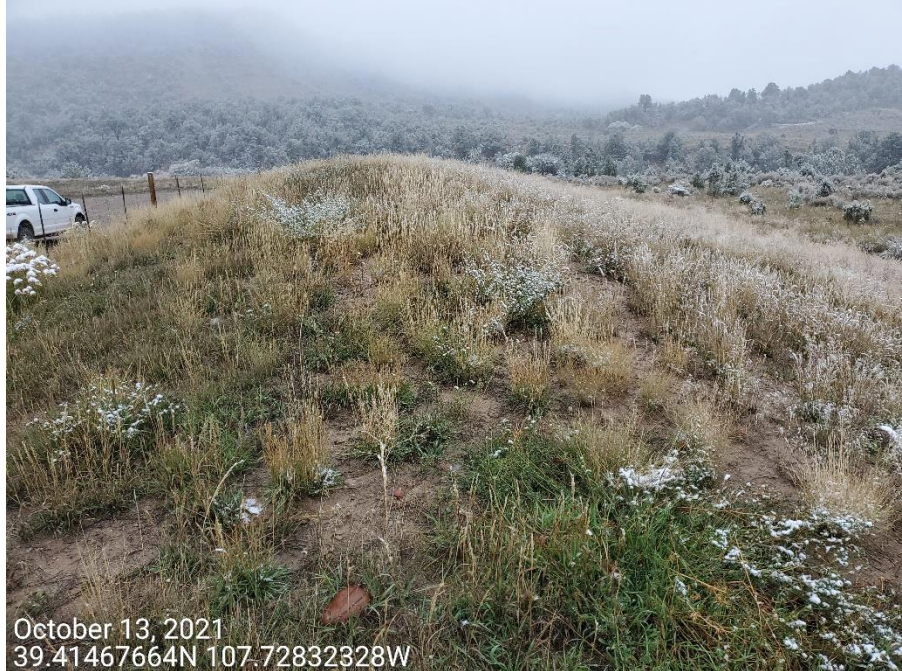
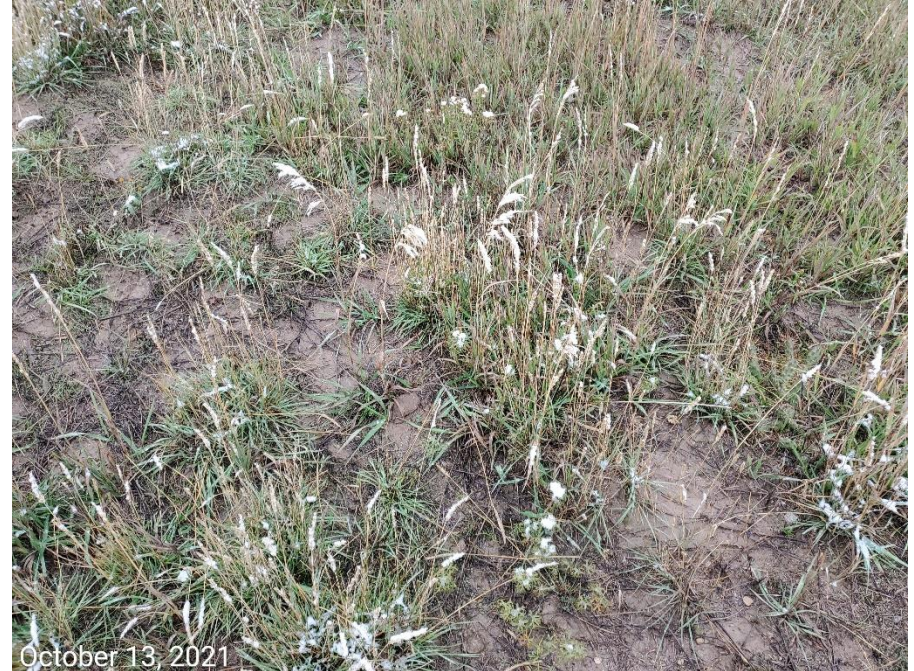
**Photo 3:** Photos taken from eastern interim areas of the Location; photos provide example of the observed reclamation. It is noted that though interim areas of the Location have achieved a uniform perennial vegetative establishment, species observed established on the interim areas of the Location are predominantly introduced, and not reflective of the reference area,

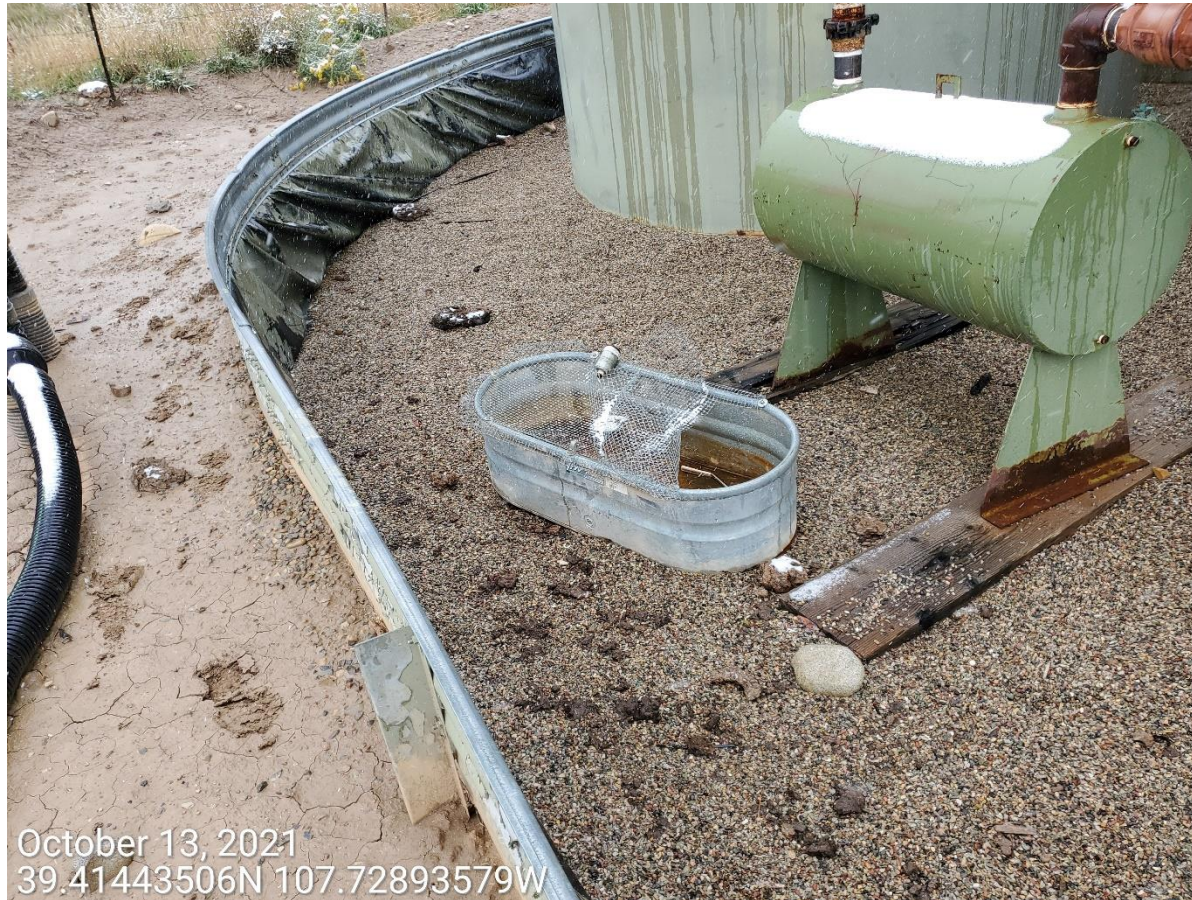
October 13, 2021  
39.41443506N 107.72893579W

**Photo 4:** Photo taken from the tank battery. Photo shows unused stock tank stored within the secondary containment of the batter. Equipment is unused and requires removal.
