Inspection Photos

10/13/2021

Operator: CAERUS PICEANCE LLC - 10456

Location ID: 334271

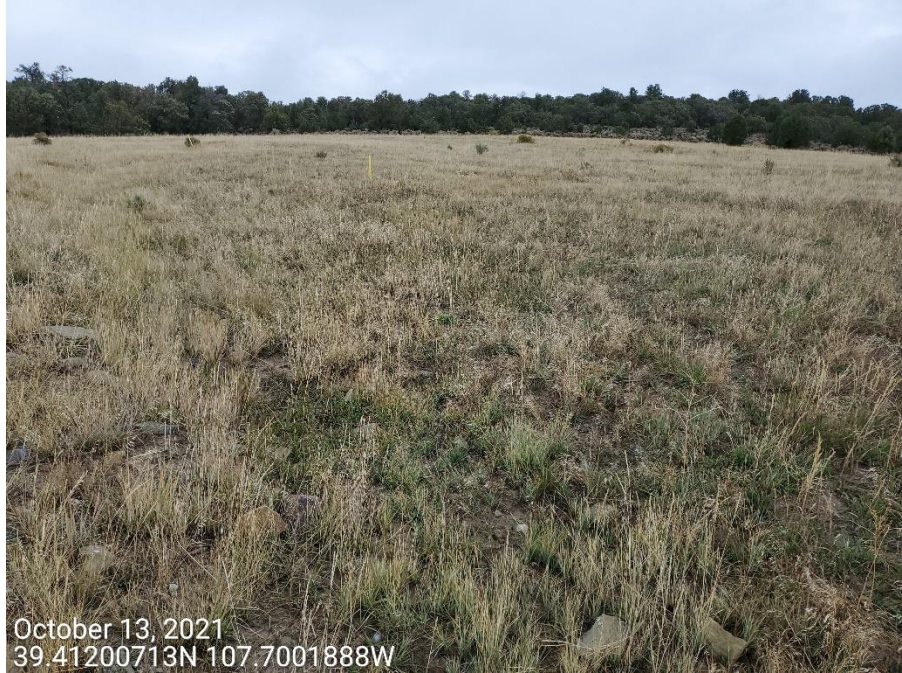
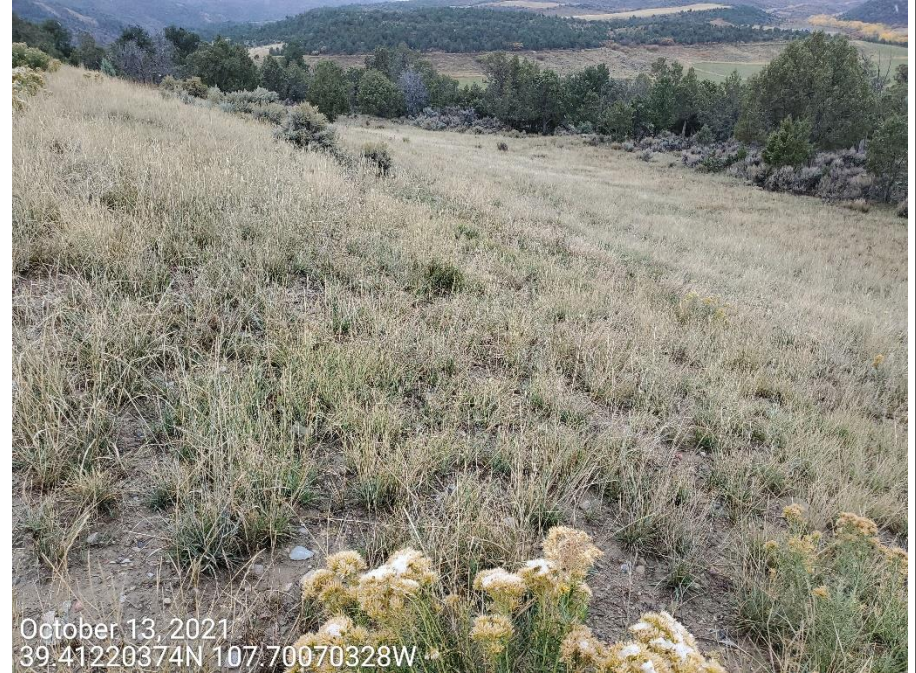
Photo 1: Photos show example of vegetative establishment on the interim areas of the Location; though the species observed established on the interim areas of the Location are predominantly introduced, and not reflective of the reference area, interim areas of the Location have achieved a uniform perennial vegetative establishment

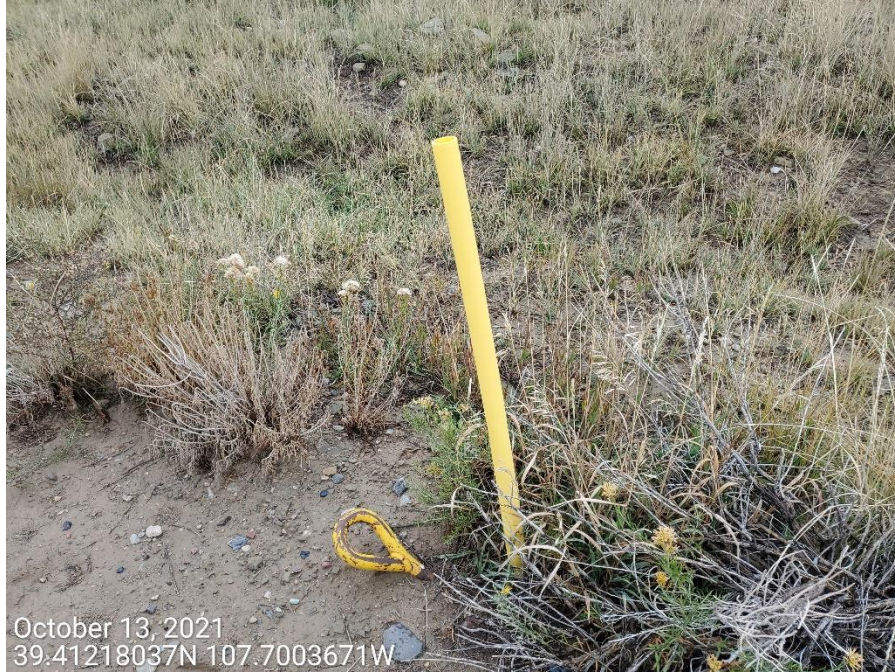
Photo 2: Photo left shows example of marked anchors observed on the Location. Photo on right shows production areas; control measures to stabilize production areas during wet conditions show signs of degrading; advise maintenance prior to BMP failure.
