# Inspection Photos

Operator: CAERUS PICEANCE LLC - 10456

Location ID: 334156

Garfield County, CO

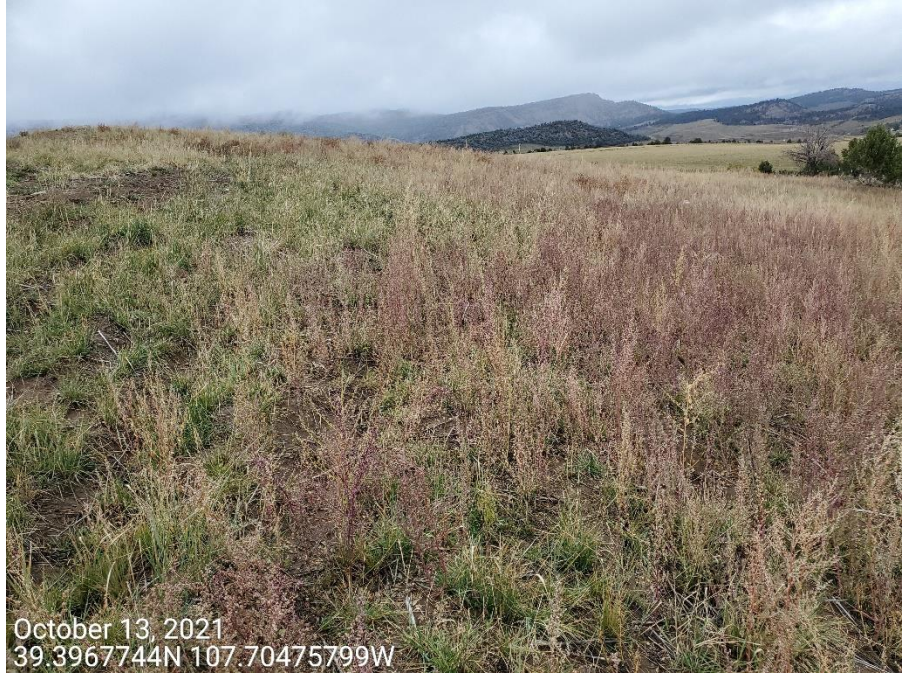
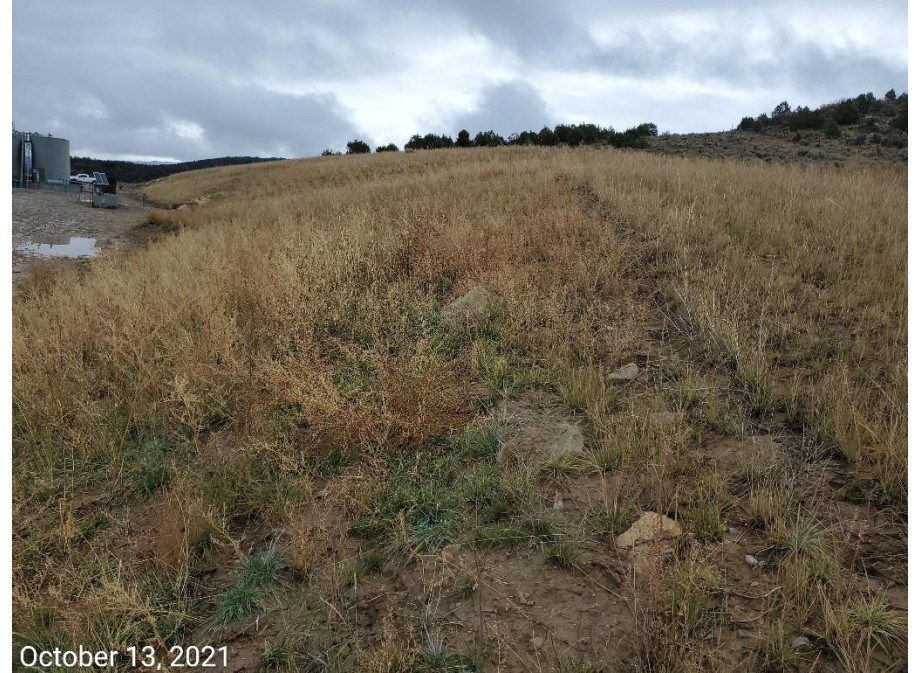
**Photo 1:** Photos show example of vegetative establishment on the interim areas of the Location; vegetation observed predominantly undesirable weedy plant species, however desirable plant establishment was observed under weeds. Weed management advised to facilitate interim areas progress towards 1003 standards.

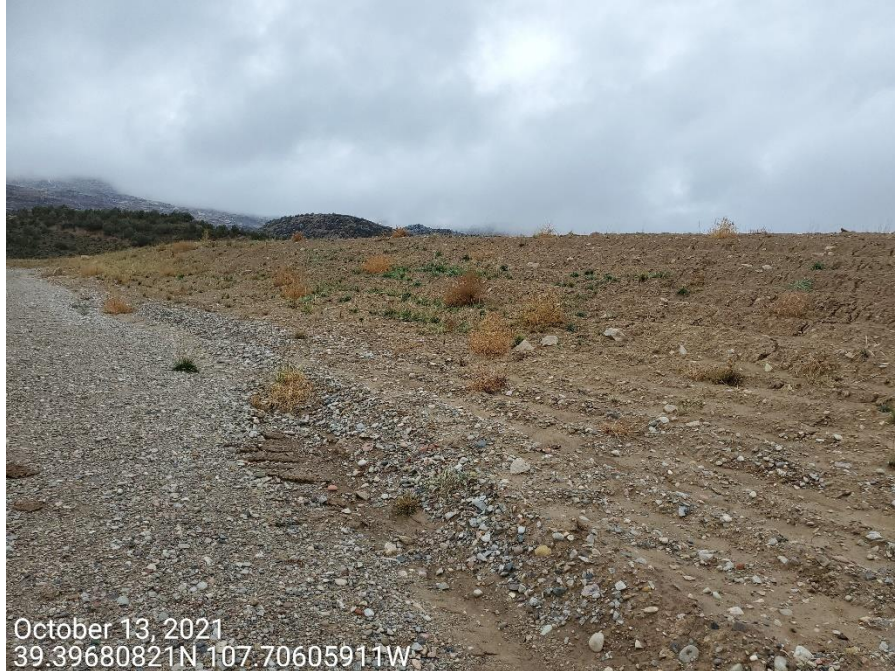
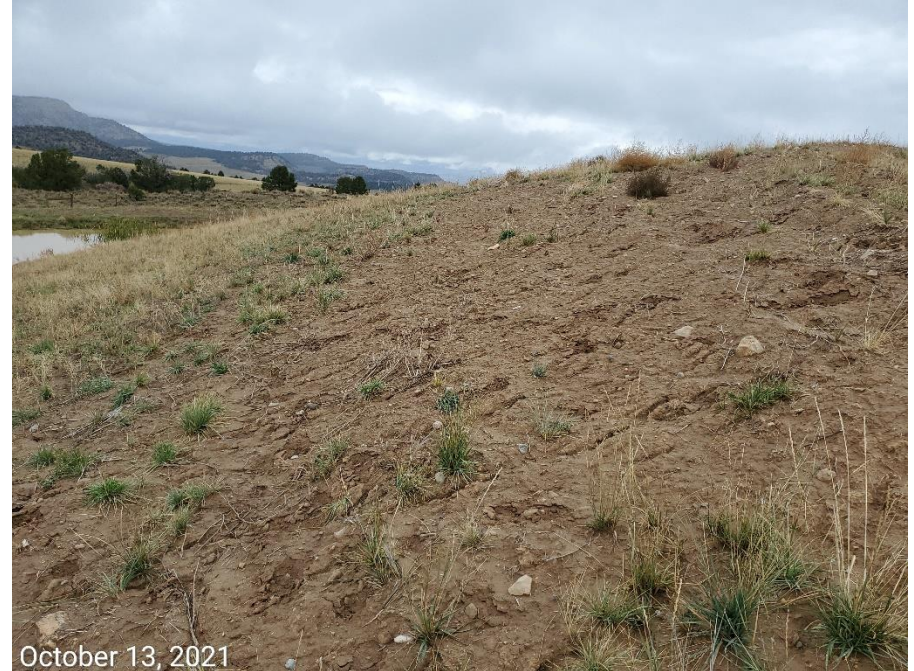
**Photo 2:** Photos taken from the soil stockpiles on the west end of the Location. Photo shows slopes remains predominantly bare and exposed soil; BMPs to protect soils from erosion degradation observed to be missing or insufficient. Areas are not progressing towards 1003 standards; additional reclamation activities required.

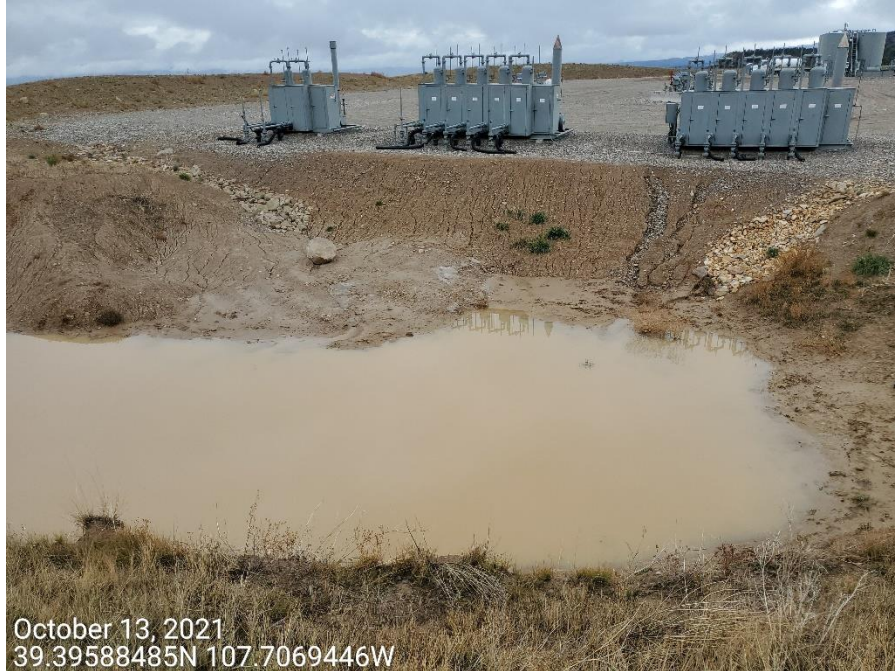
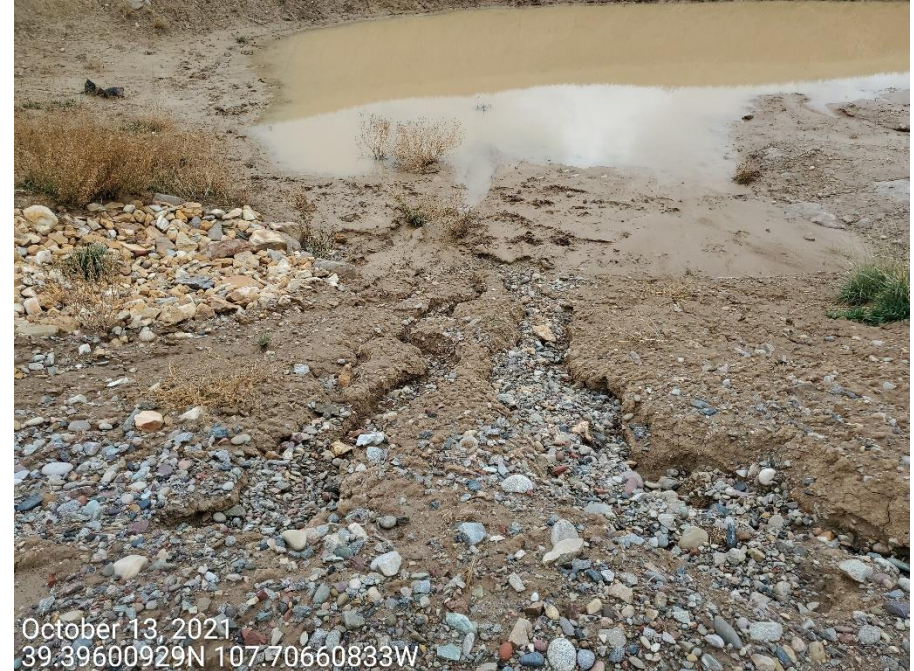
**Photo 3:** Photos taken from the sediment trap/pond on the south end of the Location. Photo shows control measures has not been not been constructed in accordance with good engineering practices or maintained in a proper functioning condition; BMP constructed with steep slopes with inadequate protection to prevent erosion degradation; BMP has not been constructed with an appropriate inlet; slopes around inlet and edge of pad insufficiently stabilize; erosion degradation evident.

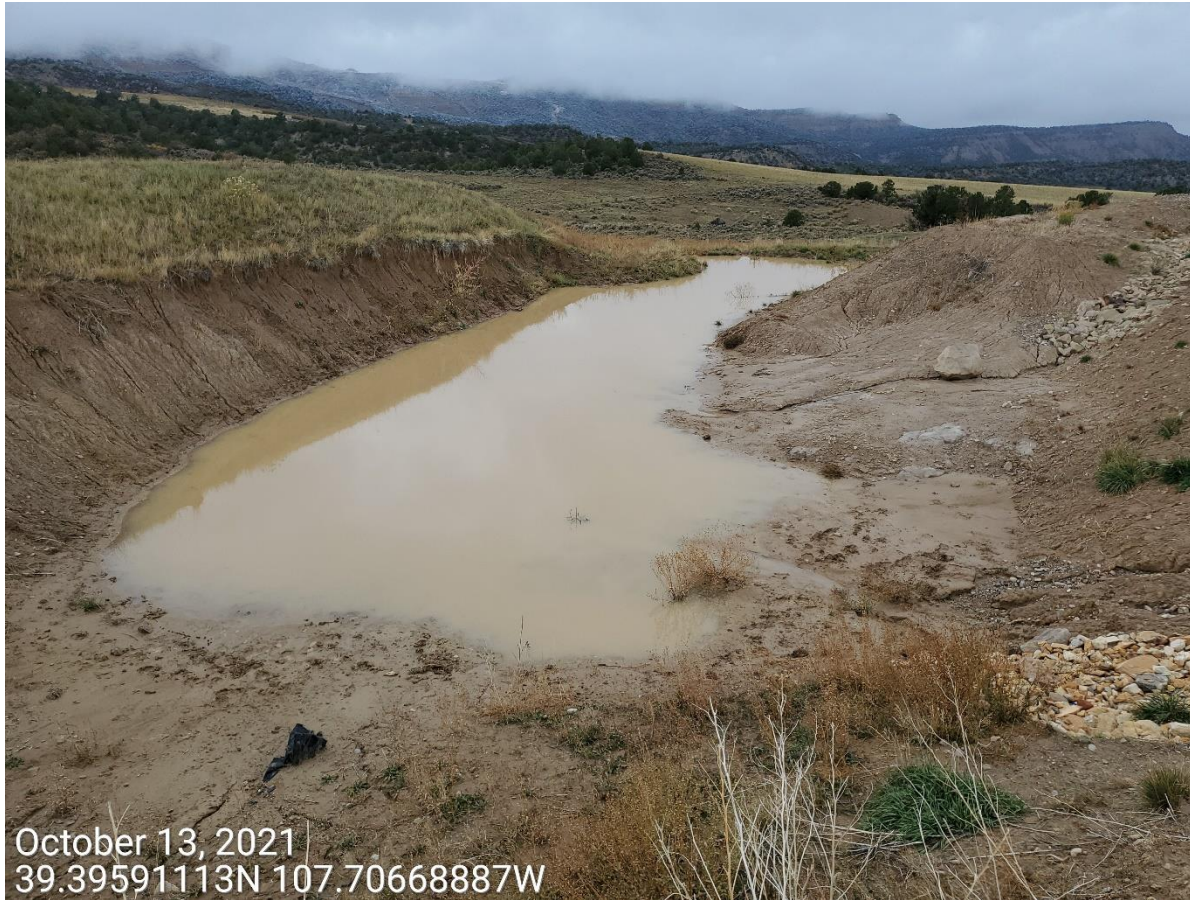
**Photo 4:** See comments under photo 3.

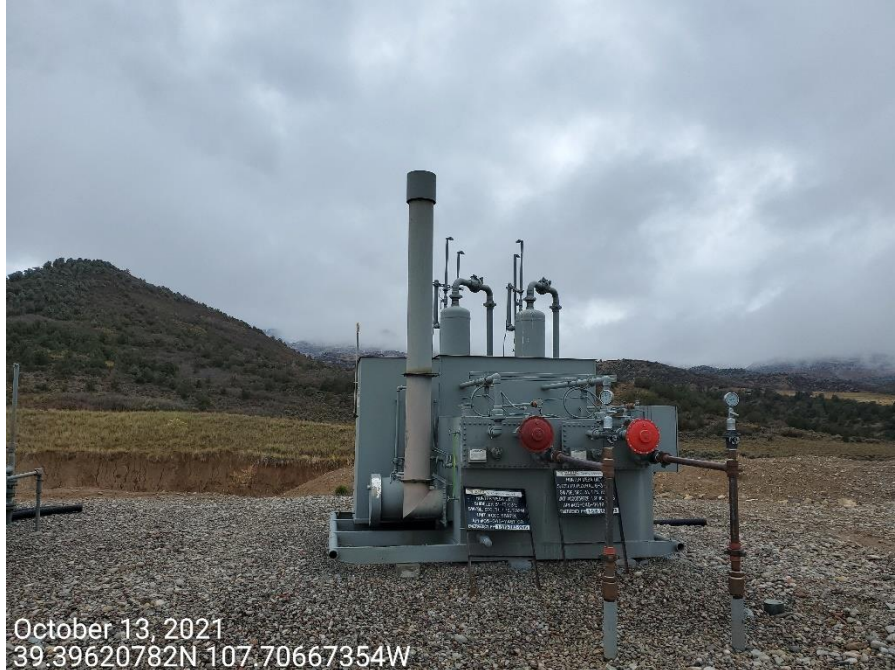
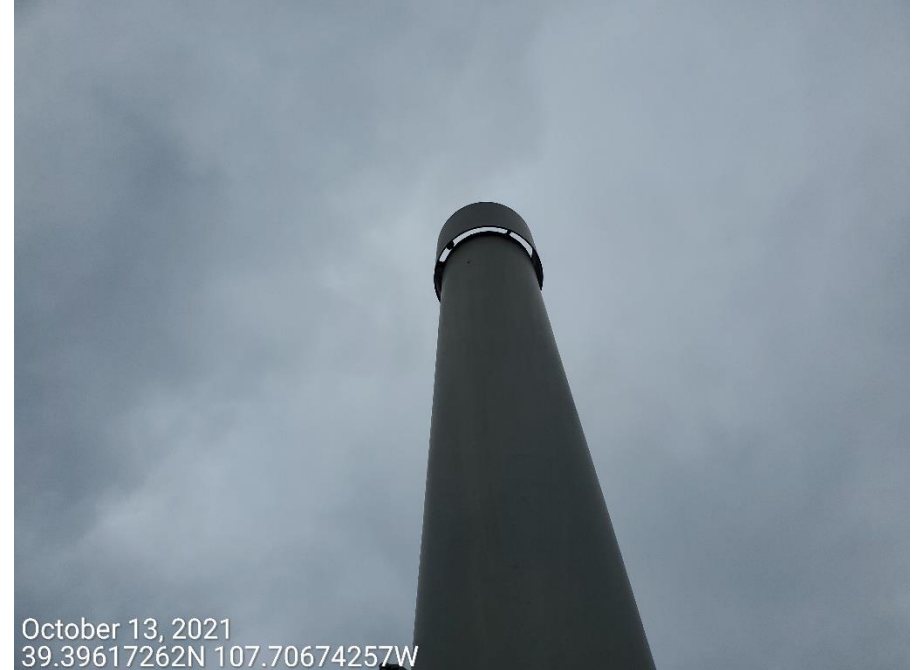
**Photo 5:** Photo shows bird protection devices are missing from the western separator unit on the Location.
