# Inspection Photos

Operator: TEP ROCKY MOUNTAIN LLC - 96850

Location ID: 336028

Garfield County, CO

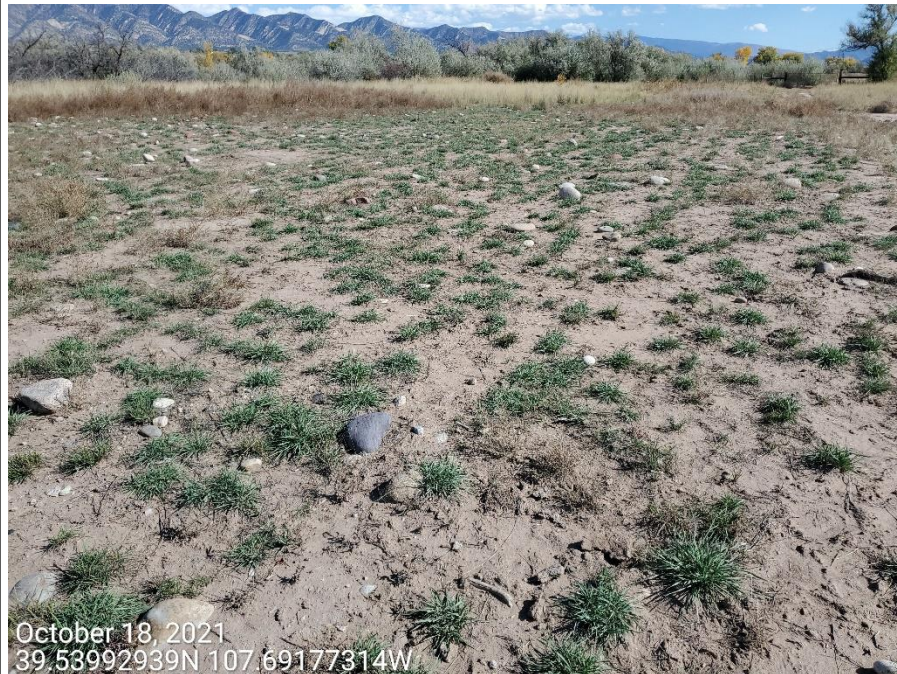
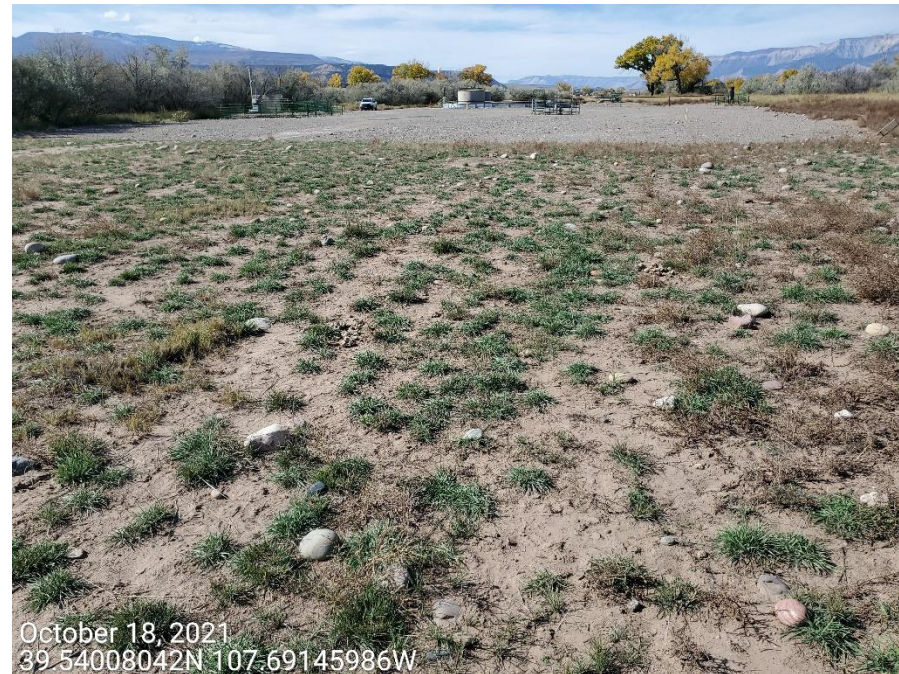
**Photo 1:** Photos taken from the interim areas on the east end of the Location. Reclamation in these areas appears to be progressing towards 1003 standards; grazing pressure and weed establishment evident and may be hindering reclamation.

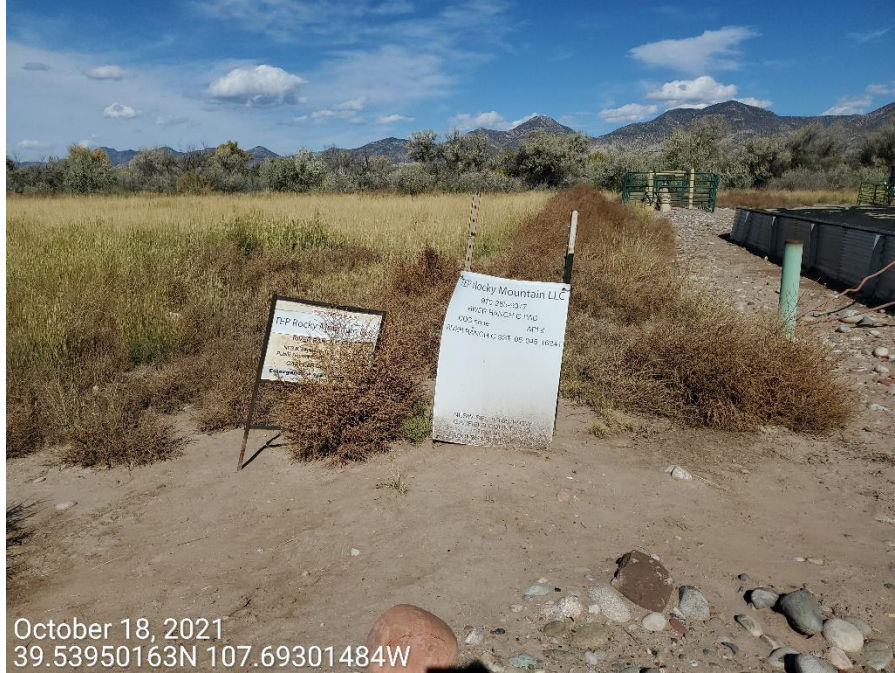
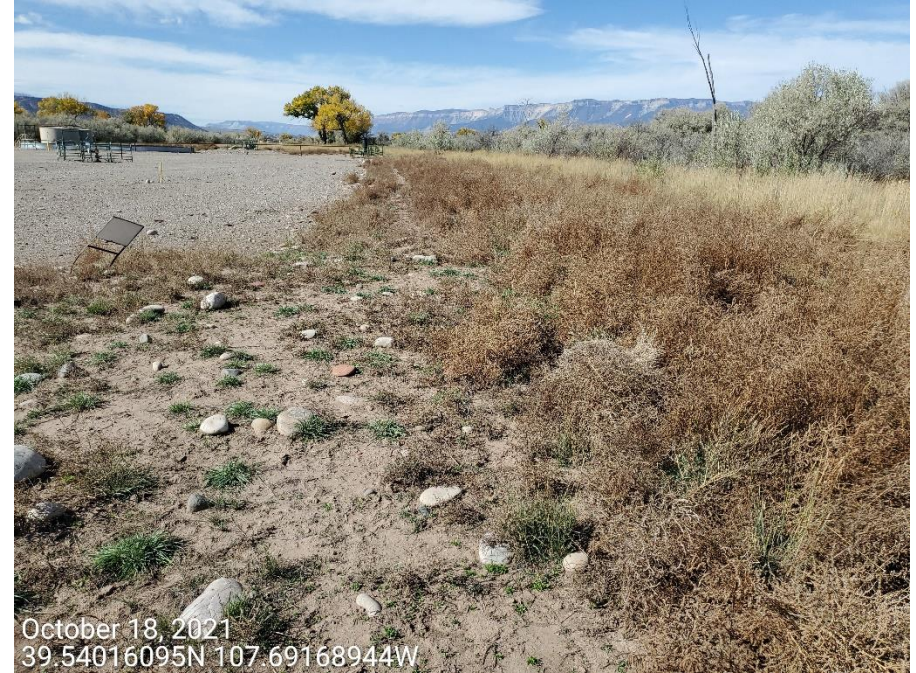
**Photo 2:** Photos taken from the western/northern perimeters of the Location. Photo shows Undesirable plant establishment observed on the Location. Weeds have died, will soon break off and is considered debris. Additional weed management required in the 2022 growing season to prevent establishment of undesirable plant species on the Location in accordance with Rule 606.c
