# Inspection Photos

Operator: TEP ROCKY MOUNTAIN LLC - 96850

Location ID: 336038

Garfield County, CO

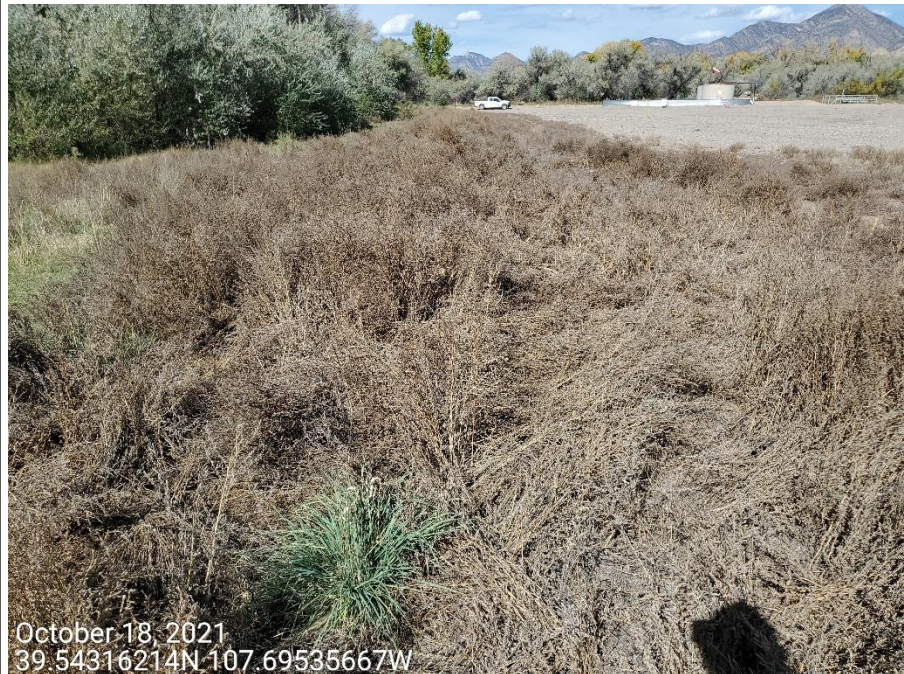
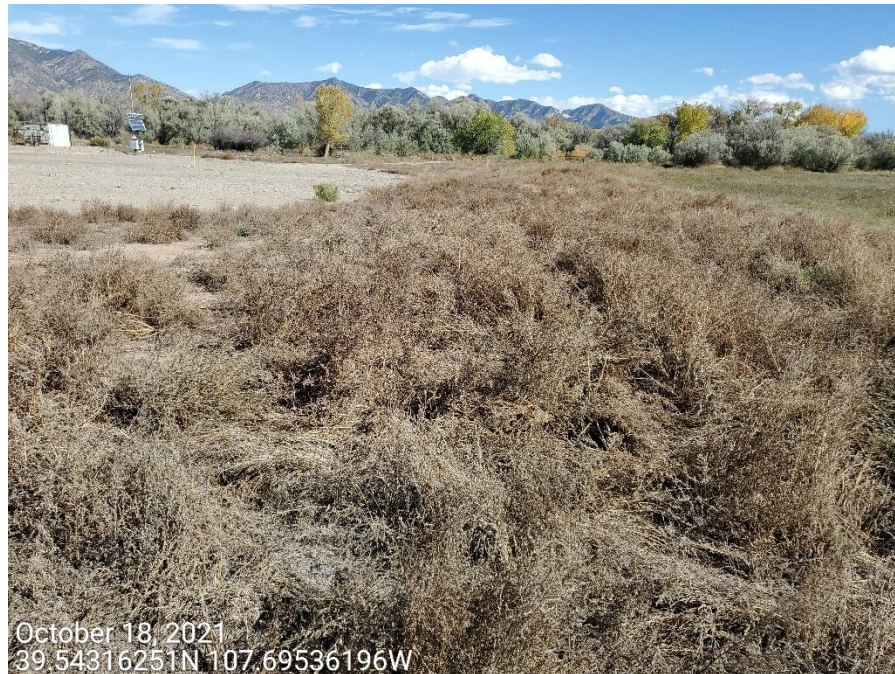
**Photo 1:** Photos taken from the interim areas of the Location. Photo shows interim areas are predominantly undesirable plant species; weeds appear to be hindering the reclamation as little to know desirable plant germination and establishment was observed.

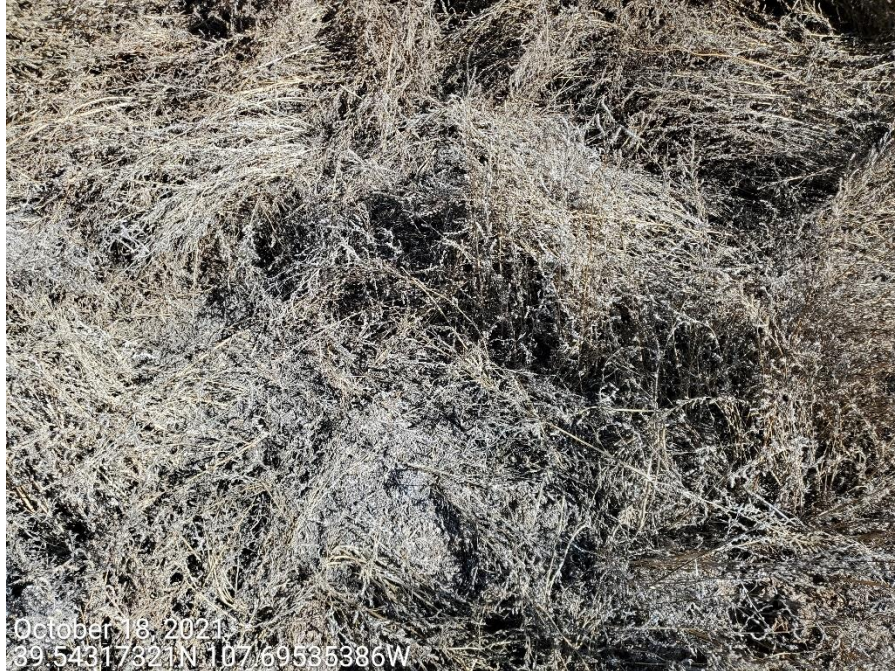
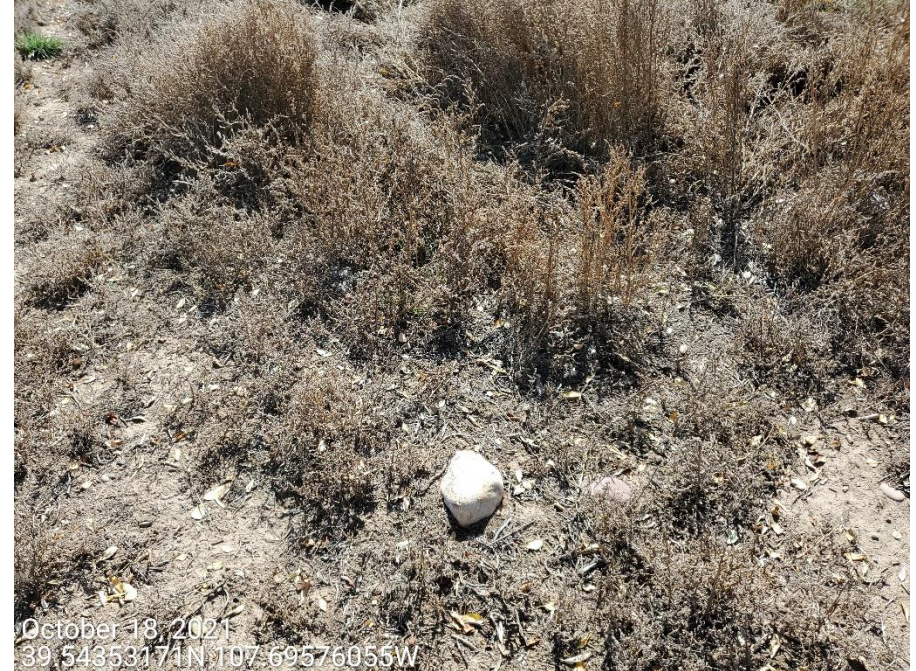
**Photo 2:** Photos taken from the interim areas of the Location. Photo shows interim areas are predominantly undesirable plant species; weeds appear to be hindering the reclamation as little to know desirable plant germination and establishment was observed.

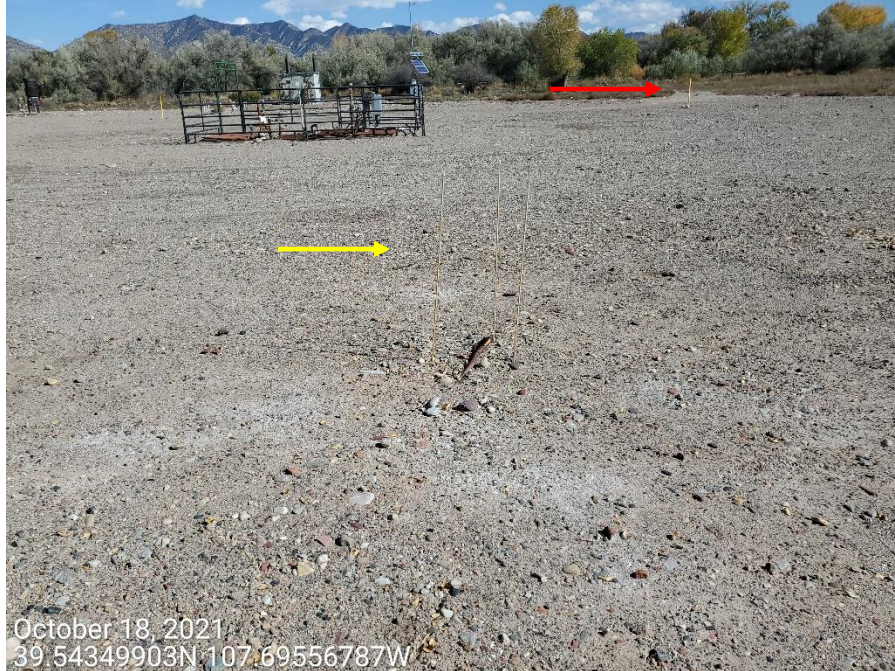
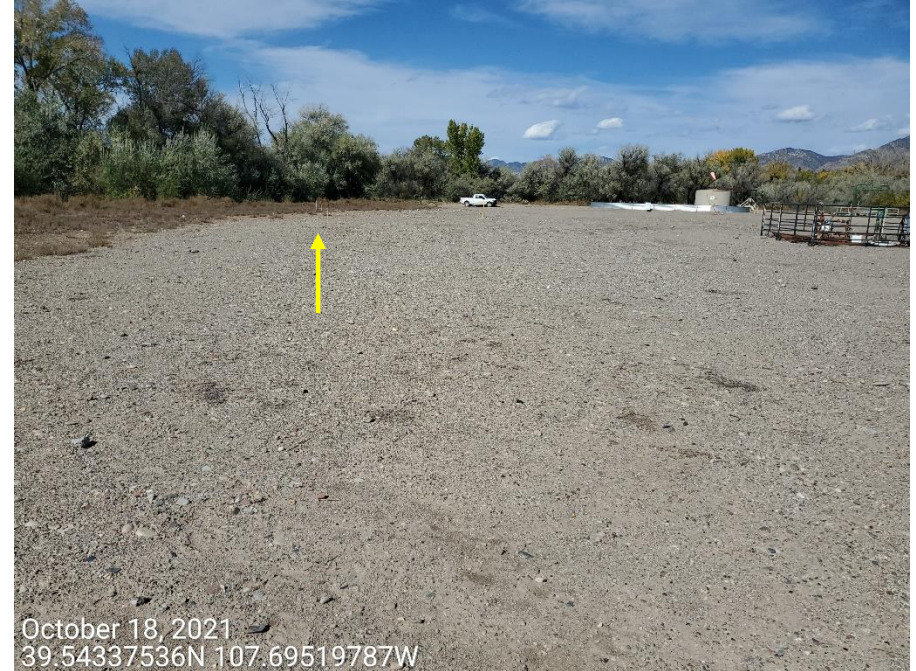
**Photo 3:** Photos show anchor on the west end of the Location without an appropriate visible marker that can be easily seen. Photo on the left taken ~6-8 feet from the marker (yellow arrow); photo also shows anchor on the east end of the Location (red) that has been appropriately marked and can be easily seen.
