Inspection Photos

10/18/2021

Operator: TEP ROCKY MOUNTAIN LLC - 96850

Location ID: 436004

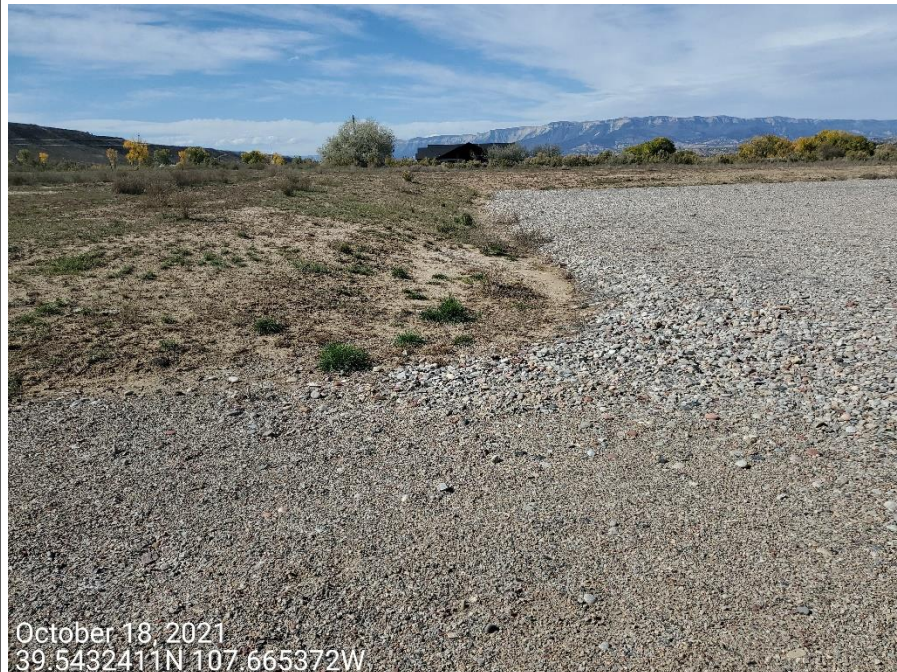
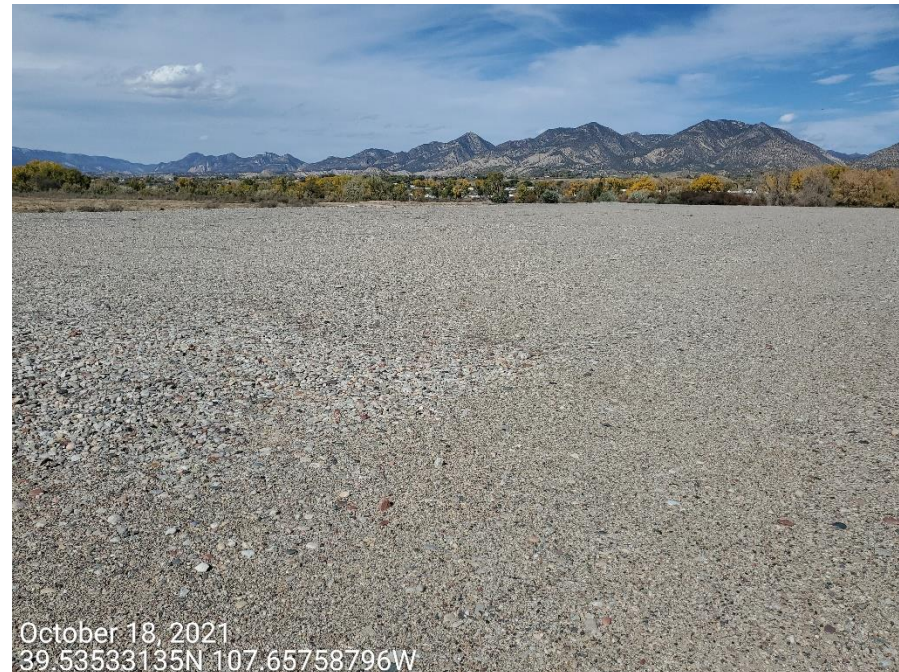
Photo 1: Photos 1-2 taken from the north end of the Location. Photos provide overview of site from west, northwest, northeast to east. Location has been constructed, however drilling operations have not commenced.

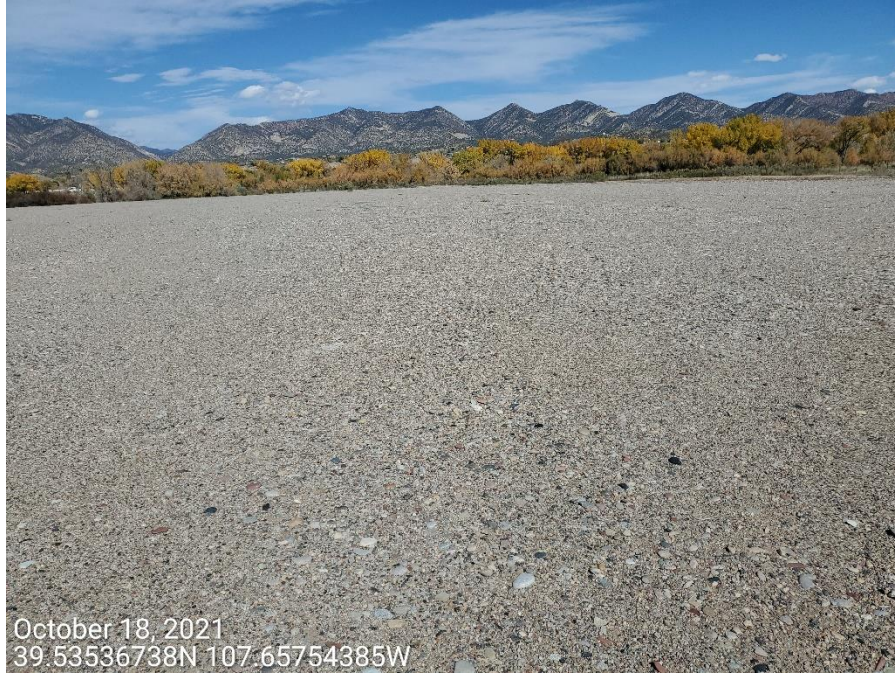
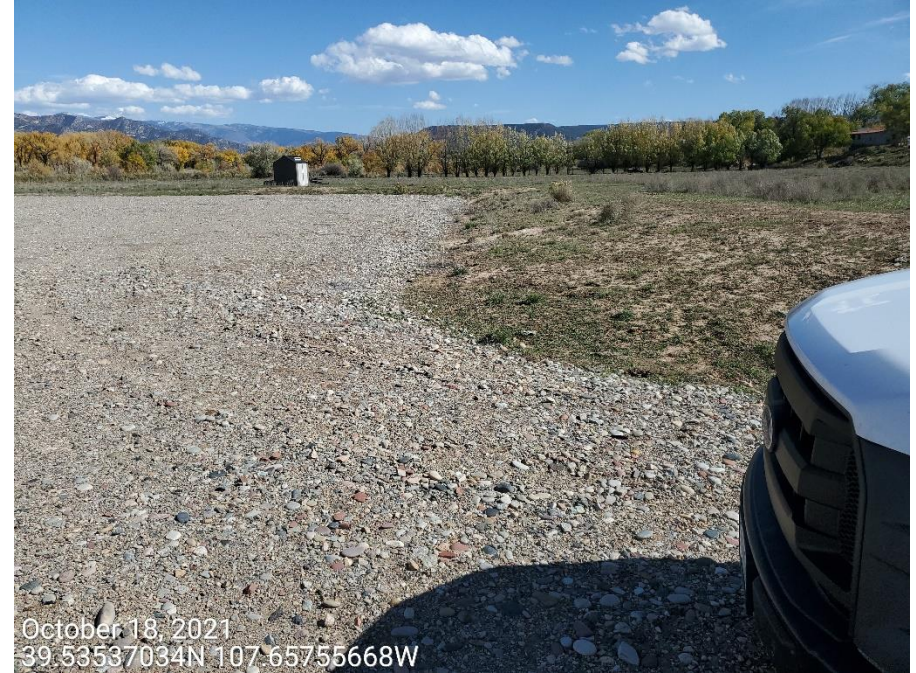
Photo 2: See comments under photo 1.

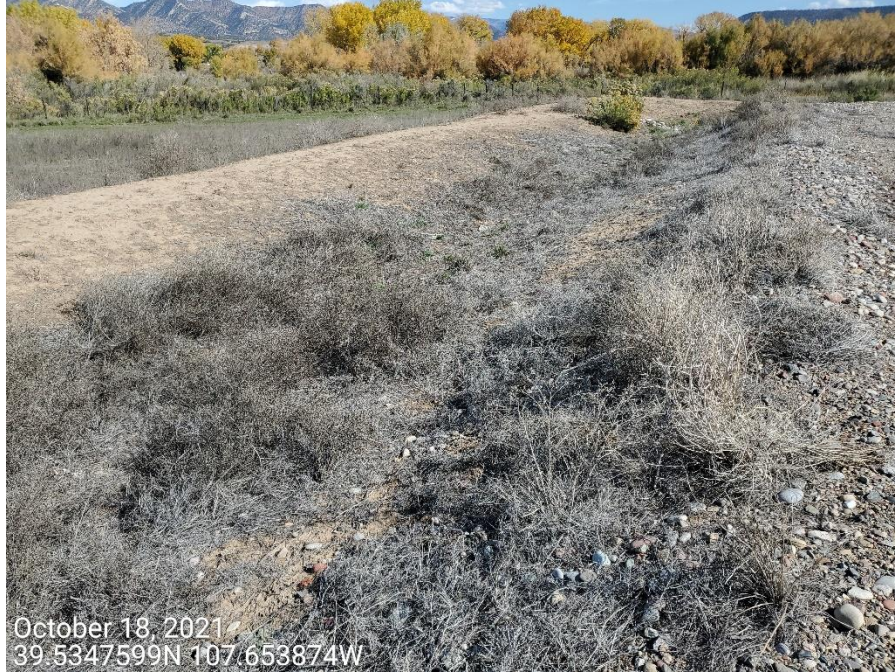
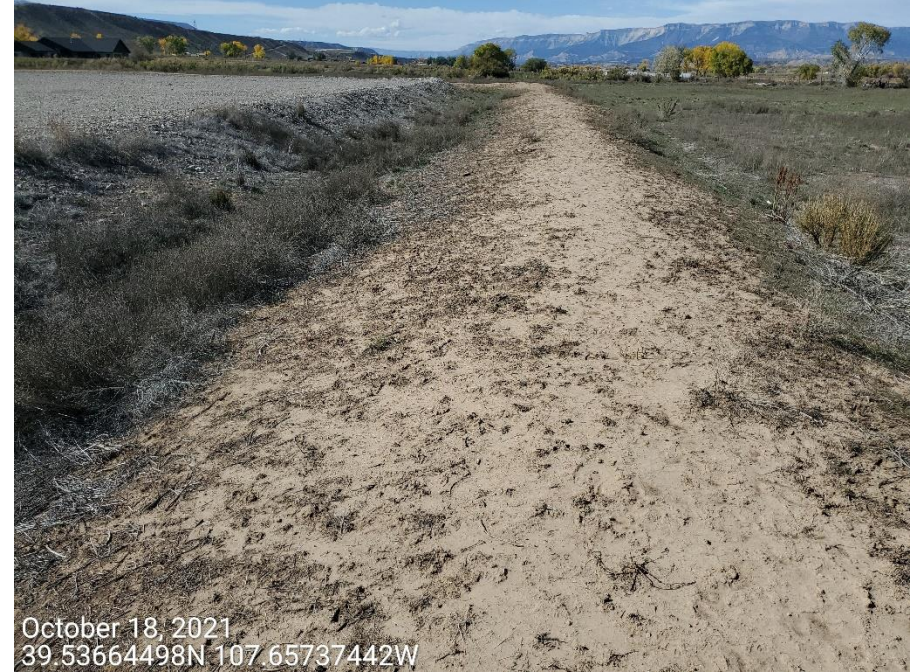
Photo 3: Photos taken from the soil stockpiles of the Location. Photos provide examples showing that BMPs to protect the stockpiled soils from degradation, and to prevent weed establishment are missing or insufficient; soil stockpiles predominantly bare and exposed soils, or vegetated by undesirable and noxious plant species such as Knapweed, Salsola sp., and Kochia sp.

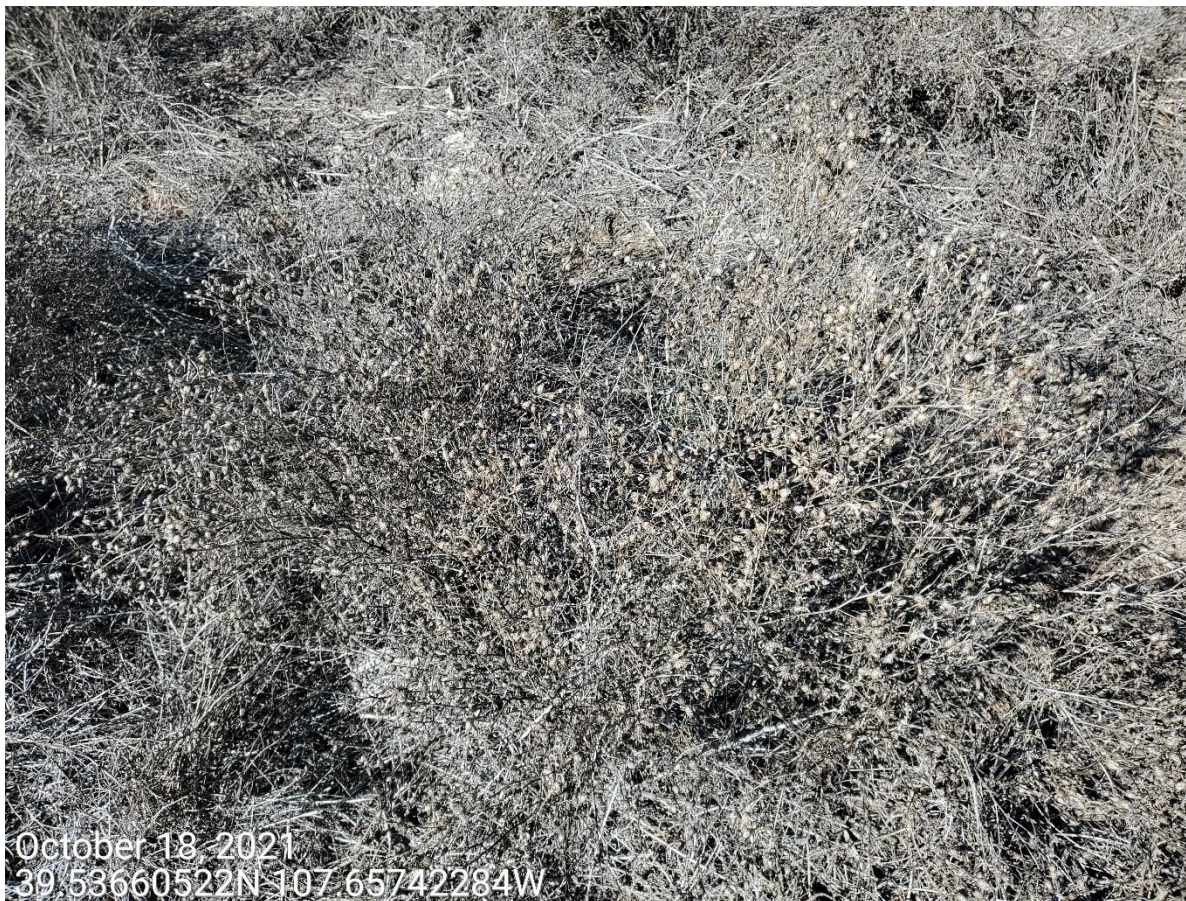
Photo 4: Continued from photo 3. Photo shows undesirable and noxious plant establishment on the Location and soil stockpiles. Weeds have died and are considered debris; additional weed management to keep Location free of Undesirable Plant species required in the 2022 growing season.
