# Inspection Photos

Operator: TEP ROCKY MOUNTAIN LLC - 96850

Location ID: 335537

Garfield County, CO

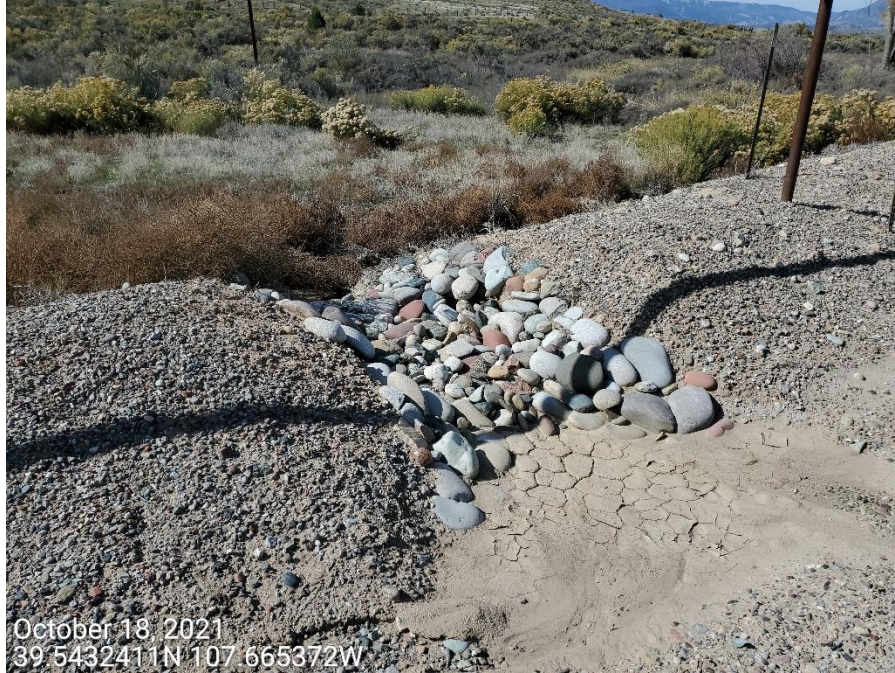
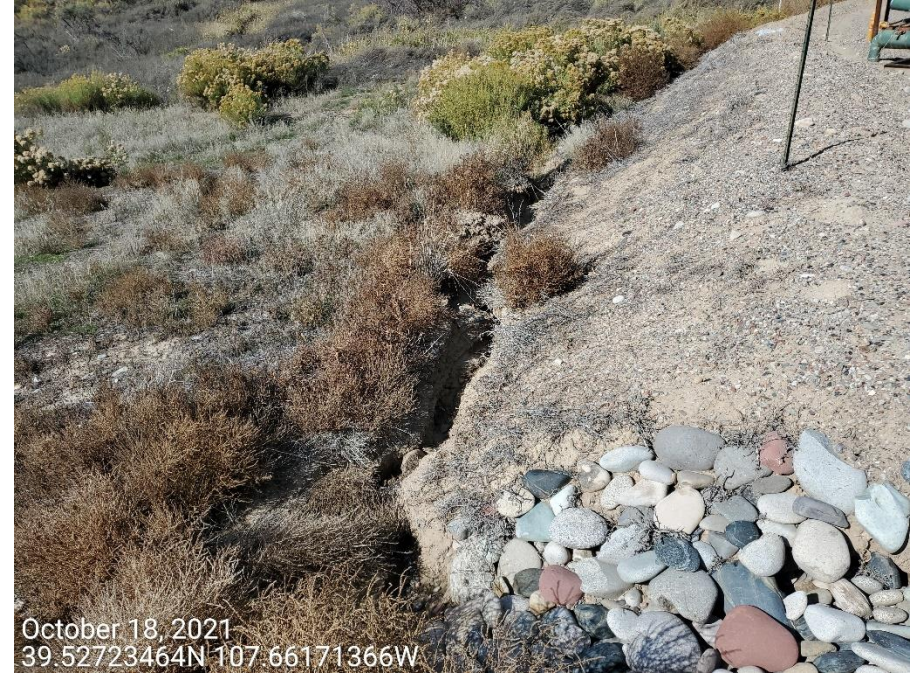
**Photo 1:** Photos taken from the west end of the Location. Photo shows outlet has not been constructed in accordance with good engineering practices to allow for proper stormwater discharge from the Location. Erosion degradation at outlet evident; stormwater discharge causing degradation and sediment deposition on offsite areas.

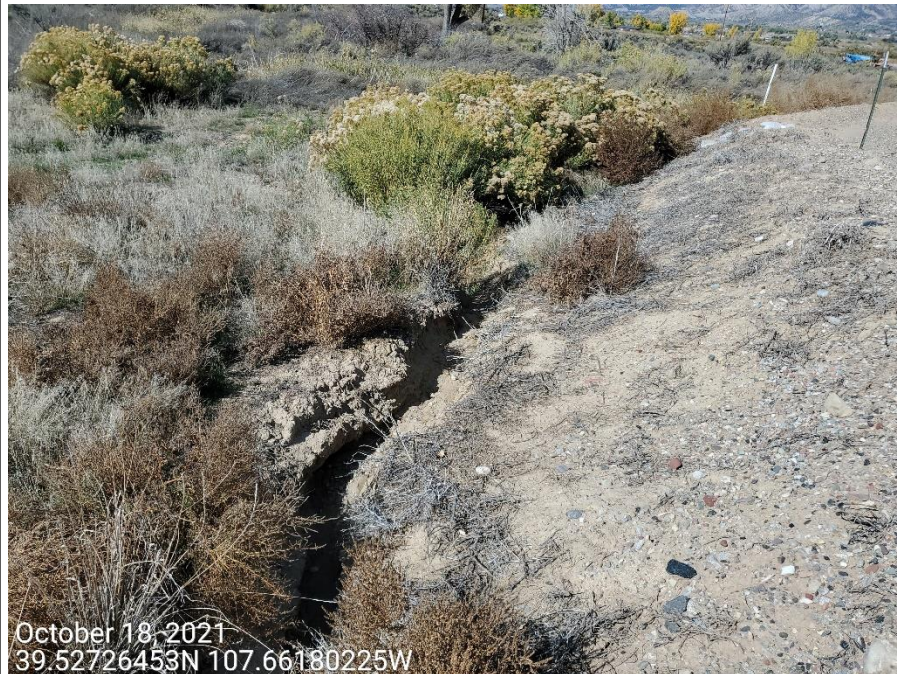
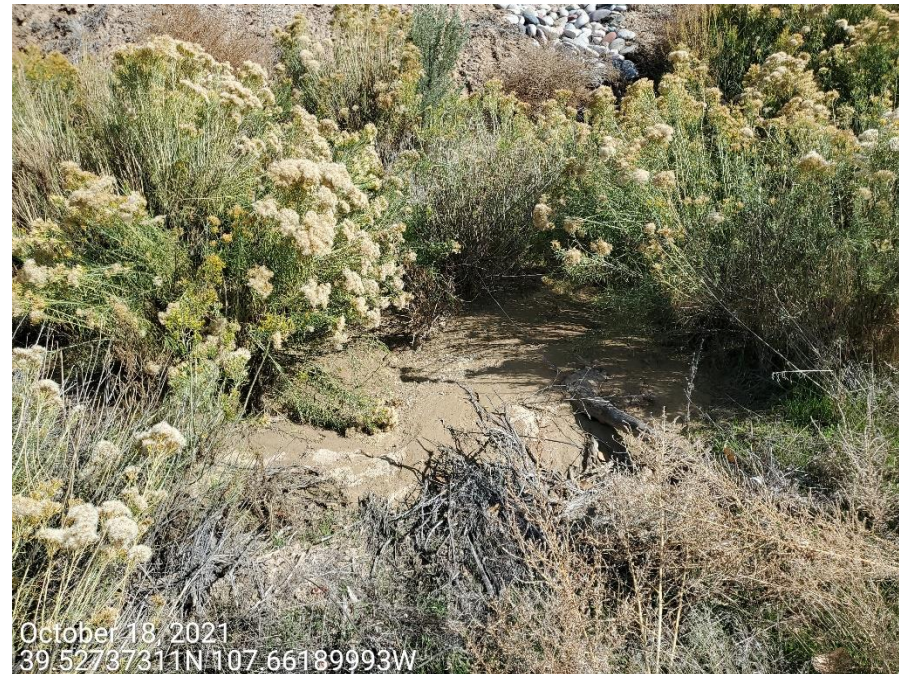
**Photo 2:** Photo shows erosion degradation and sediment deposition occurring offsite due to improper stormwater discharge from the Location.

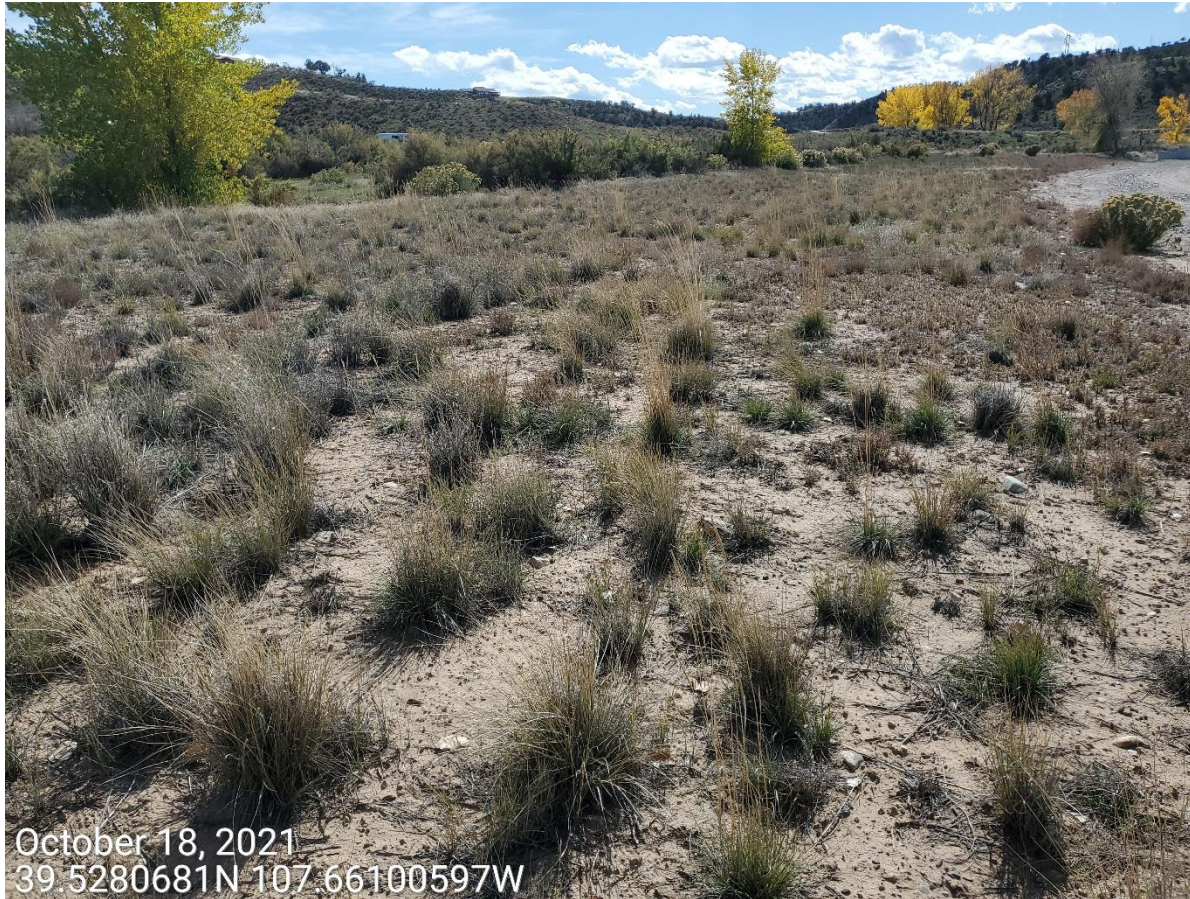
**Photo 3:** Photo provides example of interim areas; interim areas are progressing towards 1003 standards.

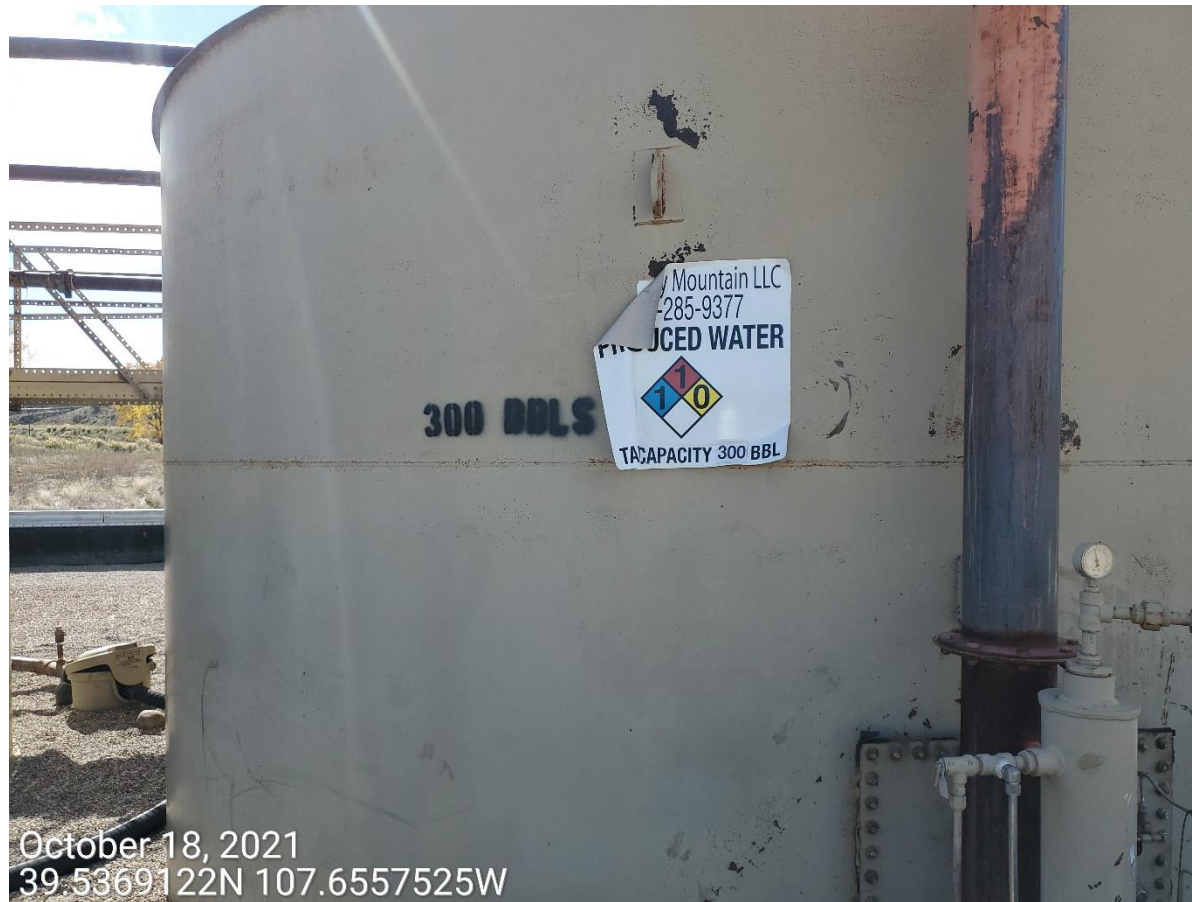
**Photo 4:** Photo shows peeling label at the tank
