Inspection Photos

Operator: TEP ROCKY MOUNTAIN LLC - 96850

Location ID: 335541

Garfield County, CO

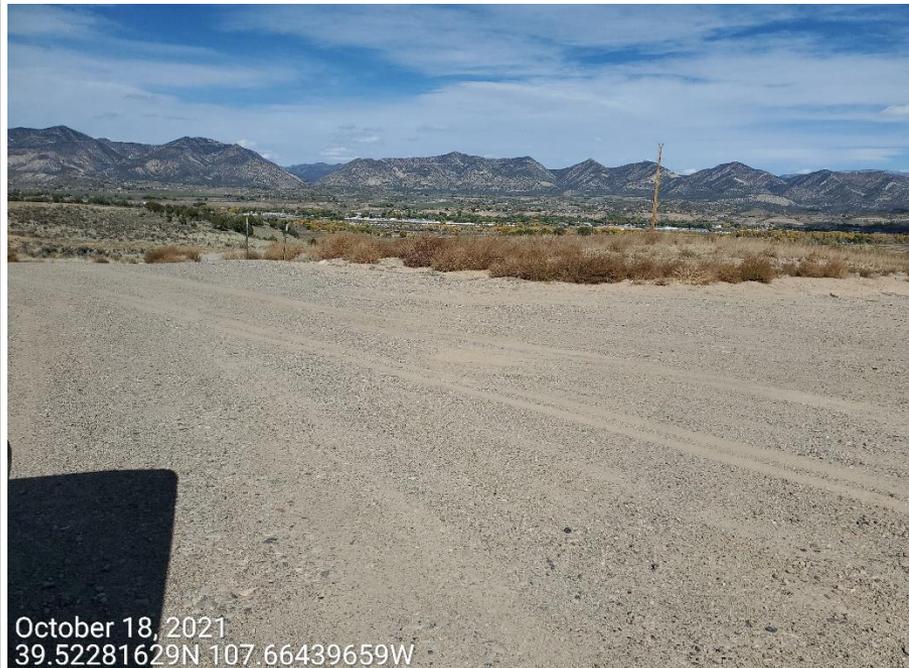
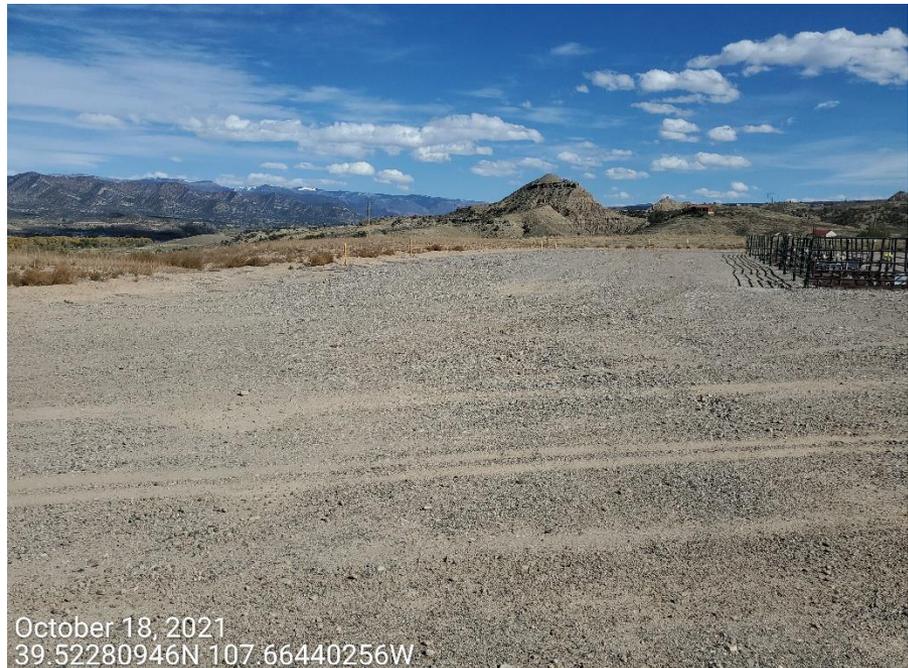
Photo 1: Photos 1-2 provide an overview from the west end of the Location facing north, northeast, southeast to southwest.

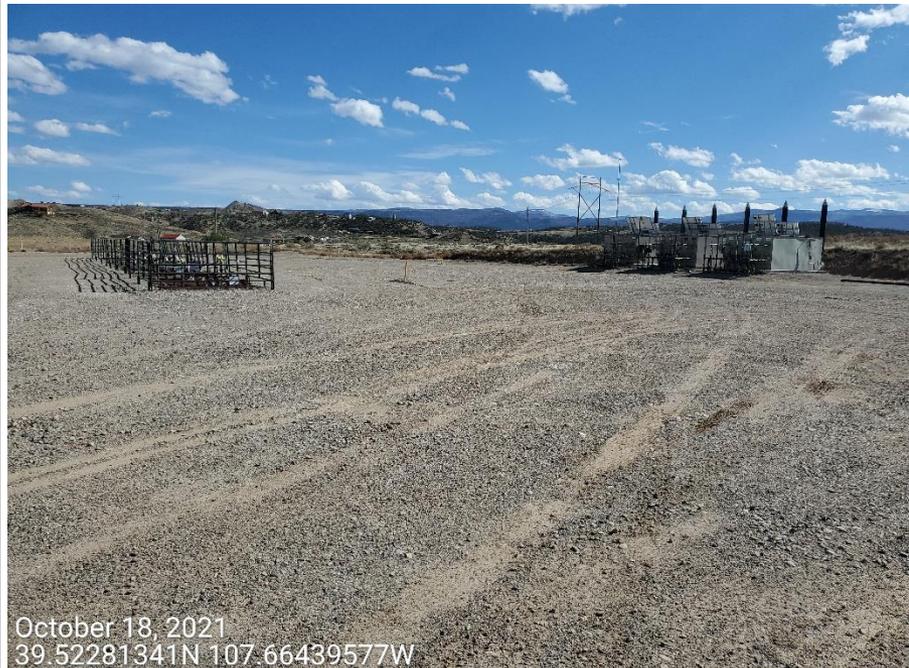
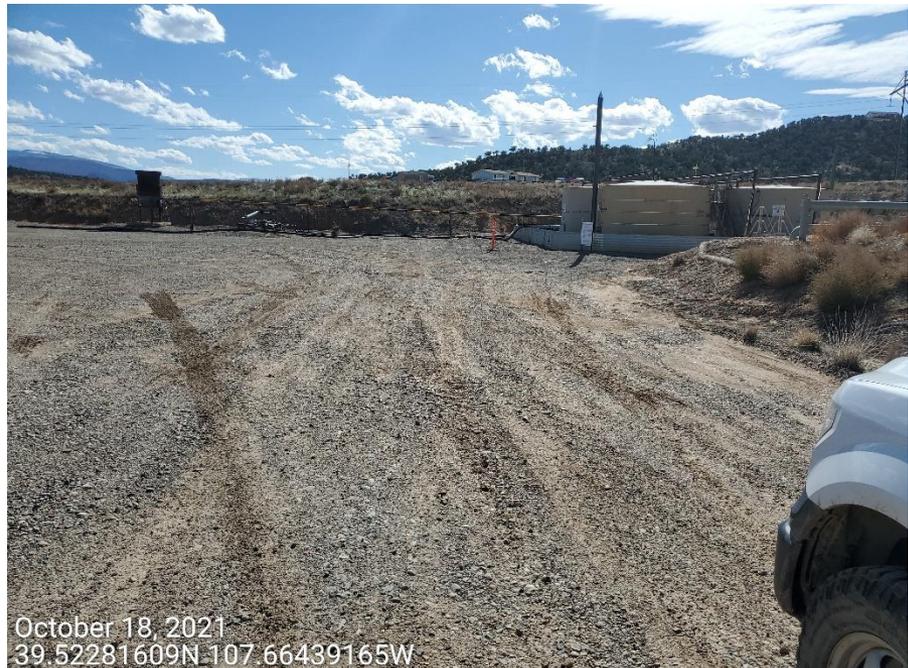
Photo 2: See comments under photo 1.

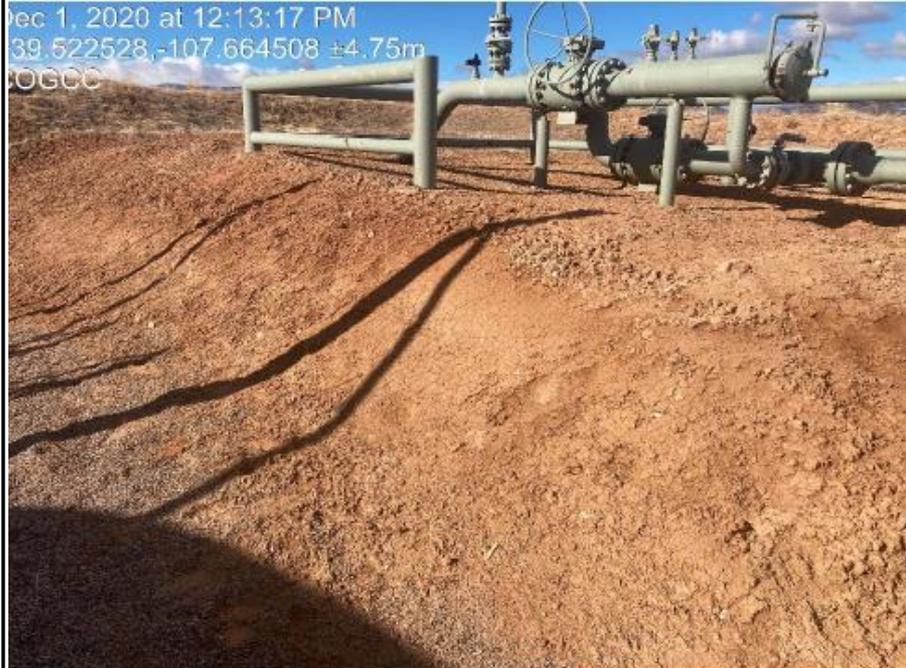
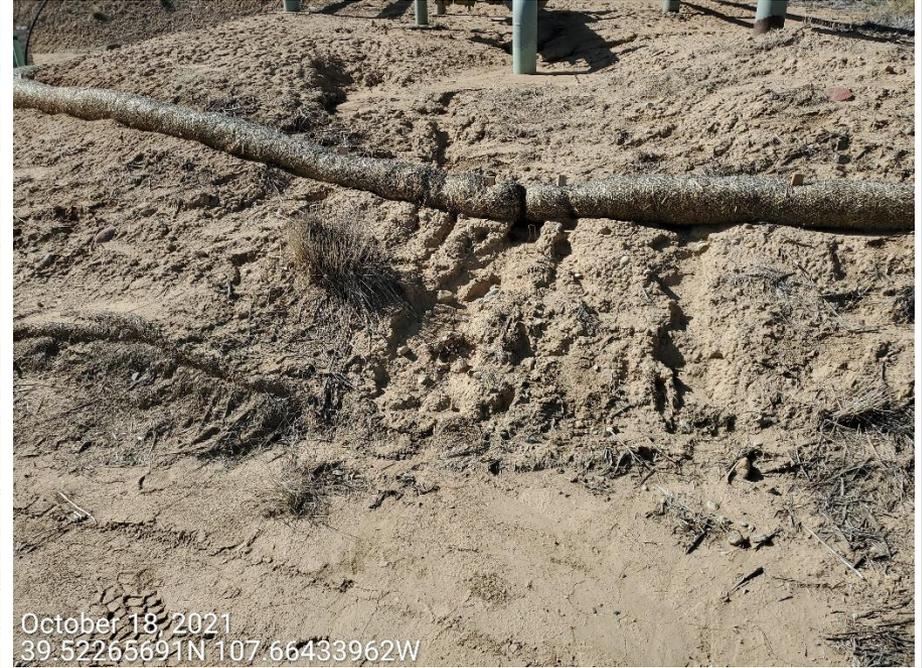
Photo 3: Photos taken from the slopes on the west end of the Location. Photo on the left taken from the 12/1/2020 inspection report that required BMPs on the slopes. Photo right shows Operator installed a single wattle on the slope; BMP has not been installed or maintained per good engineering practices; BMPs to protect and stabilize slopes remain missing or insufficient/inadequate.

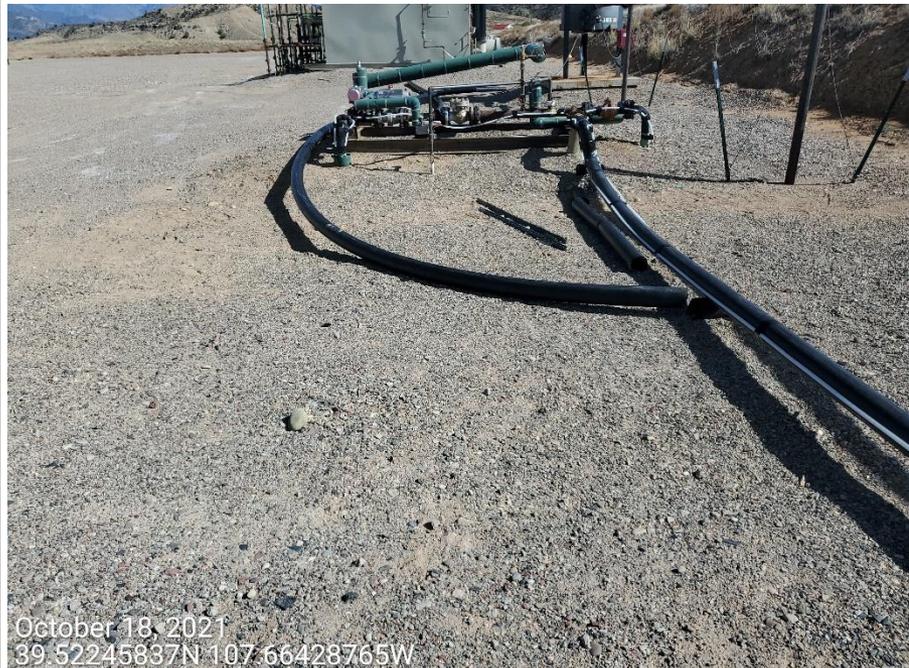
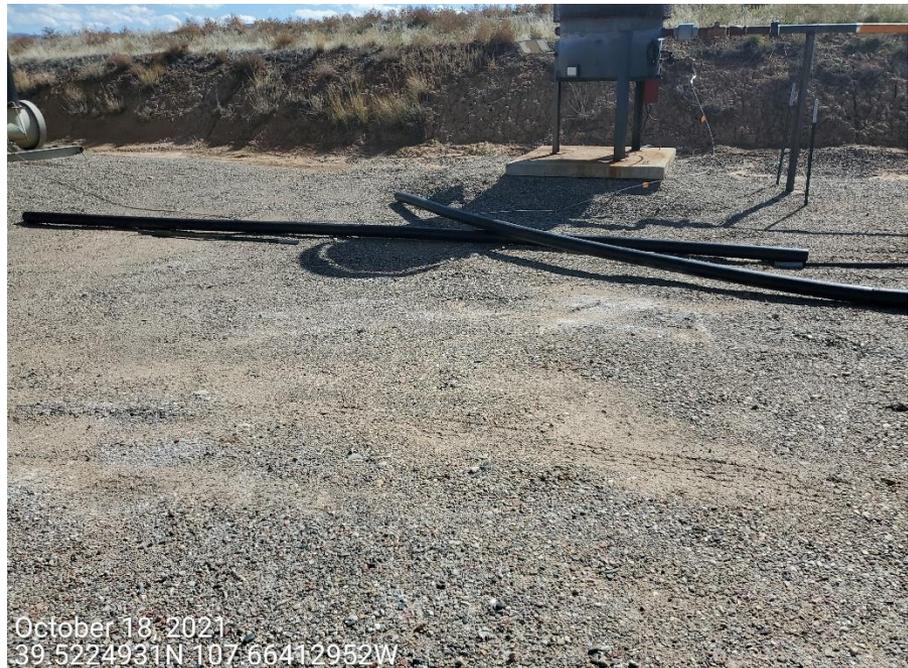
Photo 4: Photos show unused tube/pipe equipment stored on the south end of the Location.

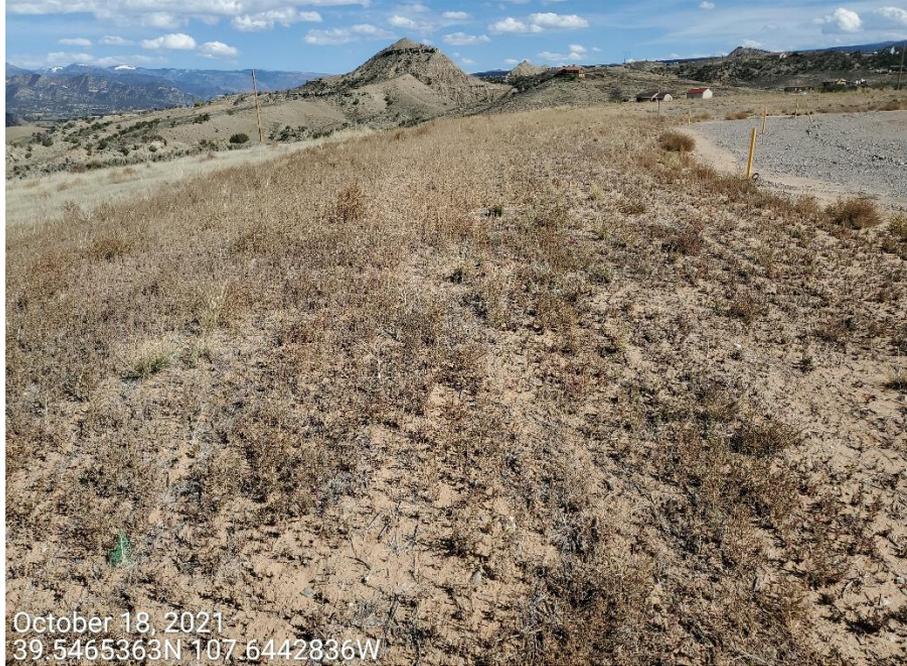
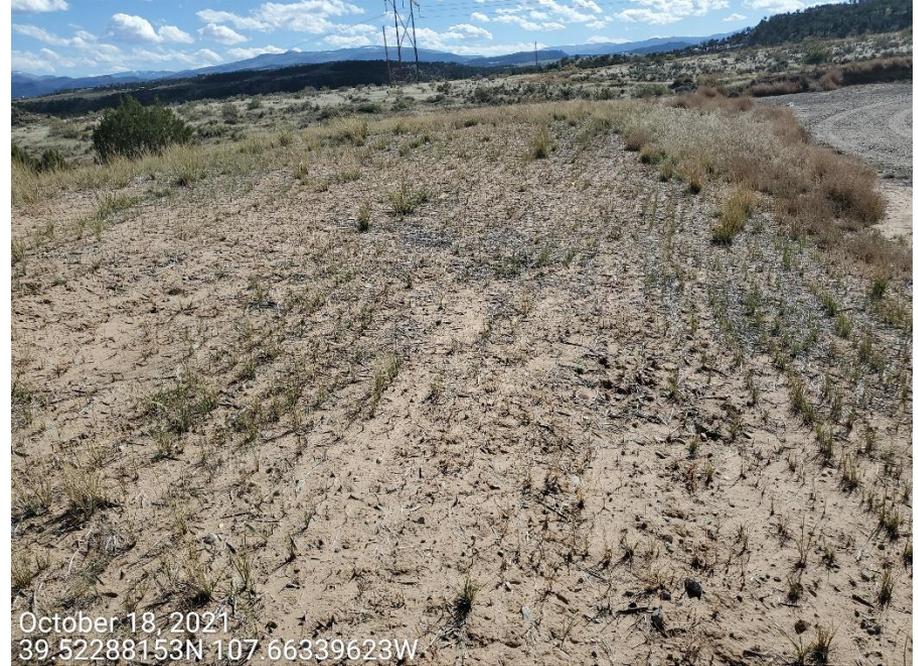
Photo 5: Photos taken from the interim areas of the Location. Photo left shows example of areas where desirable plant germination/establishment is not observed. Photo right shows examples of areas where desirable plant germination/establishment was observed, though uniform establishment is not progressing towards 1003 standards.

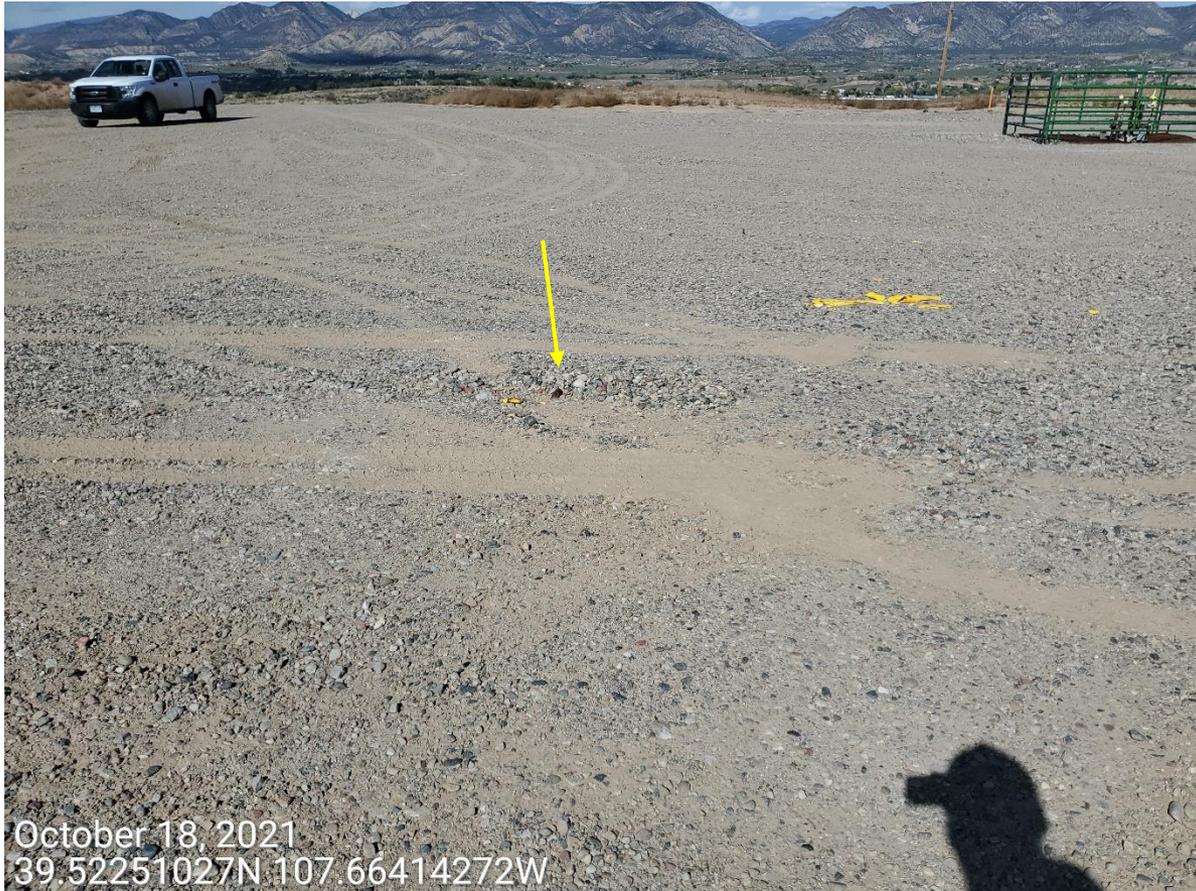
Photo 6: Photo shows example of anchors observed that have not been properly marked, or markers are in disrepair. Marker maintenance is an ongoing issue that has been documented in previous inspections; markers appear to be frequently traveled over by vehicle equipment.
