Inspection Photos

10/18/2021

Operator: TEP ROCKY MOUNTAIN LLC - 96850

Location ID: 335534

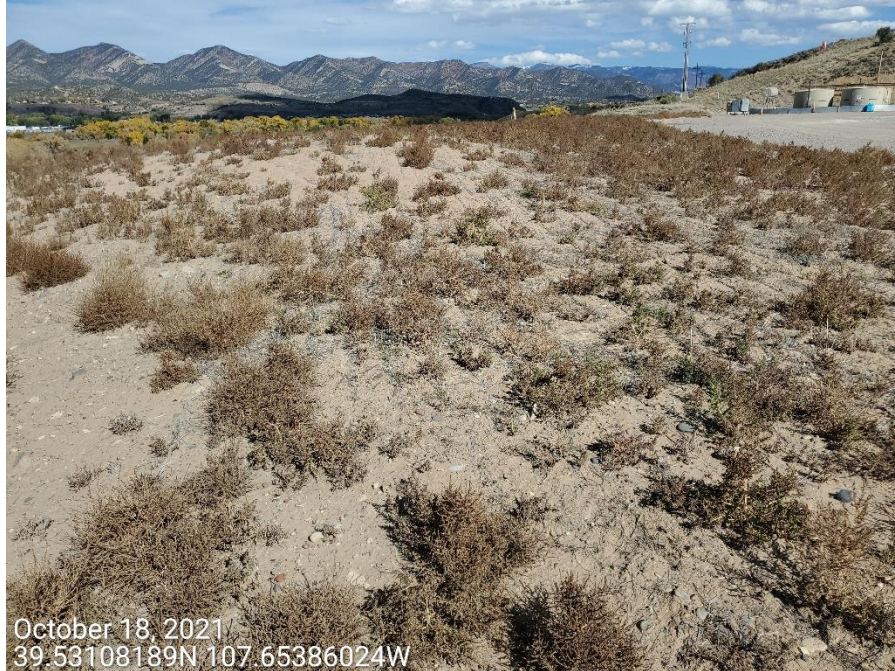
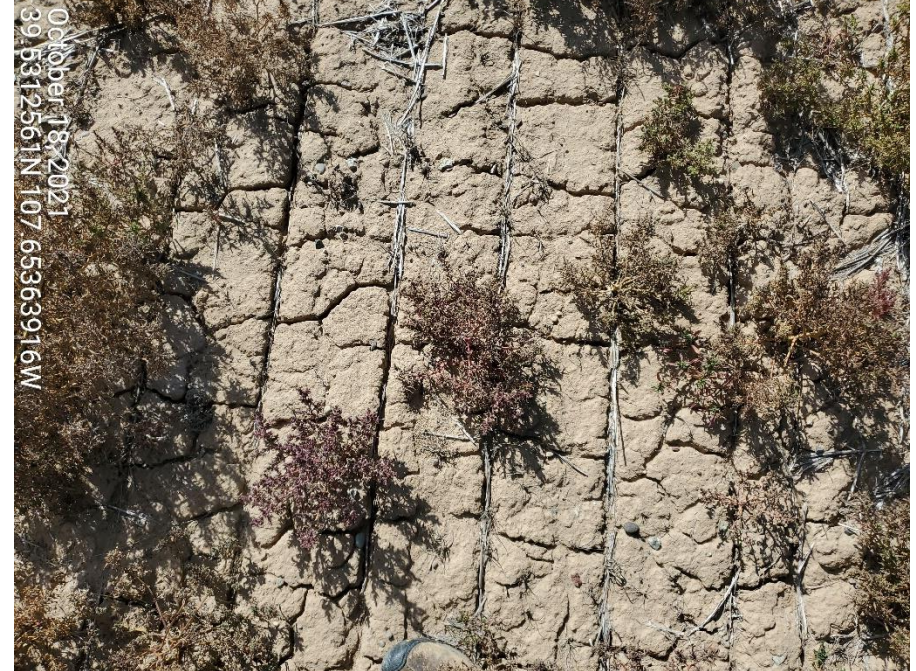
Photo 1: Photos provide example of the interim areas of the Location. Interim reclamation is not progressing towards 1003 standards; vegetation on the Location predominantly Undesirable Plant Species such as *Salsola* sp., *Kochia* sp., and knapweed. Little to no desirable plant germination and establishment observed.

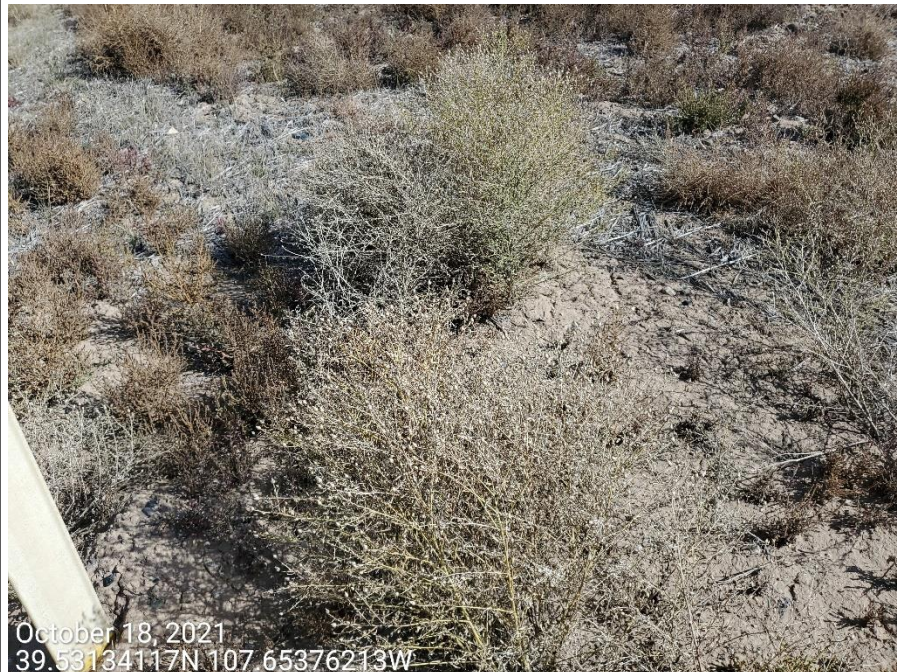
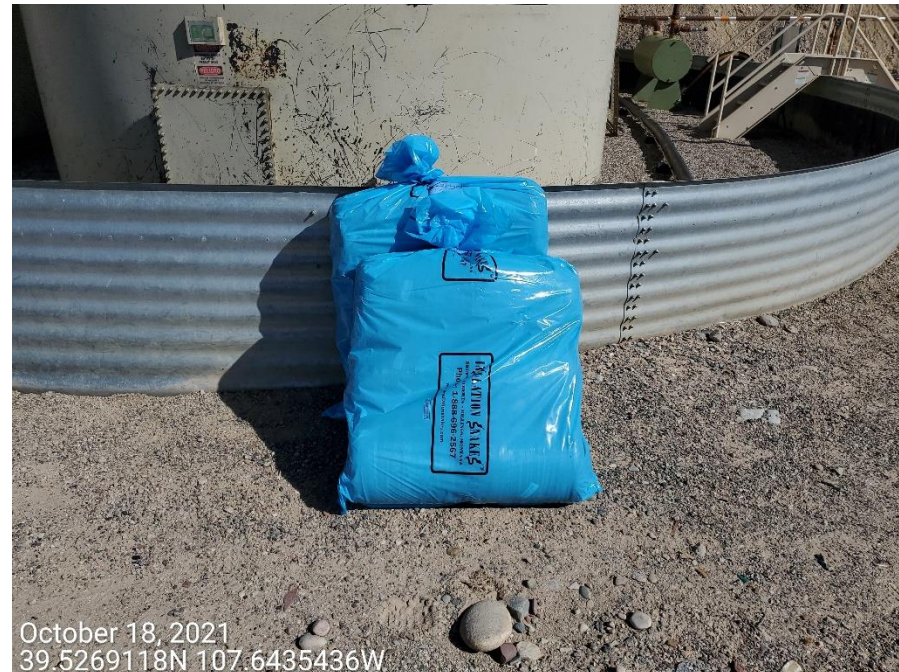
Photo 2: Photo left shows example of knapweed observed on the Location. Photo right shows unused “insulation snakes” observed stored on the Locaiton.

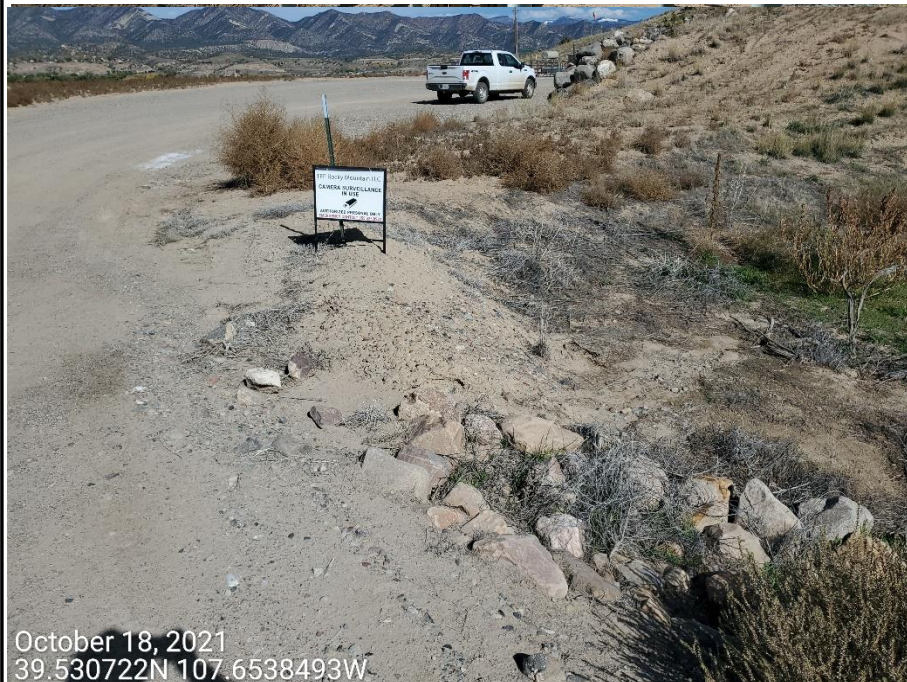
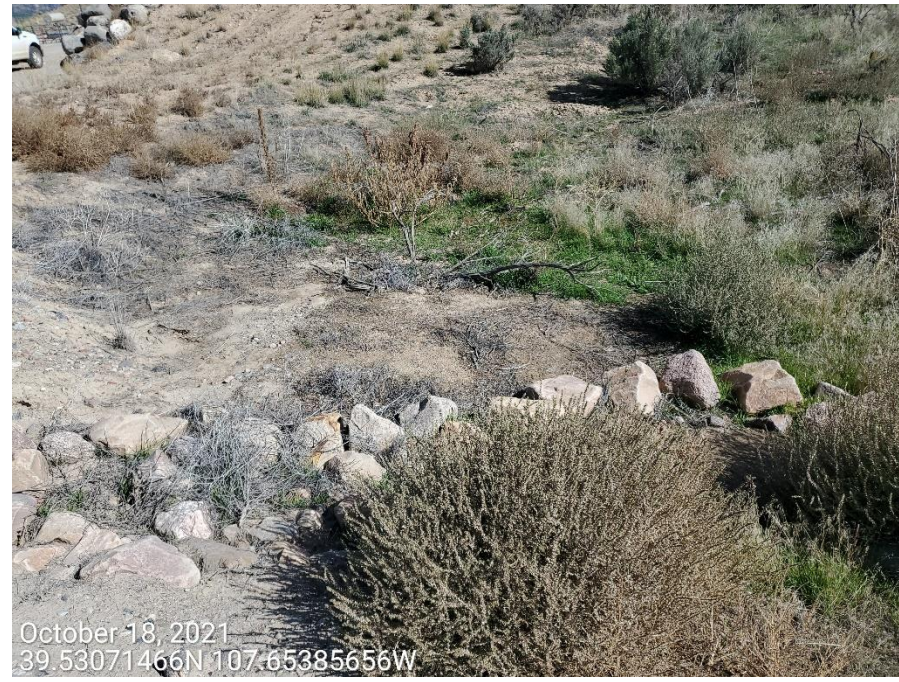
Photo 3: Photos taken from the Location entrance. Photo shows stormwater runoff from the Location resulting in sediment transport and deposition.

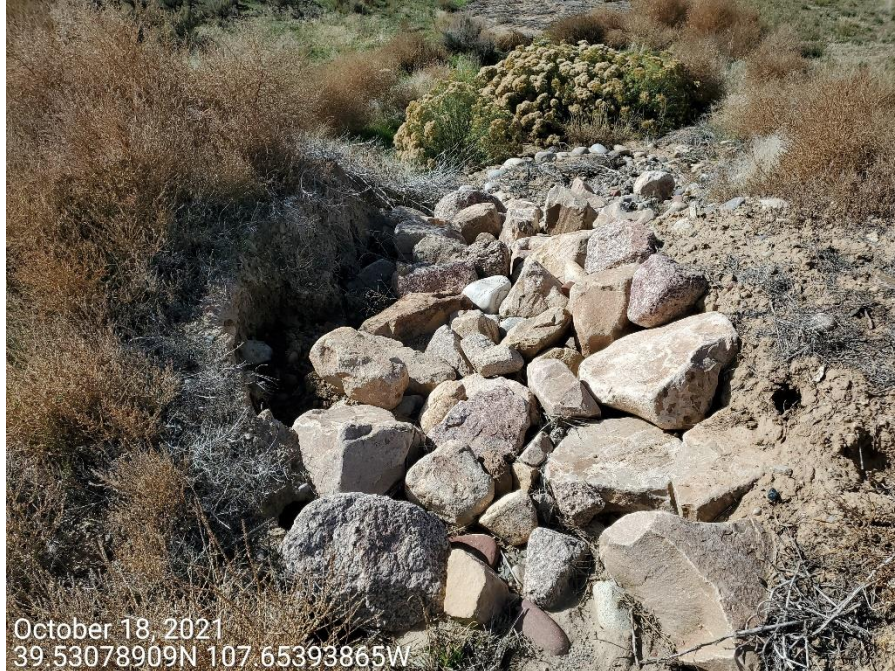
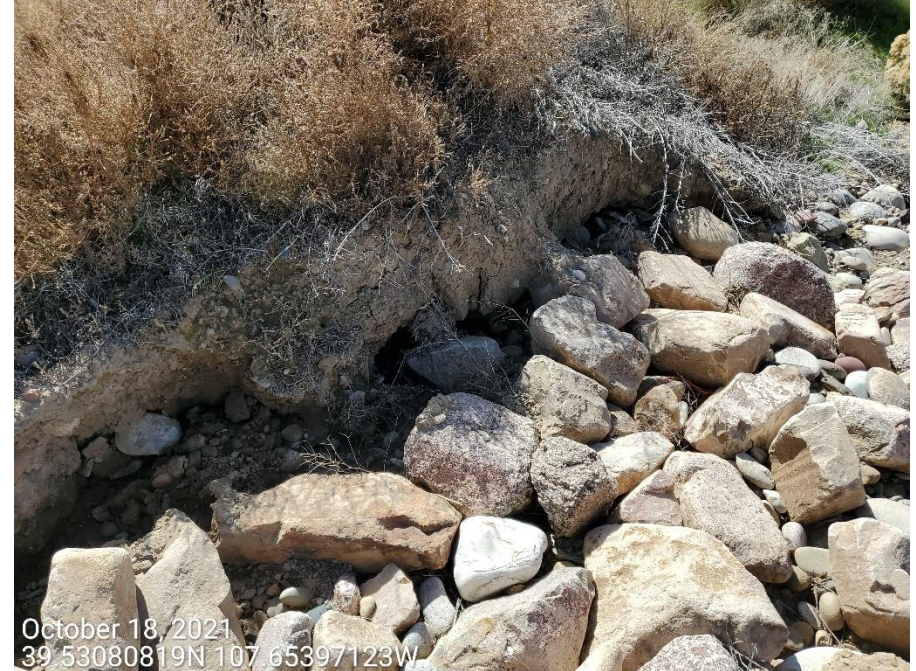
Photo 4: Photos taken from the outlet on the west end of the Location. Outlet has not been constructed in accordance with good engineering practices; use of geotextile under rip-rap not observed; stormwater runoff has resulted in degradation to both the BMP and offsite areas west of the Location.

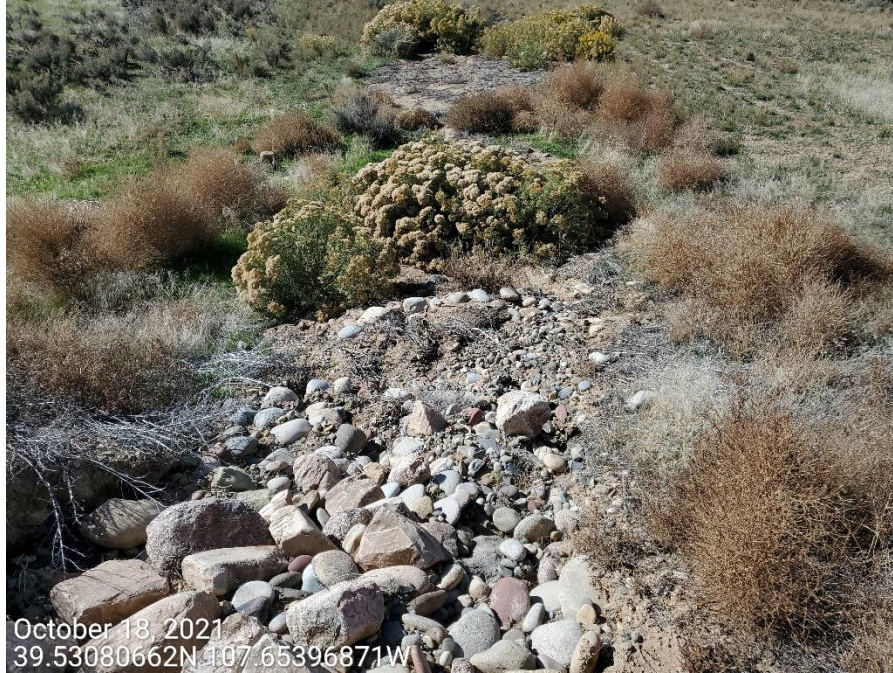
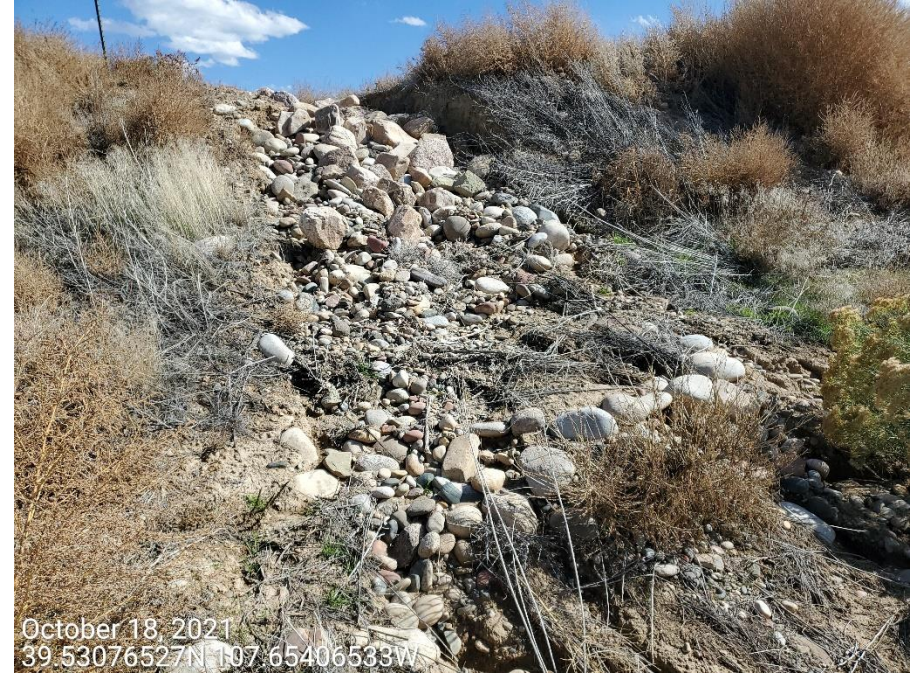
Photo 5: Continued from photo 5. Photo shows outlet control has not been installed in accordance with good engineering practices, or maintained in proper functioning condition. Stormwater runoff has resulted in degradation to both the BMP and offsite areas west of the Location

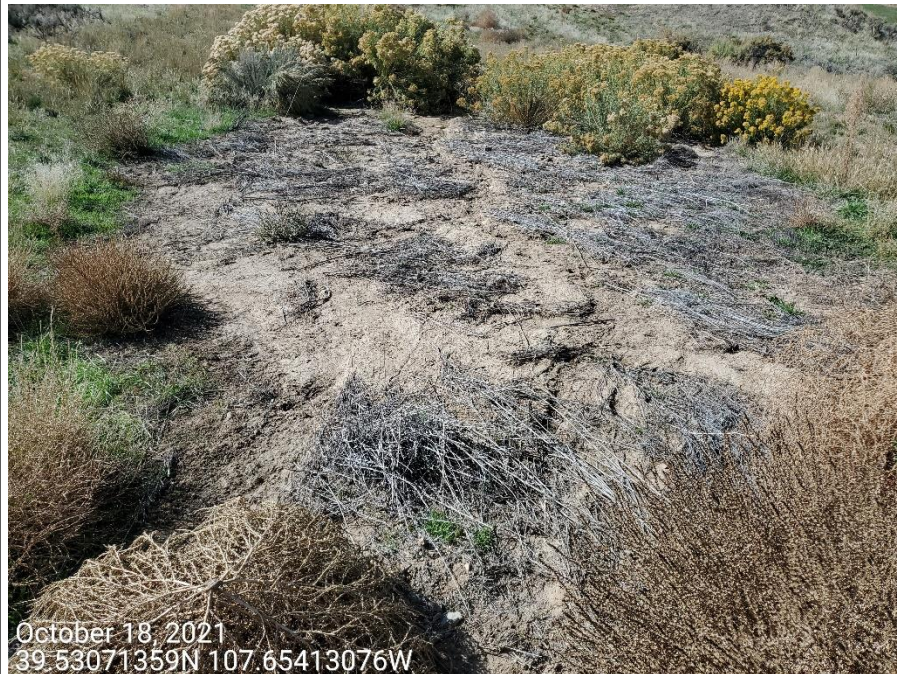
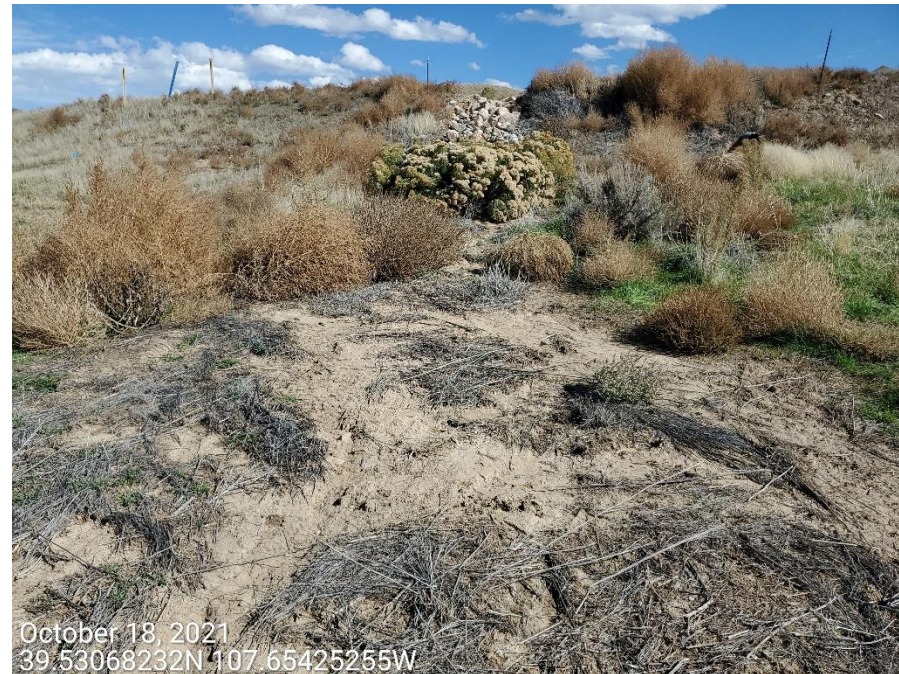
Photo 6: Photo shows areas west of the location where stormwater runoff from the location has resulted in offsite sediment deposition and surface degradation. Areas require reclamation.

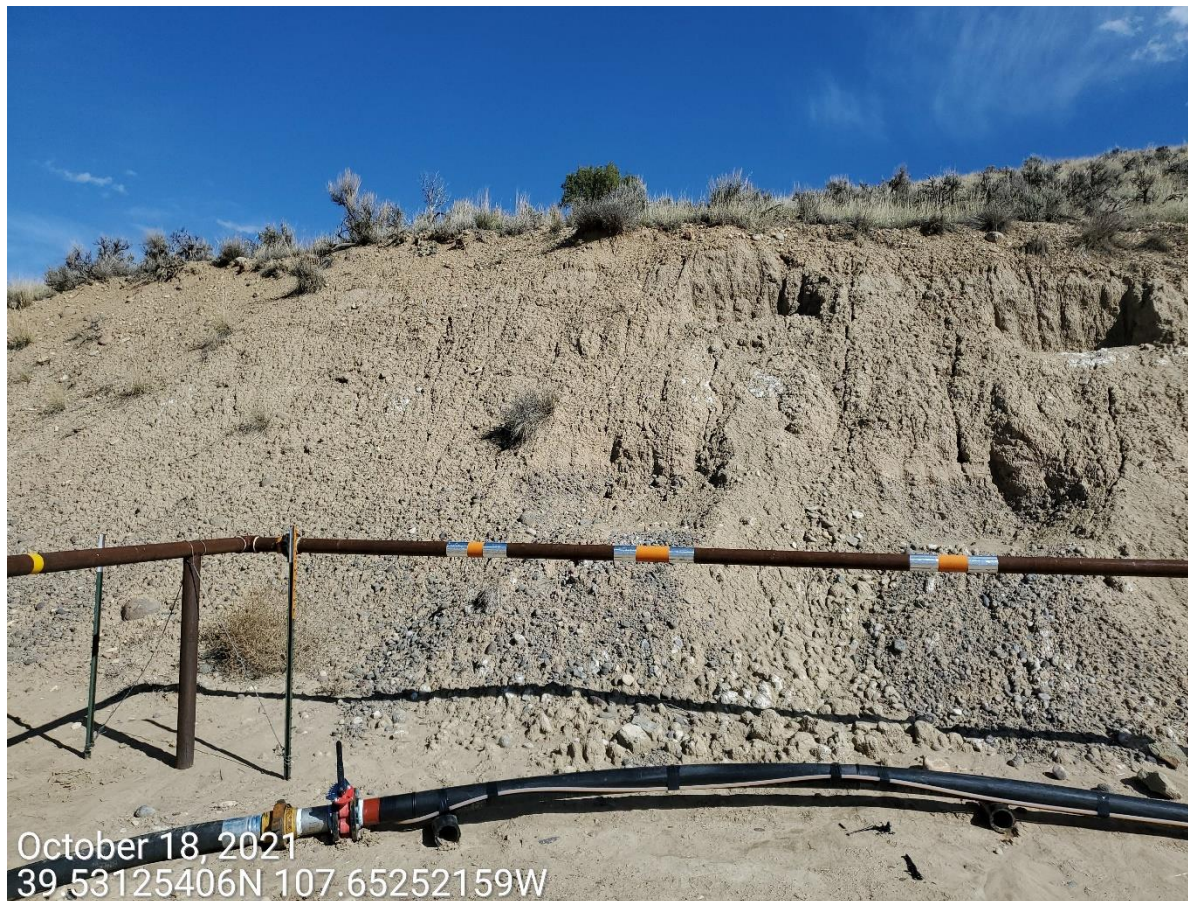
Photo 7: Photo shows example where control measures to protect and stabilize the slopes of the Location are missing or insufficient.
