Inspection Photos

Operator: BP America
API: 067-05000
Date: 10/22/2021

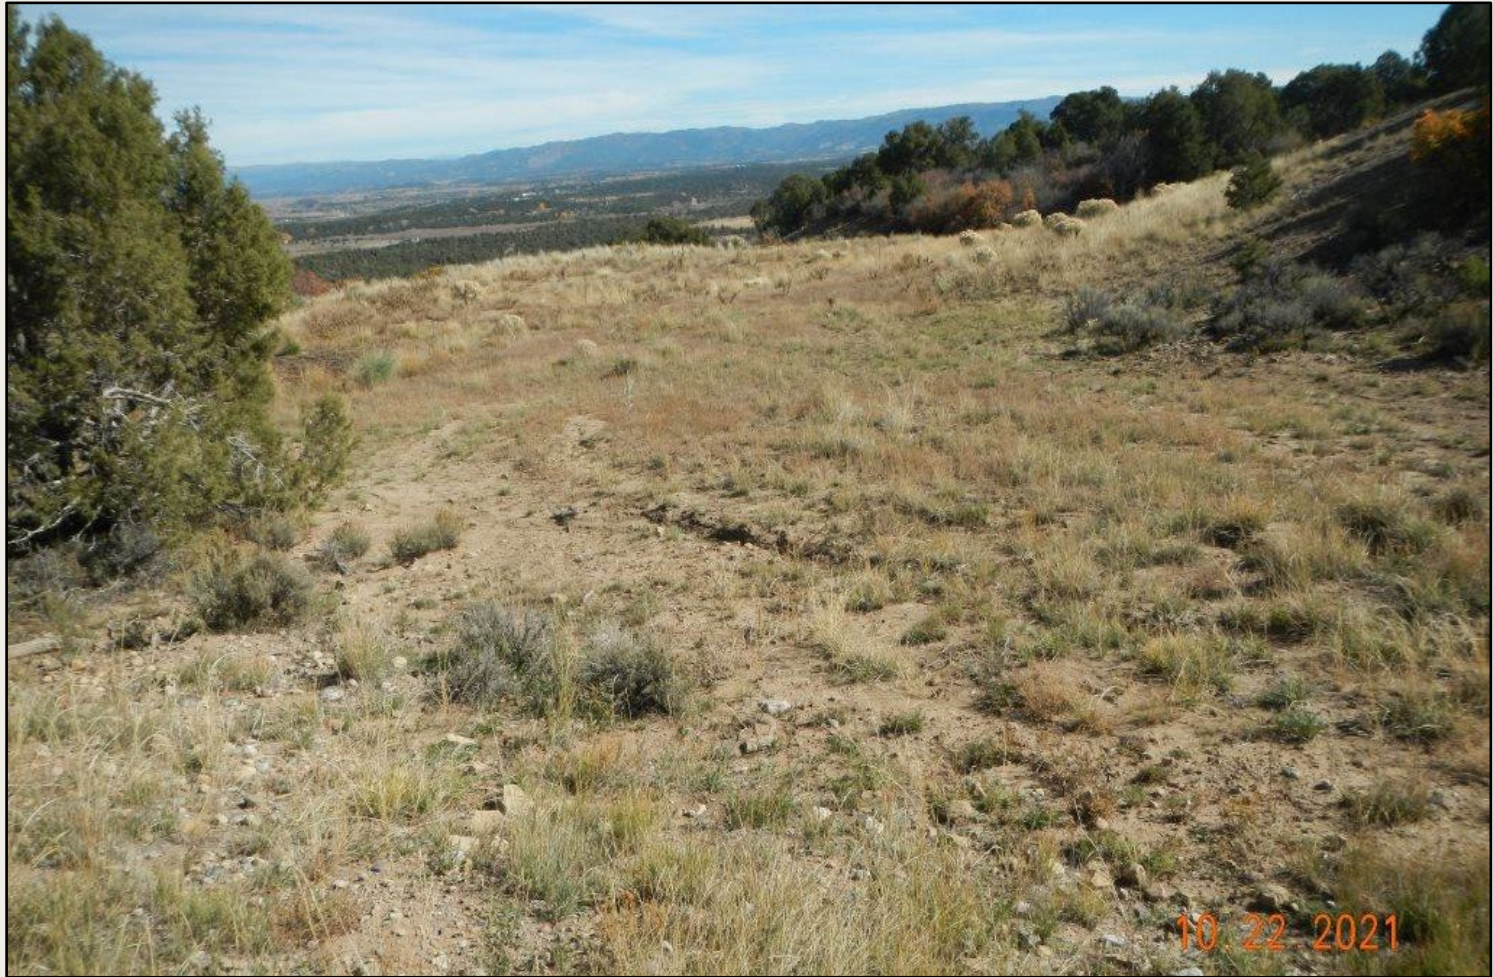
Photo 1. View of the project area from the western edge facing center. Revegetation is progressing within portions of the project area.

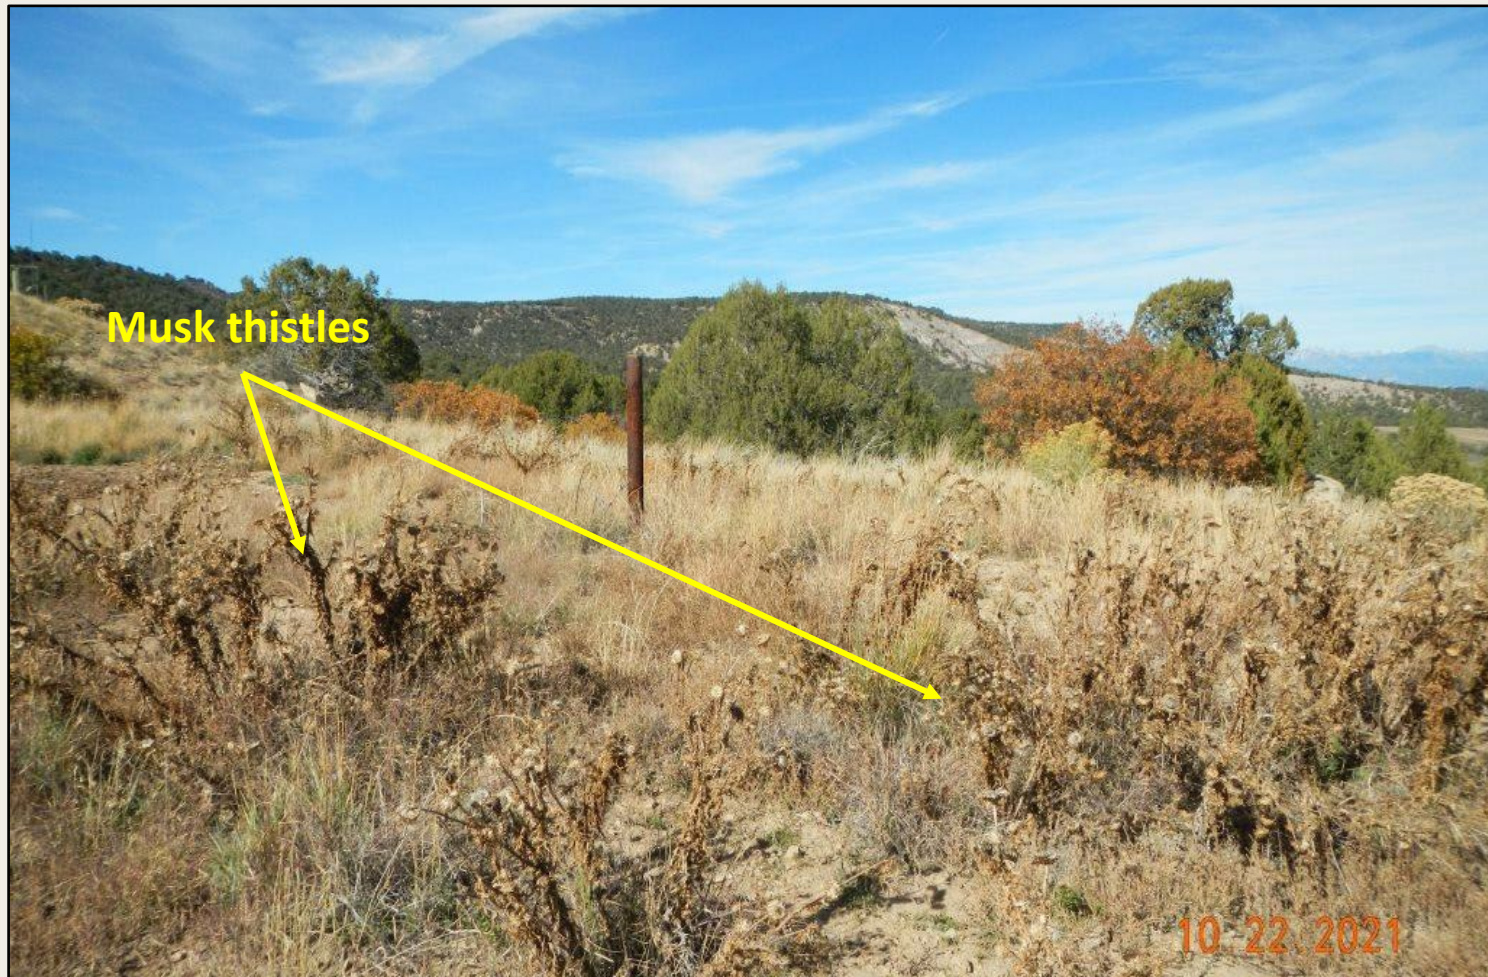
Photo 2. View of the plugged well parker facing northwestward. Dense musk thistles in post flowering and rosette condition, observed within the project area.

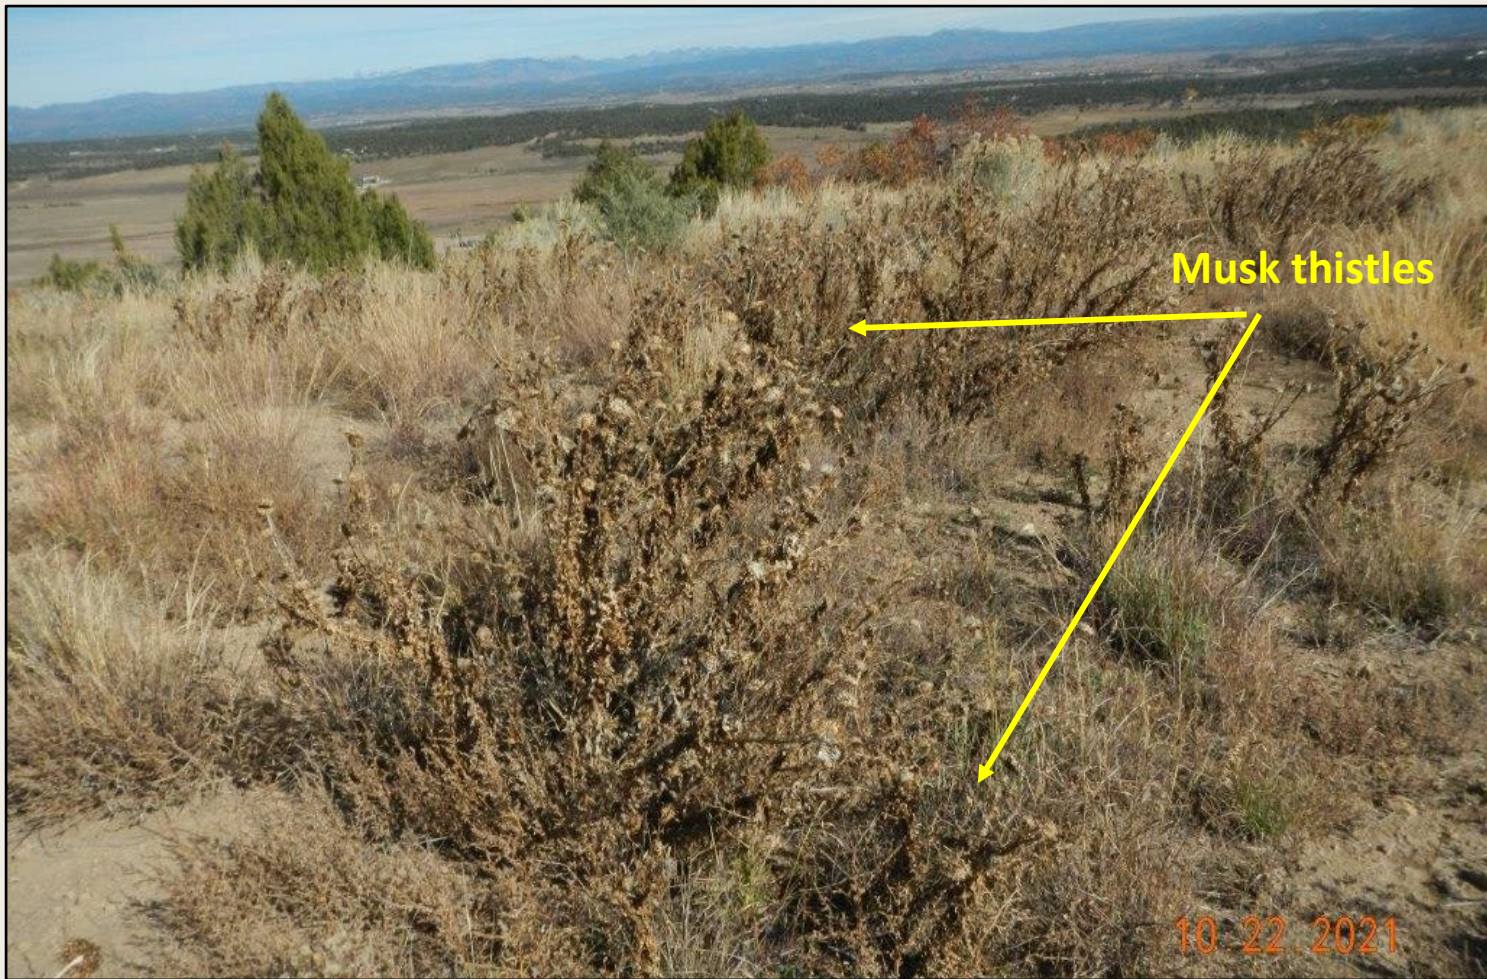
Photo 3. View of more dense musk thistles in the project area. Approximately 2000 individuals observed.

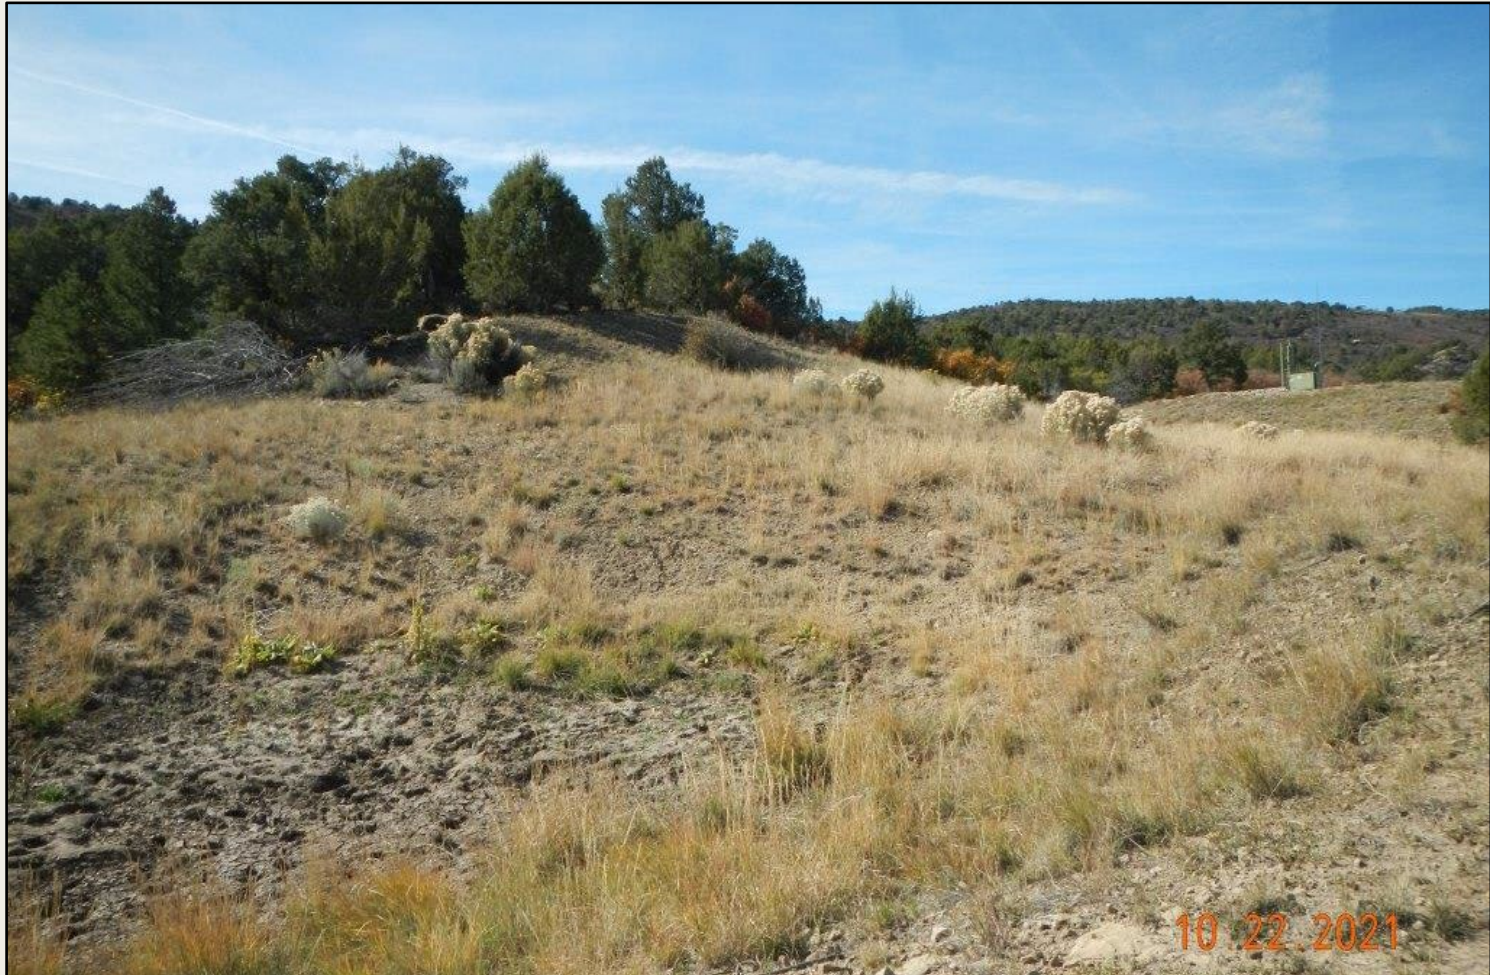
Photo 4. View of the northern project area from the northeastern corner facing westward. Revegetation is progressing here with sideoats grama, western wheatgrass, James galleta, and rubber rabbitbrush.

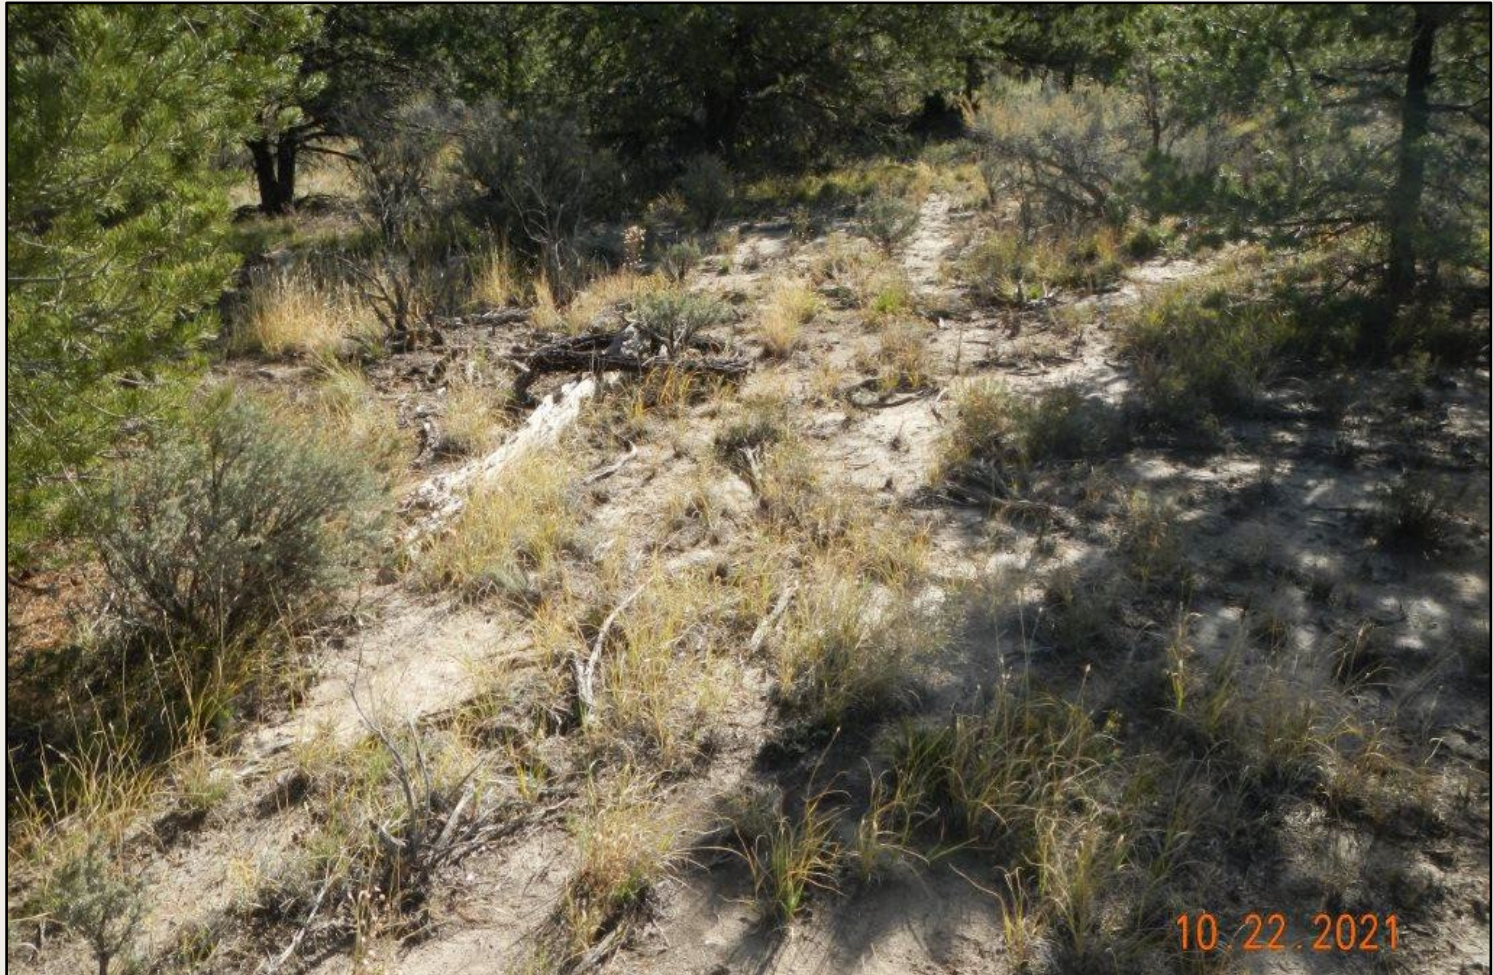
Photo 5. View of the reference area comprised of pinyon and juniper woodland with understory of sagebrush, James galleta, sandbergbluegrass, and prickly pear.
