APACHE CANYON 18-09 API# 05-071-06339 – OGRIS OPERATING LLC  
OGCC OPERATOR NUMBER 10758 - DATE: OCTOBER 25, 2021  
CORRECTIVE ACTIONS COMPLETED REGARDING COGCC FIR DOCUMENT # 690201815

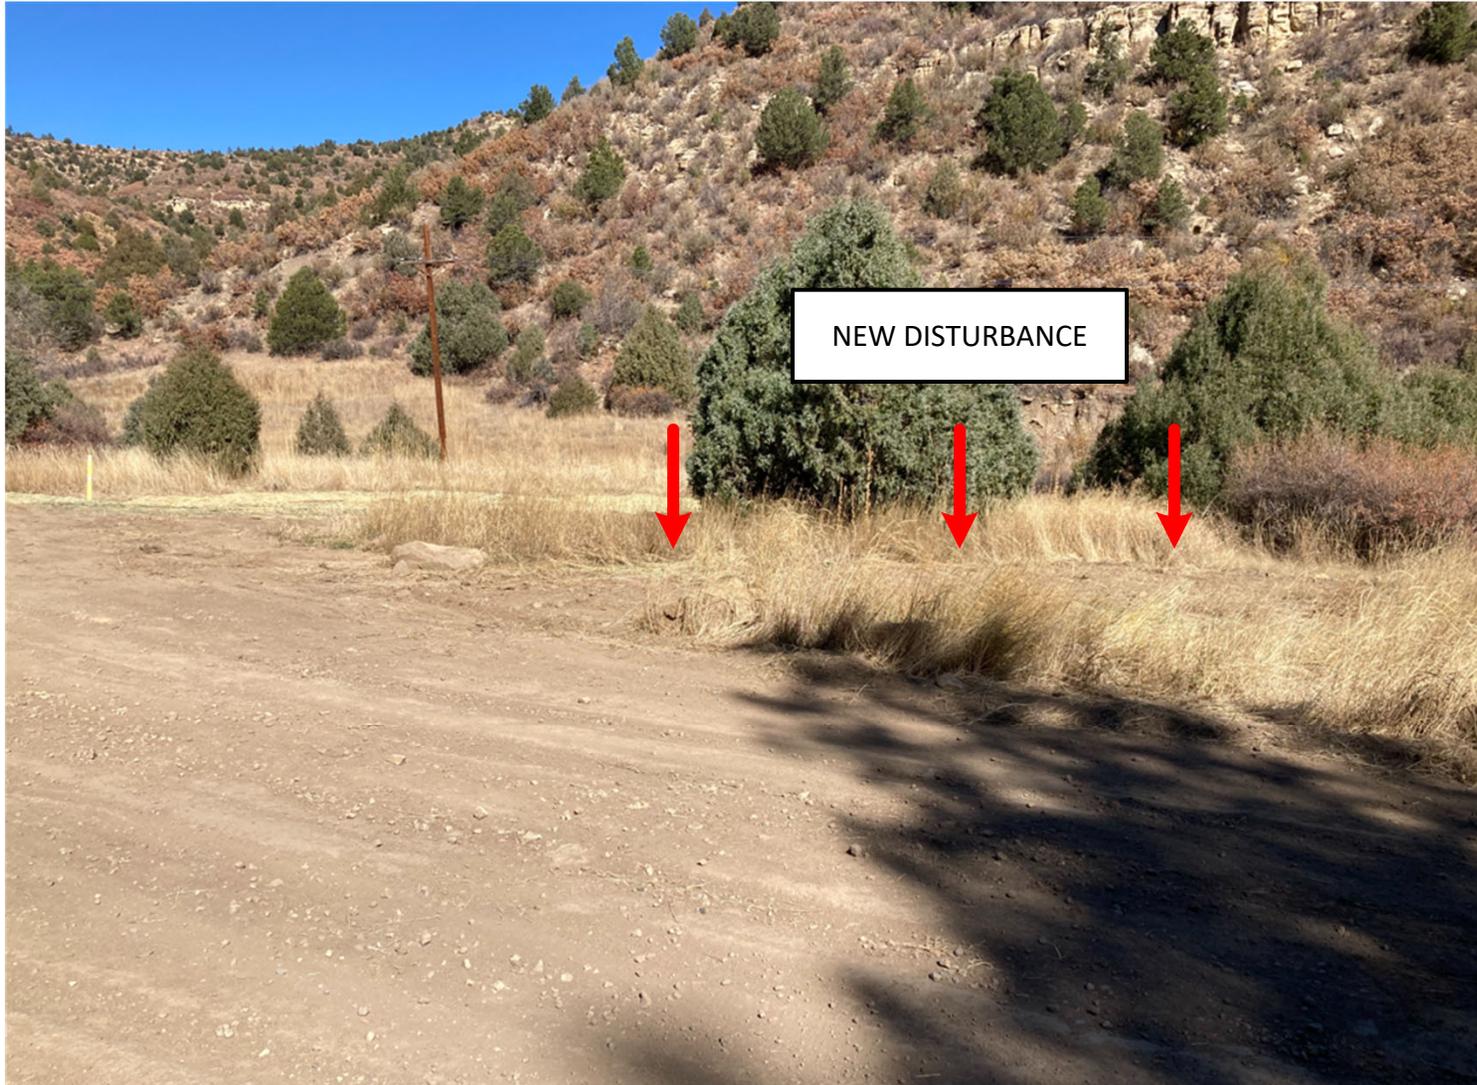
PHOTO 1: THE CONTRACTOR FROM A SEPARATE PROJECT DISTURBED THE VEGETATION BY LEAVING THE BLADE DOWN WHILE CROSSING THE ROAD. THE DISTURBANCE WAS RECLAIMED AND SEEDING WITH AN APPROVED CPW SEED MIX ON 10/25/2021.

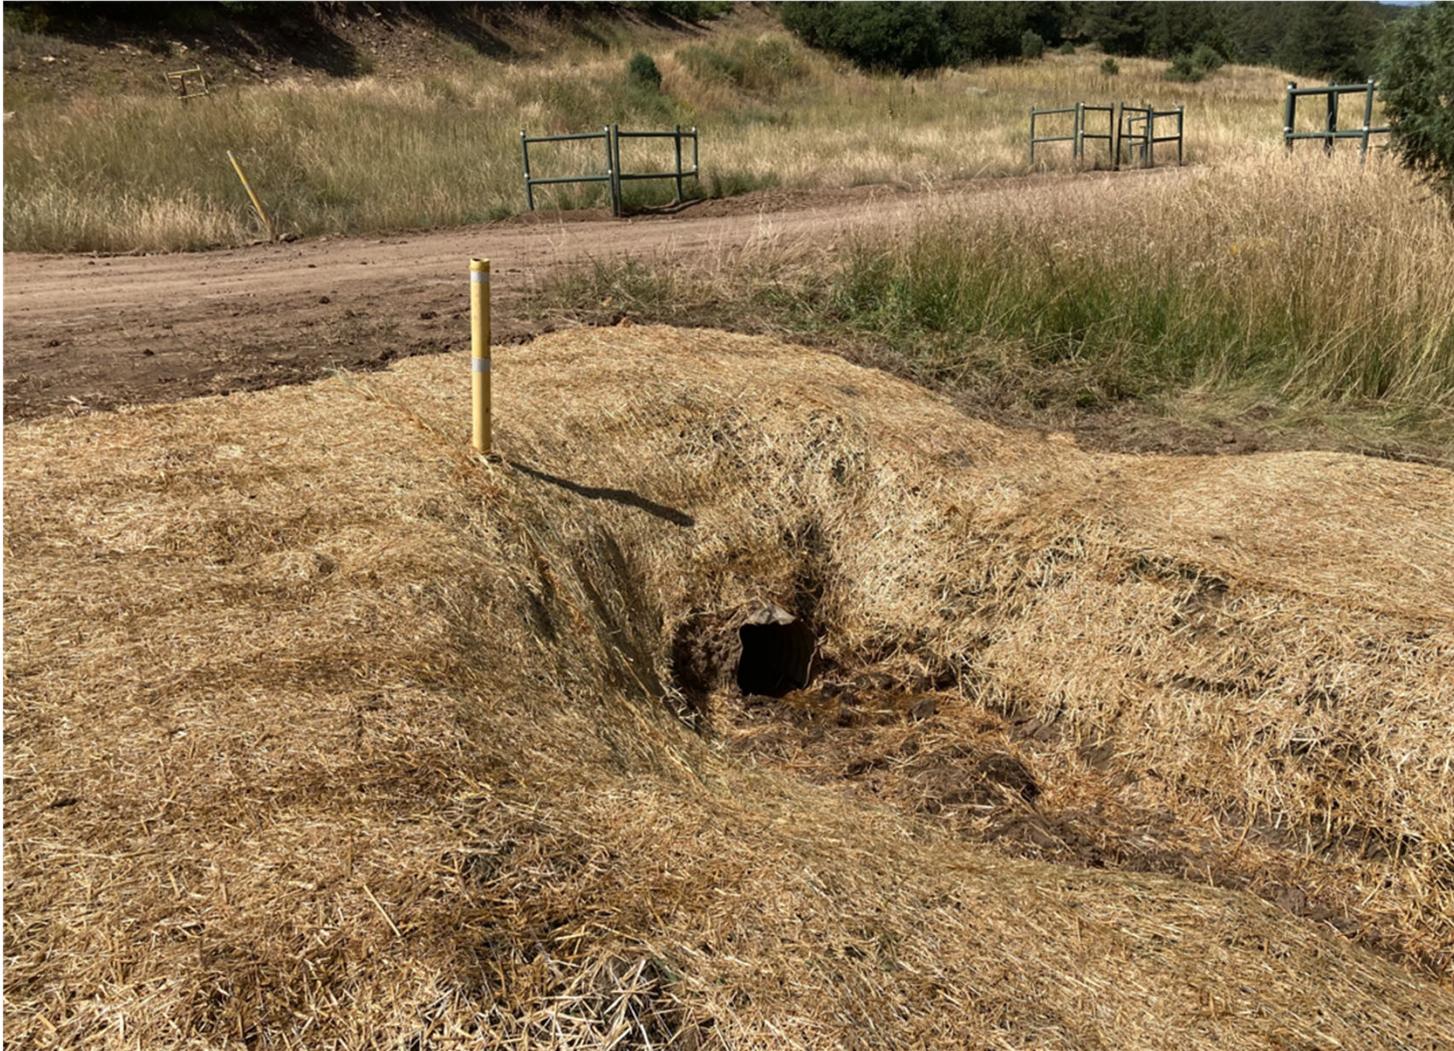
PHOTO 2: THE CULVERT OUTLET ON THE MAIN LEASE ROAD OF BIG BINGHAM CANYON AND THE RIDGE ROAD INTERSECTION WAS BELOW GRADE AND WOULD NOT DRAIN PROPERLY. POSITIVE DRAINAGE WAS ESTABLISHED FOR THE OUTLET. THE DISTURBED SOIL WAS SEEDED WITH AN APPROVED CPW SEED MIX TO ESTABLISH VEGETATION. EROSION CONTROL BLANKETS WERE INSTALLED FOR TEMPORARY SOIL STABILIZATION.

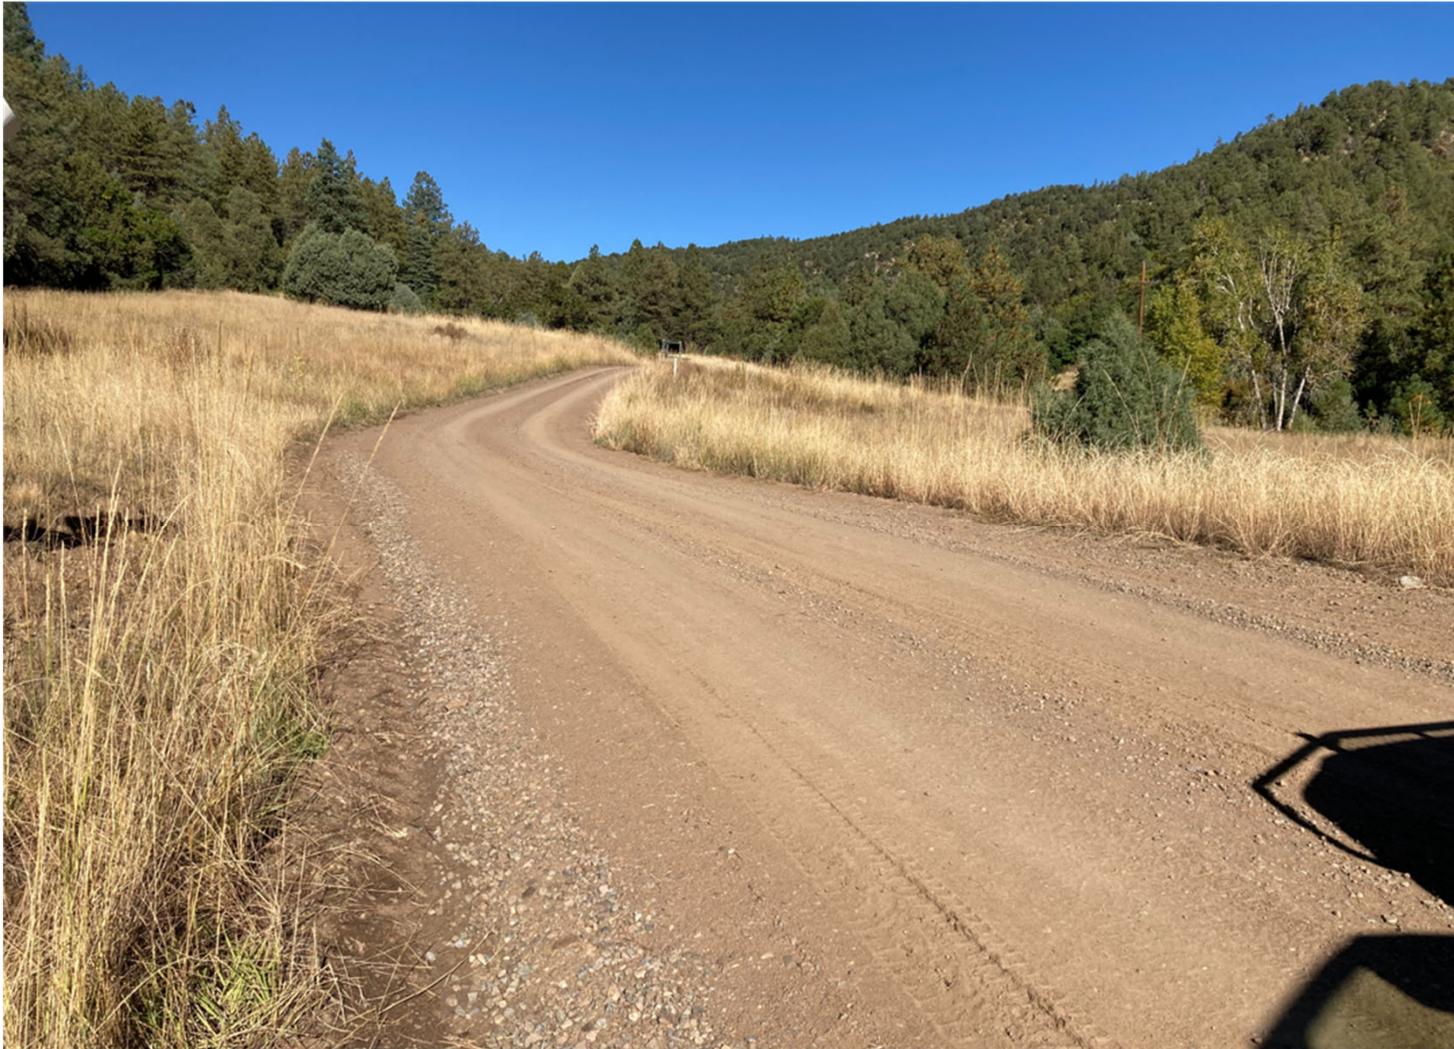
PHOTO 3: THE ROAD SURFACE WAS CROWNED TO CREATE SHEET FLOW AND ELIMINATE THE TIRE RUTS. ADDITIONAL GRAVEL WAS INSTALLED TO THE ROADWAY SURFACE TO IMPROVE STABILIZATION EFFORTS.

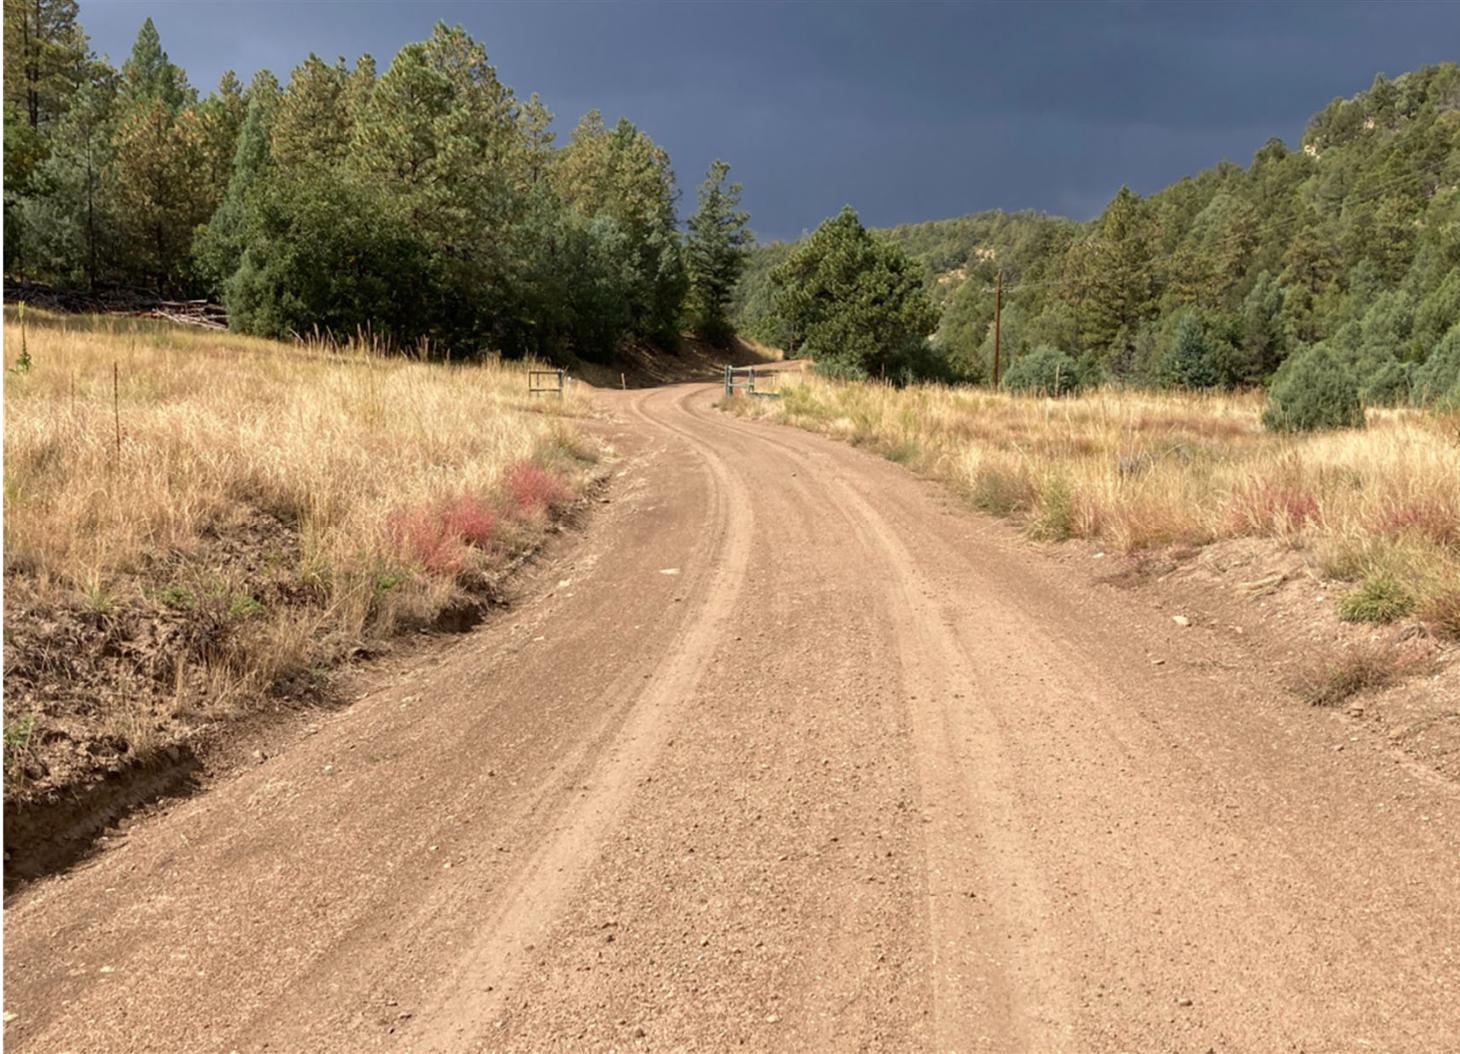
PHOTO 4: THE ROAD SURFACE WAS CROWNED TO CREATE SHEET FLOW AND ELIMINATE THE TIRE RUTS. ADDITIONAL GRAVEL WAS INSTALLED TO THE ROADWAY SURFACE TO IMPROVE STABILIZATION EFFORTS.
