Inspection Photos

10/25/2021

Operator: TEP ROCKY MOUNTAIN LLC #
96850

Location ID: 323866
Garfield County, CO

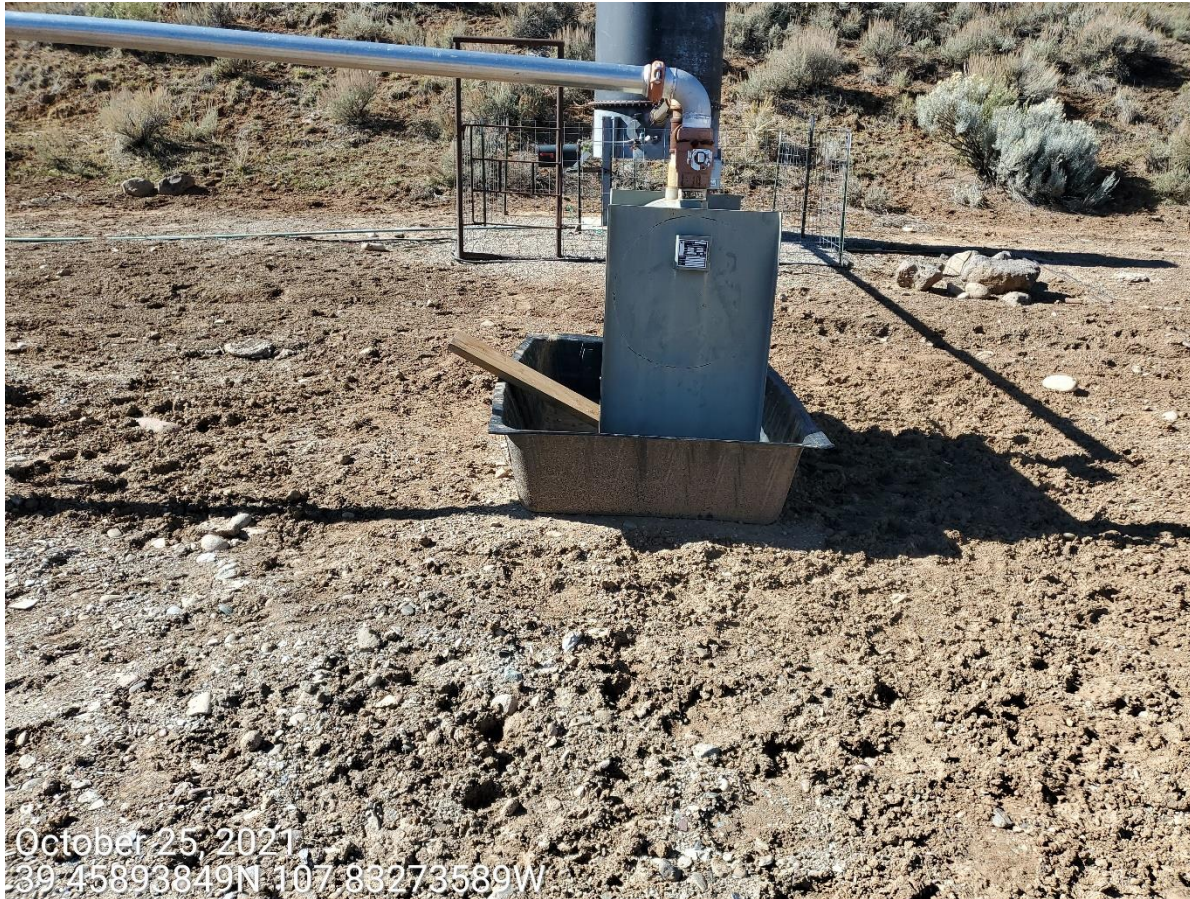
Photo 1: Photo shows that Operator has placed a board into the containment BMPs; control measures to prevent wildlife access to the containment BMP remains inadequate.

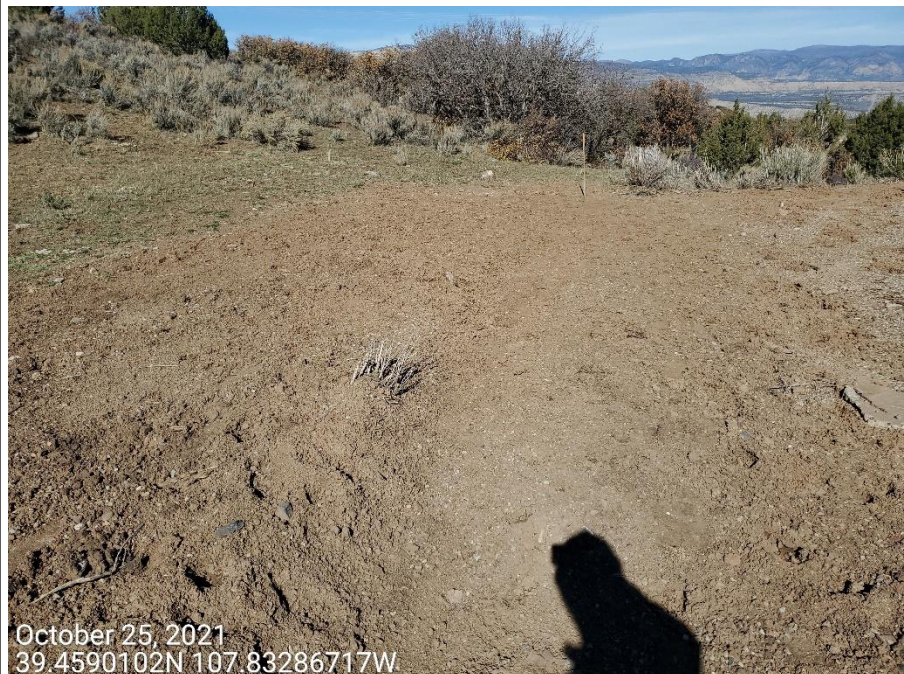
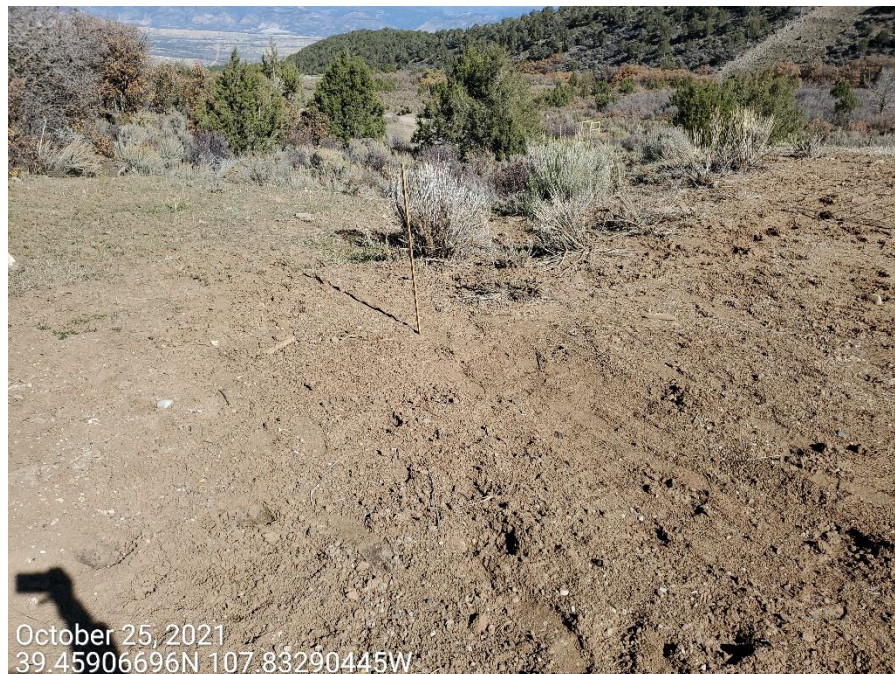
Photo 2: Photo taken from the stormwater diversion ditch on the west end of the Location, facing north. Photo shows that the stormwater diversion ditch remains improperly constructed with an appropriate outlet to prevent offsite degradation due to runorr.

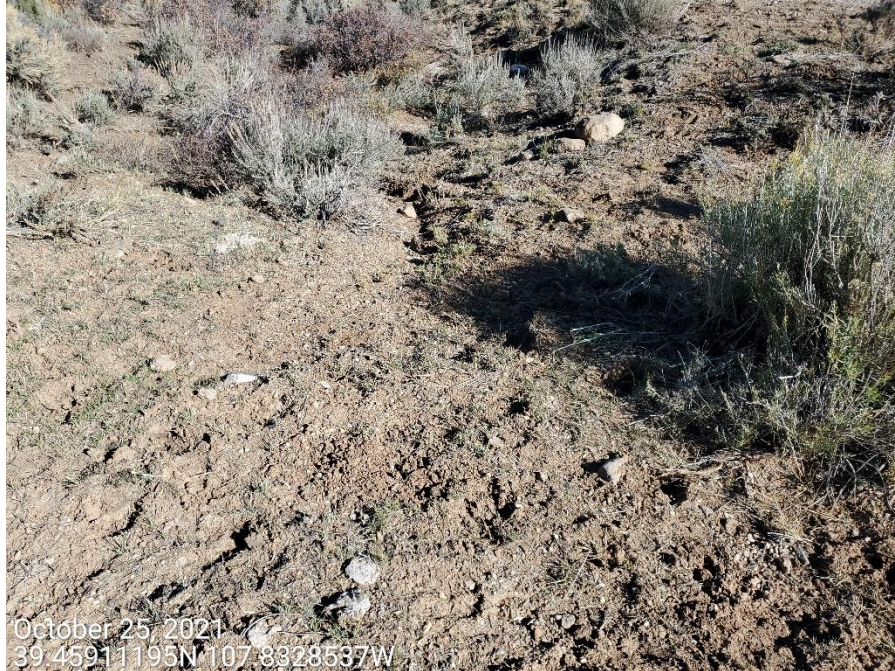
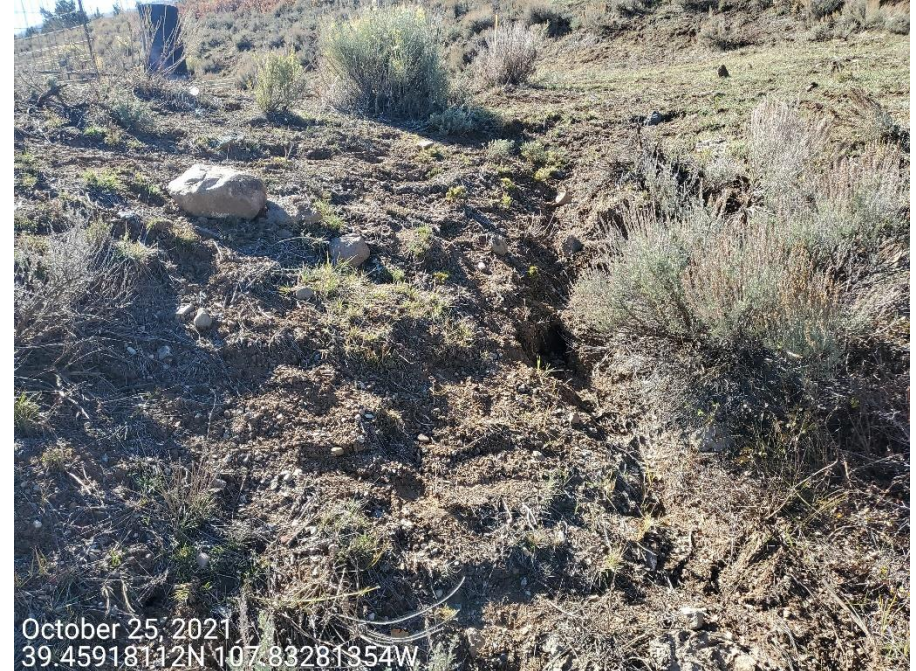
Photo 3: Photos taken north of the ditch. Photo shows offsite erosion degradation due to improper stormwater runoff controls on the Location.
