# Inspection Photos

Operator: TEP ROCKY MOUNTAIN LLC #  
96850

Location ID: 439173  
Garfield County, CO

Aaron Trujillo  
NW Reclamation Specialist  
COGCC

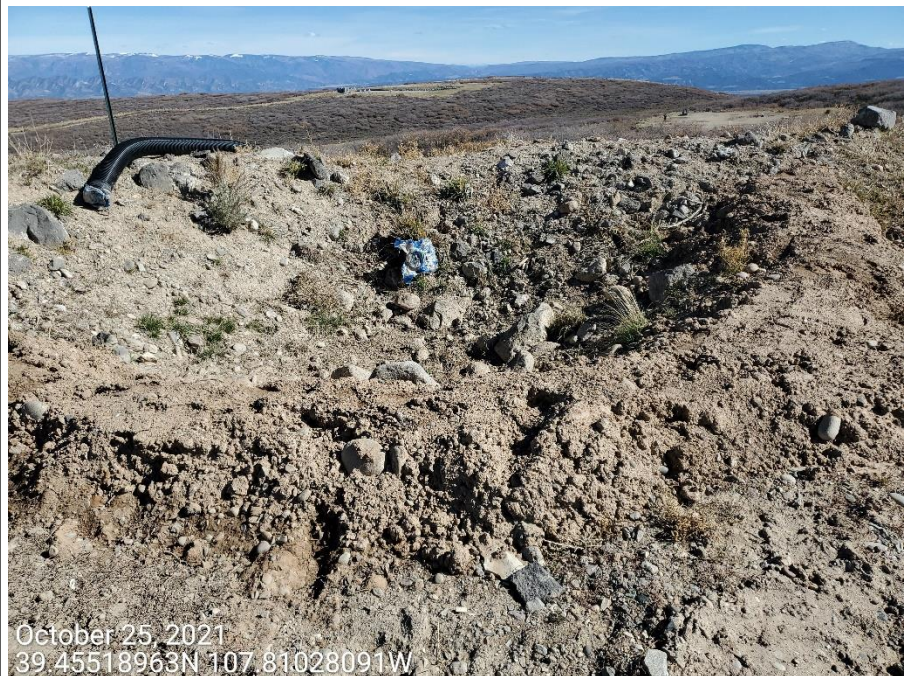
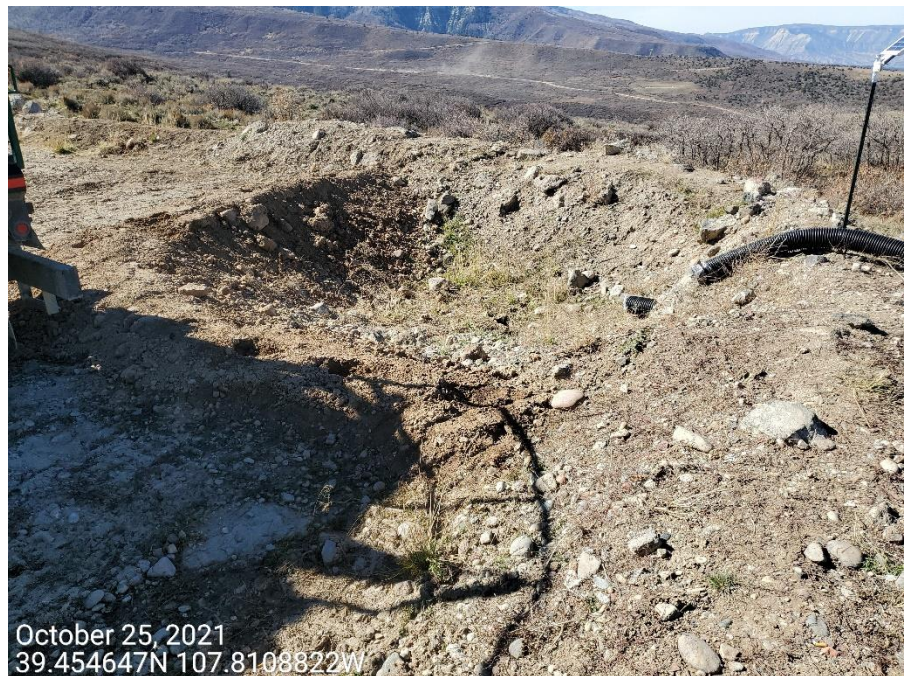
**Photo 1:** Photos show the sediment traps on the NW/NE corners of the production area. Photos show controls have not been installed in accordance with good engineering practices to allow for proper stormwater discharge.

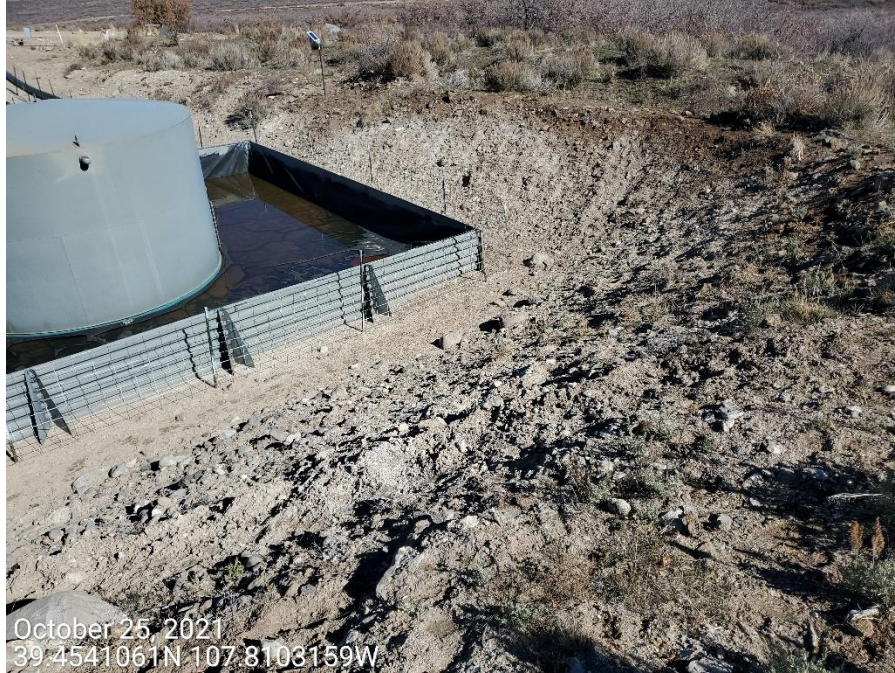
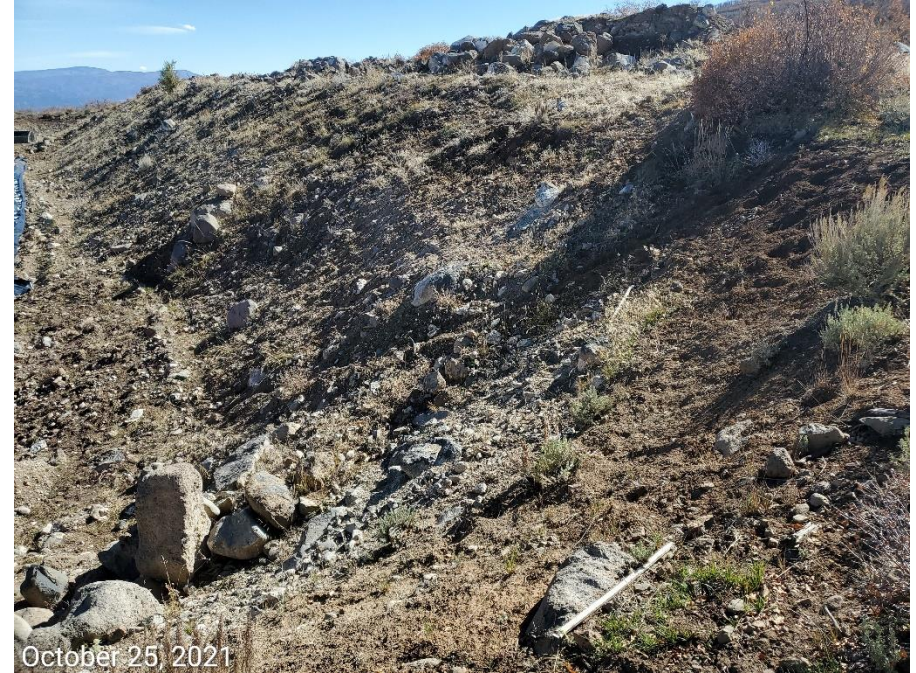
**Photo 2:** Photos provide examples showing that control measures to protect and stabilize the cut slopes of the Location remain missing or insufficient.

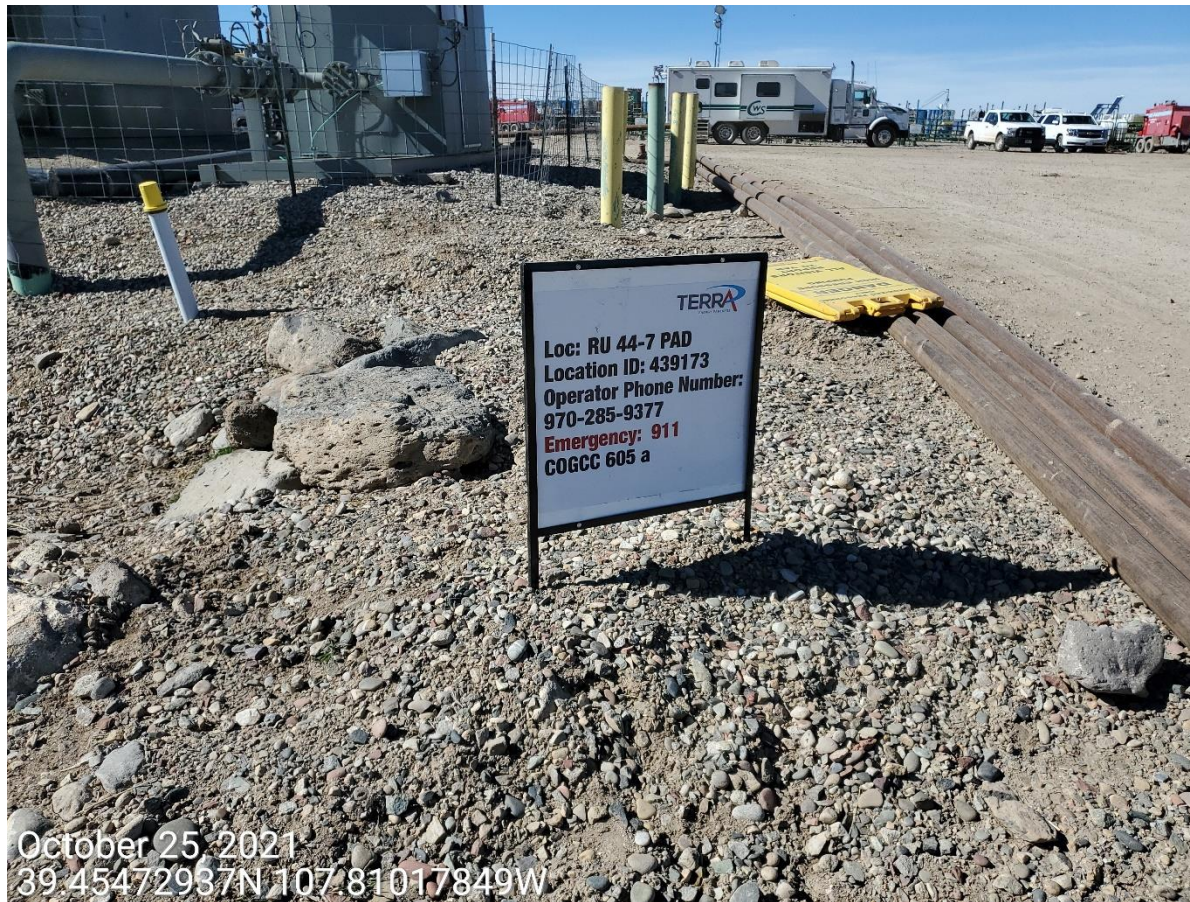
**Photo 3:** Photo shows signage has been installed at Location's entrance.
