WELLHEAD ABANDONMENT FORM

SITE NAME: Benson Farms 12N-23HZ							DATE: 8/5/2021	REM. PROJECT #:	WEATHER: Sunny 80		
SITE DIRECTIONS: ST HWY 66 and CR 9 1/2 NORHT 0.5, EAST 0.5 SOUTH .1 INTO							CLIENT: Oxy				
LEGALS AND LAT/LONG: 40.210079, -104.960574							TASMAN PERSONNEL: Brandon LeVasseur				
SOIL TYPES: Lean Clay - CL							SURFACE GRADIENT: South				
SOIL SAMPLING							FACILITY INFRASTRUCTURE				
Date/Time	Soil Sample ID	PID (ppm)	Visual	Olfactory	Photo?	Grab or Lab Sample?	EQUIPMENT		Quantity		
							Above Ground Storage Tank (AST)				
8/5/2021 12:07	WH-B01@6'	7.0	No Staining	No Odor	Yes	Lab	Buried or Partially Buried Vessel				
8/5/2021 12:08	WH-N01@5'	1.8	No Staining	No Odor	Yes	N/A	Separator				
8/5/2021 12:09	WHS01@5'	4.4	No Staining	No Odor	Yes	N/A	Emission Control Device (ECD)				
8/5/2021 12:10	WH-E01@5'	2.1	No Staining	No Odor	Yes	N/A	Dump Line				
8/5/2021 12:11	WH-W01@5'	1.5	No Staining	No Odor	Yes	N/A	Wellhead		1

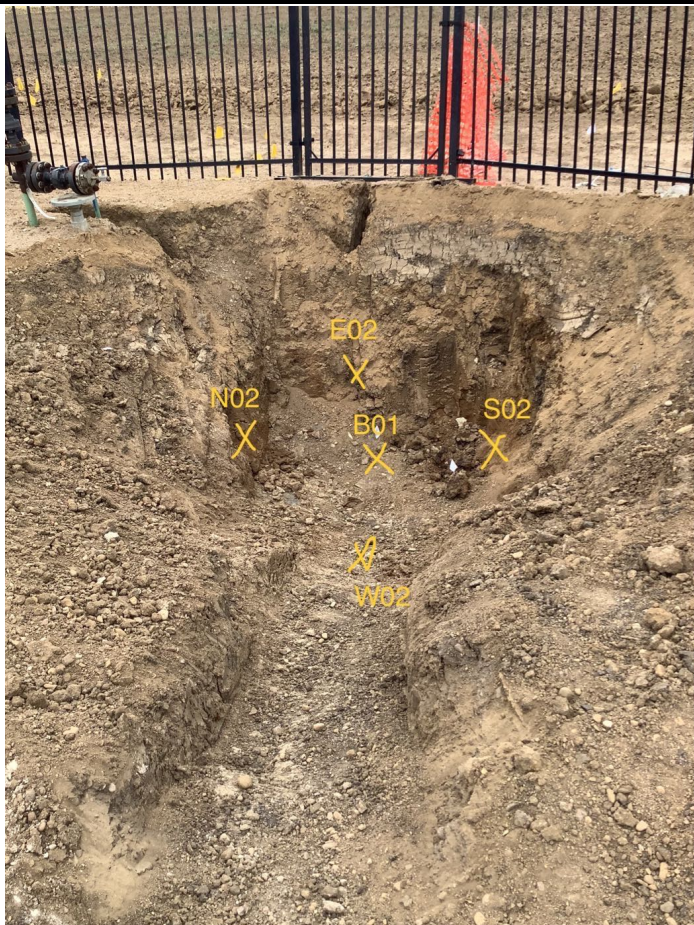
Equipment ID:		Equipment Type:		Equipment ID:		Equipment Type:	
Material:	Volume:	Contents:		Material:	Volume:	Contents:	
Notes/Conditions: 080621 sample locations				Notes/Conditions: Soil screening and sampling location 102221
