Wetland Delineation Report

Blehm 18-I Pad

Date Prepared: November 2, 2021

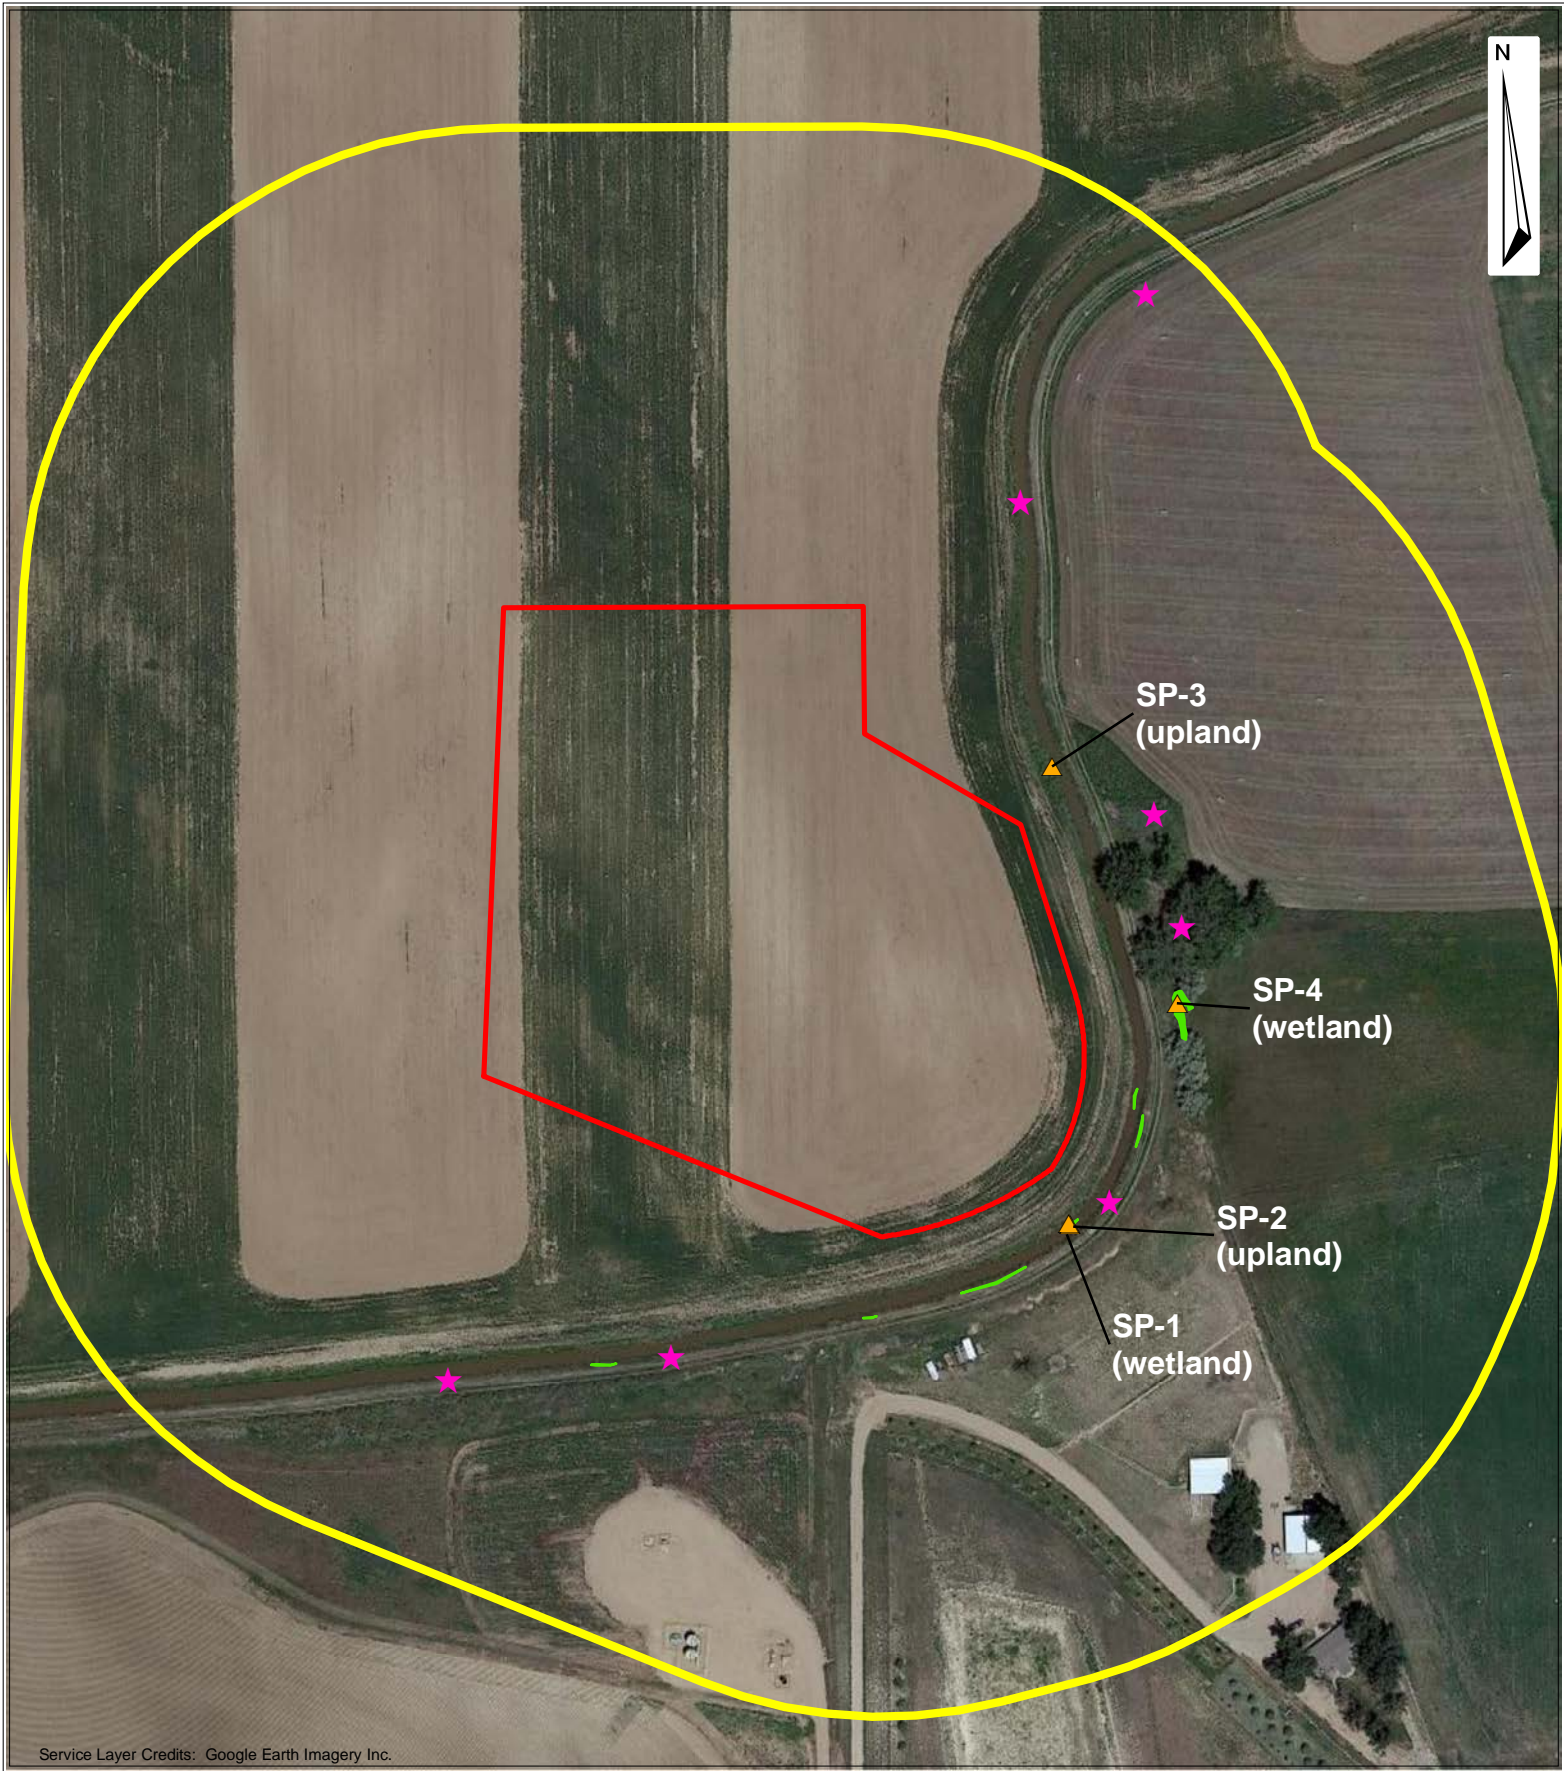
WETLANDS AND WATERS OF THE US

There are several National Wetland Inventory (NWI)- and National Hydrography Dataset (NHD)-mapped wetlands and waterbodies surrounding the Site. Wetland delineation data forms were collected at four (4) sample locations. Sample point 1 was at the ordinary high-water mark (OHWM) with hydrophytic vegetation, hydric soils and wetland hydrology observed and therefore a wetland. Sample point 2 was approximately 2 feet above the OHWM and did not contain hydrophytic vegetation, hydric soils nor wetland hydrology and was an upland. Sample point 3 was at the OHWM and did not contain hydrophytic vegetation, hydric soils nor wetland hydrology and was an upland. Sample point 4 was east of the ditch and adjacent ditch access road with hydrophytic vegetation, hydric soils and wetland hydrology observed and therefore a wetland. See attached site map (Appendix A), site photos (Appendix 2) and wetland delineation data forms (Appendix 3).

Based on the results of our surveys, per Rule 1202.a.(3), there are several wetlands within 500 feet of the WPS of the site. However, no wetlands are located within the WPS of the site, and no impacts to wetlands are expected from construction, pre-production, or production activities.

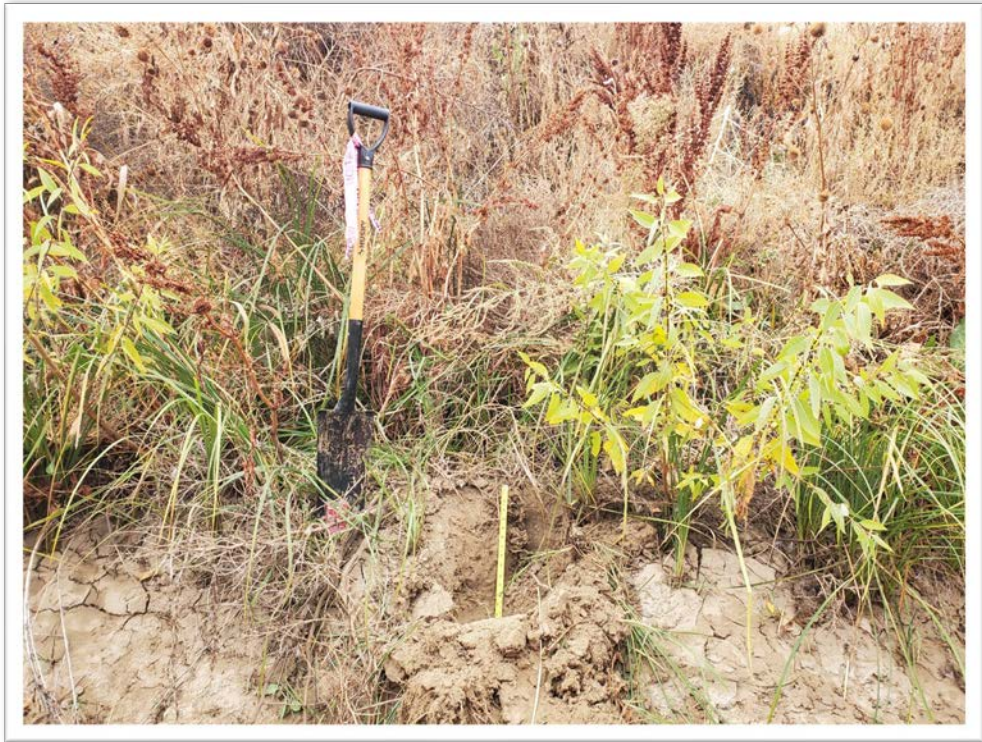
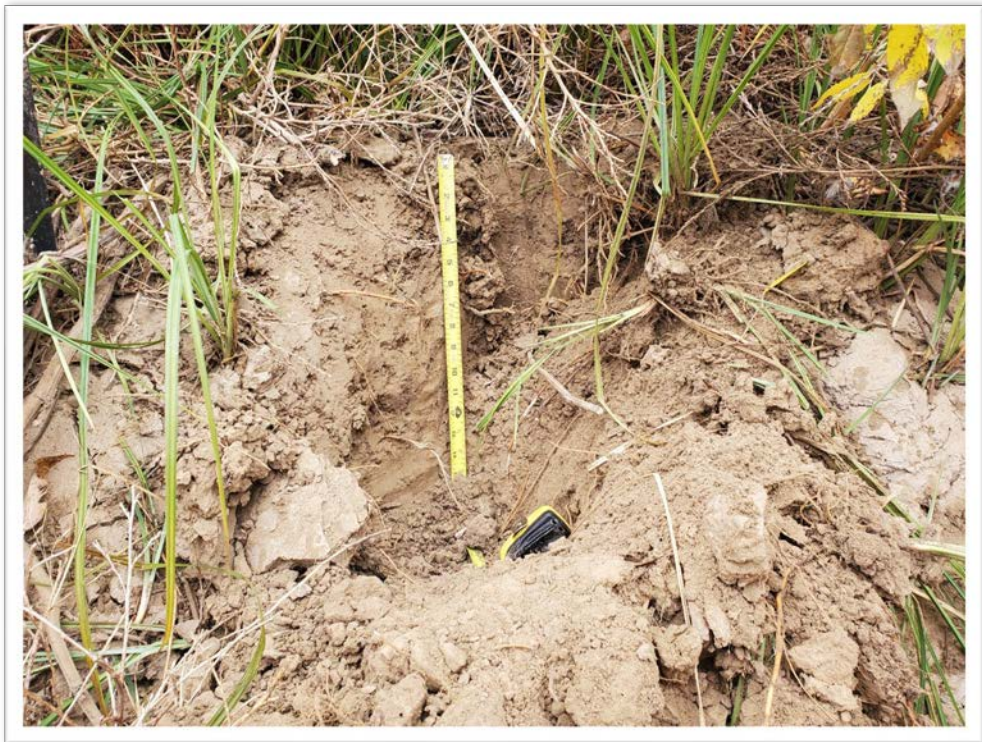
Photo 1. SP-1

Hydrophytic Vegetation Present?	Yes <input checked="" type="checkbox"/>	No <input type="checkbox"/>	Is the Sampled Area within a Wetland?	Yes <input checked="" type="checkbox"/>	No <input type="checkbox"/>
Hydric Soil Present?	Yes <input checked="" type="checkbox"/>	No <input type="checkbox"/>			
Wetland Hydrology Present?	Yes <input checked="" type="checkbox"/>	No <input type="checkbox"/>			
Remarks: Ditch currently dry. Species present are mostly WLOn Sm. terrale, typically deep rooted.

Depth (inches)	Matrix		Redox Features				Texture	Remarks
	Color (moist)	%	Color (moist)	%	Type ¹	Loc ²		
0-4	10YR 4/2	90	10YR 5/6	10	C	PLM	SCL	Thick rhizomes
4-16	10YR 6/3	60	10YR 5/6	10	C	PLM	SCL	
	10YR 4/1	30

Sediment deposits on vegetation/branches at bank's edge @ OHWM.

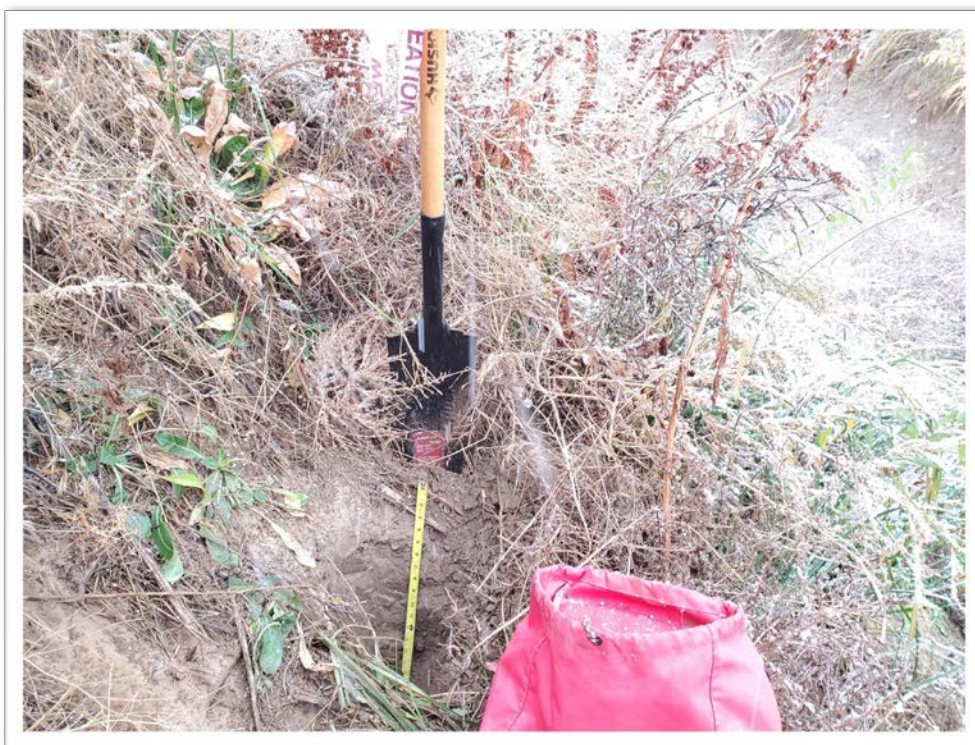
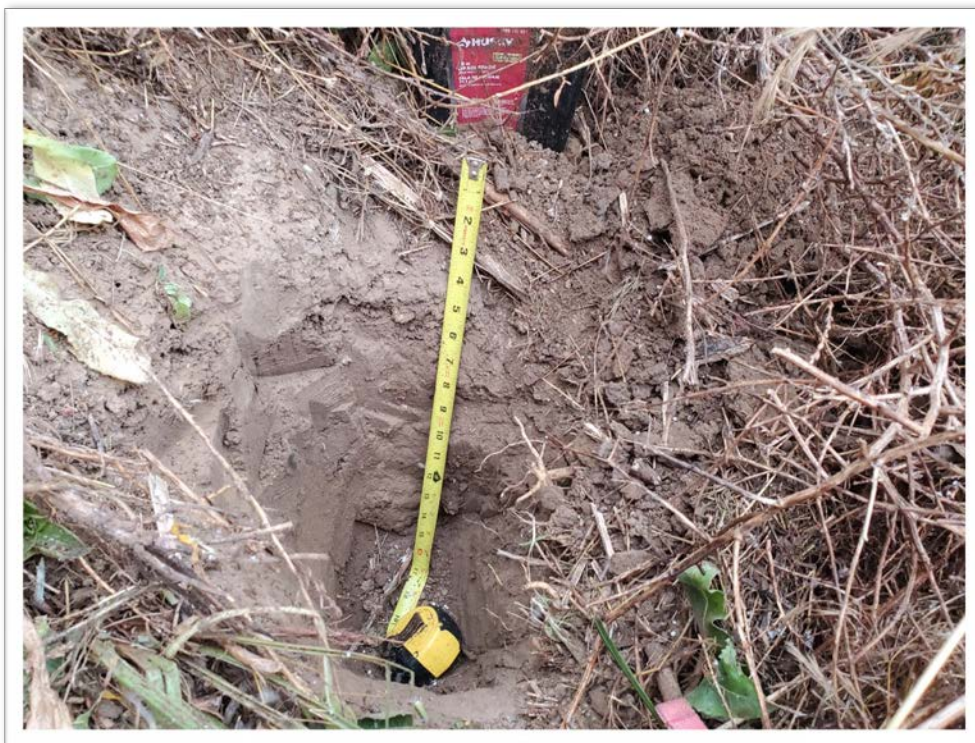
Photo 3. SP-2

Hydrophytic Vegetation Present?	Yes _____ No <u>✓</u>	Is the Sampled Area within a Wetland?	Yes _____ No <u>✓</u>
Hydric Soil Present?	Yes _____ No <u>✓</u>		
Wetland Hydrology Present?	Yes _____ No <u>✓</u>		
Remarks: ~2 Feet up (vertically) from SP-1.

Remarks: NO redoxomorph features.
moistened soils to obtain color/texture.

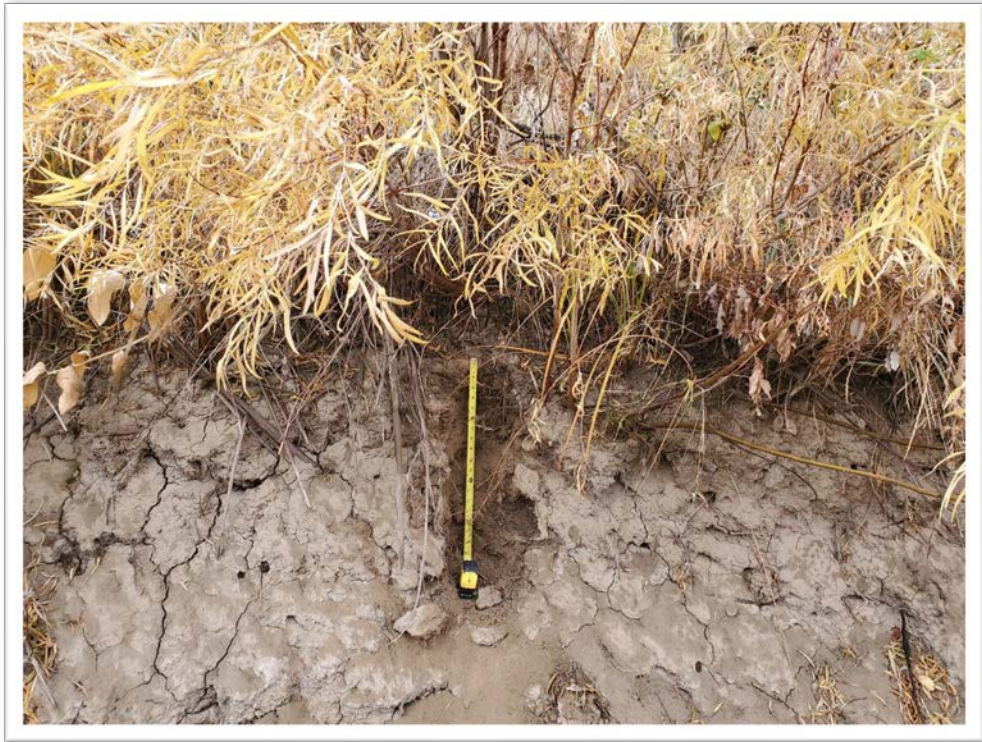
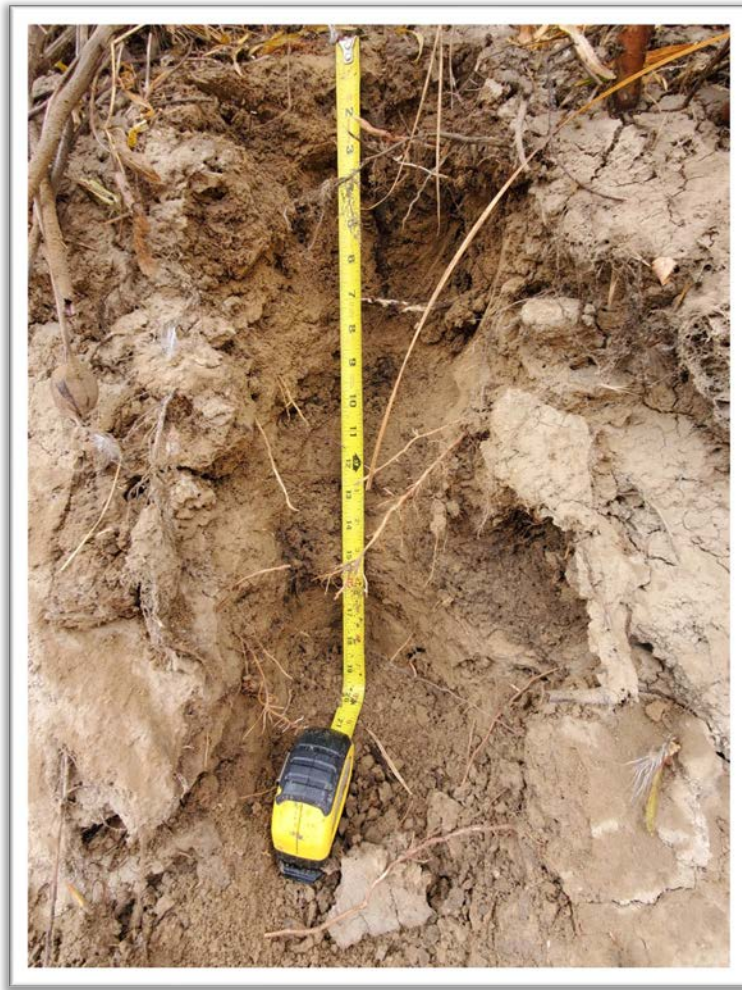
Photo 5. SP-3

Hydrophytic Vegetation Present? Yes <input type="checkbox"/> No <input checked="" type="checkbox"/>	Is the Sampled Area within a Wetland? Yes <input type="checkbox"/> No <input checked="" type="checkbox"/>
Hydric Soil Present? Yes <input type="checkbox"/> No <input checked="" type="checkbox"/>	
Wetland Hydrology Present? Yes <input type="checkbox"/> No <input checked="" type="checkbox"/>	
Remarks: <u>Western extent of ditch in project - to west ditch becomes more incised w/ steeper walls.</u>

NO redoxomorphic features.
Moistened soils to get color / texture.

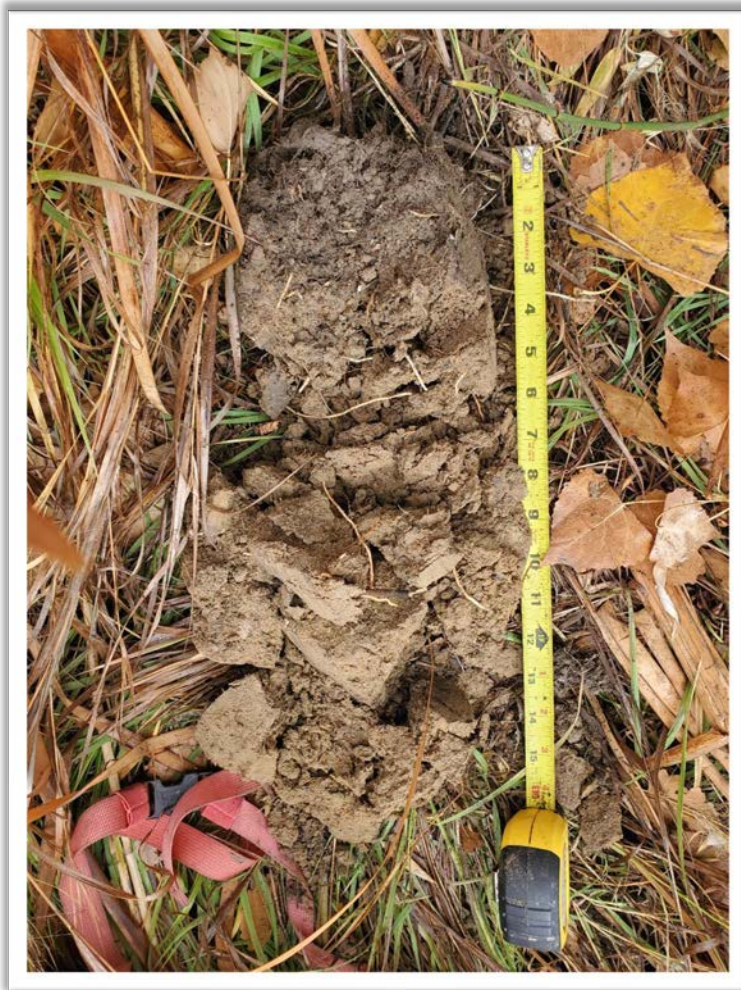
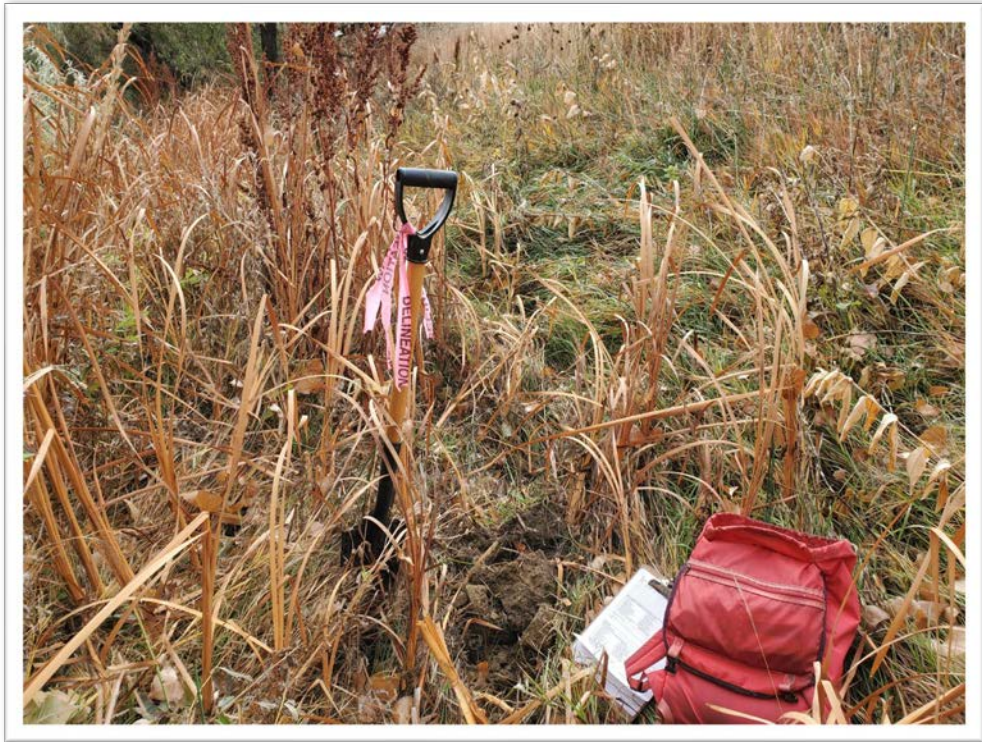
Photo 7. SP-4

Hydrophytic Vegetation Present?	Yes <input checked="" type="checkbox"/> No <input type="checkbox"/>	Is the Sampled Area within a Wetland?	Yes <input checked="" type="checkbox"/> No <input type="checkbox"/>
Hydric Soil Present?	Yes <input checked="" type="checkbox"/> No <input type="checkbox"/>		
Wetland Hydrology Present?	Yes <input type="checkbox"/> No <input type="checkbox"/>		
Remarks: <u>Pit located on outside slope of berm (ditch), at edge of agricultural field.</u>

Depth (inches)	Matrix		Redox Features		Type ¹	Loc ²	Texture	Remarks
	Color (moist)	%	Color (moist)	%				
0-4	10YR 3/2	60	7.5YR 5/8	5	C	PL, M	Sicl	
	10YR 5/3	35						
4-16	10YR 4/2	10	5YR 5/8	20	C	PL, M	Sicl	
	10YR 5/3	70
