## Attachment B

## WELLHEAD ABANDONMENT FORM

<b>SITE NAME:</b> Francen 14-30 Wellhead							<b>DATE:</b> 6/14/2021	<b>REM. PROJECT #:</b> 17139	<b>WEATHER:</b> 90's Sunny	
<b>SITE DIRECTIONS:</b> 1500 feet East and 200 feet North of CR 49 along CR64							<b>CLIENT:</b> PDC - Erin Crawford			
<b>LEGALS AND LAT/LONG:</b> 40.451513, -104.595710							<b>TASMAN PERSONNEL:</b> Jesse Marcus			
<b>SOIL TYPES:</b> Silty Clay							<b>SURFACE GRADIENT:</b> Southeast			
SOIL SAMPLING							FACILITY INFRASTRUCTURE			
Date/Time	Soil Sample ID	PID (ppm)	Visual	Olfactory	Photo?	Grab or Lab Sample?	EQUIPMENT	Quantity		
							Above Ground Storage Tank (AST)			
6/14/2021 12:39	FL01-01@4'	0.6	No Staining	No Odor	Yes	Grab	Buried or Partially Buried Vessel			
6/14/2021 12:40	WH01@6'	4.2	No Staining	No Odor	Yes	Lab	Separator			
6/14/2021 12:41	FLR01@2.5'	0.6	No Staining	No Odor	Yes	Lab	Emission Control Device (ECD)			
6/14/2021 12:42	FLR01@4'	0.6	No Staining	No Odor	Yes	Grab	Dump Line

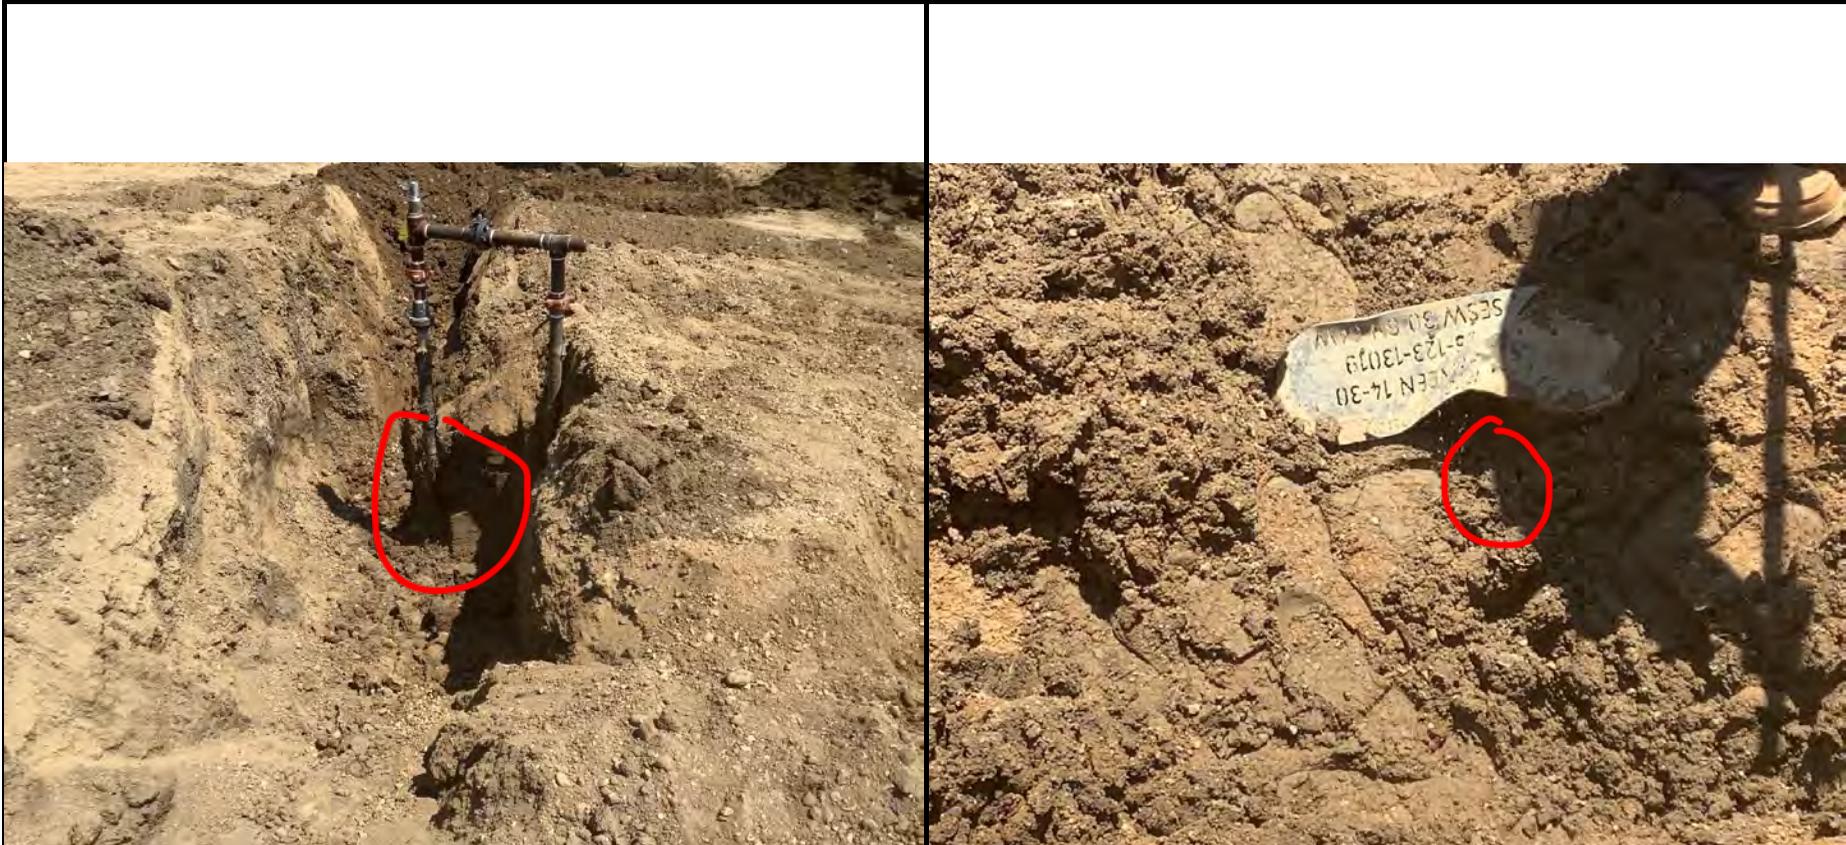
<b>Equipment ID:</b> FL01-01@4'		<b>Equipment Type:</b>		<b>Equipment ID:</b> WH01@6'		<b>Equipment Type:</b>	
<b>Material:</b>	<b>Volume:</b>	<b>Contents:</b>		<b>Material:</b>	<b>Volume:</b>	<b>Contents:</b>	
<b>Notes/Conditions:</b>				<b>Notes/Conditions:</b> Sample collected adjacent to cut and capped well casing and from the base of the excavation.

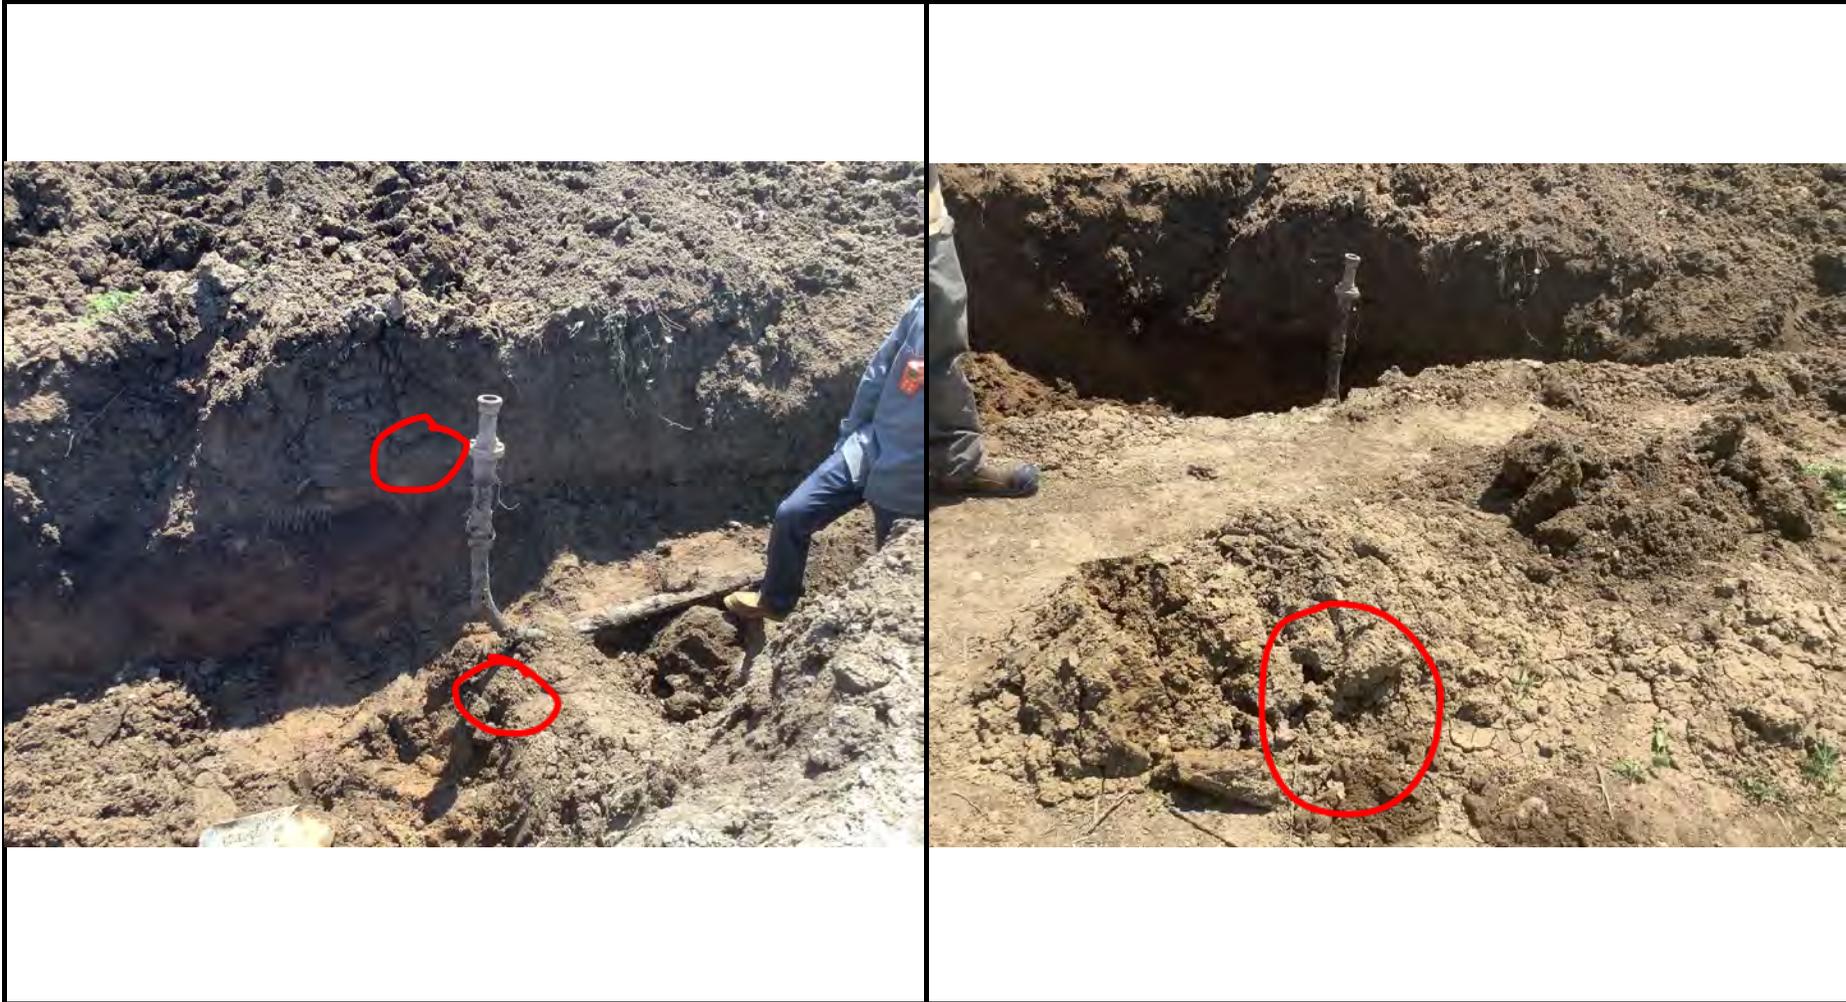
<b>Equipment ID:</b> FLR01@2.5', 4'			<b>Equipment Type:</b>			<b>Equipment ID:</b> WHS01-W @0-6"			<b>Equipment Type:</b>		
<b>Material:</b>		<b>Volume:</b>	<b>Contents:</b>			<b>Material:</b>		<b>Volume:</b>	<b>Contents:</b>		
<b>Notes/Conditions:</b>						<b>Notes/Conditions:</b>

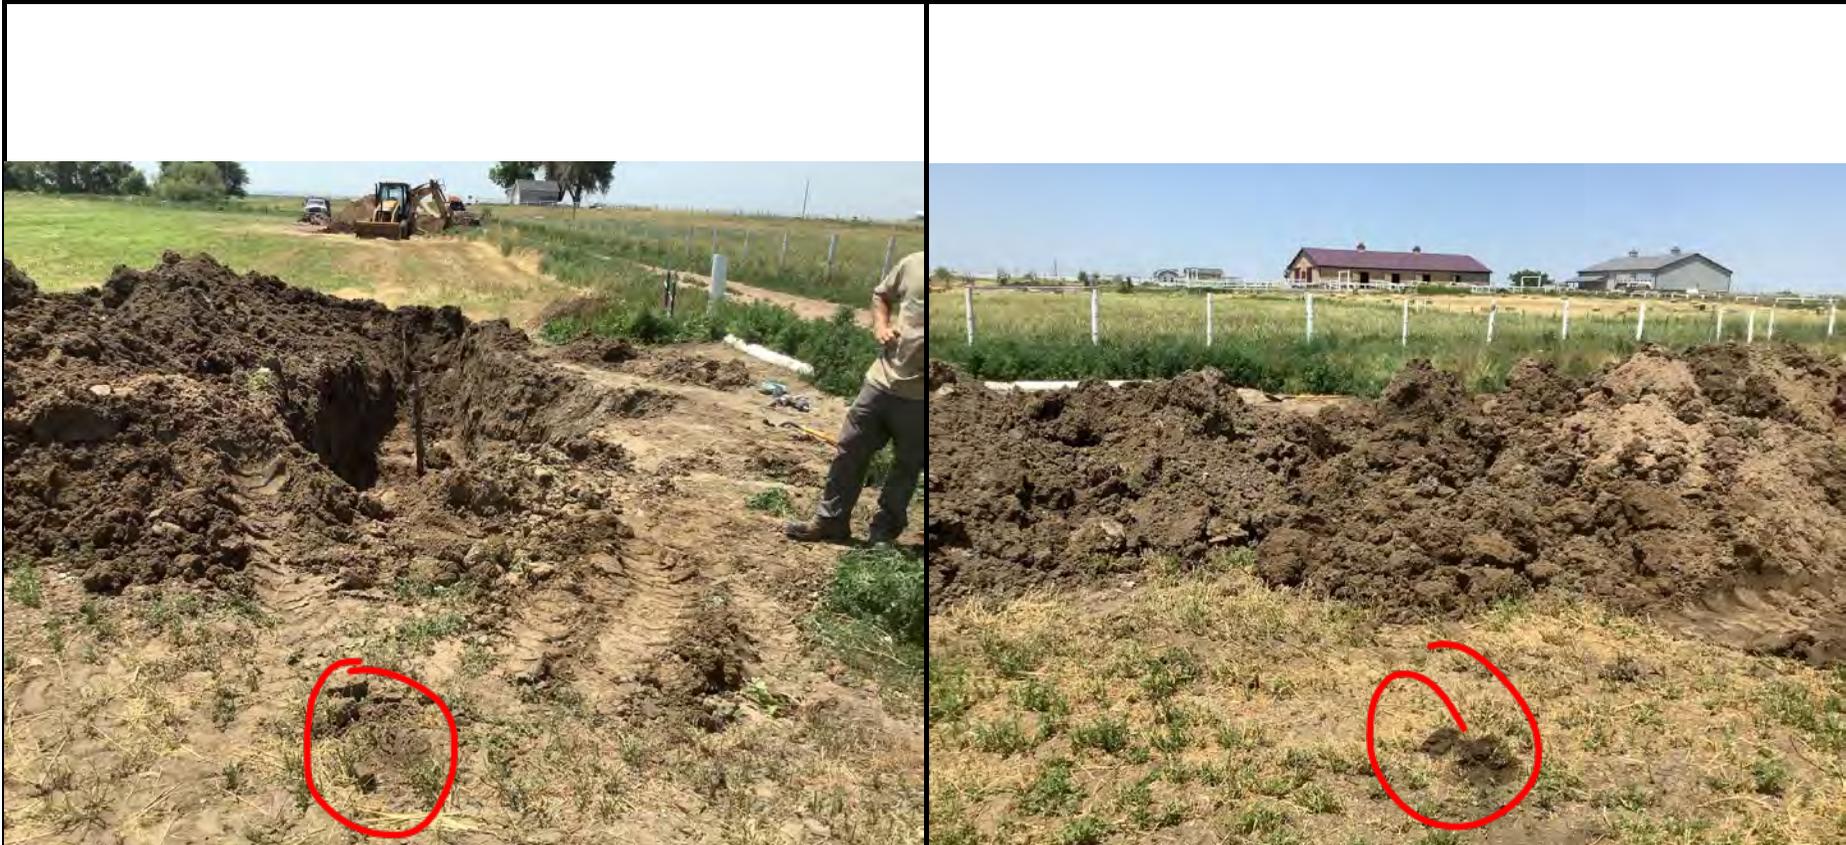
<b>Equipment ID:</b> WHS01-N @0-6"		<b>Equipment Type:</b>		<b>Equipment ID:</b> WHS01-E @0-6"		<b>Equipment Type:</b>	
<b>Material:</b>	<b>Volume:</b>	<b>Contents:</b>		<b>Material:</b>	<b>Volume:</b>	<b>Contents:</b>	
<b>Notes/Conditions:</b>				<b>Notes/Conditions:</b>

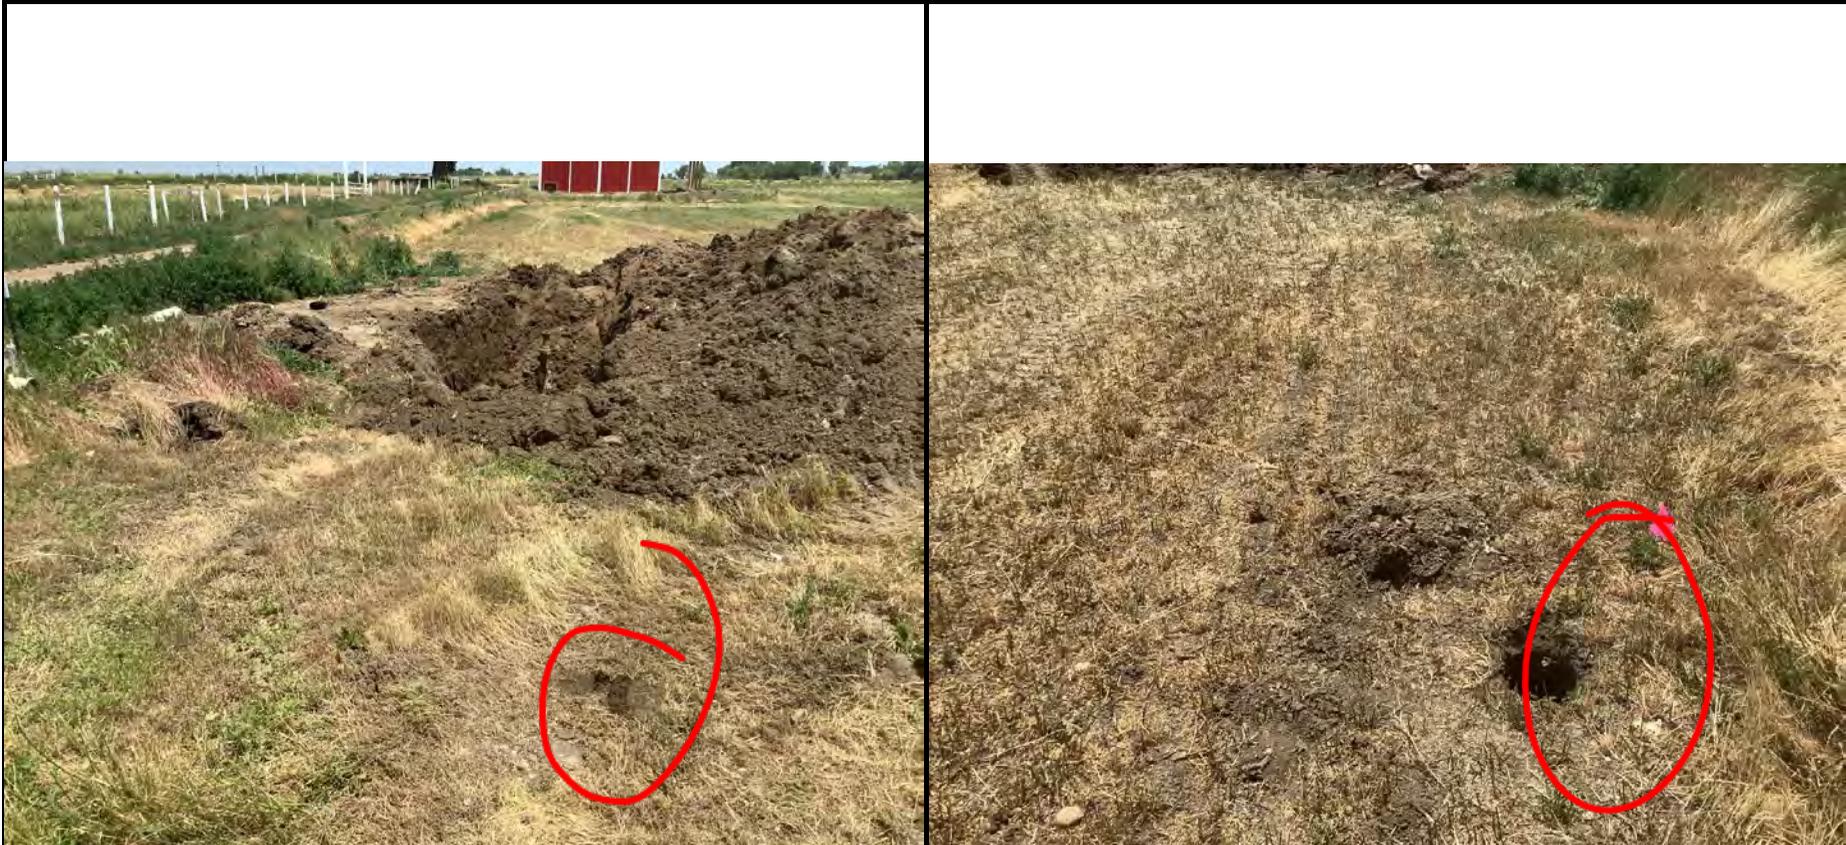
<b>Equipment ID:</b> WHS01-S @0-6"			<b>Equipment Type:</b>			<b>Equipment ID:</b> BKG01 @2.5'			<b>Equipment Type:</b>		
<b>Material:</b>		<b>Volume:</b>	<b>Contents:</b>			<b>Material:</b>		<b>Volume:</b>	<b>Contents:</b>		
<b>Notes/Conditions:</b>						<b>Notes/Conditions:</b>
