Inspection Photos

Operator: CAERUS PICEANCE LLC - 10456

Location ID: 334156

Garfield County, CO

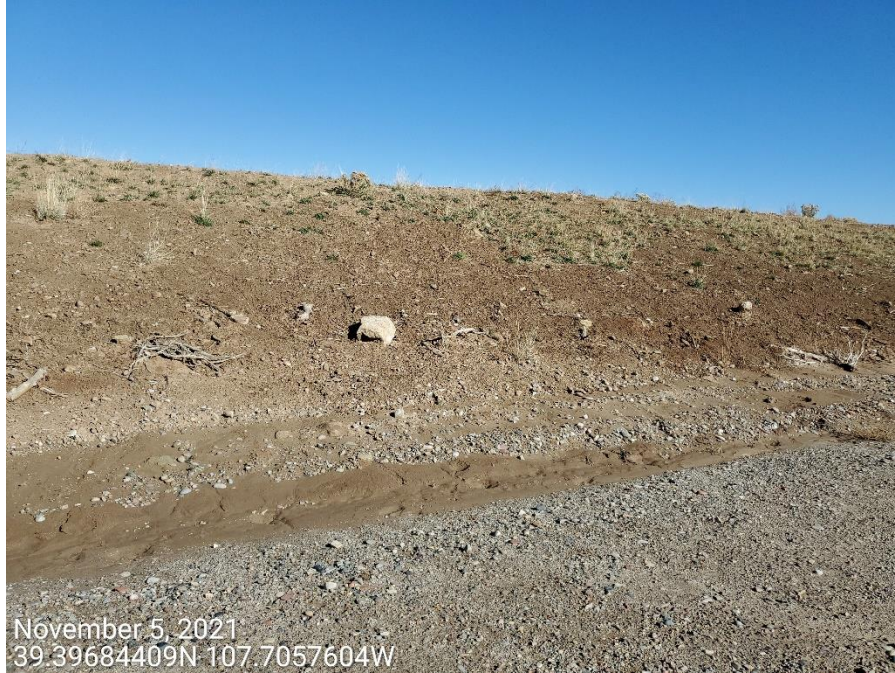
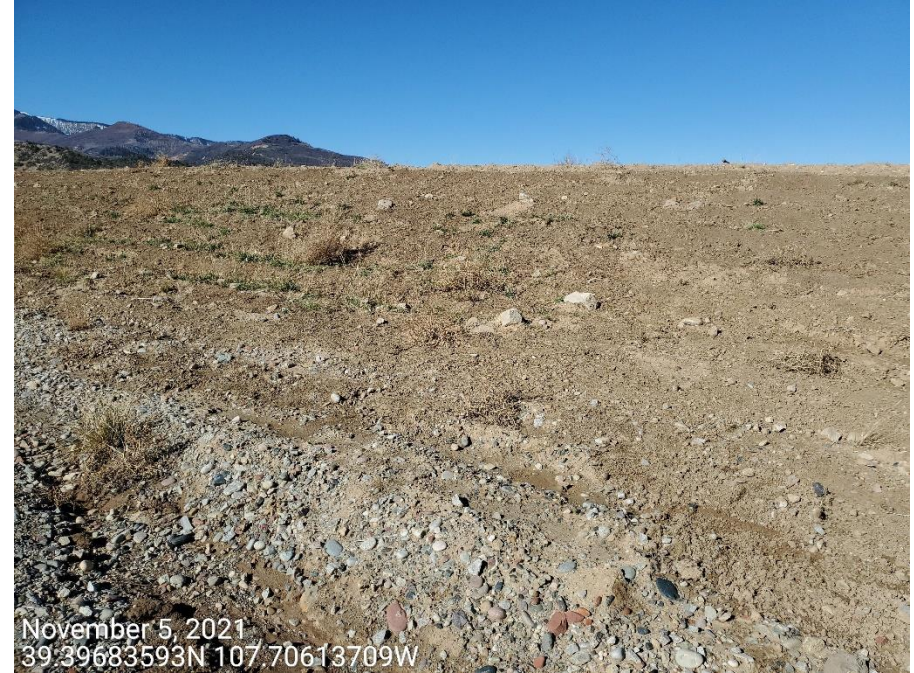
Photo 1: Photos provide examples showing control measures to protect and stabilize the soil stockpiles on the location remain missing or insuffcieint.

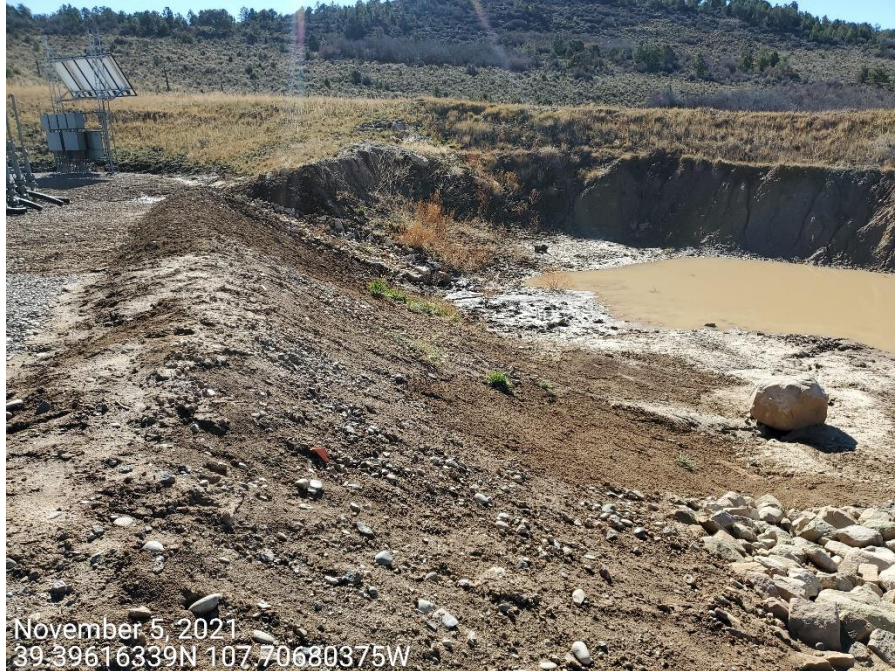
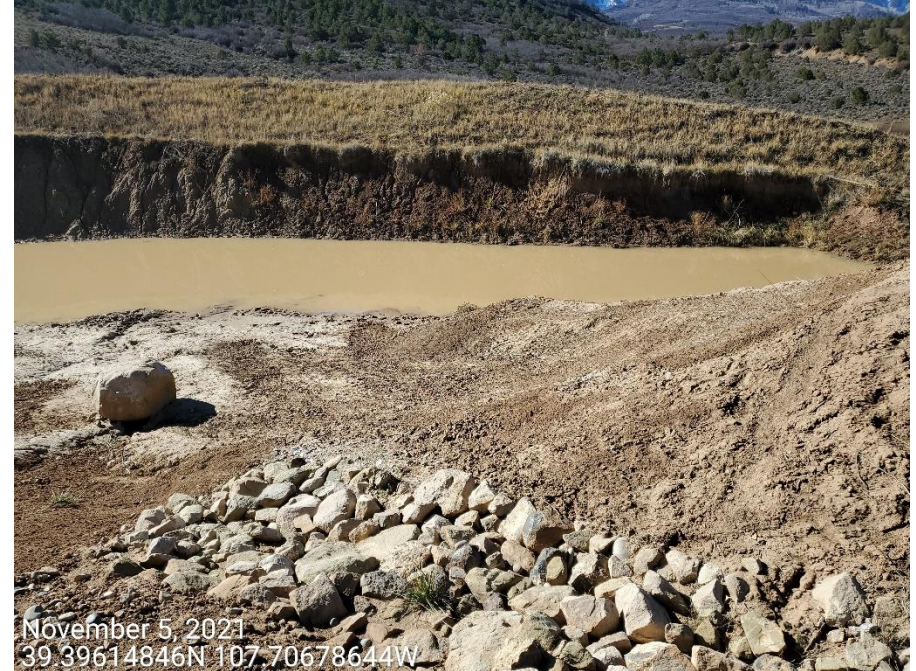
Photo 2: Photos taken from the sediment trap on the west end of the Location.

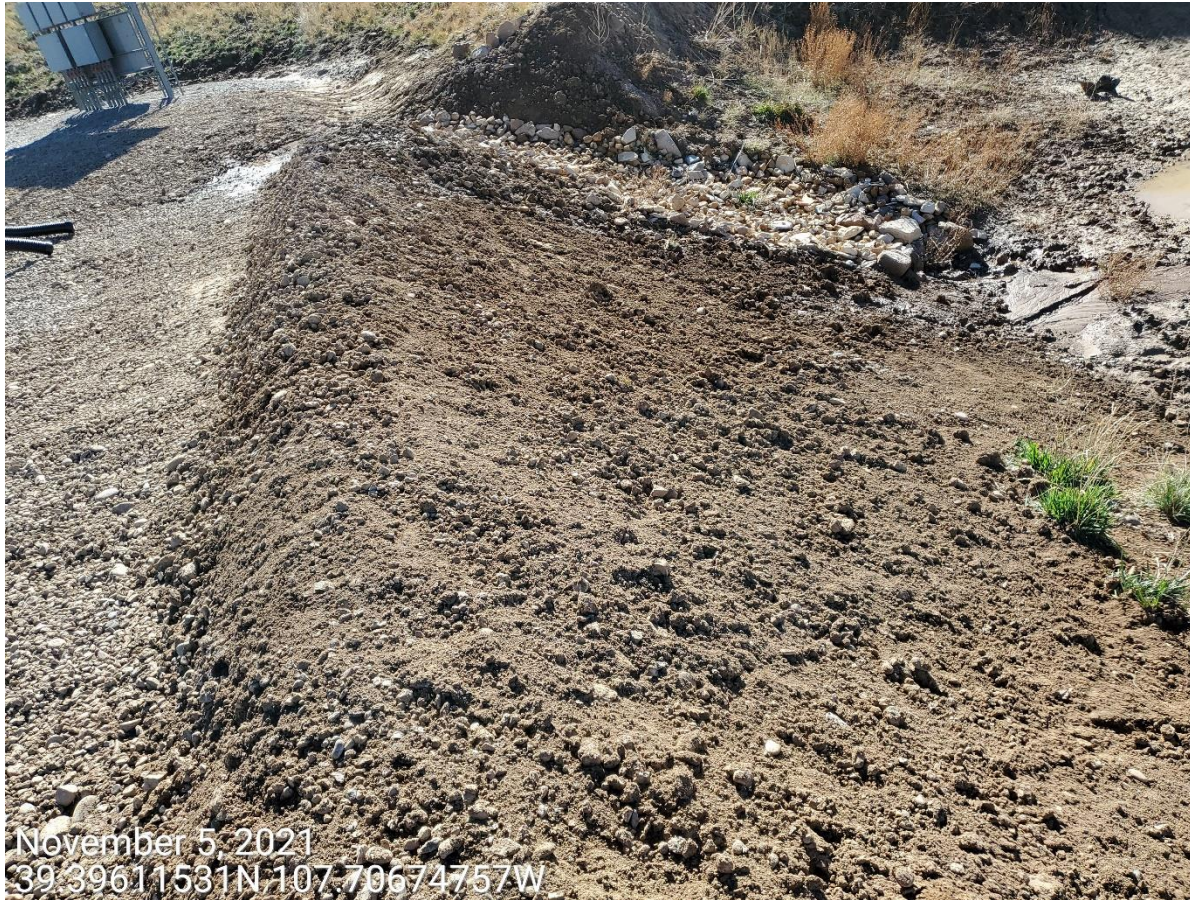
Photo 3: Continued from photo 2. Photo shows Operator has repaired erosion on the east end of the trap, however soils have been left unconsolidated; control measures to stabilize slopes of the sediment trap remain missing or insufficient.

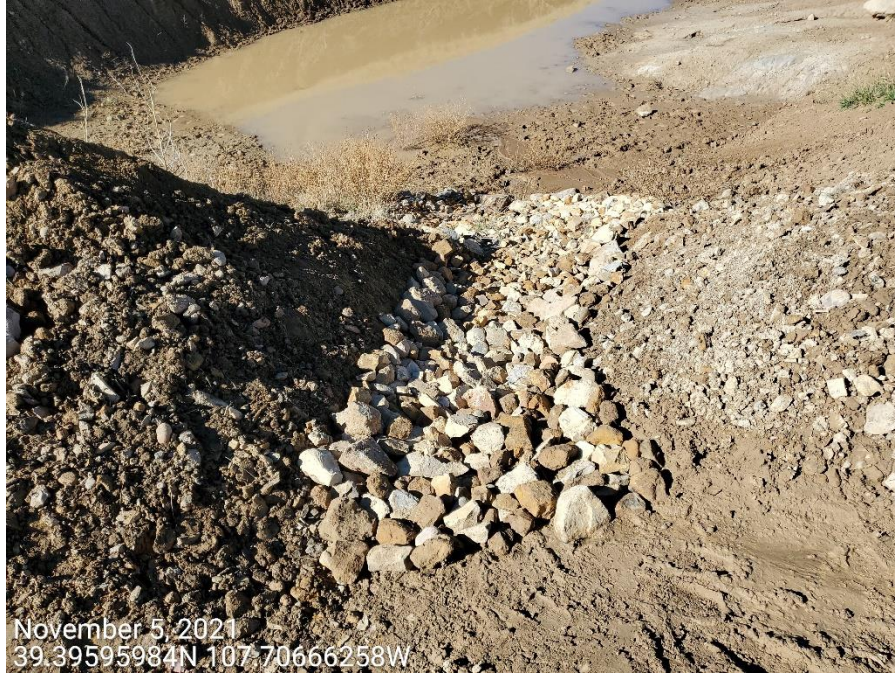
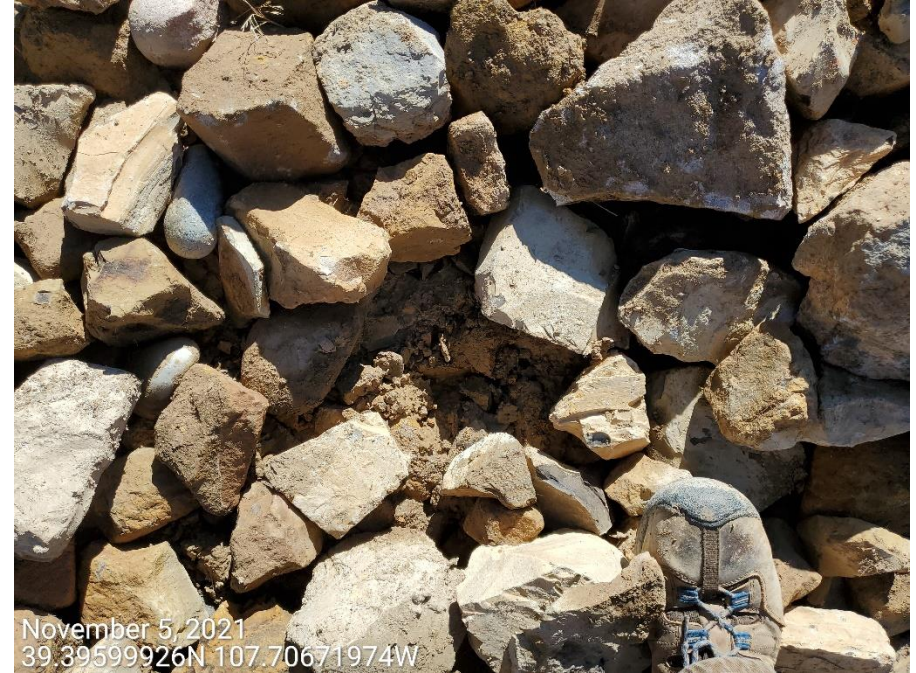
Photo 4: Photos shows the outlet from the production area leading into the sediment trap is improperly armored and missing geotextile lining per good engineering practices.

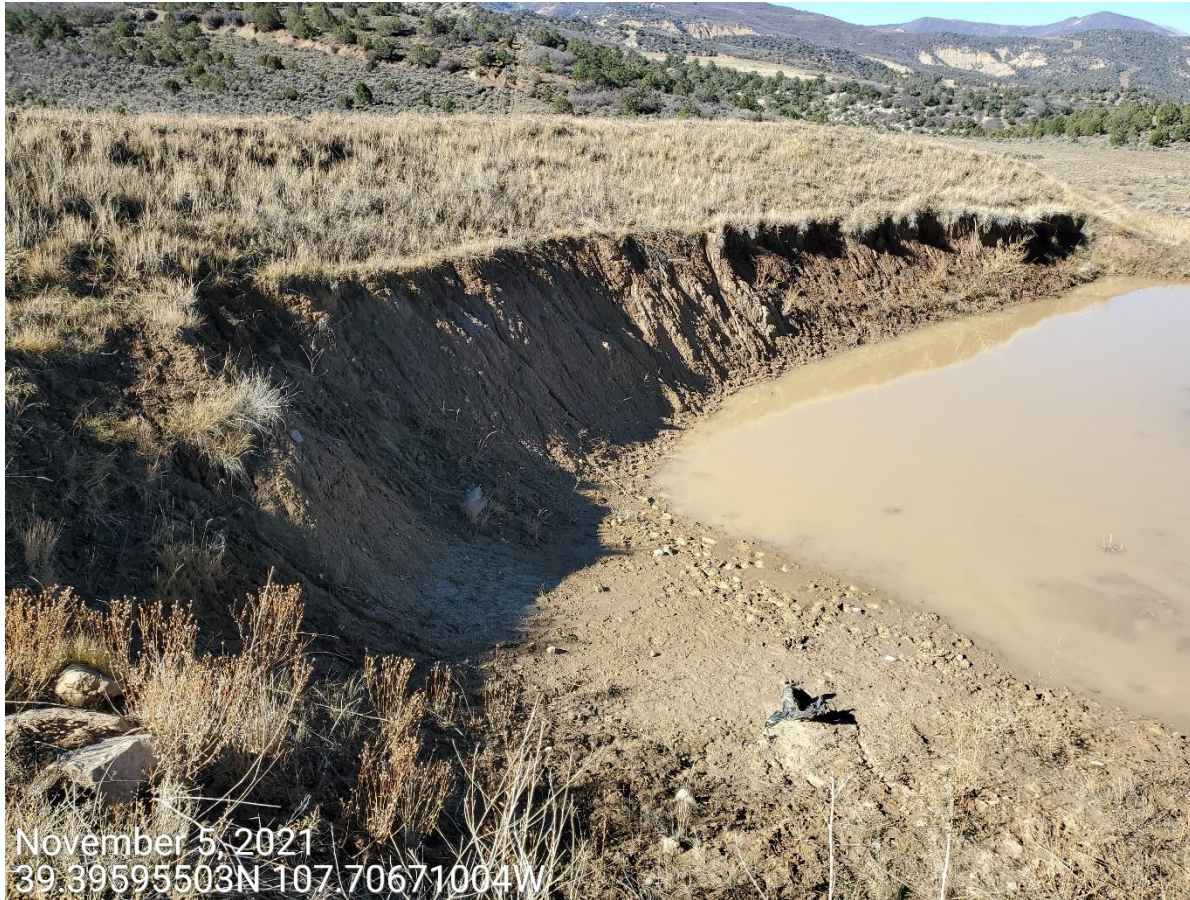
Photo 5: Photo example showing trap has been constructed with steep slopes; rill erosion evident; control measures to stabilize/protect slopes remain missing or insufficient.
