# Inspection Photos

Operator: TEP ROCKY MOUNTAIN LLC #96850

Location ID: 323866

Garfield County, CO

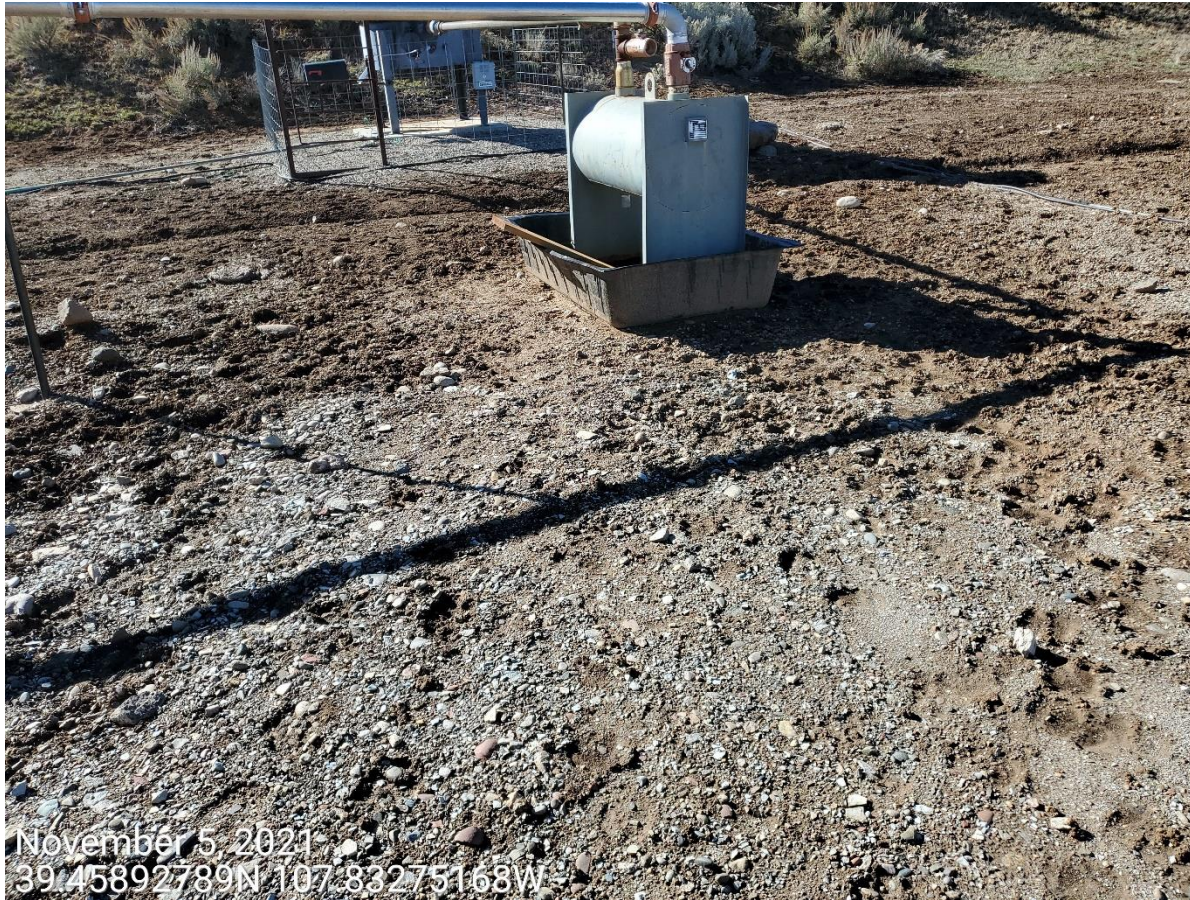
**Photo 1:** Photo shows wildlife protection devices to prevent wildlife access to the containment BMP remains missing or insufficient.

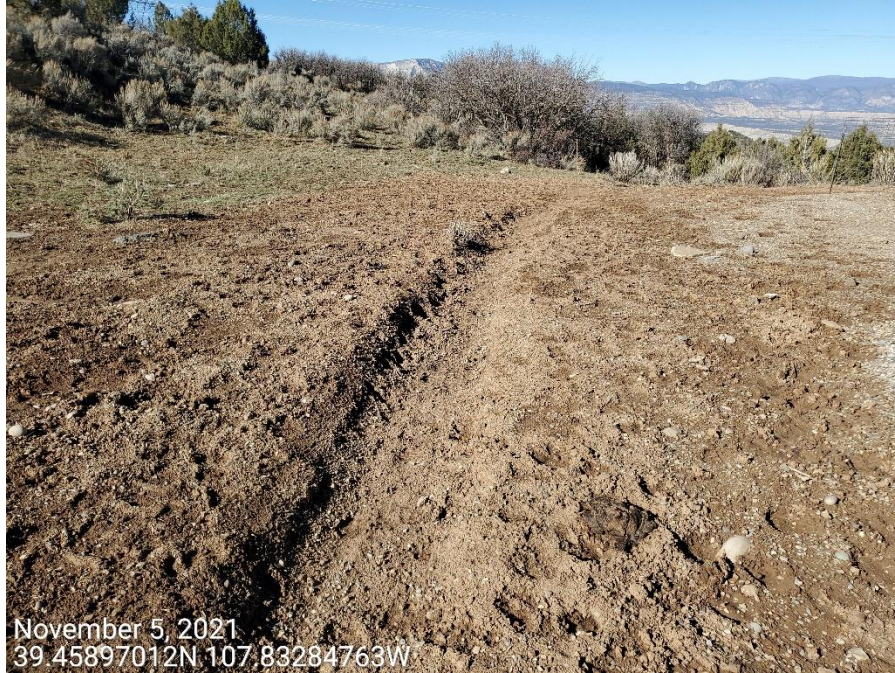
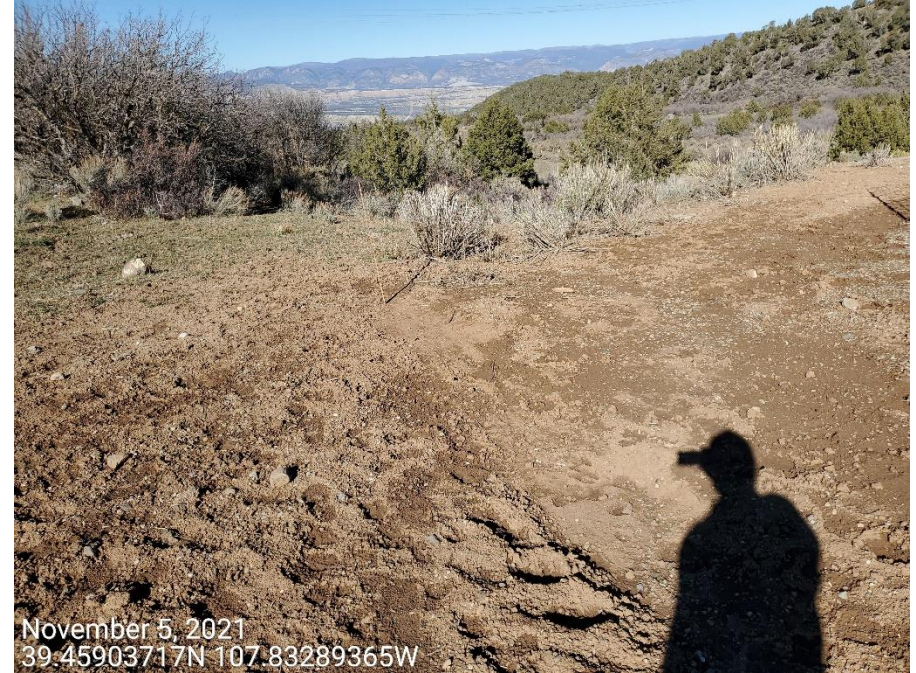
**Photo 2:** Photo taken from the stormwater diversion ditch on the west end of the Location, facing north. Photo shows that the stormwater diversion ditch remains improperly constructed with an outlet, to prevent offsite degradation due to runoff.

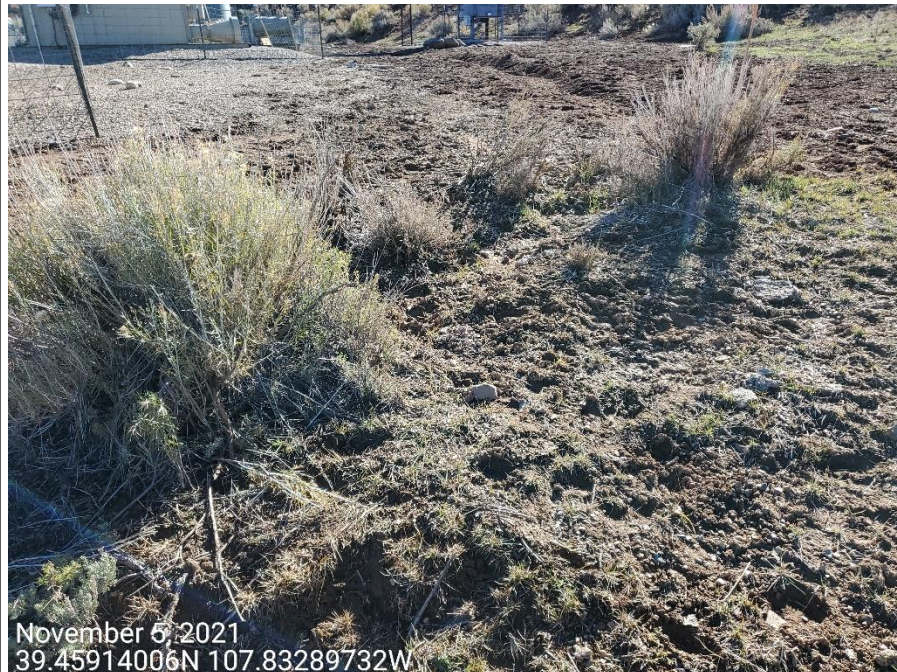
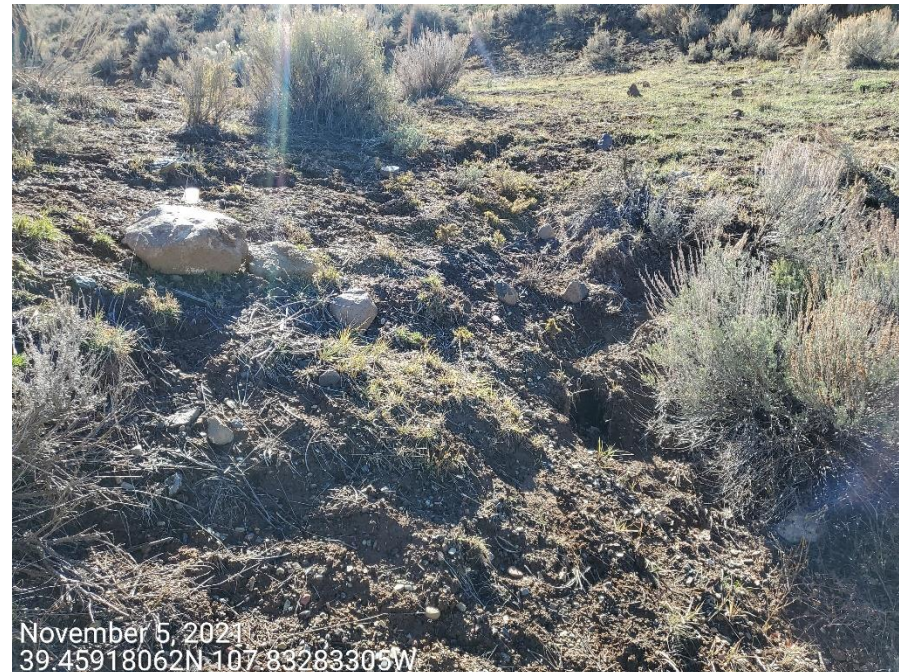
**Photo 3:** Photos taken north of the ditch. Photo shows offsite erosion degradation due to improper stormwater runoff controls on the Location.
