# Inspection Photos

Operator: TEP ROCKY MOUNTAIN LLC #96850

Location ID: 311696

Garfield County, CO

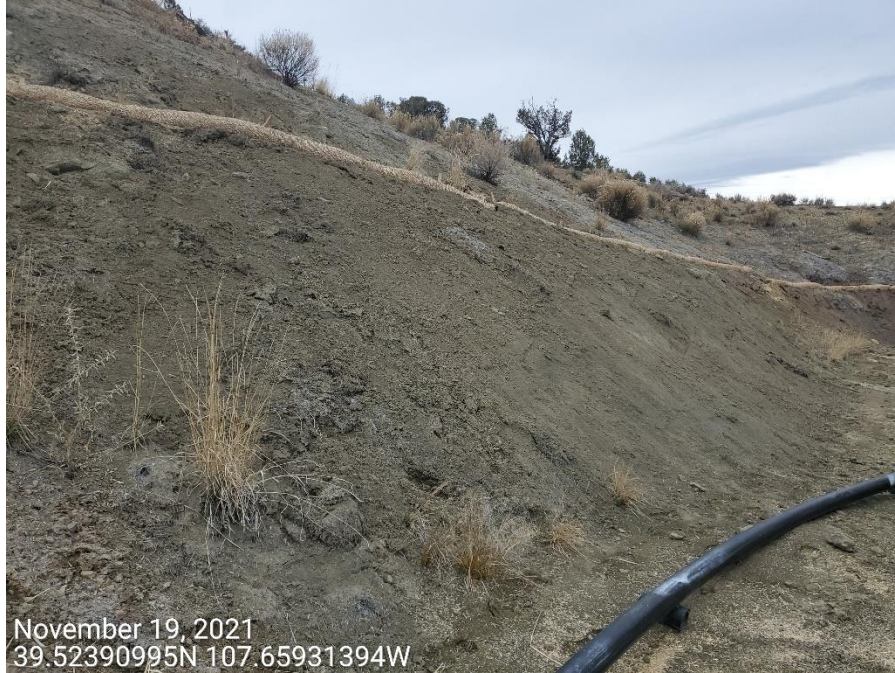
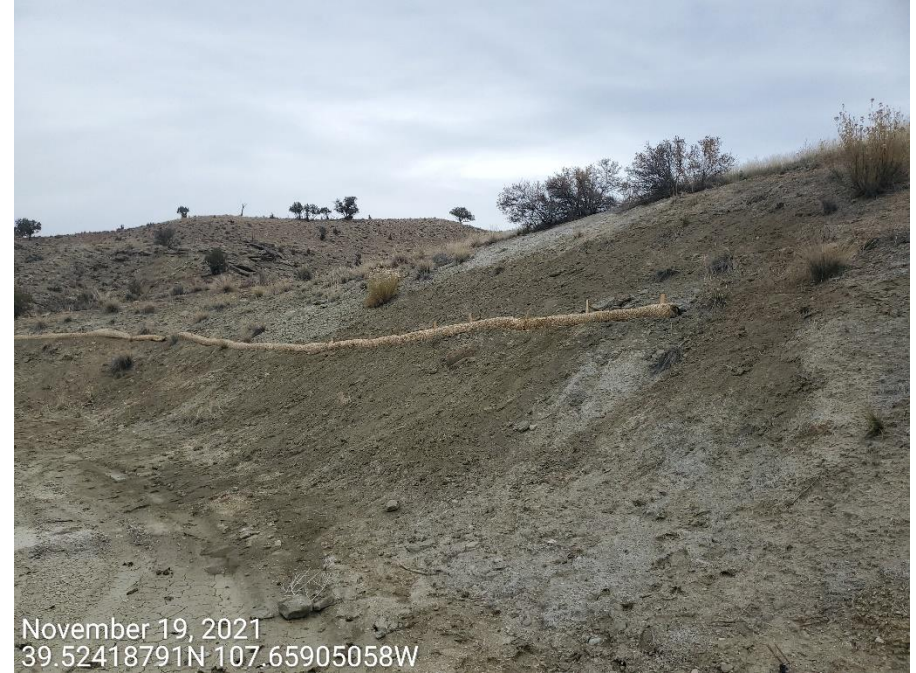
**Photo 1:** Photos taken from the cut slopes along the east end of the Location. Photos provide example showing Operator has placed a single row of straw wattle along portions of the cut slope. Soils along cut slopes remain loose and unstabilized. Control measures to manage runoff, and to protect and stabilize slopes of the Location remain missing or insufficient.

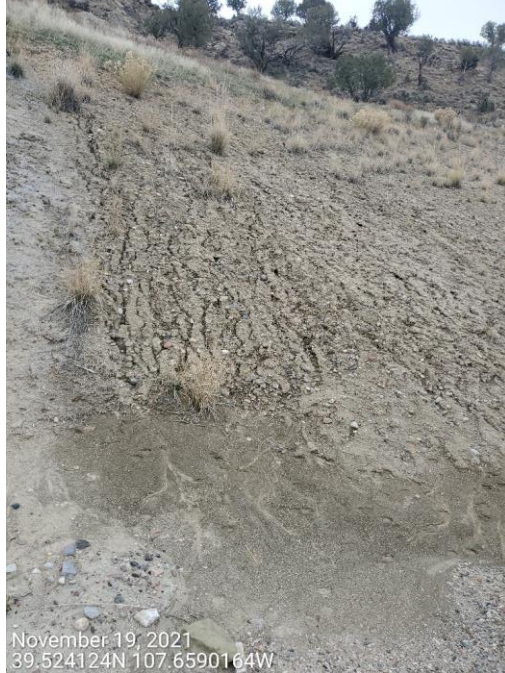
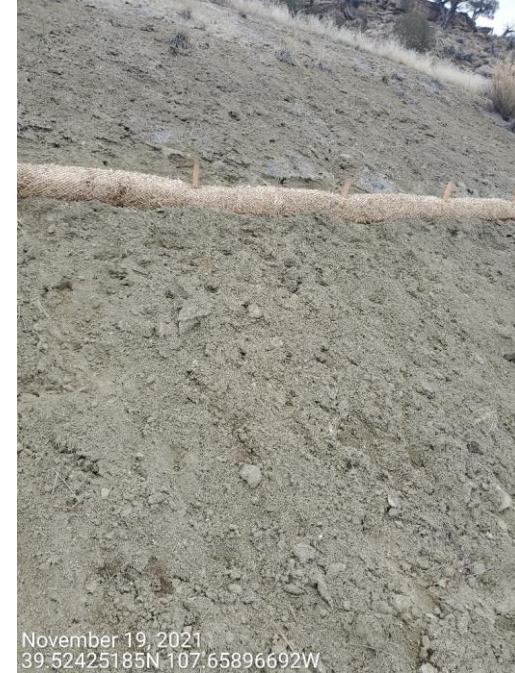
**Photo 2:** Photos taken from the cut slopes along the east end of the Location. Photos provide example showing Operator has placed a single row of straw wattle along portions of the cut slope. Soils along cut slopes remain loose and unstabilized. Control measures to manage runoff, and to protect and stabilize slopes of the Location remain missing or insufficient.

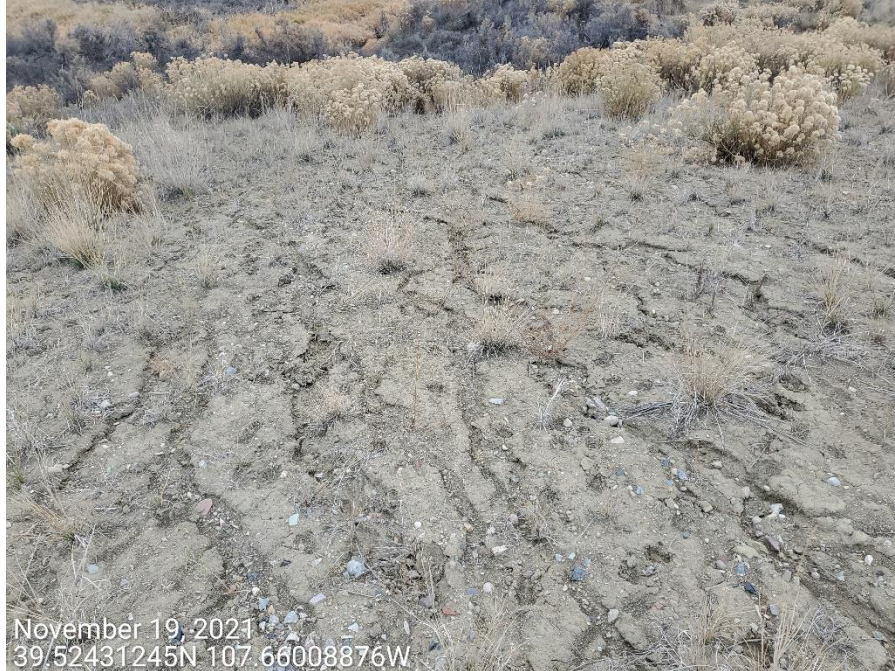
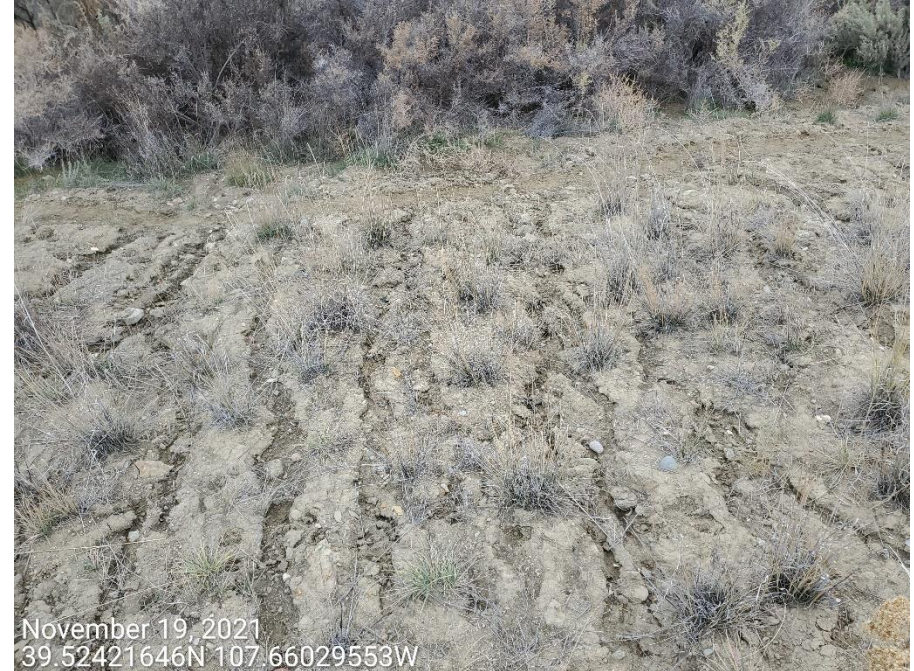
**Photo 3:** Photos taken from the fill slopes along the west end of the Location. Unable to find evidence that work was conducted to address stormwater and erosion degradation issues at the slopes on the west end of the Location. Control measures to manage runoff, and to protect and stabilize slopes of the Location remain missing or insufficient.
