Inspection Photos
Operator: Simcoe
API: 067-08834
Date: 11/17/2021

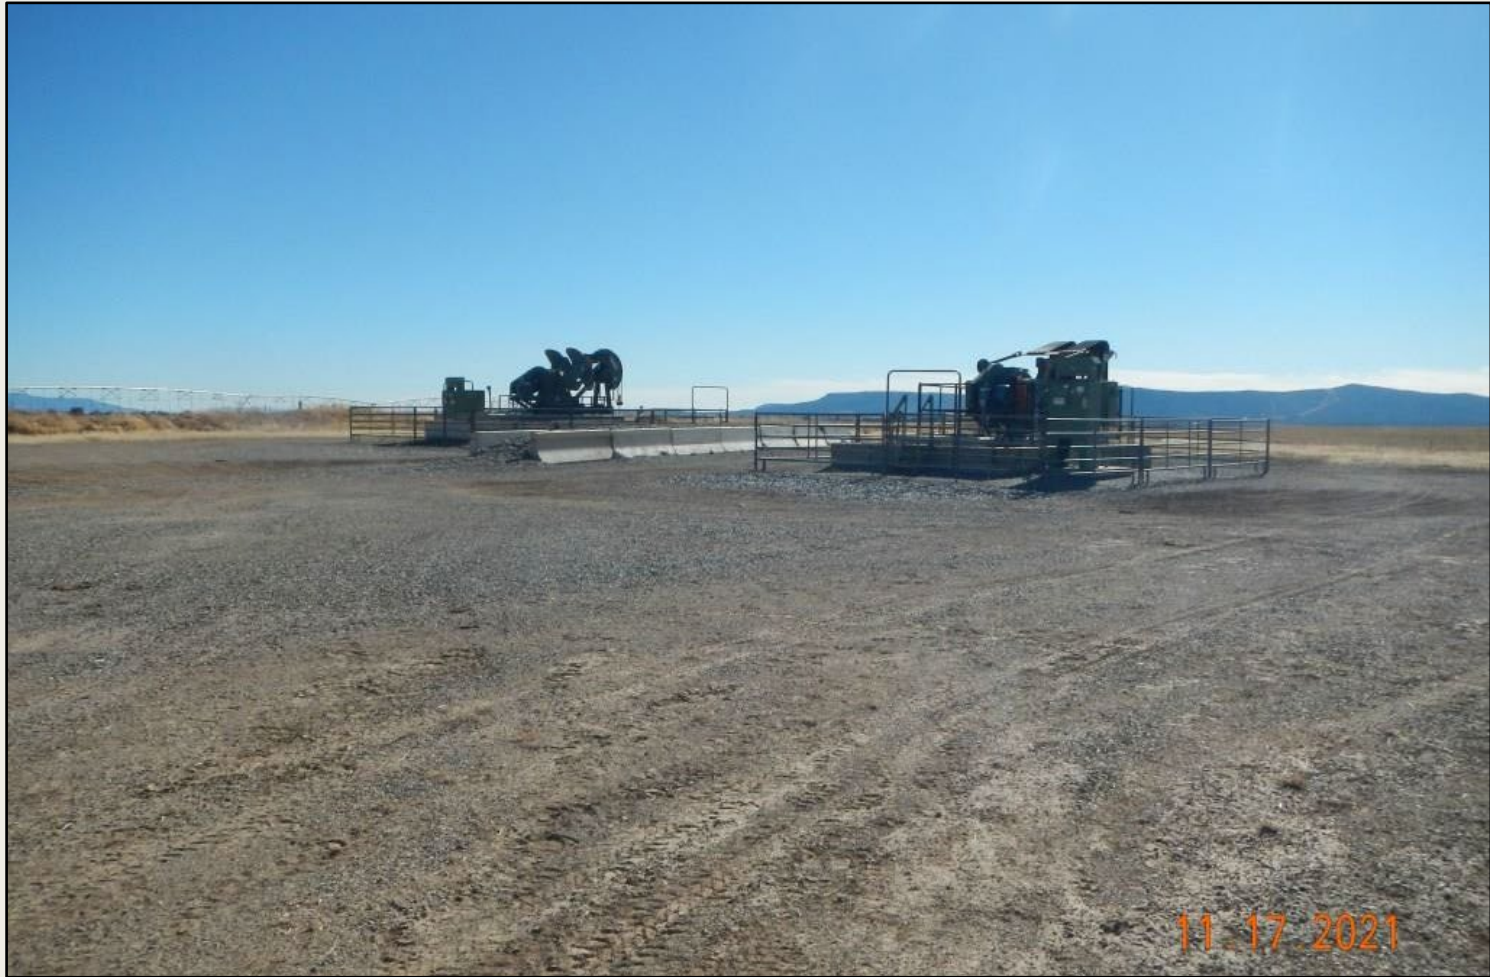
Photo 1. View of the project area from the well pad entrance facing center.

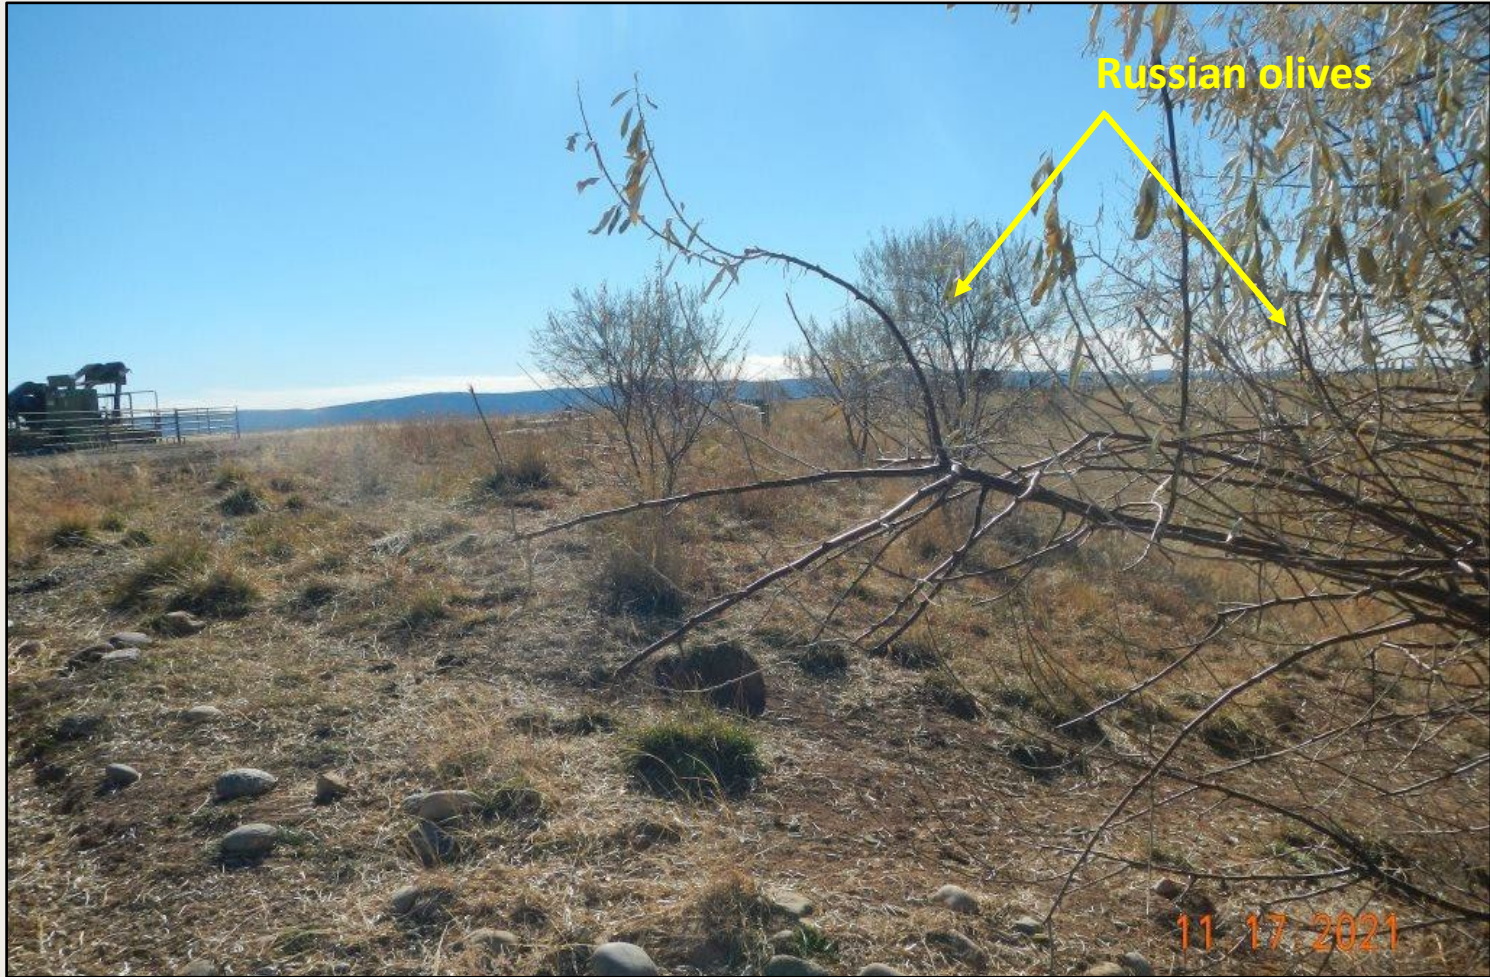
Photo 2. View of the western project area from the northwestern corner facing southward. Approximately 15 Russian olive trees need to be removed. Revegetation is progressing with sand dropseed, western wheatgrass, intermediate wheatgrass.

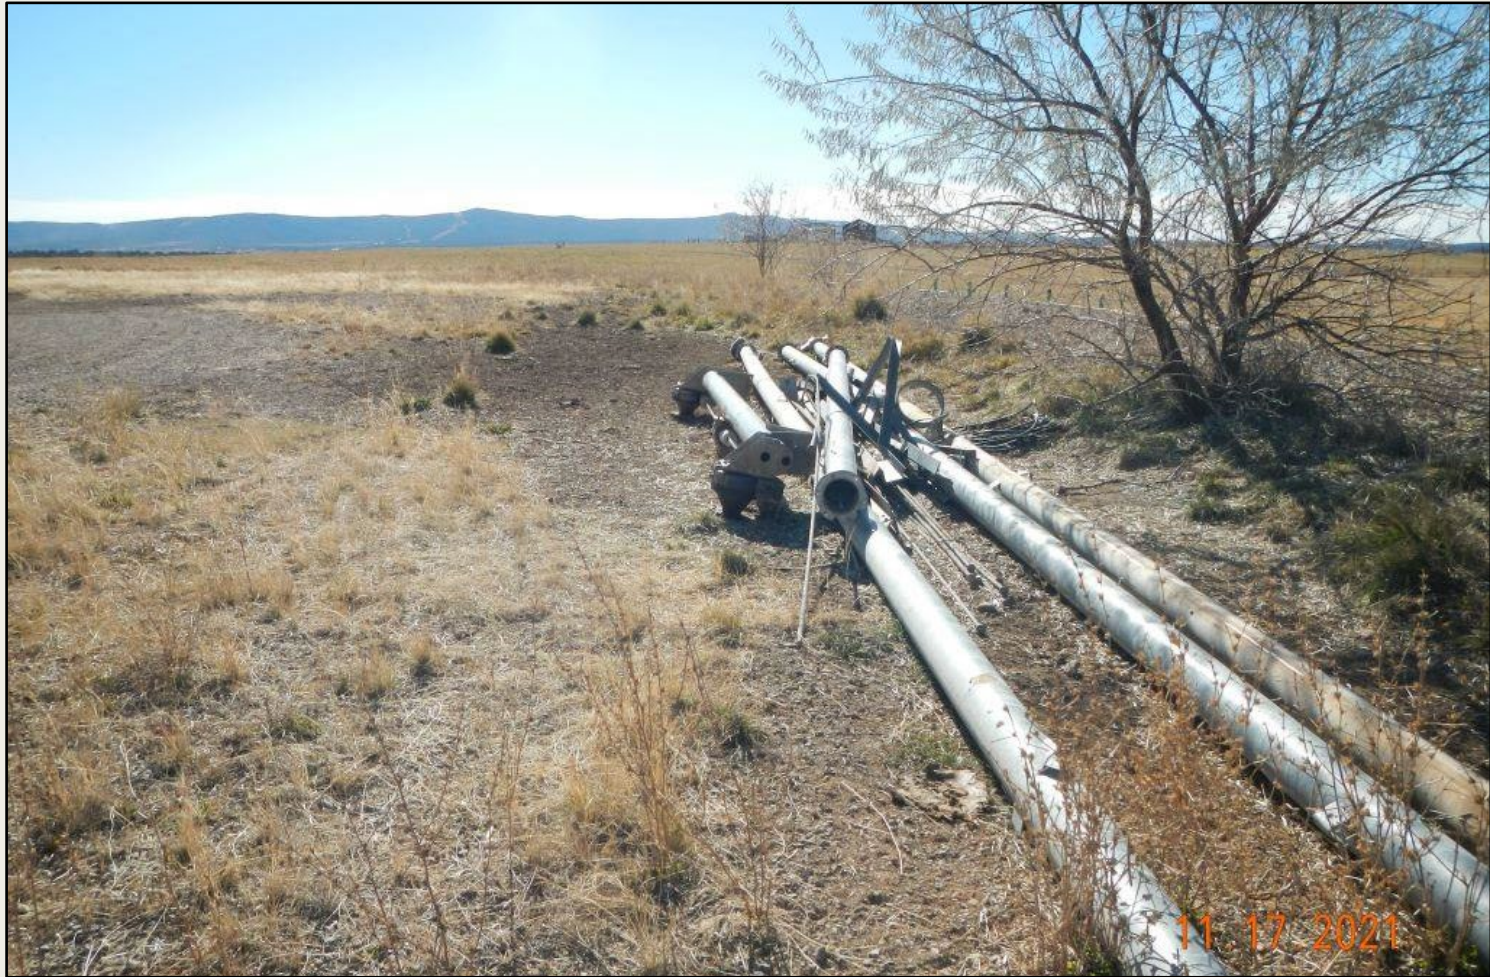
Photo 3. View of pipes within the western project area need to be removed.

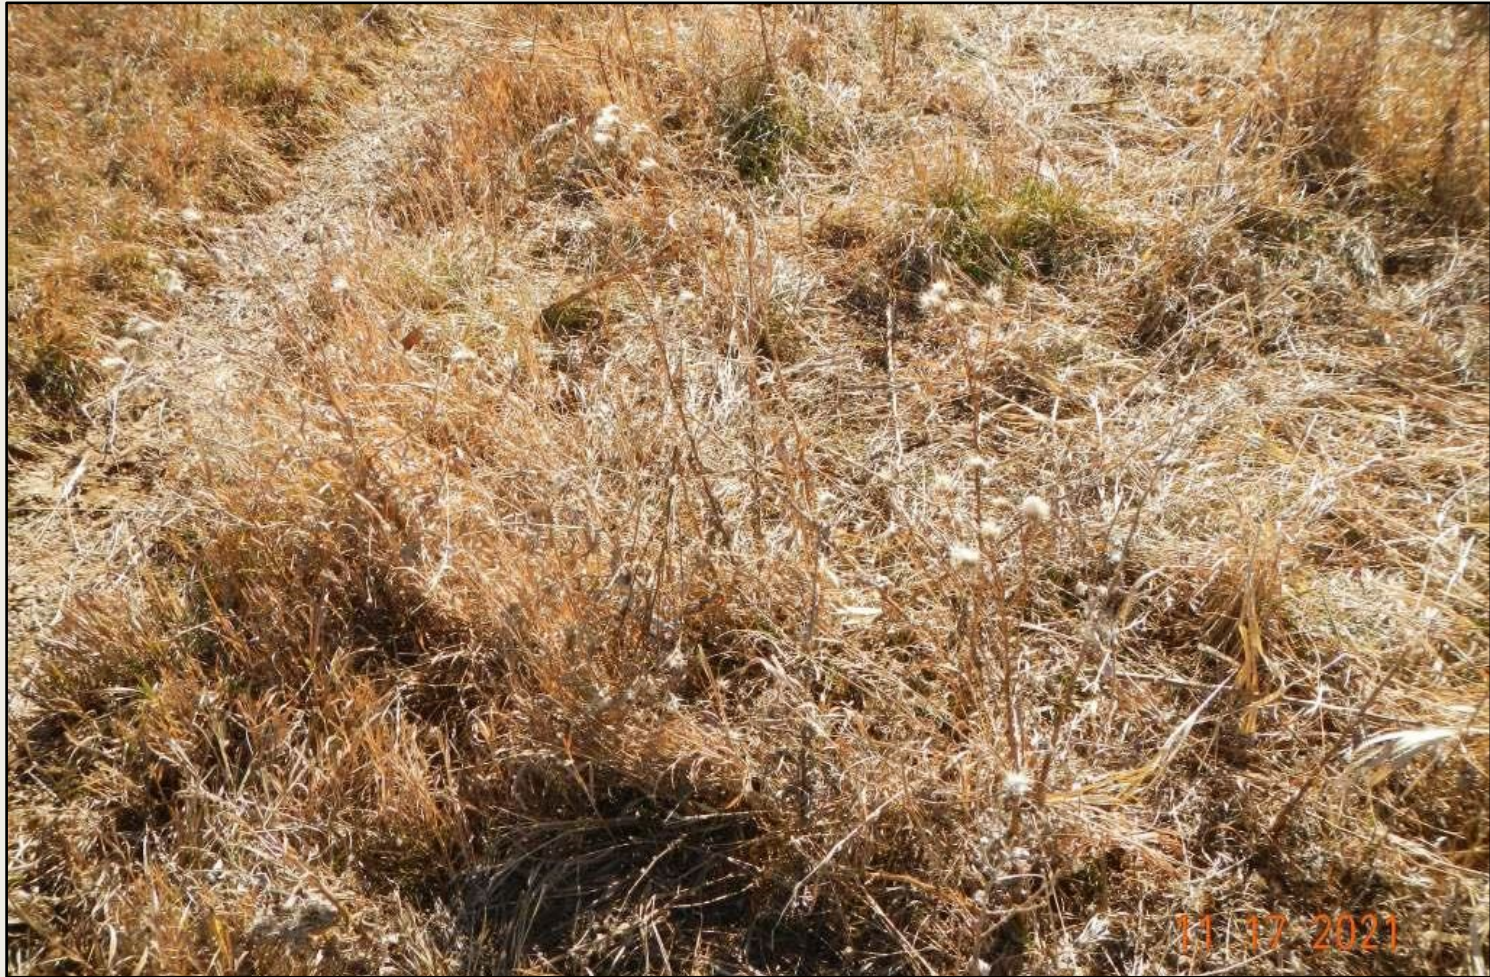
Photo 4. View of Canada thistles need to be controlled within the southwestern project area, approximately 150 individuals observed.

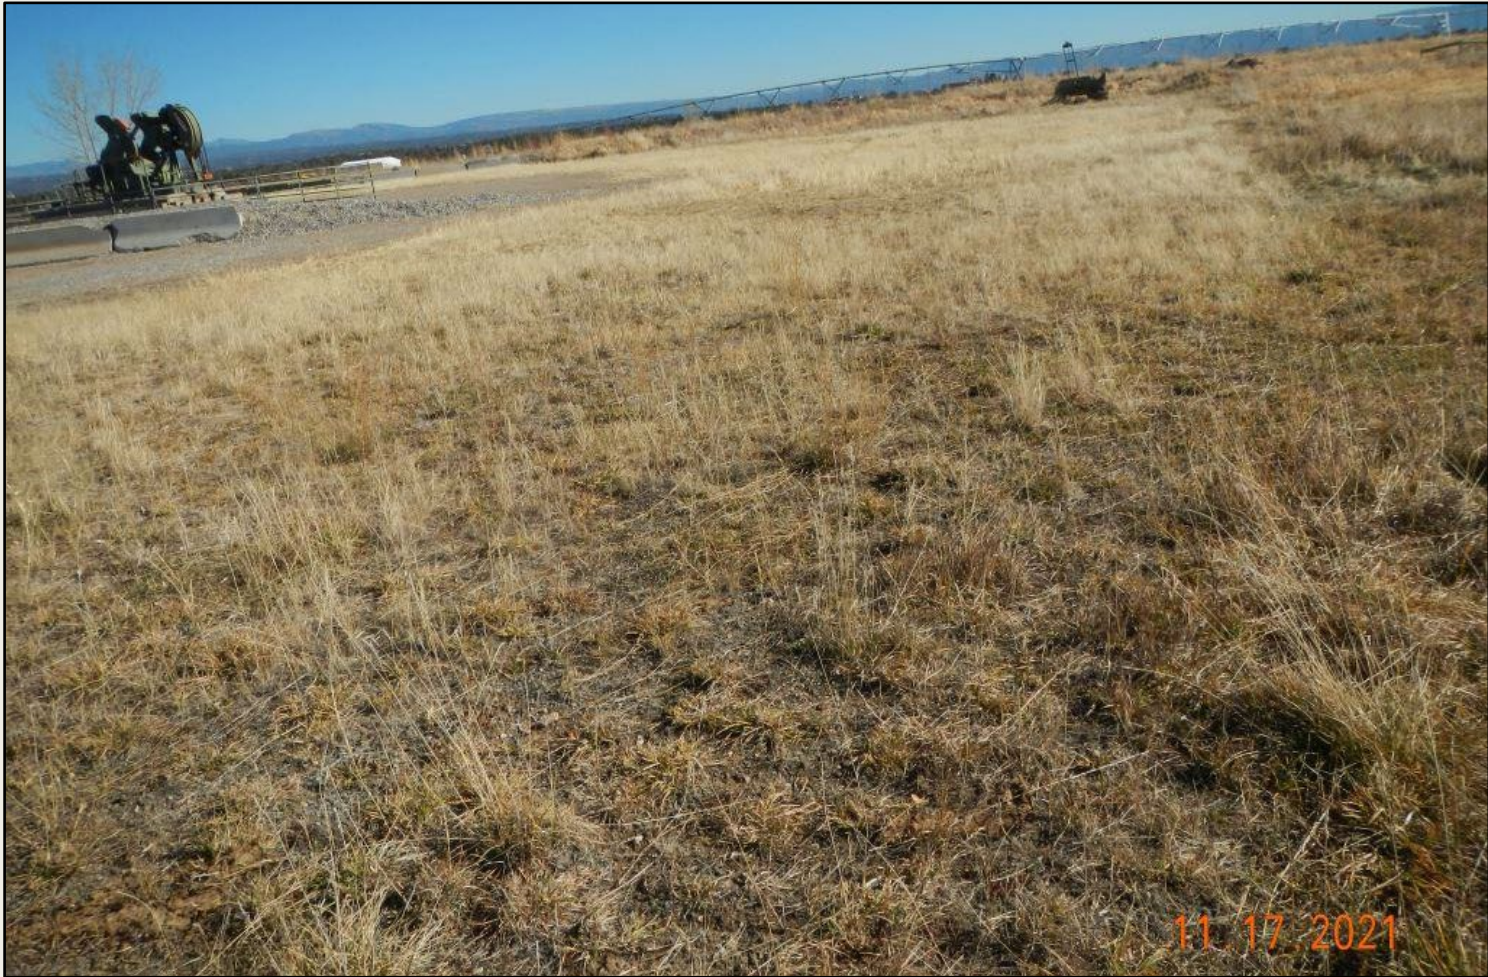
Photo 5. View the southern project area from the southwestern corner facing eastward.

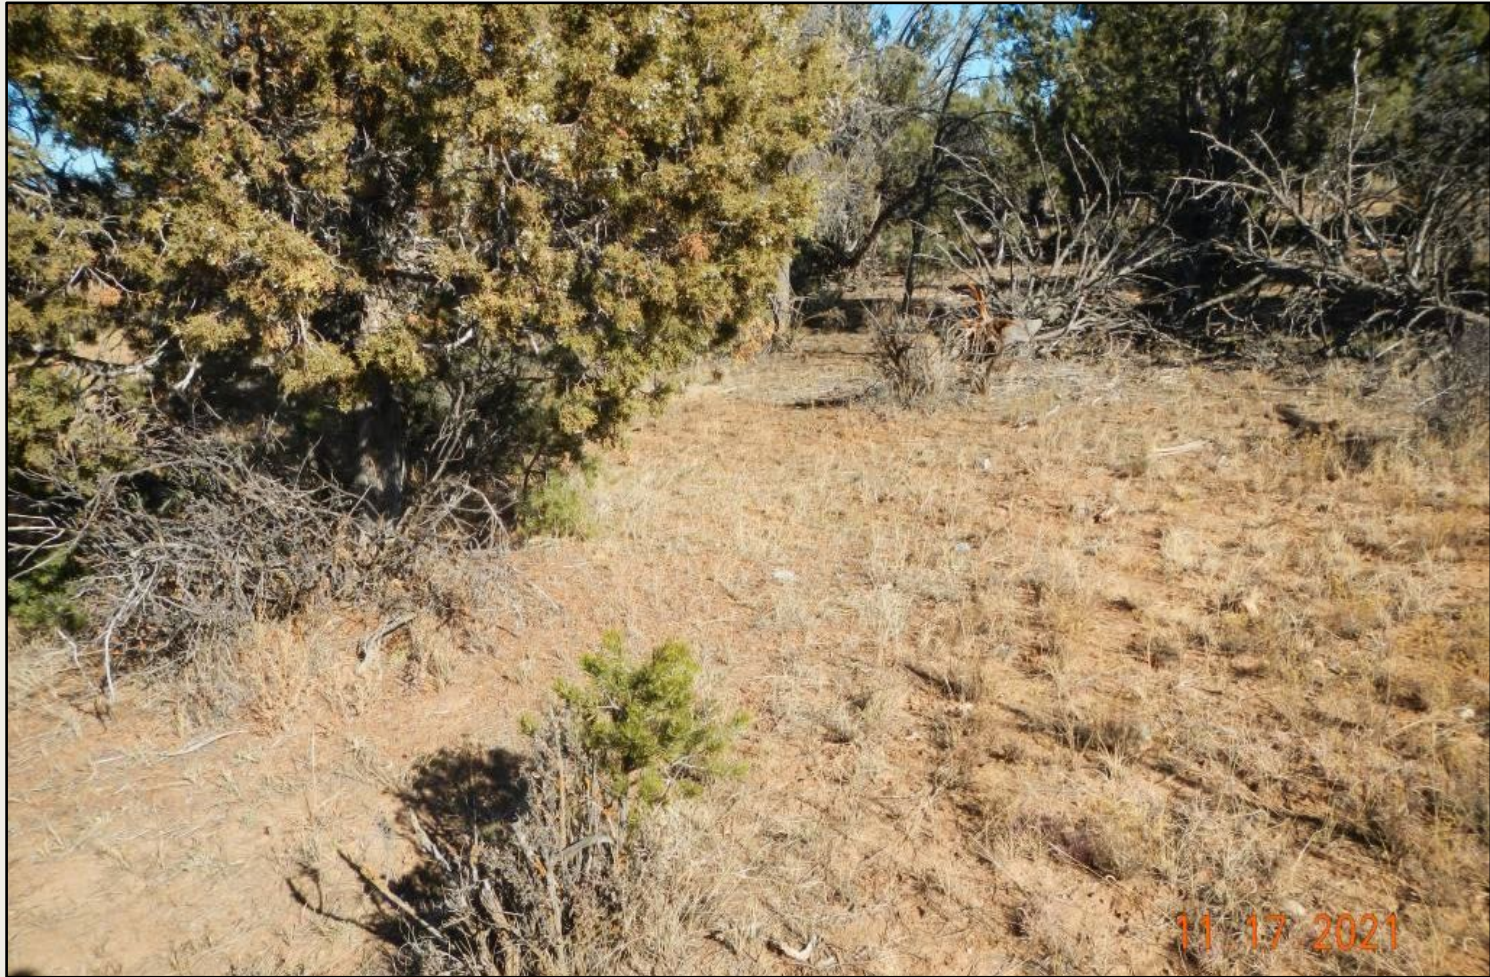
Photo 6. View of reference area comprised of pinyon and juniper woodland with gambel oak, western wheatgrass, and mountain mahogany in the understory.
