## Attachment B

WELLHEAD ABANDONMENT FORM

<b>SITE NAME:</b> Kerbs 1-20 Wellhead							<b>DATE:</b> 5/13/2021		<b>REM. PROJECT #:</b>		<b>WEATHER:</b> 40s Sunny	
<b>SITE DIRECTIONS:</b> 0.2 miles E of county rds 44 & 60, S into							<b>CLIENT:</b> PDC - Erin Crawford					
<b>LEGALS AND LAT/LONG:</b> 40.301565, -104.805232							<b>TASMAN PERSONNEL:</b> Kevin Fletcher					
<b>SOIL TYPES:</b> Clayey Sand - SC							<b>SURFACE GRADIENT:</b> East					
SOIL SAMPLING							FACILITY INFRASTRUCTURE					
Date/Time	Soil Sample ID	PID (ppm)	Visual	Olfactory	Photo?	Grab or Lab Sample?	EQUIPMENT		Quantity			
							Above Ground Storage Tank (AST)					
5/13/2021 16:54	SS01@4'	580.3	HC Staining	HC Odor	Yes	Lab	Buried or Partially Buried Vessel					
5/13/2021 16:55	GS01@3'	24.2	No Staining	HC Odor	Yes	Grab	Separator					
5/13/2021 16:56	GS02@3'	580.1	HC Staining	HC Odor	Yes	Grab	Emission Control Device (ECD)					
5/13/2021 16:57	GS03@3'	483.2	HC Staining	HC Odor	Yes	Grab	Dump Line

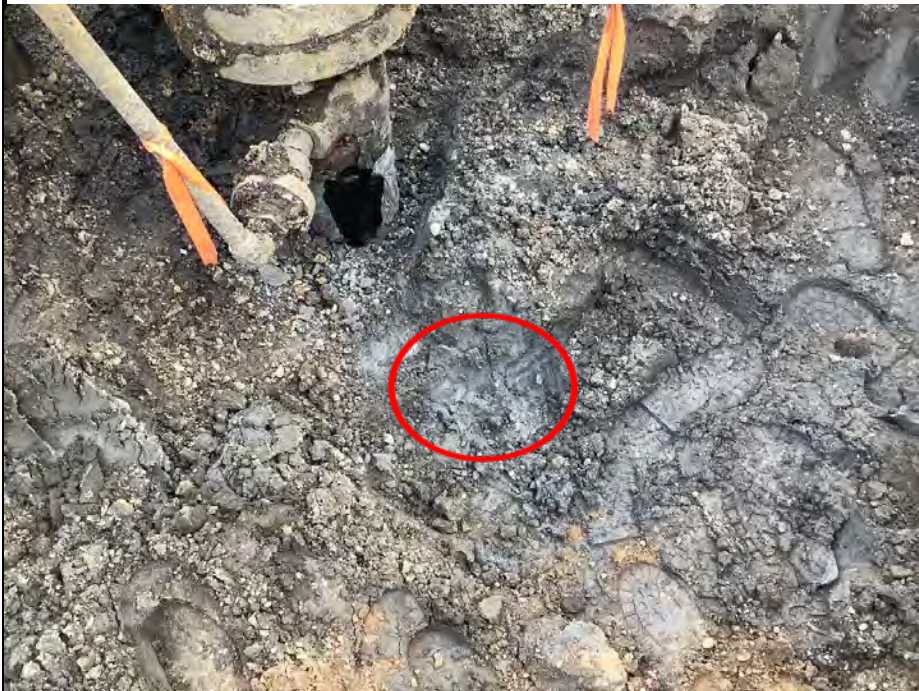
Equipment ID:SS01		Equipment Type:		Equipment ID:GS01		Equipment Type:					
Material:		Volume:		Contents:		Material:		Volume:		Contents:	
Notes/Conditions: SS01@4'						Notes/Conditions: GS01@3'

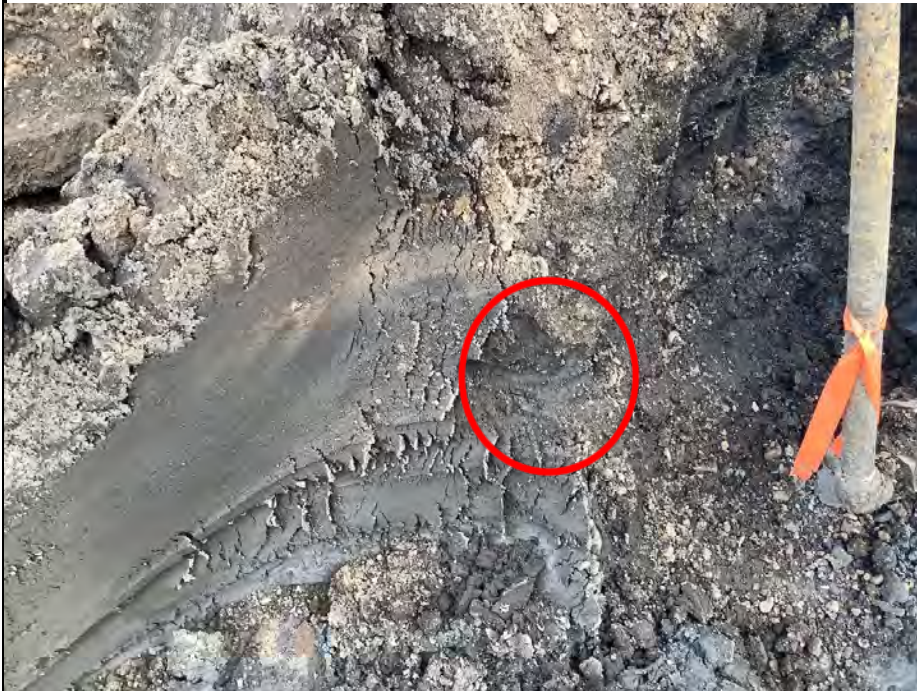
Equipment ID: GS02		Equipment Type:		Equipment ID: GS03		Equipment Type:	
Material:	Volume:	Contents:		Material:	Volume:	Contents:	
Notes/Conditions: GS02 @ 3'				Notes/Conditions: GS03 @ 3'

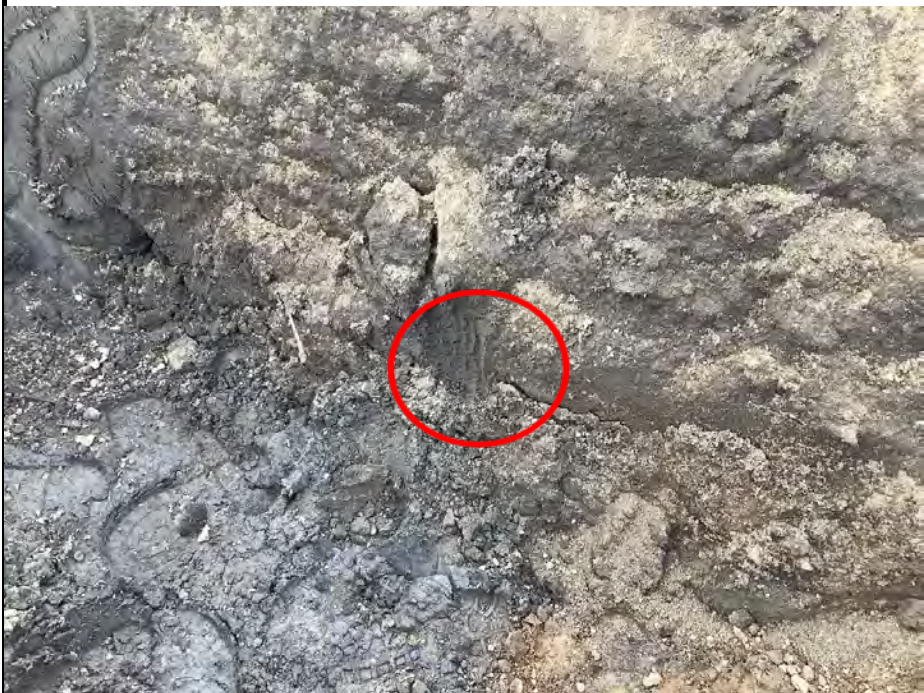
Equipment ID: GS04		Equipment Type:		Equipment ID:		Equipment Type:					
Material:		Volume:		Contents:		Material:		Volume:		Contents:	
Notes/Conditions: GS04 @ 3'						Notes/Conditions:

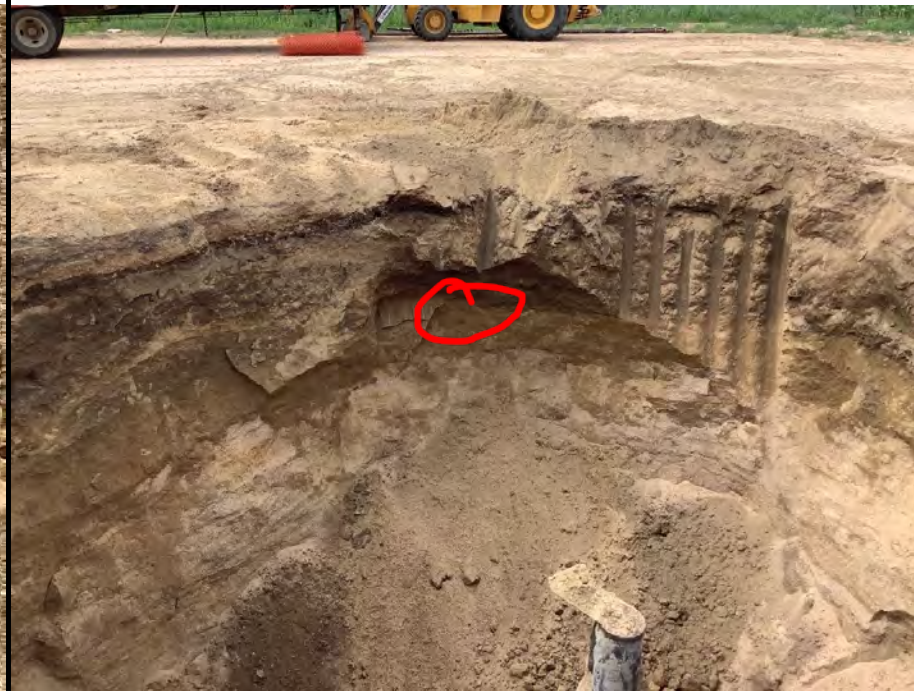
Equipment ID: BKG01		Equipment Type:		Equipment ID: SS03		Equipment Type:	
Material:	Volume:	Contents:		Material:	Volume:	Contents:	
Notes/Conditions:				Notes/Conditions:

6/23/2021 09:36	SS05@4'	4.7	No Staining	No Odor	Yes	Lab	Wellhead				
6/23/2021 09:40	SS06@12'	1.2	No Staining	No Odor	Yes	Lab	Flowline				
6/23/2021 09:46	SS07@4'	3.6	No Staining	No Odor	Yes	Lab	Other:				
6/23/2021 09:50	SS08@12'	2.3	No Staining	No Odor	Yes	Lab	Soil Loads Removed				
6/23/2021 10:02	SS09@4'	1.2	No Staining	No Odor	Yes	Lab	IMPACTED SOIL IDENTIFIED?				
6/23/2021 10:06	SS10@12'	3.5	No Staining	No Odor	Yes	Lab	ESTIMATED VOLUME OF IMPACTS:				
6/23/2021 10:45	SS11@2.5'	0.7	No Staining	No Odor	Yes	Lab	Date		Number	CY	
6/23/2021 10:52	BKG01@2.5'	0.8	No Staining	No Odor	Yes	Lab	6/23/2021		9	90	
6/23/2021 11:50	SS12@15'	17.3	No Staining	No Odor	Yes	Lab					
6/23/2021 11:58	SS13@14'	0.7	No Staining	No Odor	Yes	Lab					
6/23/2021 12:06	SS14@14'	1.3	No Staining	No Odor	Yes	Lab					
6/23/2021 12:12	SS15@14'	0.6	No Staining	No Odor	Yes	Lab	Total Removed		9	90	
6/23/2021 12:20	SS16@14'	0.6	No Staining	No Odor	Yes	Lab	Disposal Facility: WM - Ault

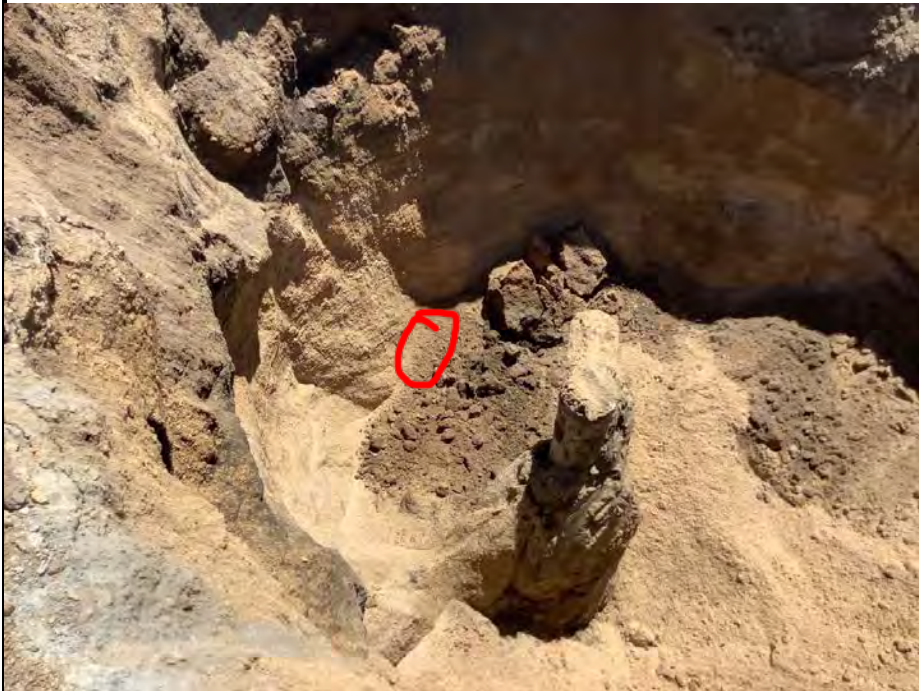
Equipment ID: GS07		Equipment Type:		Equipment ID: GS08		Equipment Type:	
Material:	Volume:	Contents:		Material:	Volume:	Contents:	
Notes/Conditions:				Notes/Conditions:

6/22/2021 13:07	GS07@12'	85.8	No Staining	HC Odor	Yes	Grab	Wellhead		1			
6/22/2021 13:10	GS08@4'	160.8	HC Staining	HC Odor	Yes	Grab	Flowline		1			
6/22/2021 13:12	GS09@12'	64.2	No Staining	HC Odor	Yes	Grab	Other:					
6/22/2021 13:16	GS10@4'	75.8	HC Staining	HC Odor	Yes	Grab	Soil Loads Removed					
6/22/2021 13:19	GS11@12'	118.4	No Staining	HC Odor	Yes	Grab	IMPACTED SOIL IDENTIFIED?					
							ESTIMATED VOLUME OF IMPACTS:					
							Date		Number		CY	
							6/22/2021		8		80	
							Total Removed		8		80	
							Disposal Facility: WM - Ault					
							Groundwater Recovery					
							DATE GW ENCOUNTERED:			DEPTH:		
							GROUNDWATER IN CONTACT WITH IMPACTED SOIL?					
							LNAPL OR SHEEN OBSERVED ON GW?					
GROUNDWATER SAMPLING							Date		BBLS			
Date/Time	Groundwater Sample ID	Depth Collected	Turbid?	Sheen?	Odor?	Photo?						
							Total Removed		0			
							Disposal Facility:
