# Interim Reclamation and Stormwater Inspection

Operator: EDGE ENERGY II LLC- #10671

Location ID: 456286

Inspection Photos  
Location Name: Deporter /29-A Pad  
Location ID: 456286

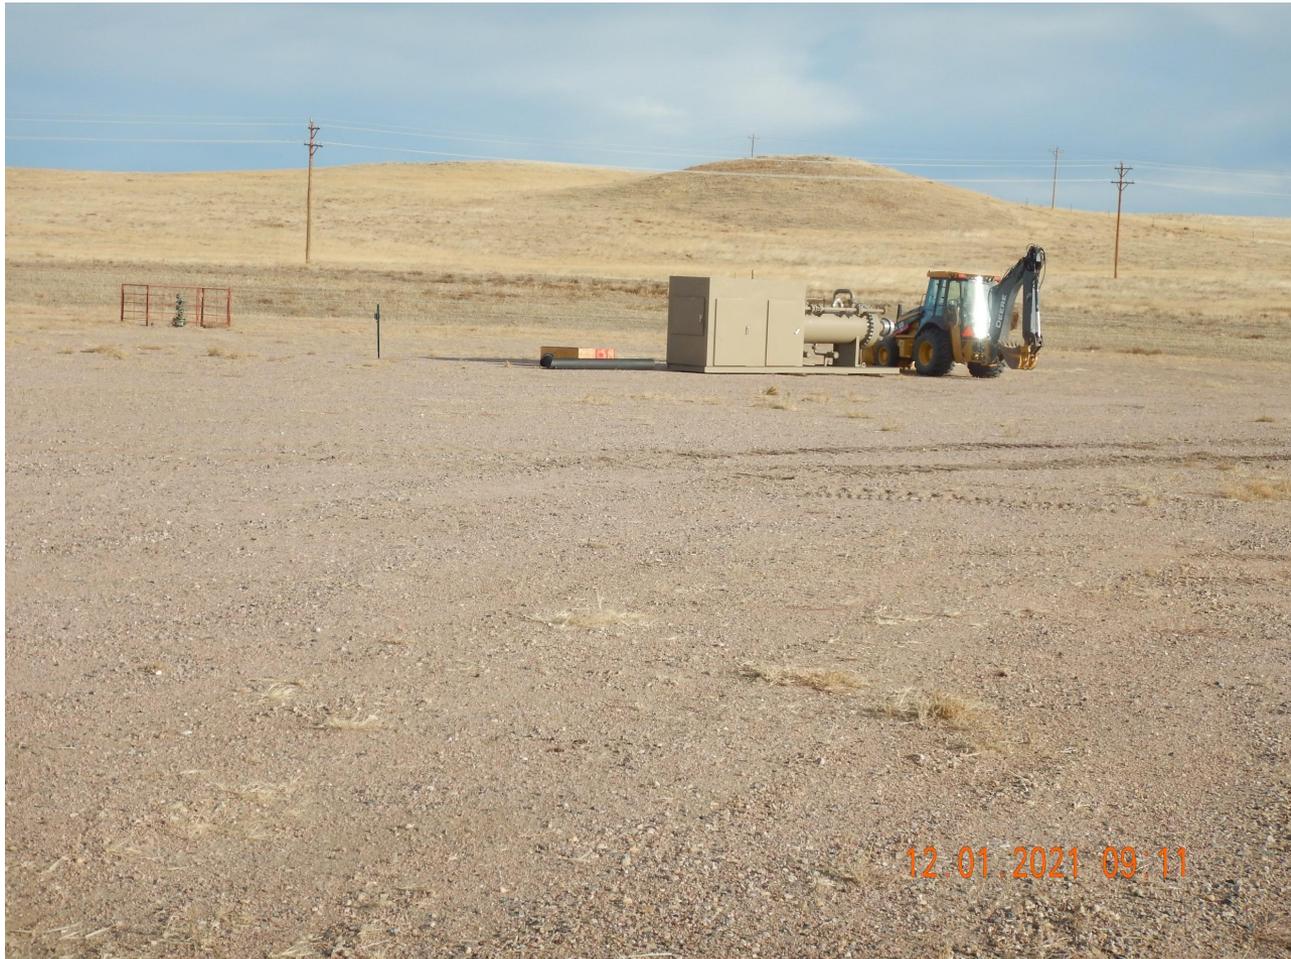
**Photo 1.** Photo taken from location, facing Northeast. Photo illustrates Operator is starting to mobilize equipment to location.

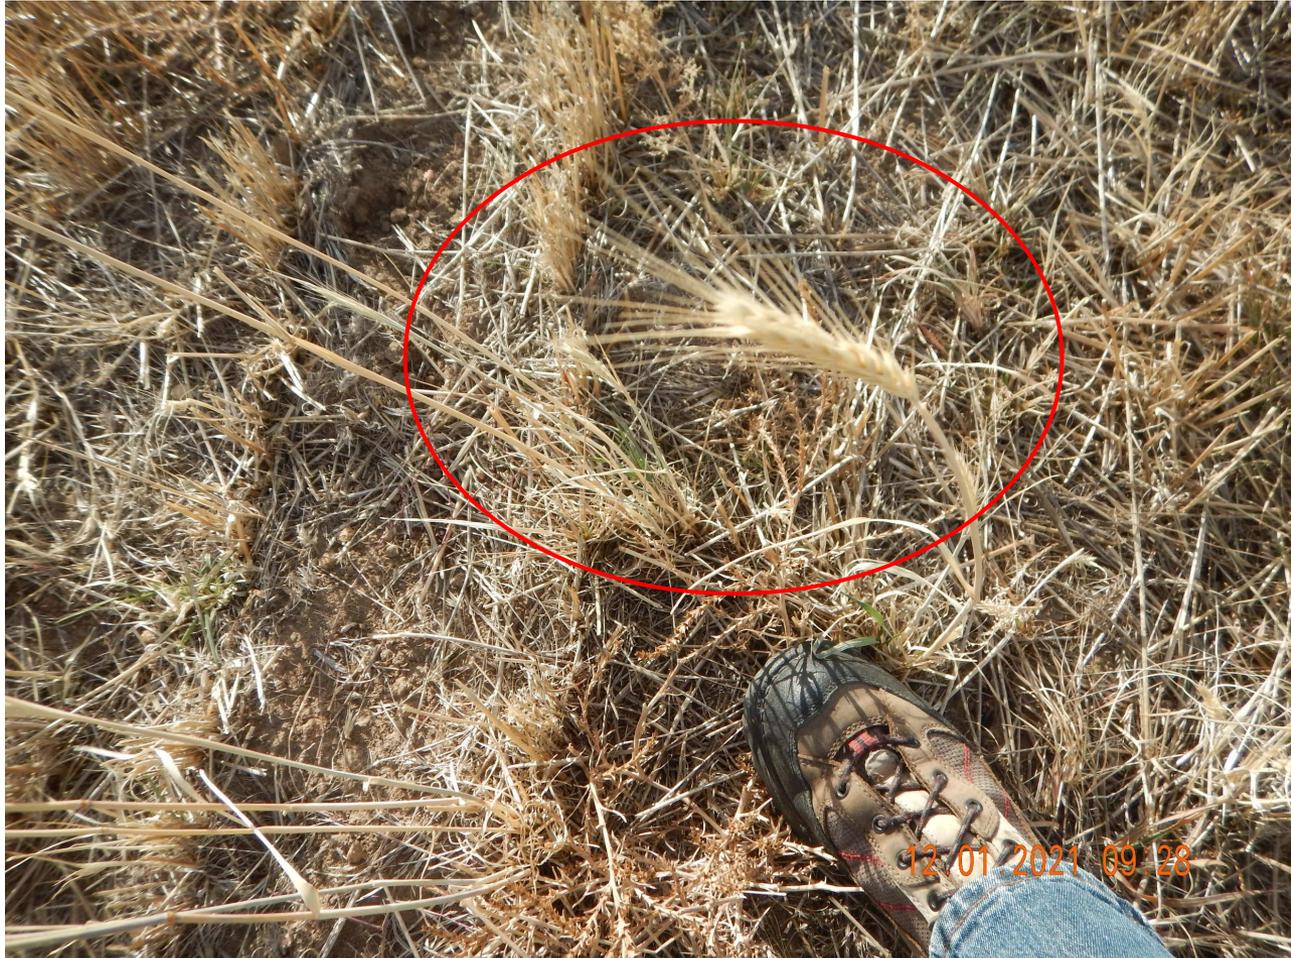
**Photo 2.** Photo taken from a portion of the interim reclamation area. Photo illustrates Common rye that has matured and gone to seed. This was observed throughout the interim reclamation areas.

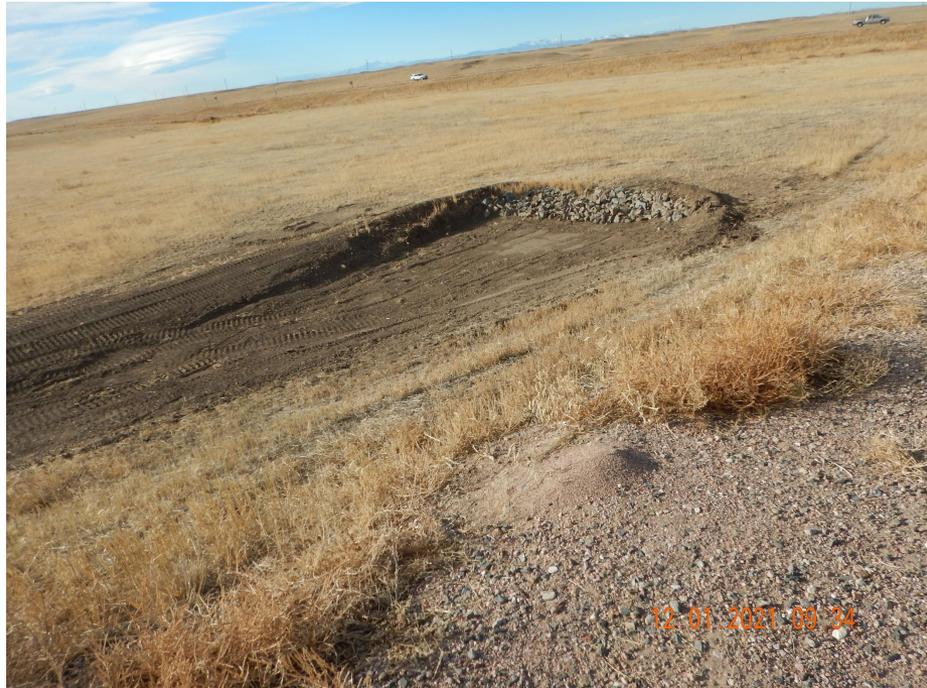
**Photo 3.** Photo taken from the southwestern location, facing Southwest. Photo illustrates Operator has enlarged the previous sediment trap to a stormwater pond with a stabilized outlet.

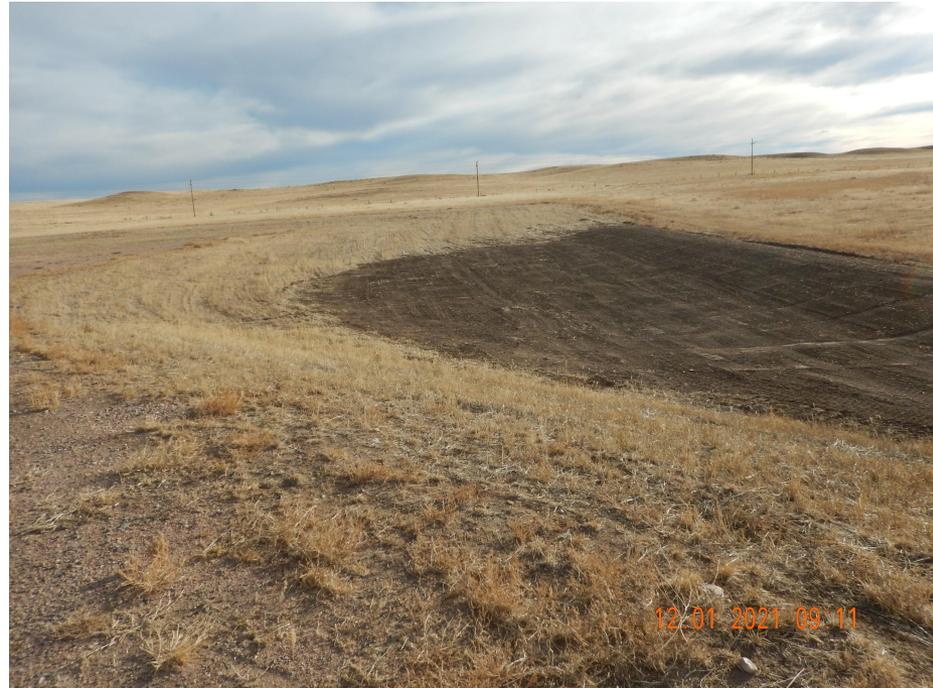
**Photo 4.** Photo taken from the southwestern location, facing East. Photo illustrates the eastern stormwater pond.

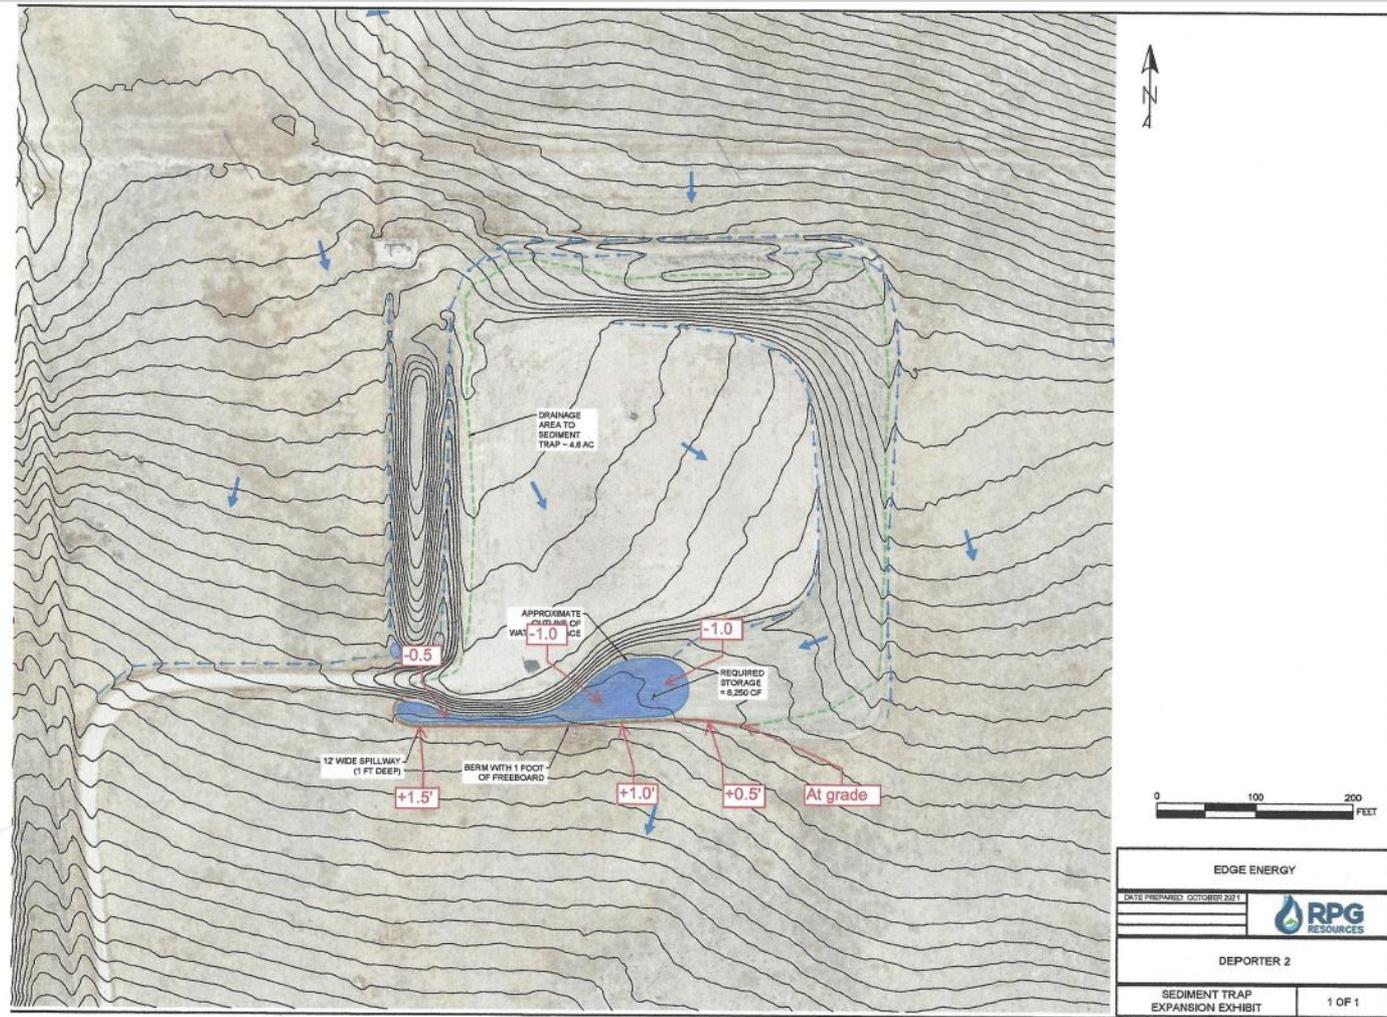
**Photo 5.** Photo illustrates the engineered designed 8250 CF stormwater pond

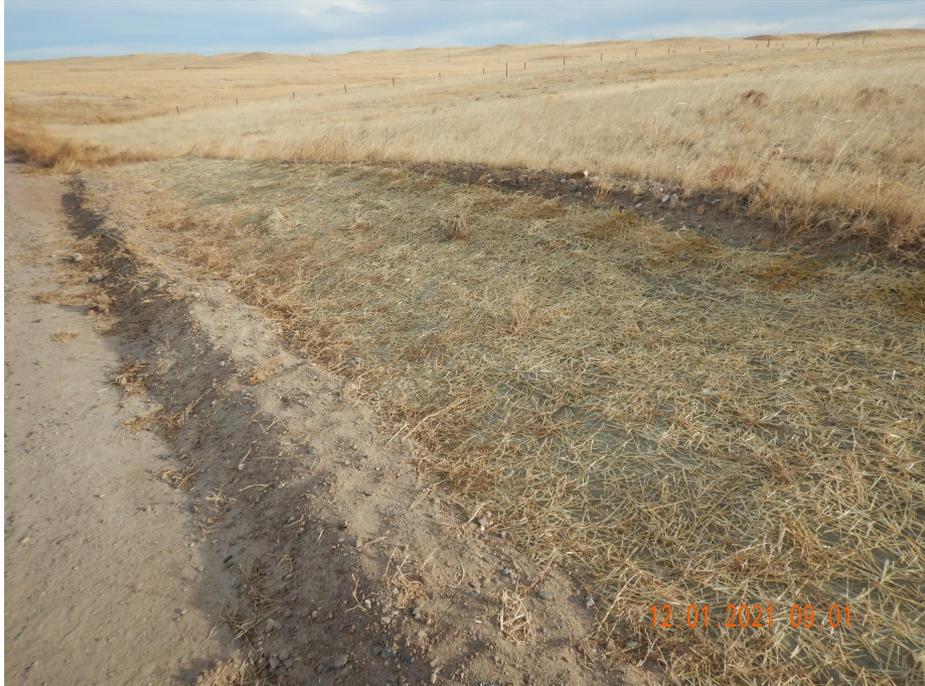
**Photo 6.** Photo taken from the southern access road, facing Northeast. Photo illustrates Operator has stabilized the cut slope along the access road.

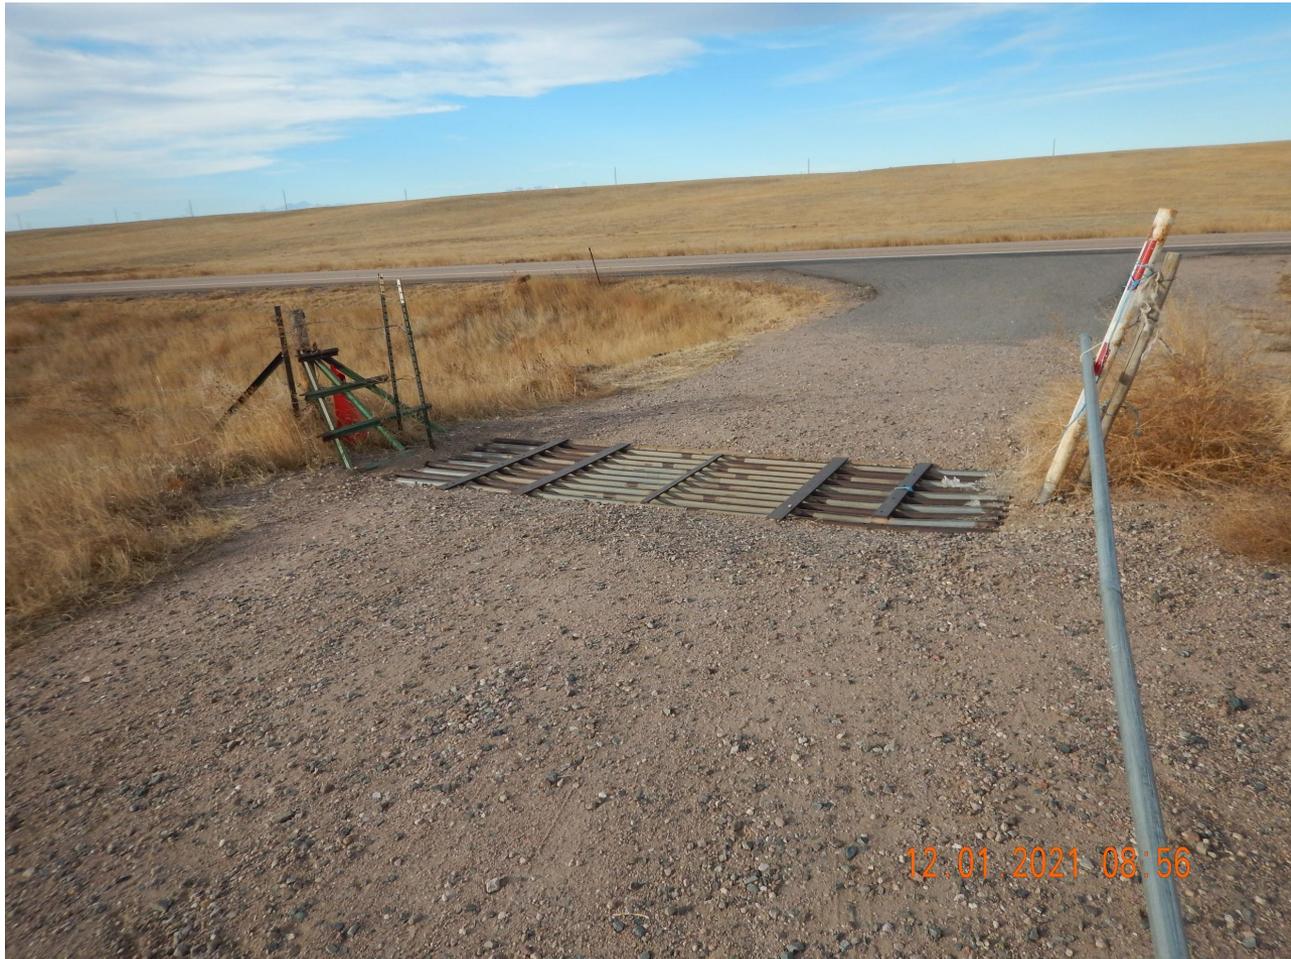
**Photo 8.** Photo taken from the entrance of location, facing West. Photo illustrates the cattle guard has not yet been replaced but there are plans to replace with a used cattle guard from a nearby PA location.
