Inspection Photos

Operator: LARAMIE ENERGY LLC # 10433

Location ID: 335950

Garfield County, CO

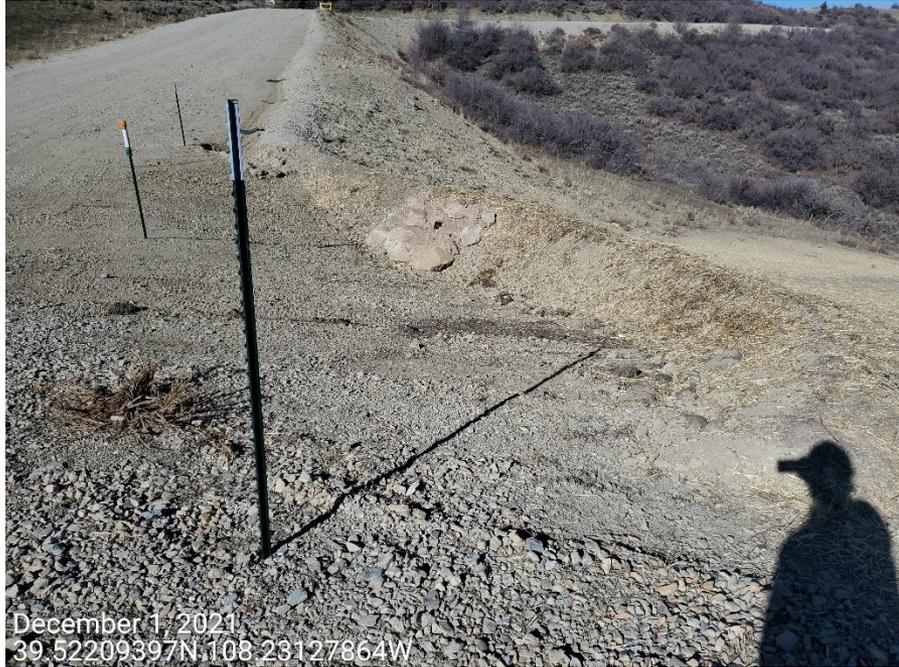
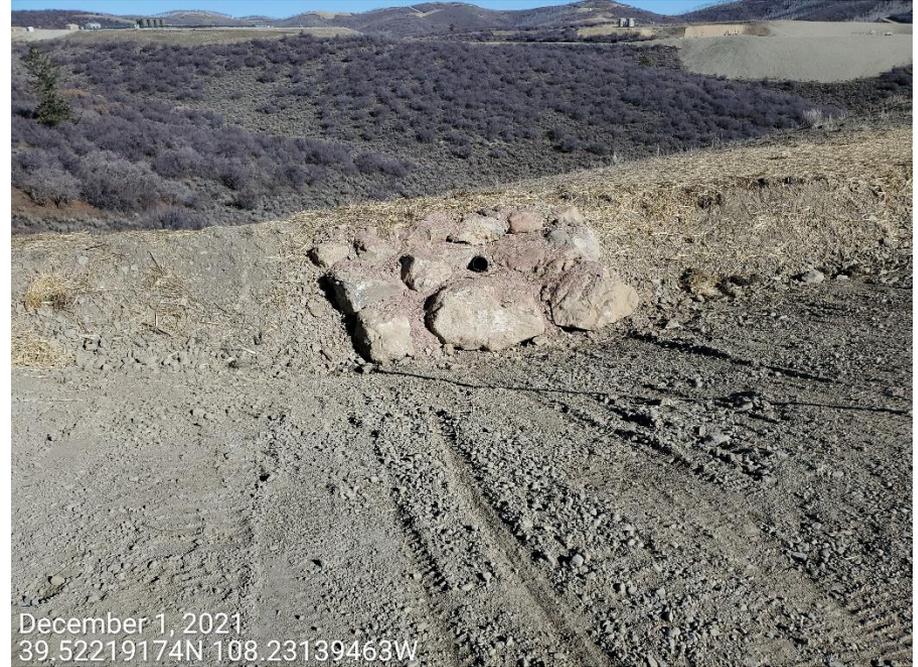
Photo 1: Photos taken from the northwestern end of the Location, facing west and north. Photos show Operator has installed a sediment trap in conjunction with a slope drain; erosion degradation repaired.

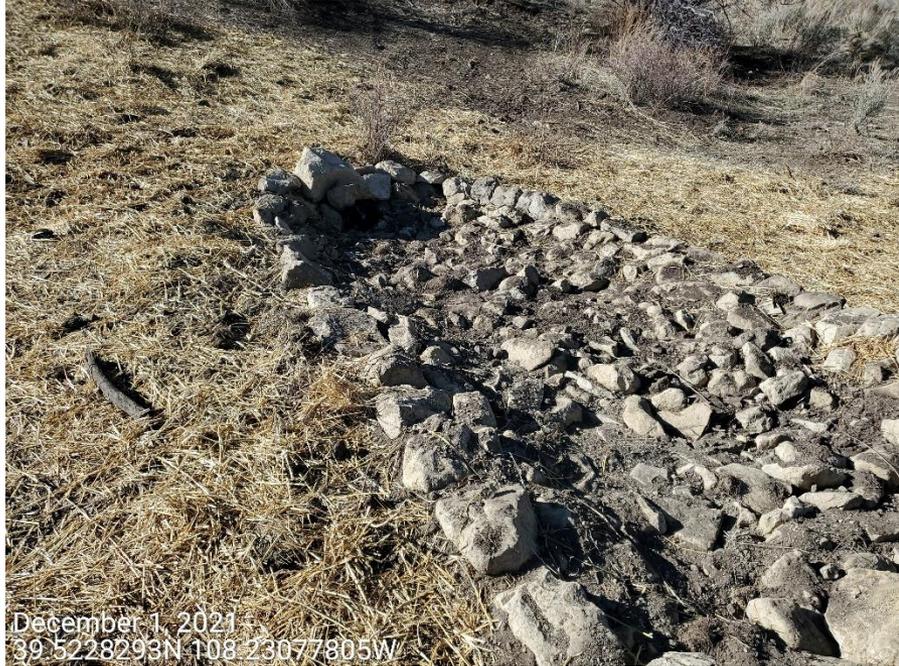
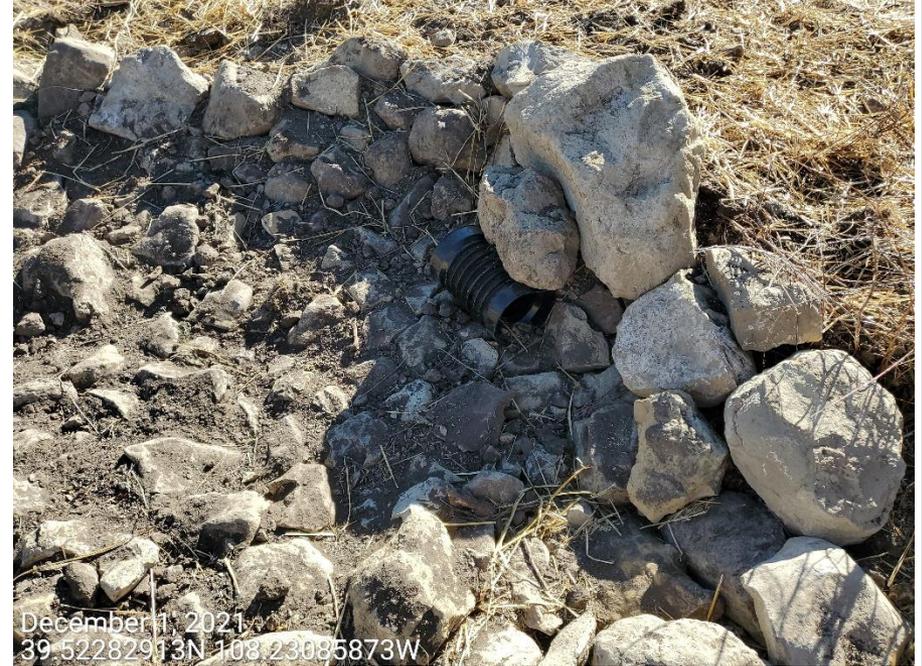
Photo 2: Armored slope drain outlet.
