Inspection Photos

12/01/2021

Operator: LARAMIE ENERGY LLC # 10433

Location ID: 383337

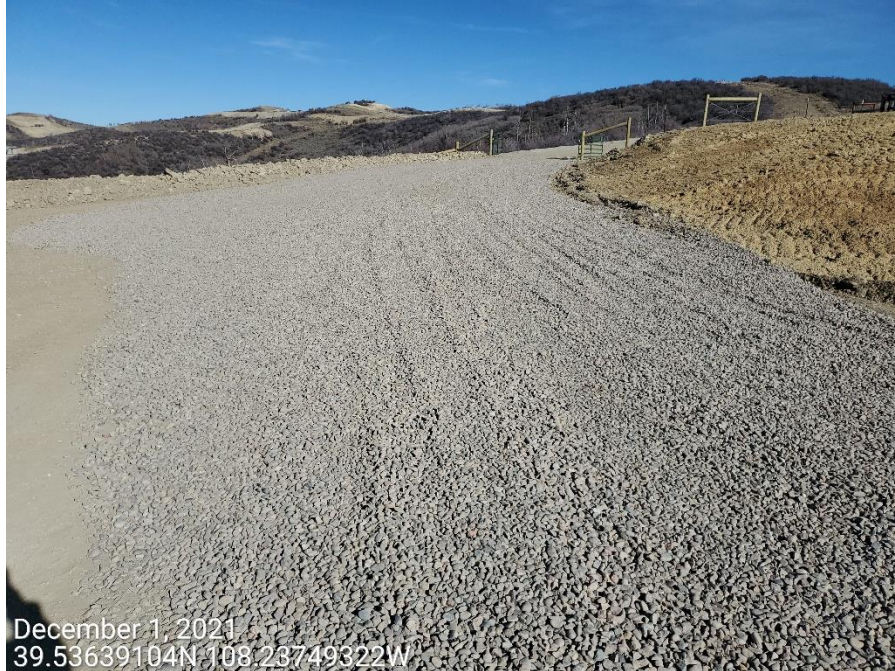
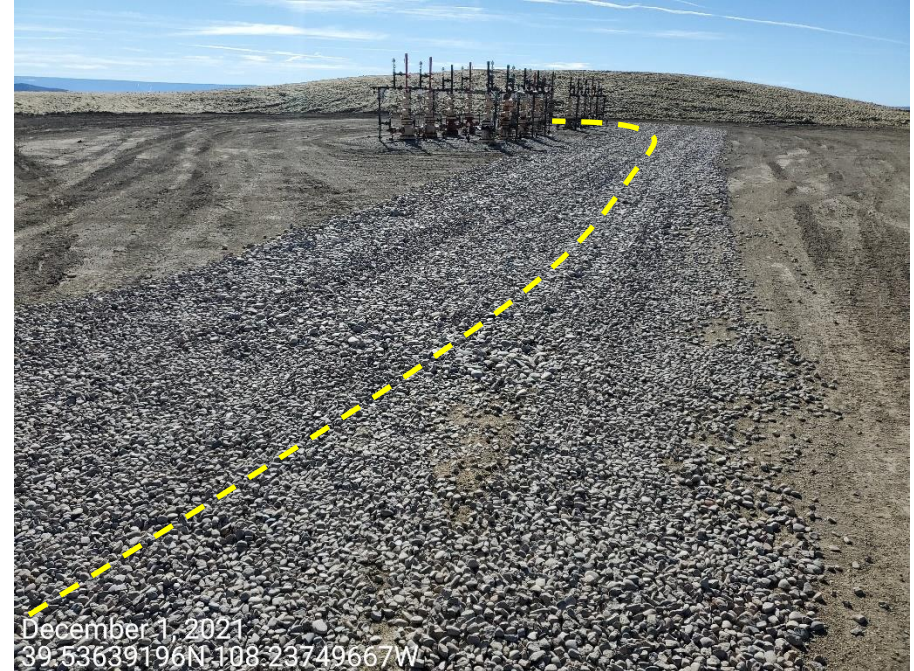
Photo 1: Photos show Operator placed gravel on select sections of the Location; from the entrance leading south around the wells. Control measures to stabilize the entire Location, minimize tracking and offsite sediment transport per good engineering practices remain missing or insufficient.

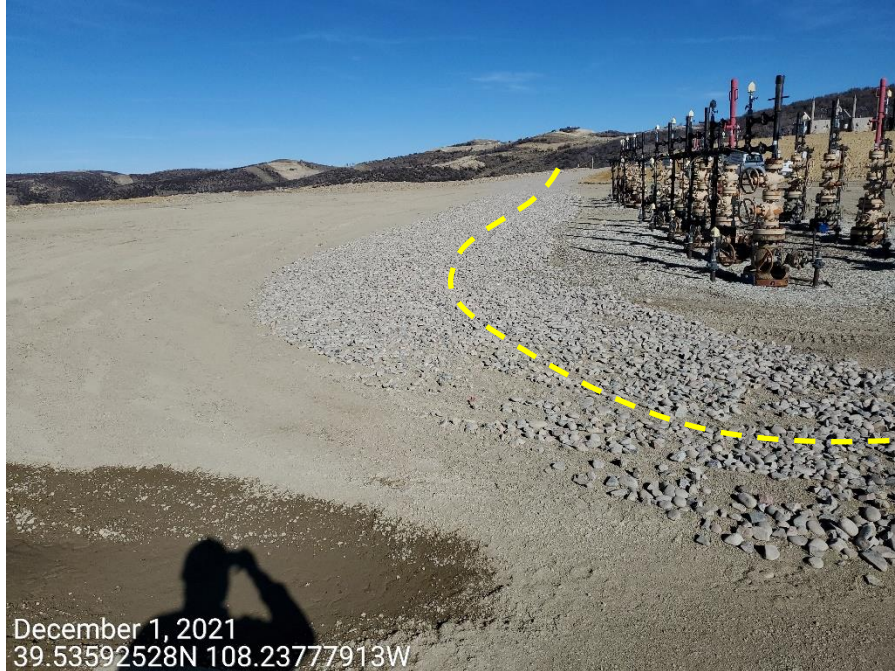
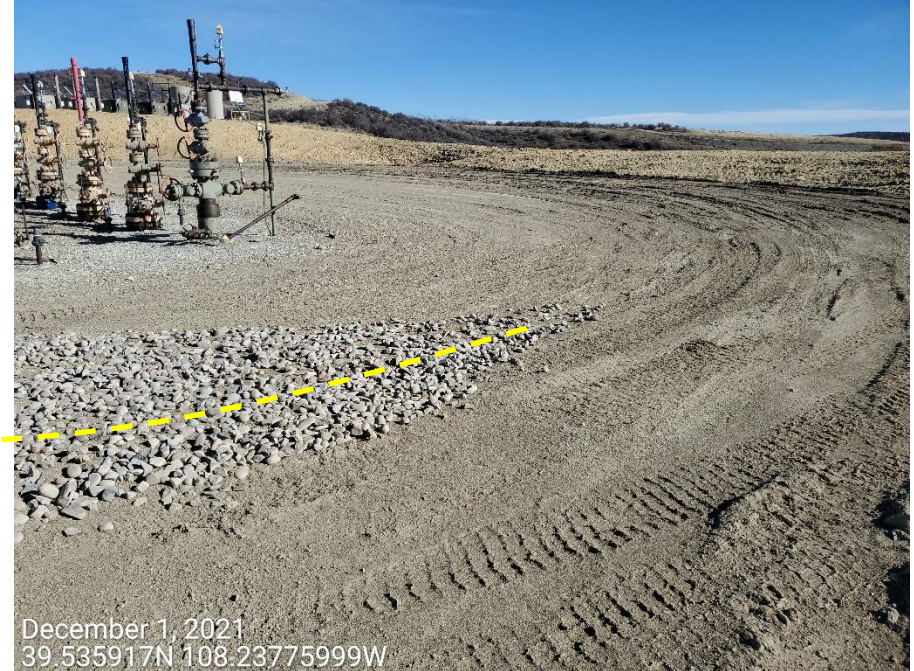
Photo 2: Photos show Operator placed gravel on select sections of the Location; from the entrance leading south around the wells. Control measures to stabilize the entire Location, minimize tracking and offsite sediment transport per good engineering practices remain missing or insufficient.

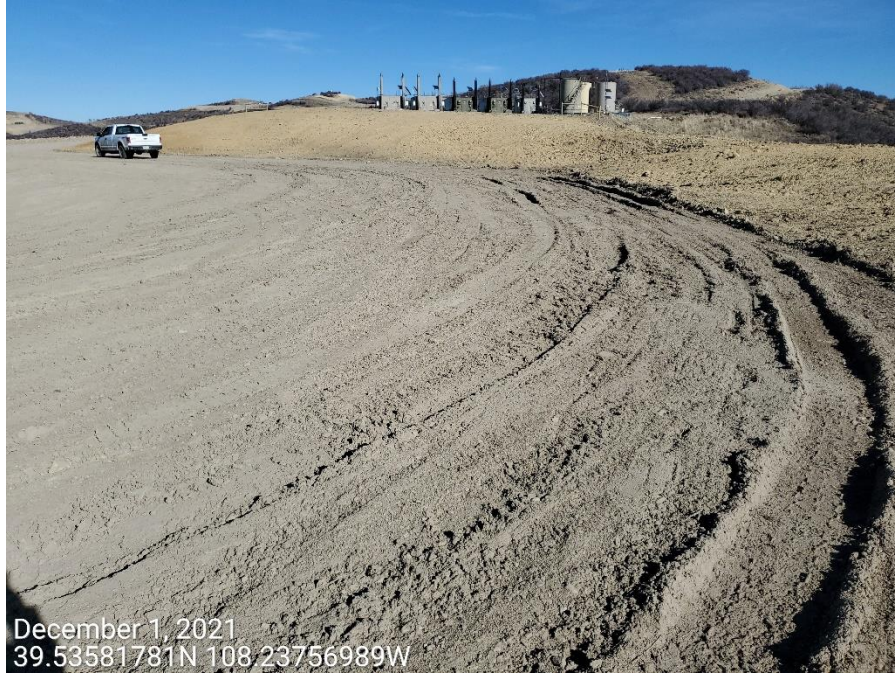
Photo 3: Photo taken from the east end of the Location. Photo provides example showing control measures to stabilize the entire Location, minimize tracking and offsite sediment transport per good engineering practices remain missing or insufficient.

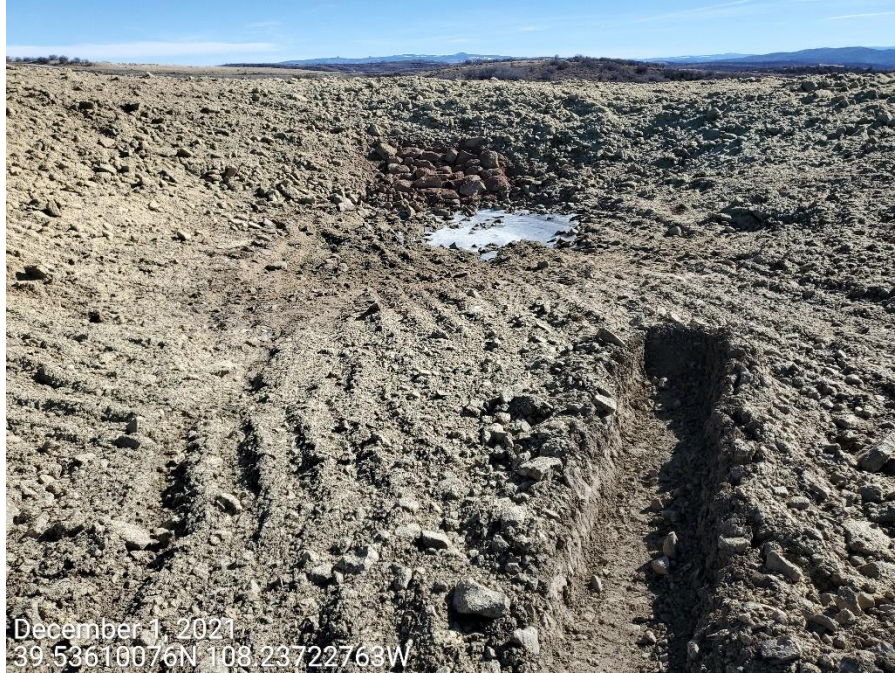
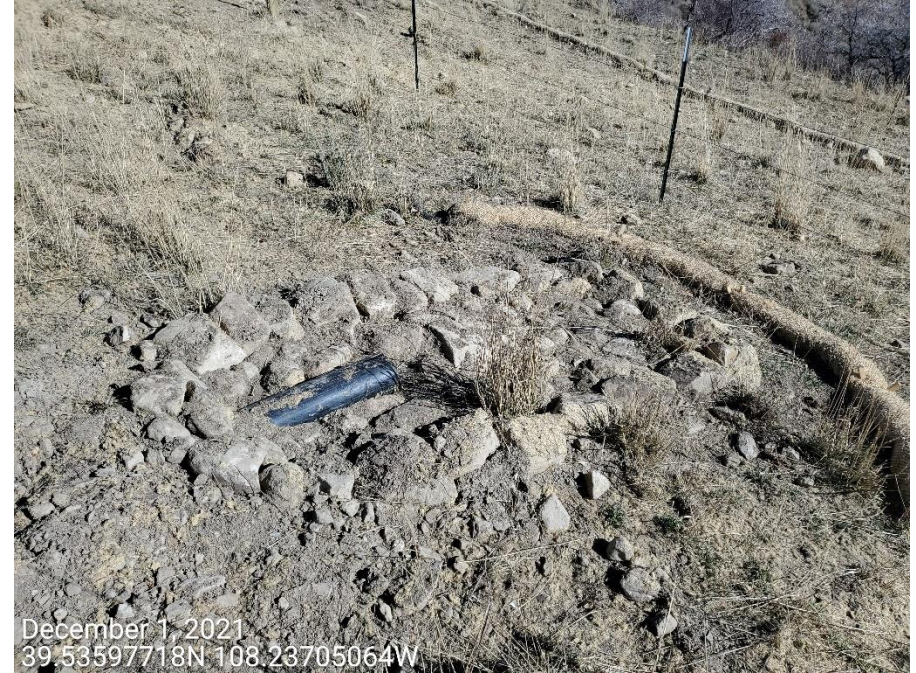
Photo 4: Sediment trap has been re-constructed with an appropriate engineered outlet.
