# Inspection Photos

API: 099-06255

Operator: BERRY\* WALTER V DBA BERRY  
ENERGY INC

Inspection Date: 11/30/2021

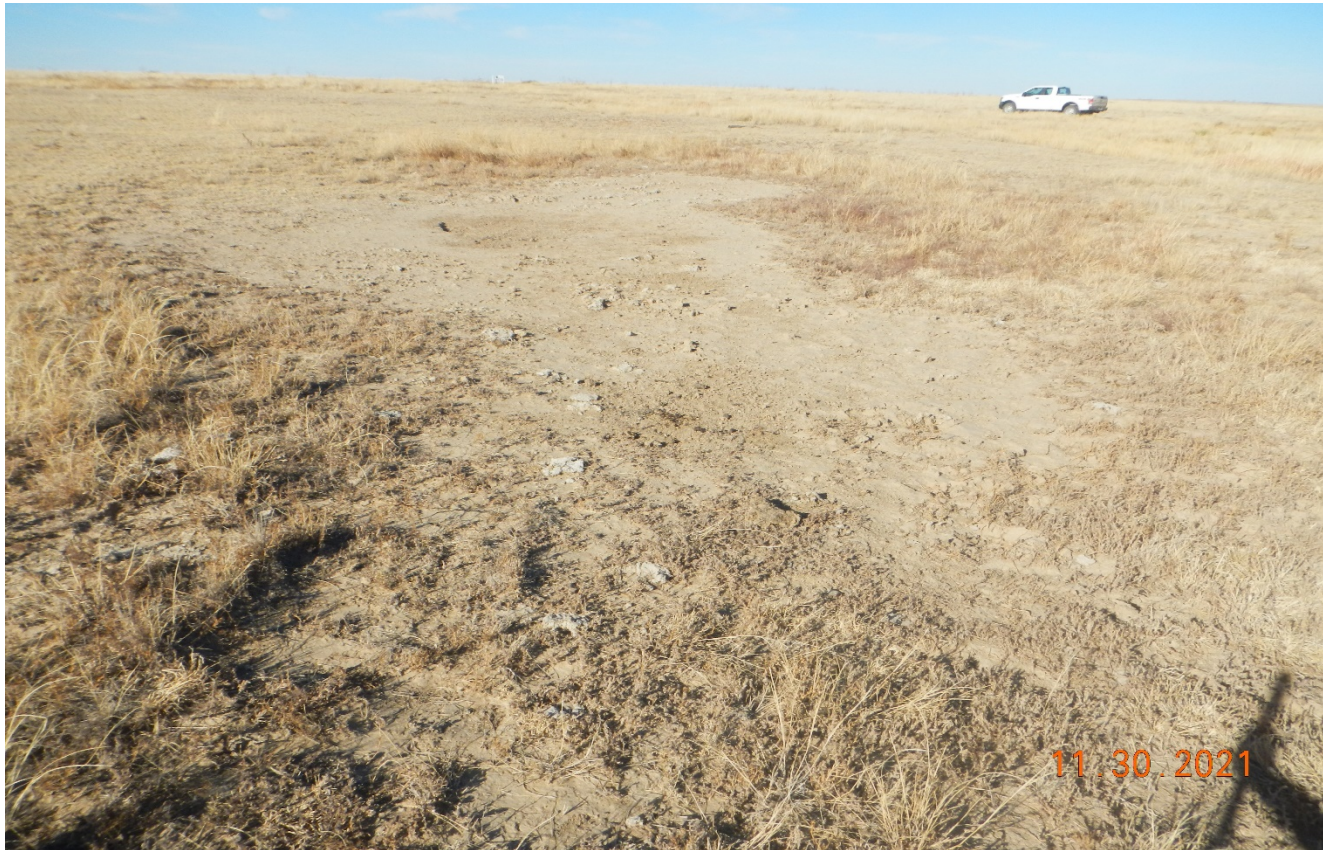
**Photo 1.** South side of the location facing northeast. This area does not have vegetation establishment which is approximately 100'x50'.

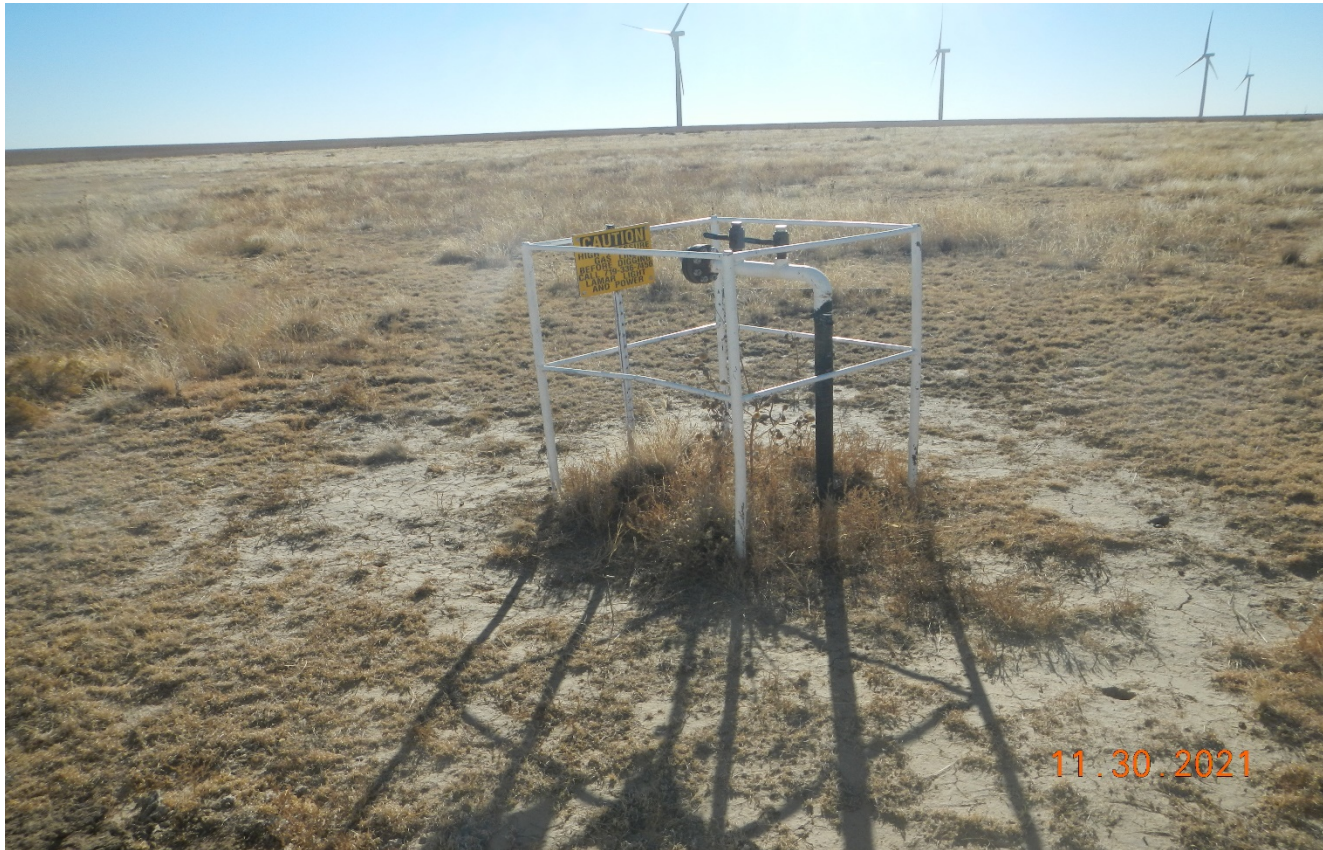
**Photo 2.** There is a pipe riser that remains at the north side of the location.

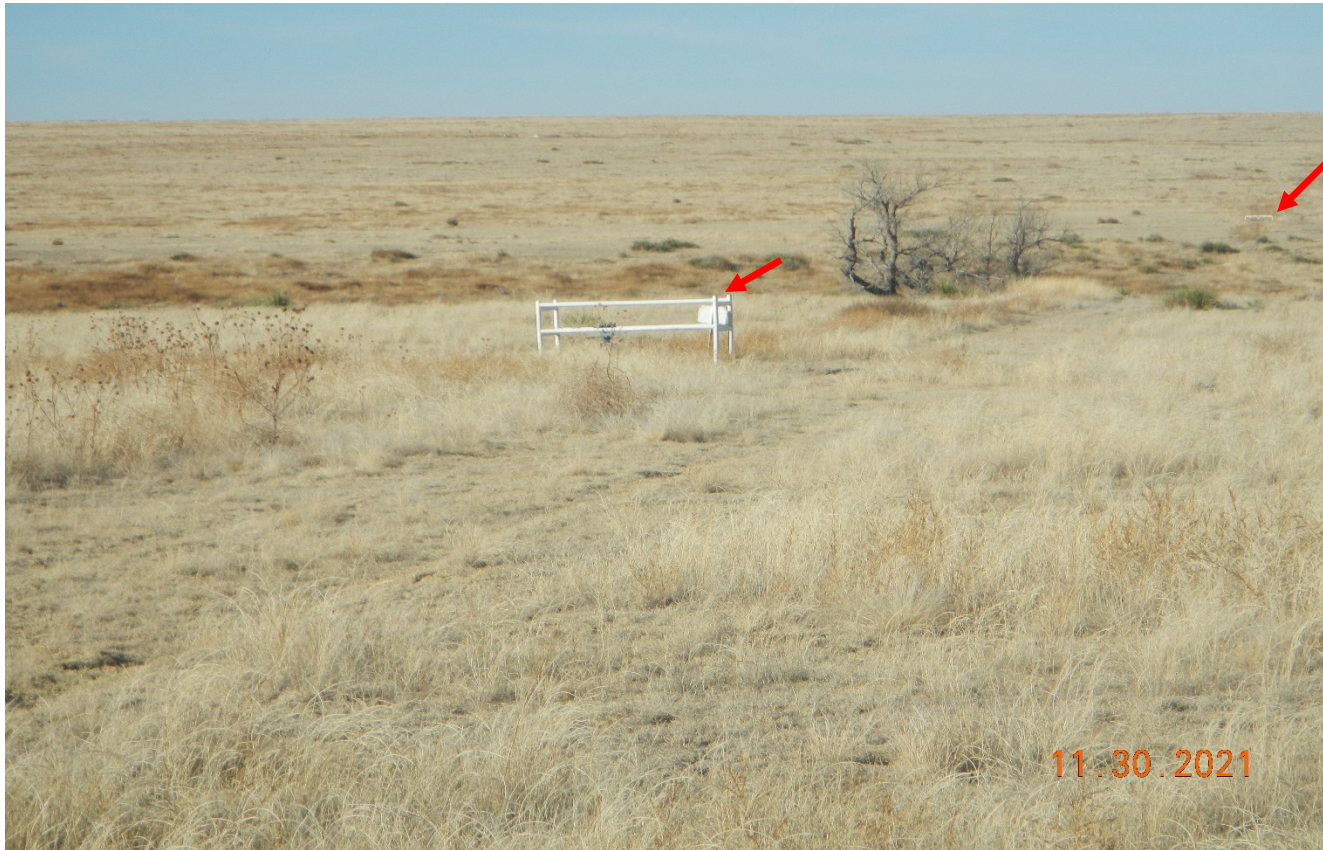
**Photo 3.** Facing northwest approximately 1400 ft. northwest of the location. There are two pipe risers associated with the well site that have not been removed. All equipment/risers must be removed. Lat/Long:37.78859,-102.44911.
