Inspection Photos

API: 099-06354

Operator: BERRY* WALTER V DBA BERRY
ENERGY INC

Inspection Date: 11/30/2021

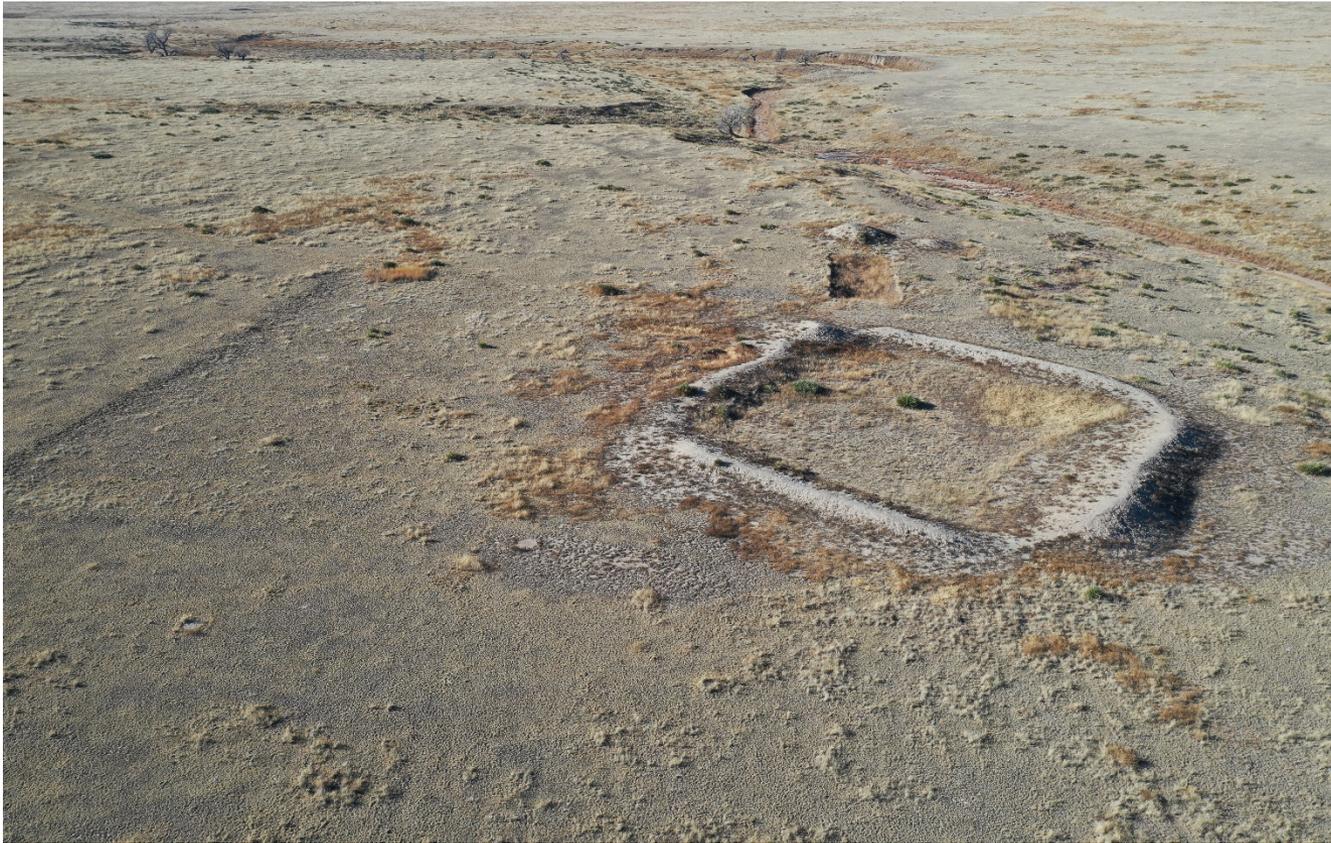
Photo 1. Drone aerial photo facing northwest toward the abandoned well location. The pits were never backfilled and reclaimed.

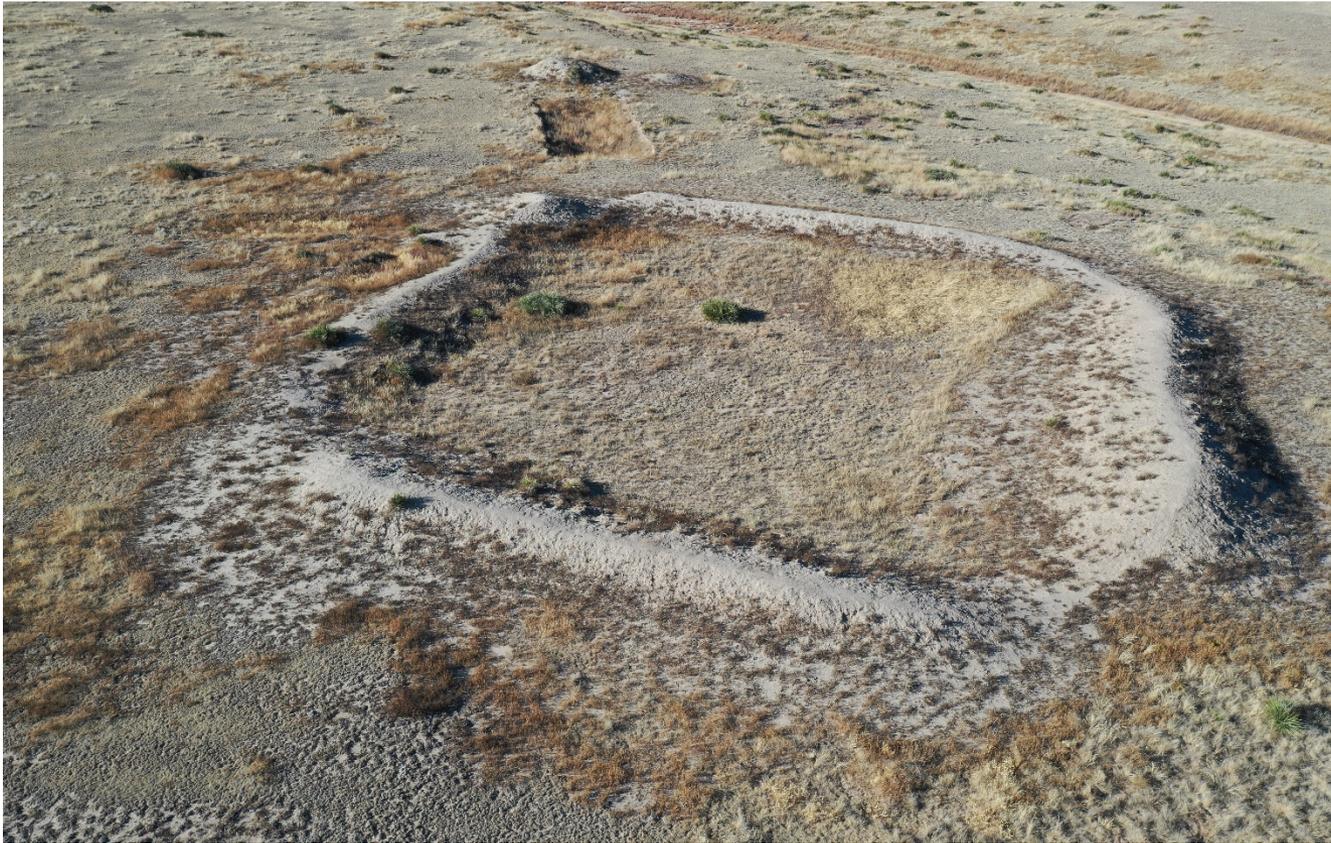
Photo 2. Facing northwest downward toward the pit. The berms of the pit are approximately 150'x150' in size.

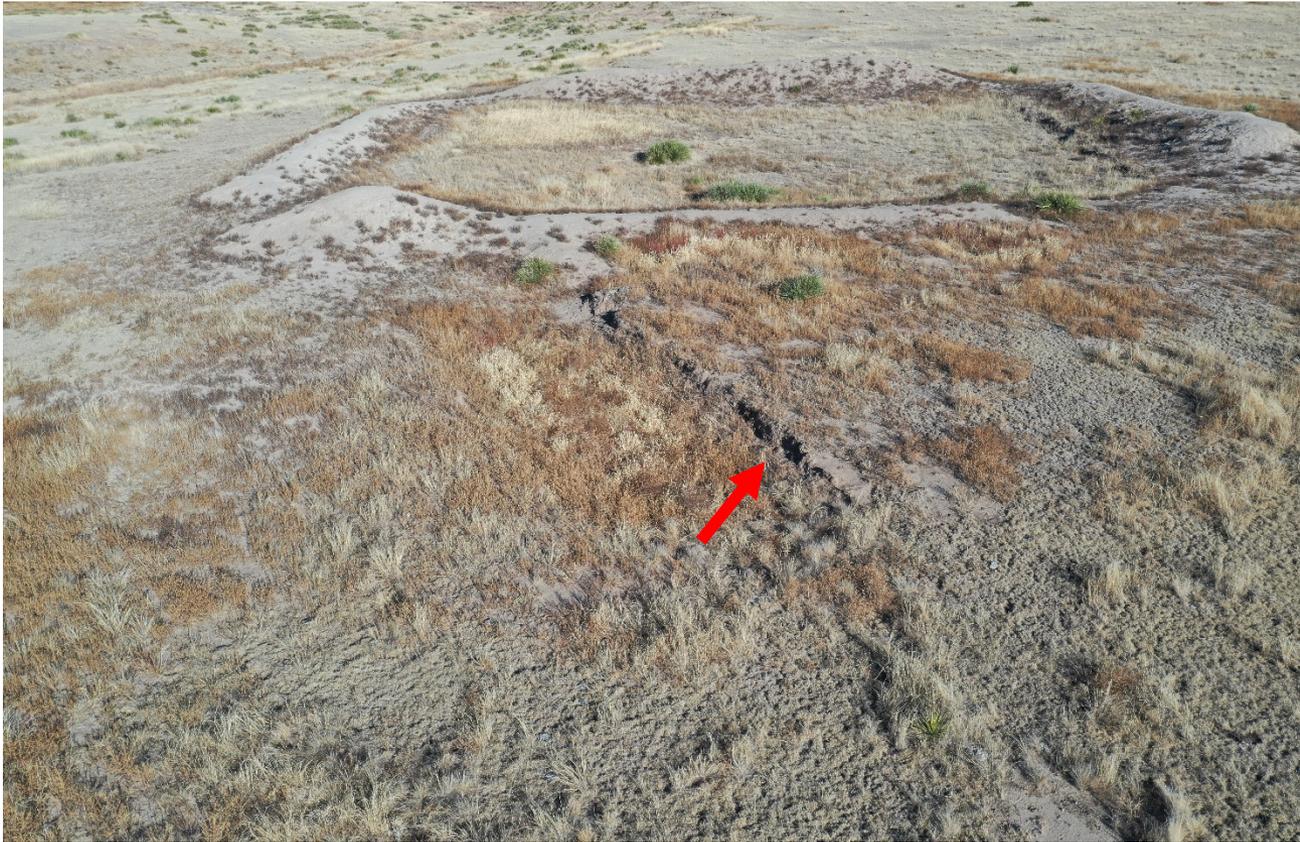
Photo 3. Facing northeast toward the pit. There is trench shown at red arrow which is diverted toward the pit from the location of the abandoned well. This area was never backfilled and reclaimed.

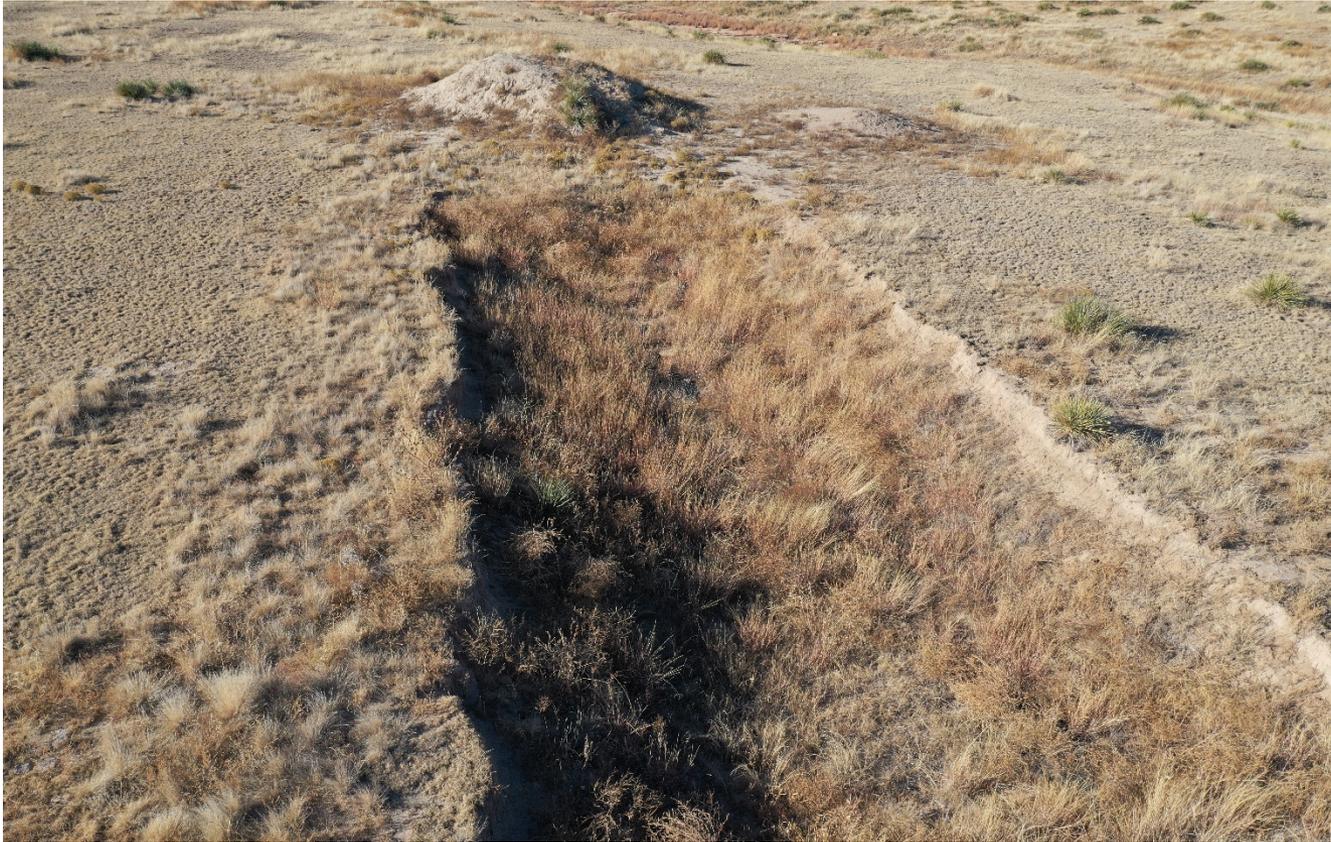
Photo 4. Facing northwest toward a lined pit which is approximately 100'x30' in size. There is degraded liner debris that remains in the pit.

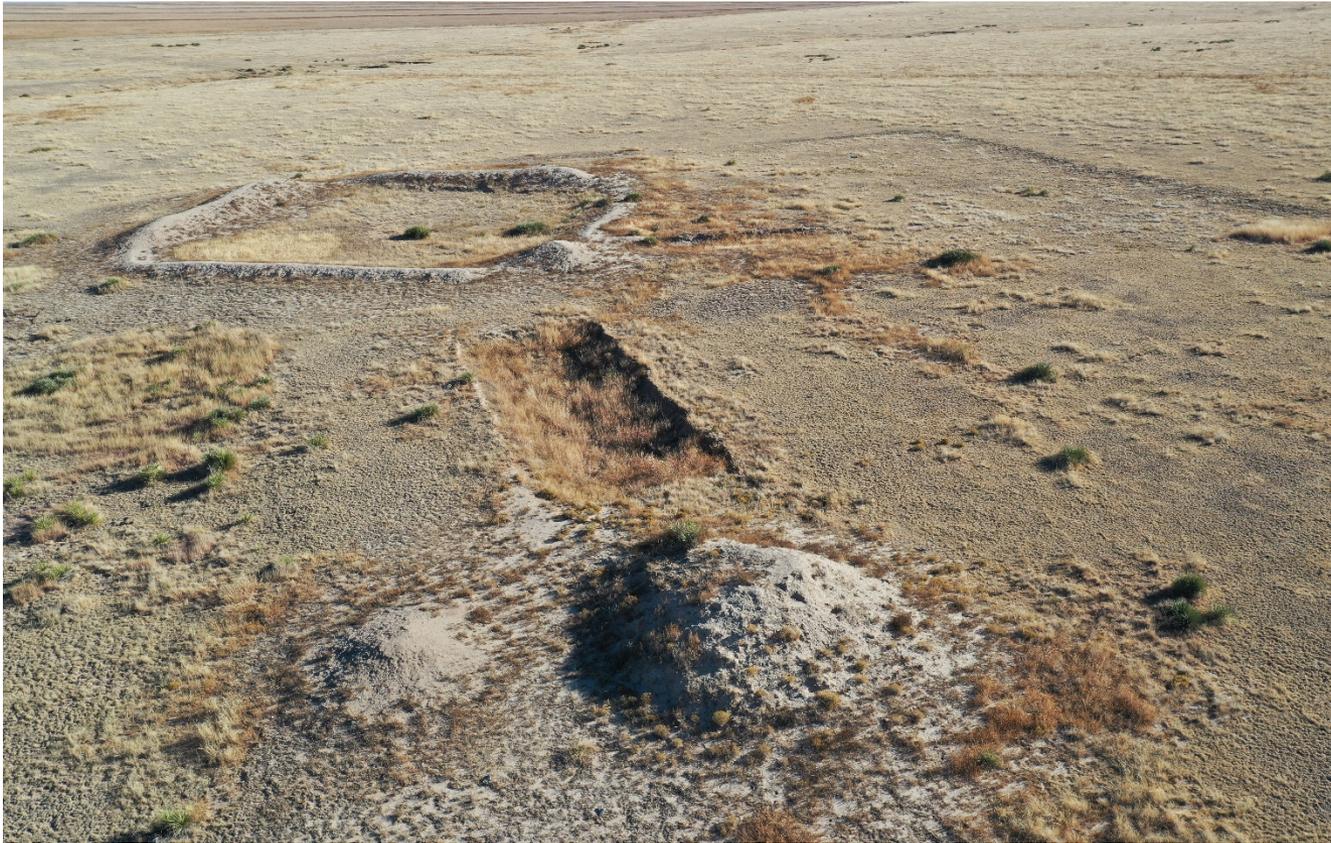
Photo 5. Drone aerial photo facing southeast toward the abandoned well location. The pits were never backfilled and reclaimed.
