Inspection Photos  
Operator: Simcoe  
API: 067-09375  
Date: 11/17/2021

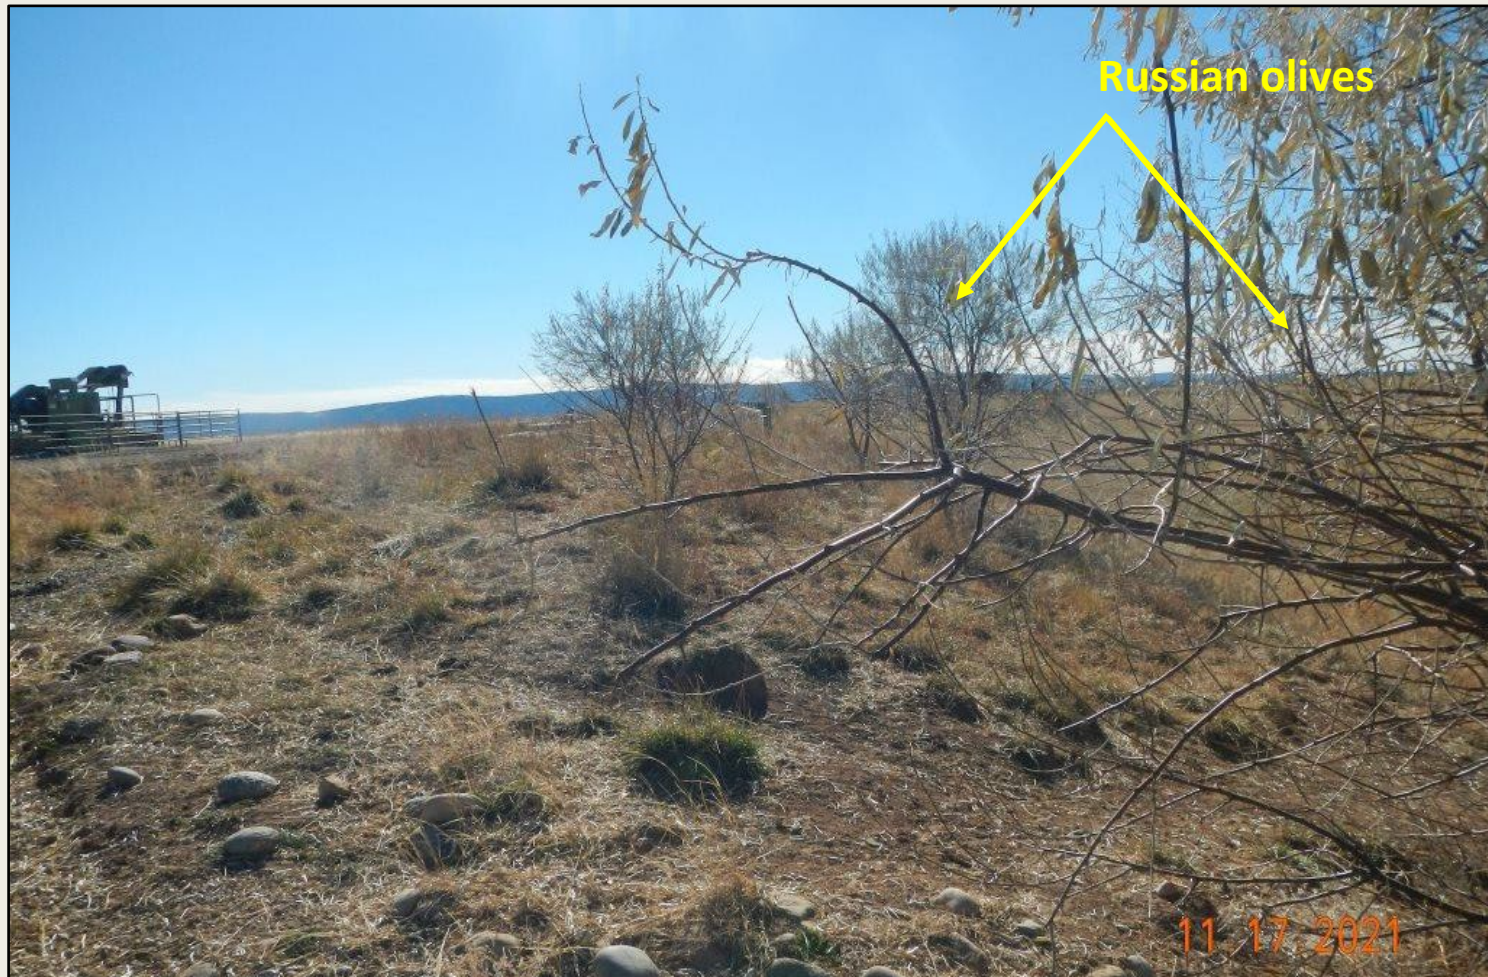
Photo 2. View of the western project area from the northwestern corner facing southward. Approximately 15 Russian olive trees need to be removed. Revegetation is progressing with sand dropseed, western wheatgrass, intermediate wheatgrass.

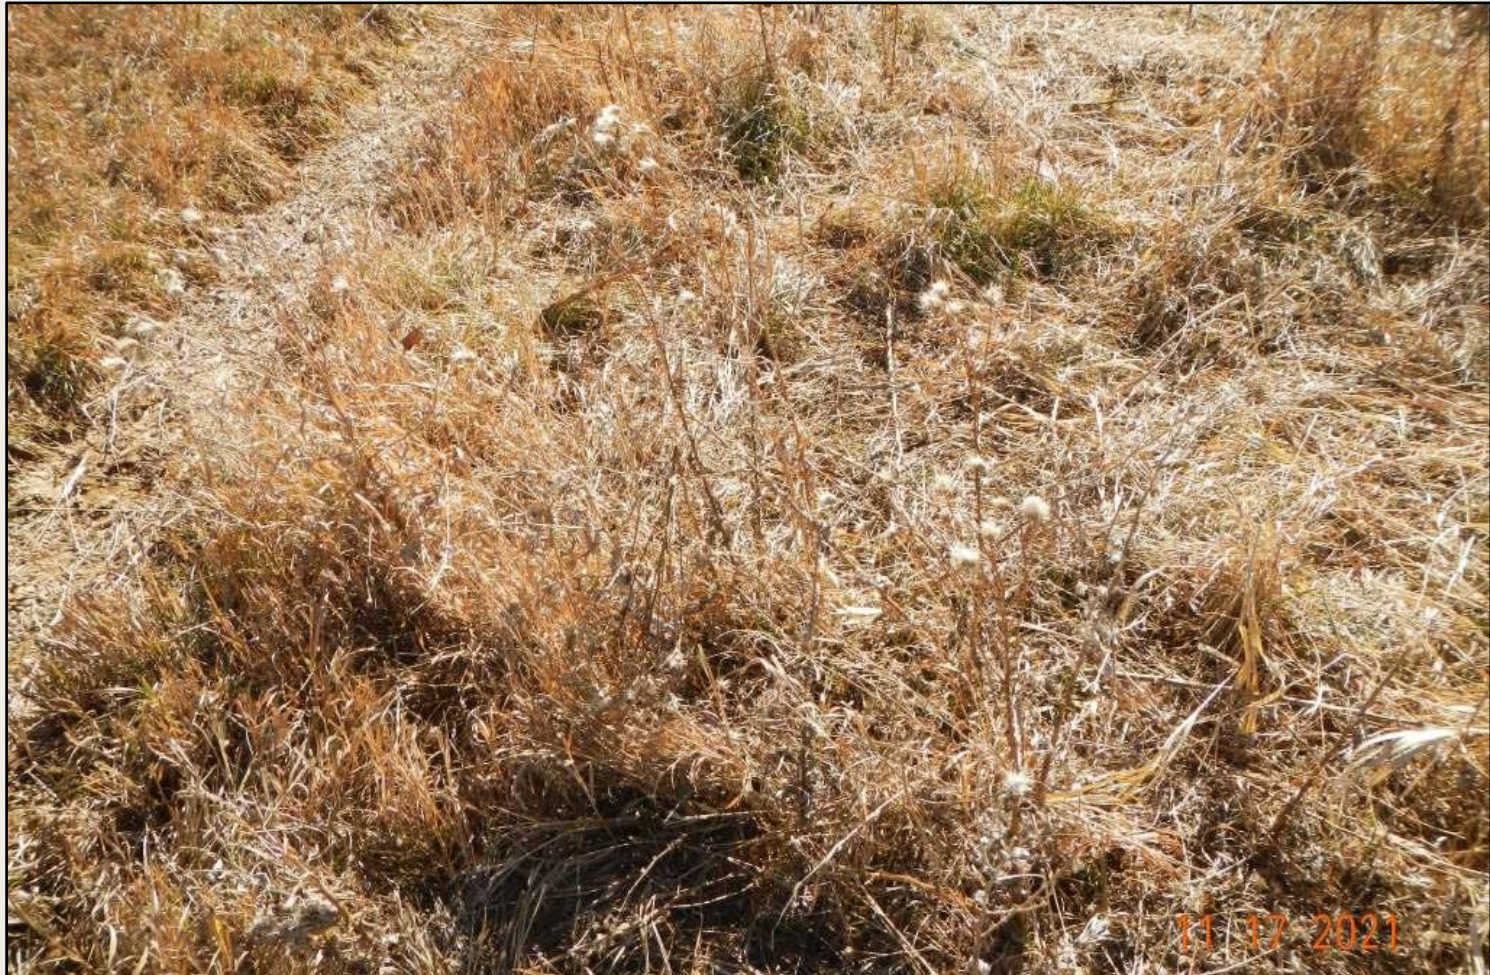
Photo 4. View of Canada thistles need to be controlled within the southwestern project area, approximately 150 individuals observed.
